**Cumberland Council**  
**Ash Dieback Assessment**  
**New Road**  
**Whitehaven**  
**October 2025**

1.1 This New Road Ash Dieback Assessment has been commissioned by Cumberland Council, Parks and Open Spaces, Allerdale House, Workington.

1.2 The assessment commissioned to assess Ash, *Fraxinus excelsior*, tree specimens situated within Cumberland Council amenity woodlands to the east and west of New Road Whitehaven. The Ash dieback inspection assessment being undertaken from ground level with no exploratory excavation works undertaken.

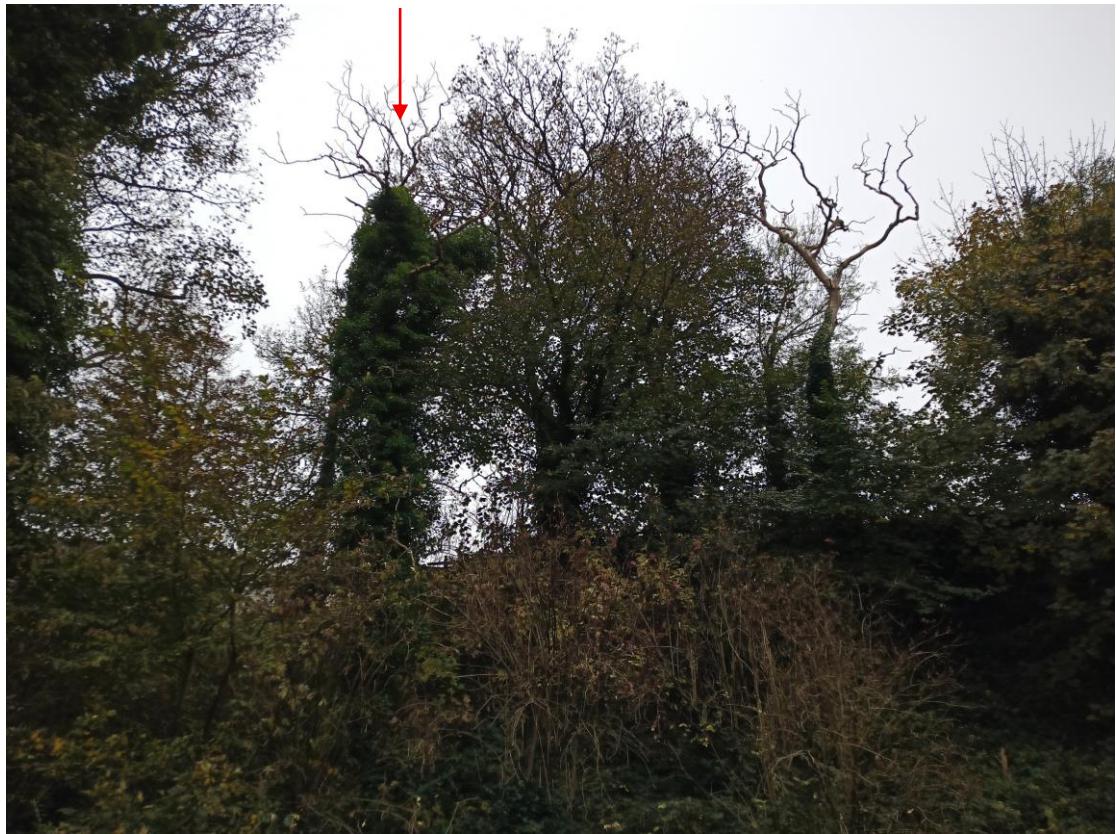
T142. Dead standing stem with extensive established Ivy. Fell recommended.

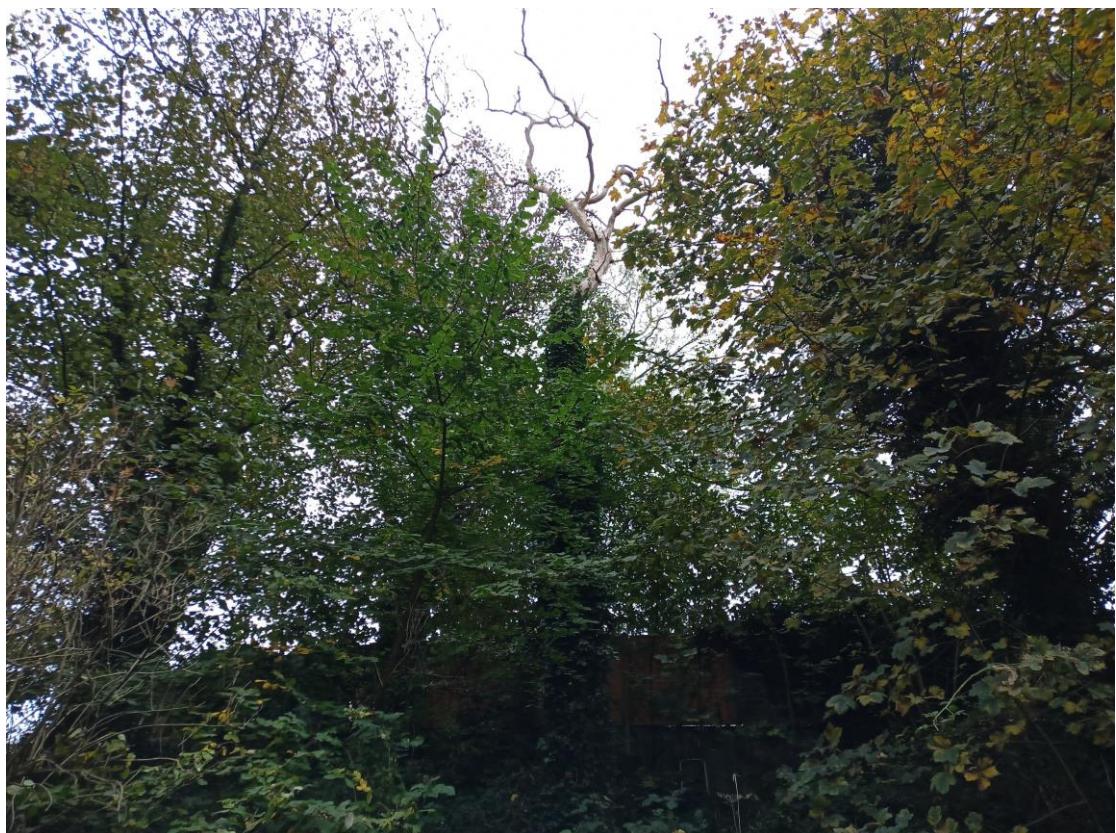
T144. Dead standing stem with extensive established Ivy. Fell recommended.

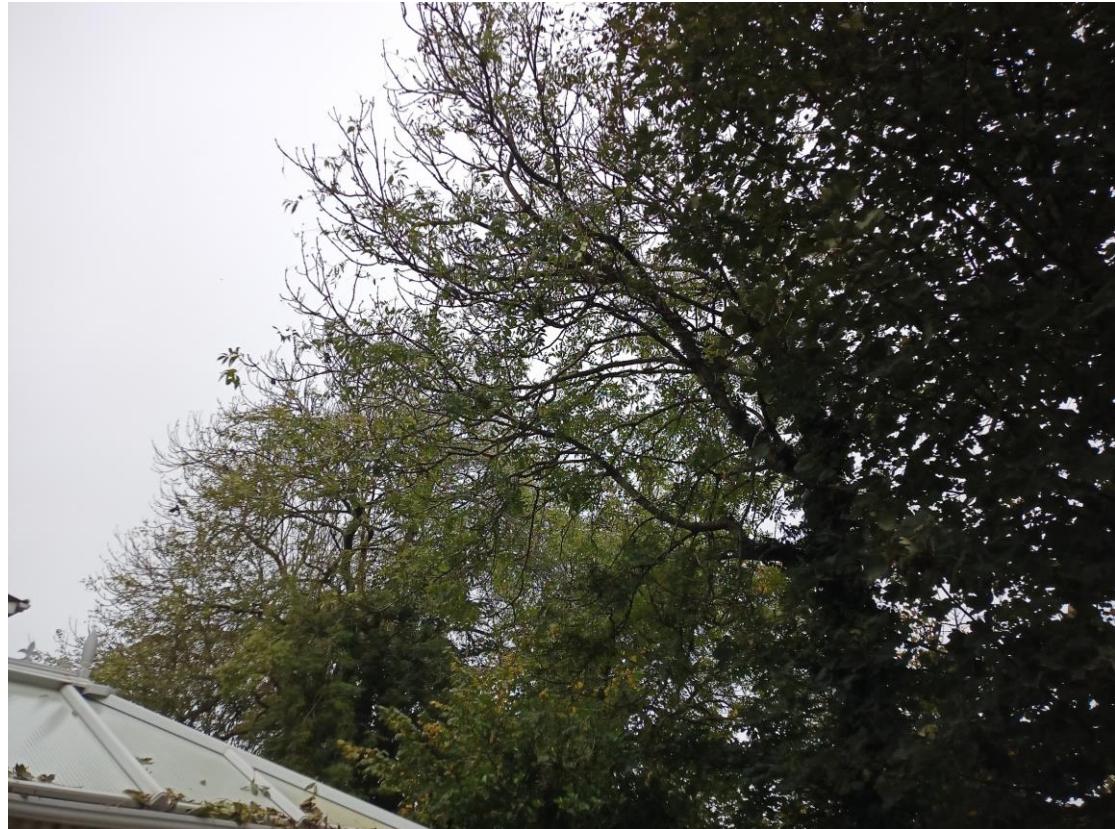
T143. Specimen to rear of 17 Wellington Row. Asymmetrical crown over boundary and garden. Extensive established Ivy on main stem. Evidence of stage 2 Ash dieback at time of inspection. Fell recommended. Prune to crown raise and side prune back to boundary could be considered. However. The prognosis, due to the presence of Ash dieback, long term would be removal.
