Ref: ENQ768104

SURVEY REPORT

PROPERTY ADDRESS
Old Whittles Building, 6 Duke Street
Whitehaven
Cumbria
CA28 7ER

Dampness to the walls
Fungal decay

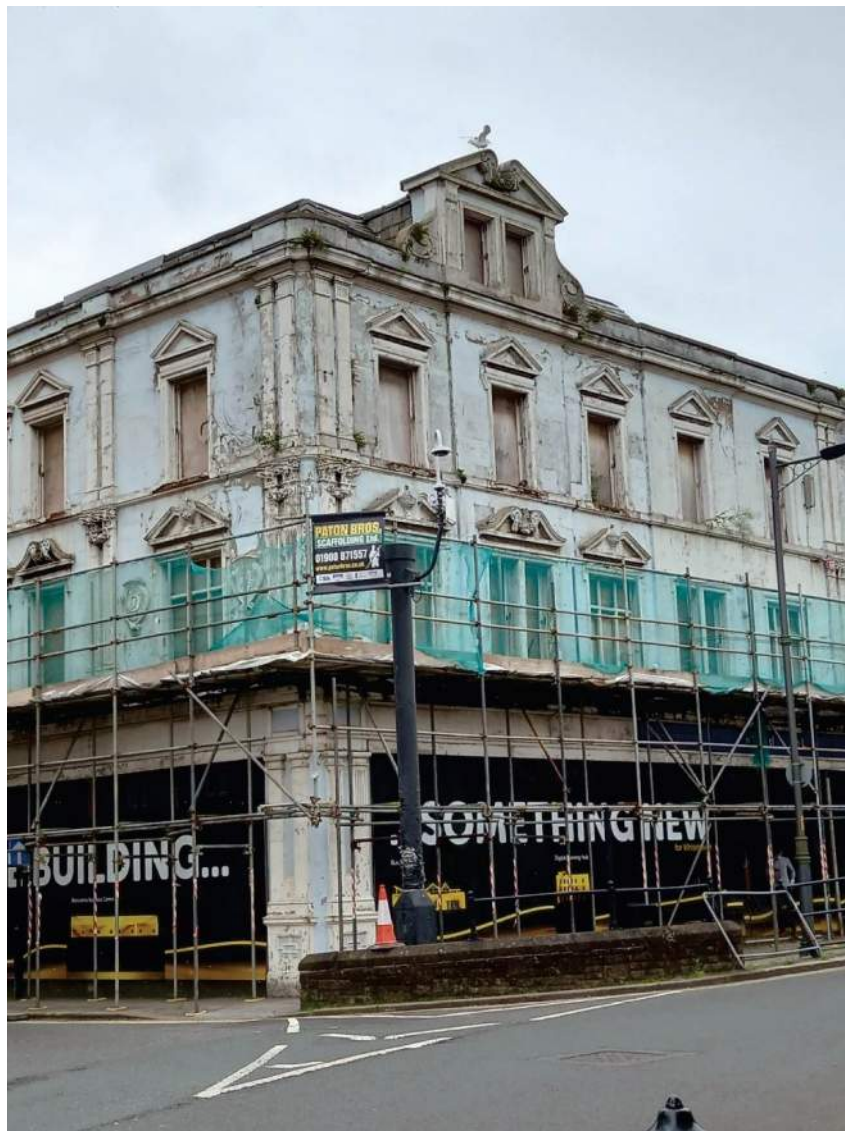
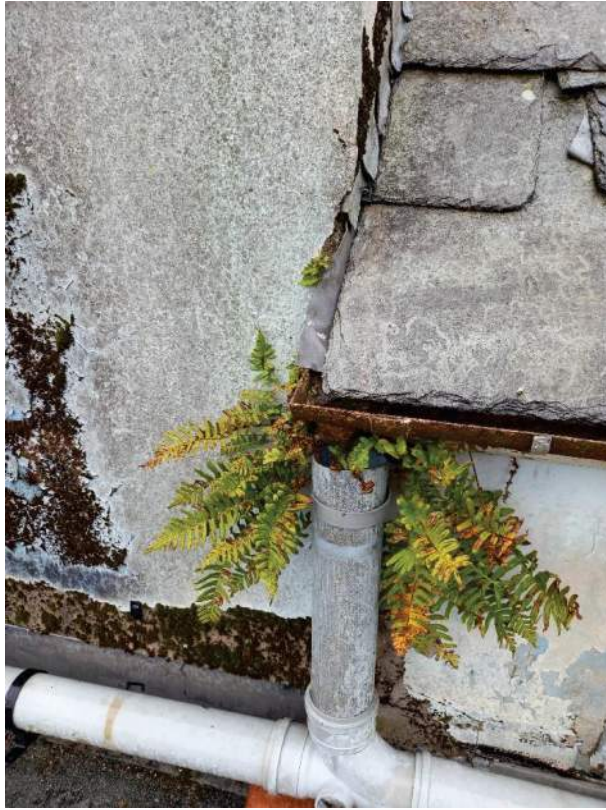
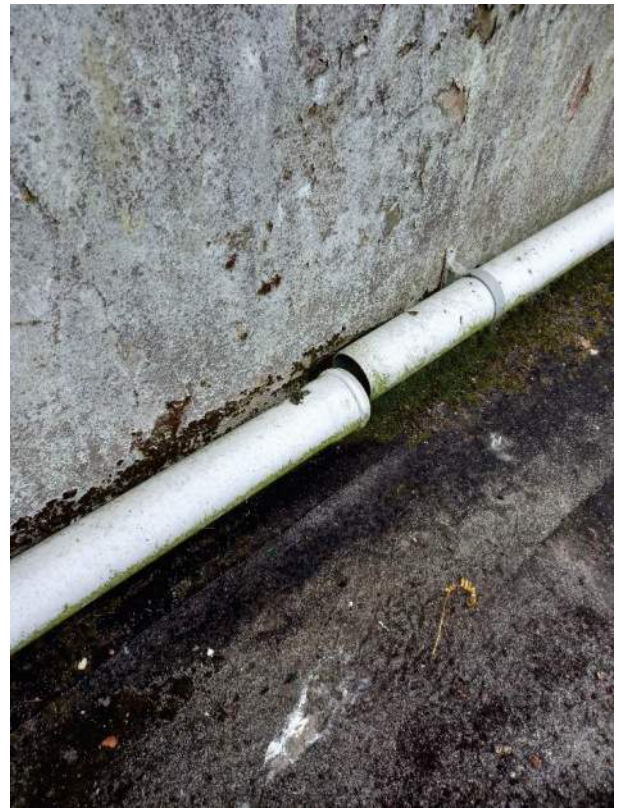
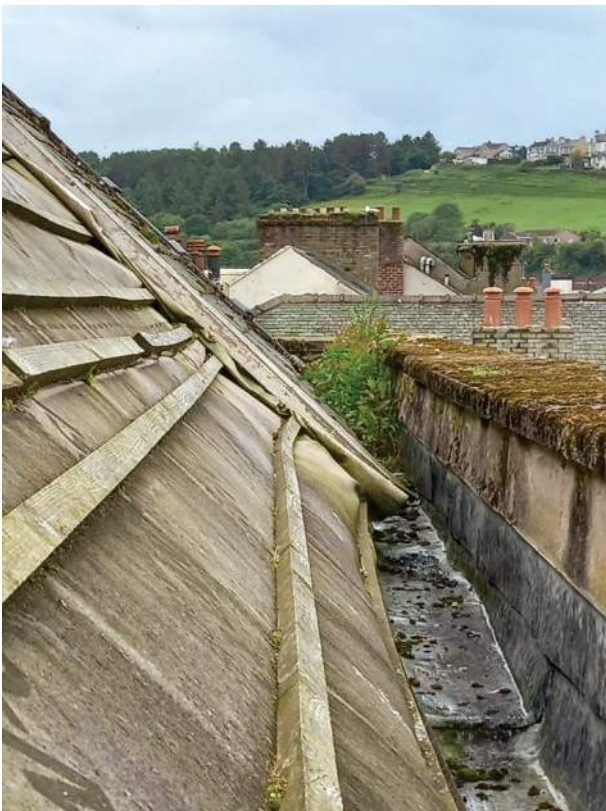
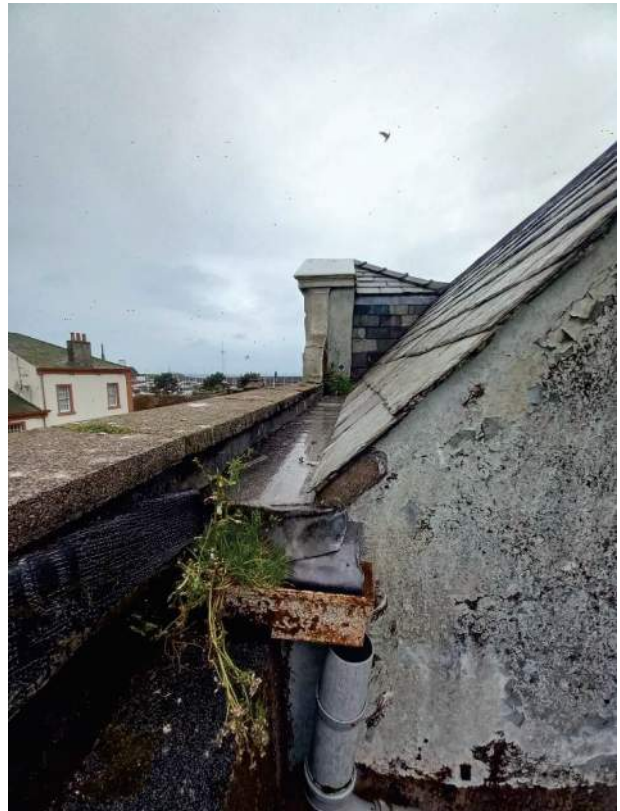
The property is a derelict building and has been empty for a number of years.

This has allowed the gutters to become blocked and dislodged which in turn is allowing some rain water penetration to the building especially the front and left hand gable walls.

This is a new project and we were informed on site the property is going to be fully overhauled with new flat roof coverings, gutters and down spouts carried out by the main building contractor.

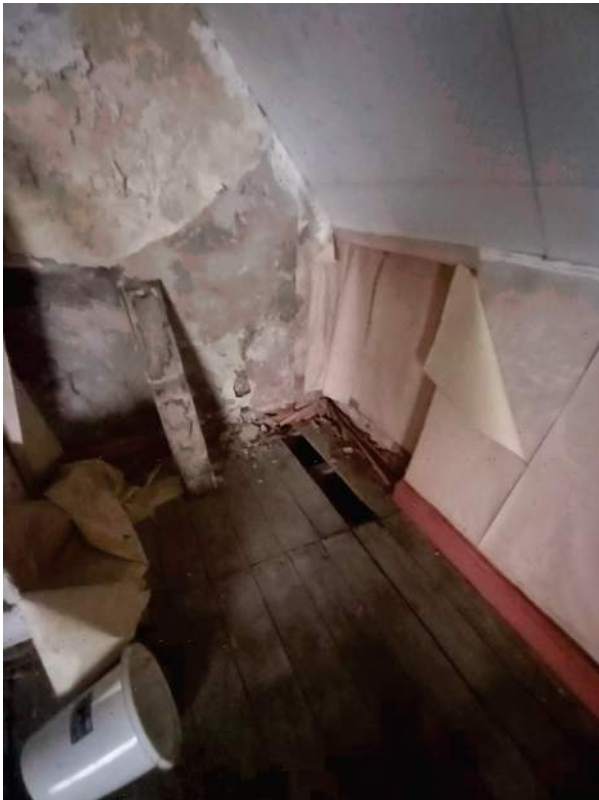
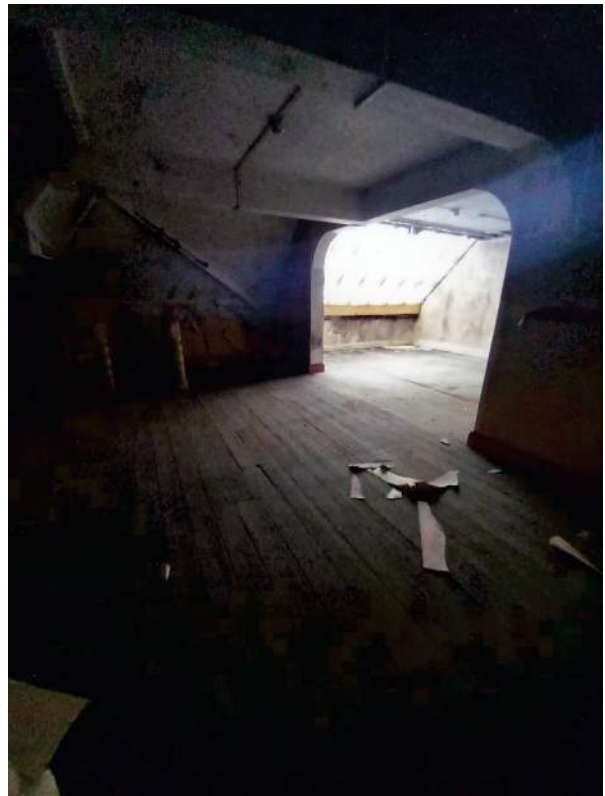
Area 1 – Top Floor Attic (3rd)

Decay by the wet rot fungus (*Coniophora puteanea*) is evident to skirting boards to the front right hand corner of the room.

Defective wall plaster was evident to the rear left hand gable wall where roof coverings are missing

Cause of Attack: This attack appears to have been caused by defective external rain water goods and roof coverings as noted above.

The defective wall plaster is to be removed along with and defective skirting boards

The wall plaster is to be replaced using a sand/cement render incorporating a salt retardant additive and the skirting boards replaced with new treated skirtings.

This work is to be carried out by the main contractor under separate contract.

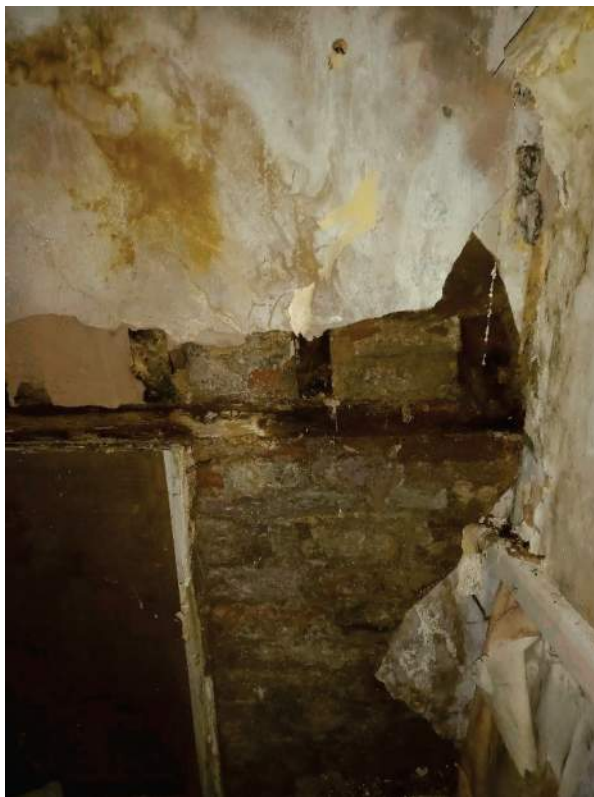
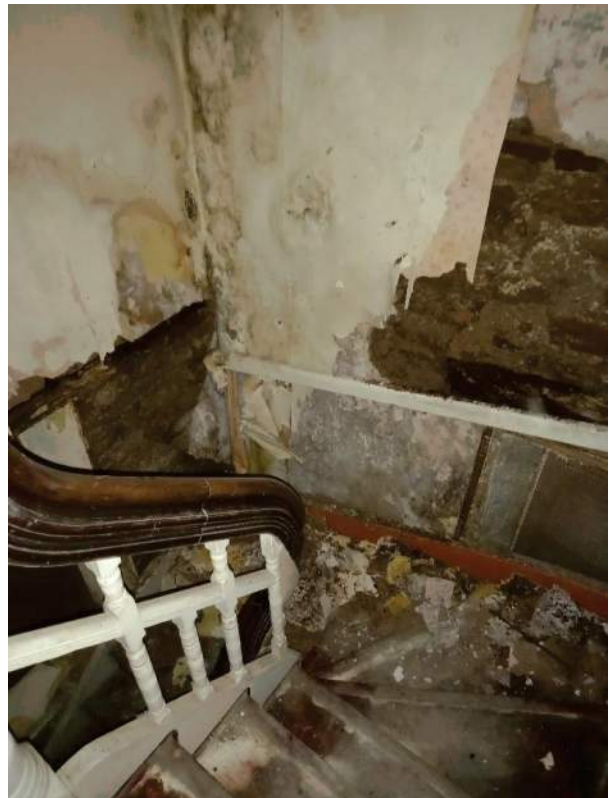
Area 2 – 2nd Floor

Decay by the wet rot fungus (*Coniophora puteanea*) is evident to the floor/ceiling joist, full length of the room, to the front elevation.

This is to the front bearing ends of the joist.

Defective wall plaster was evident to the same area as indicated on the enclosed sketch where pockets of wall plaster was removed to expose the front bearing ends of the joist.

Decay is also evident to the wall plate that has been built into the brickwork directly beneath the floor joist which also acts as lintols above the windows.

The decay is most prominent to the front left hand corner of the room around the staircase extending along the left hand gable wall and along the front wall.

Cause of Attack: This attack appears to have been caused by defective external rain water goods and roof coverings as noted above.

Peter Cox are to carry out **TREATMENT No.5** as follows:-

Prop the front bearing ends of the joist using scaffold planks and acro props.

- b) Remove sufficient floor boarding to allow the joist to be cut back to sound timber away from the wall and remove debris from site
- c) Renew the above stated timbers ensuring that all contact surfaces are coated with either a bituminous solution or 2 liberal brush coats of water repellent fungicidal fluid and capped or laid on PVC DPC membrane. All exposed timber used will be treated with our fungicidal fluid.

Replacement joist ends will be bolted and connected to the remaining sections.

Remove all built in lintols and wall plates to the front wall and left hand gable wall
Brick up the wall where the wall plate was located.
Replace window lintols with either concrete or steel lintols.
Hack off all defective wall plaster.
Re plaster to Peter Cox specifications as noted earlier.

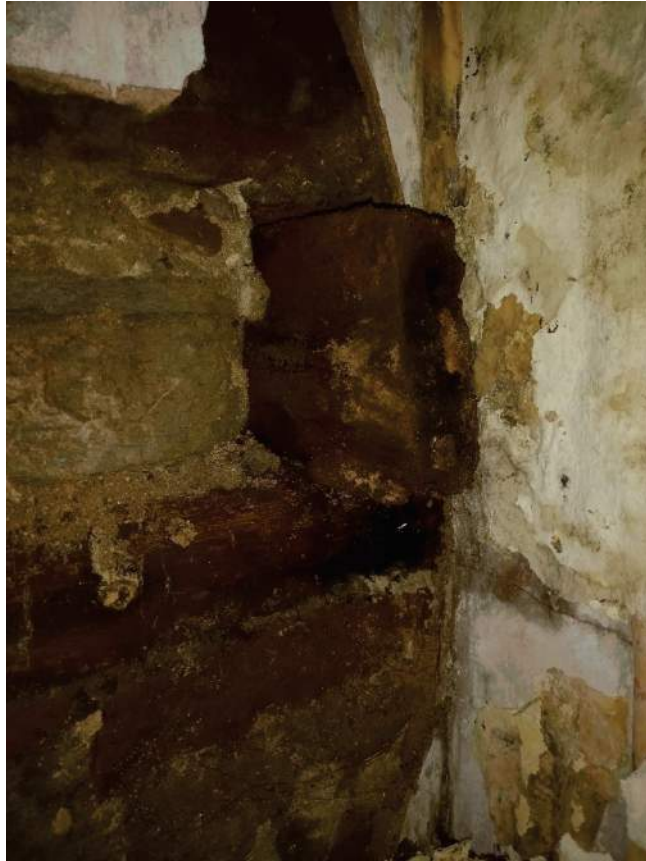
Note – The staircase does not appear to be original and has been fitted more recently.

Floor joist have been cut away to accommodate the staircase, but the short front joist ends have been left within the wall and plastered over, and now need to be removed and the pockets bricked up when the lintol/wall plate is replaced.

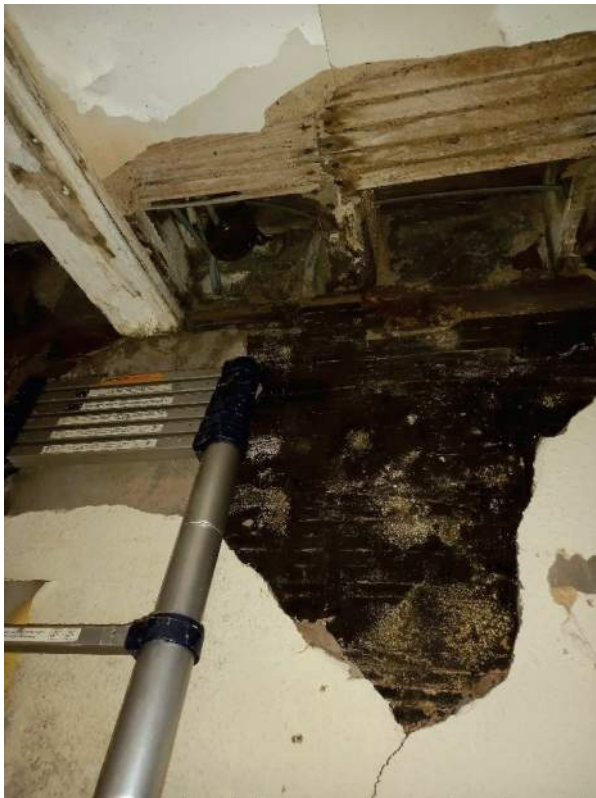
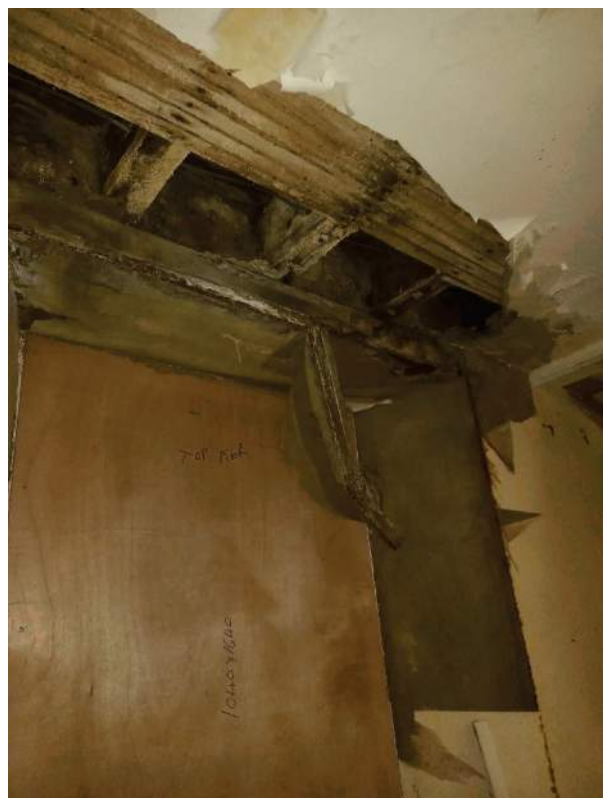
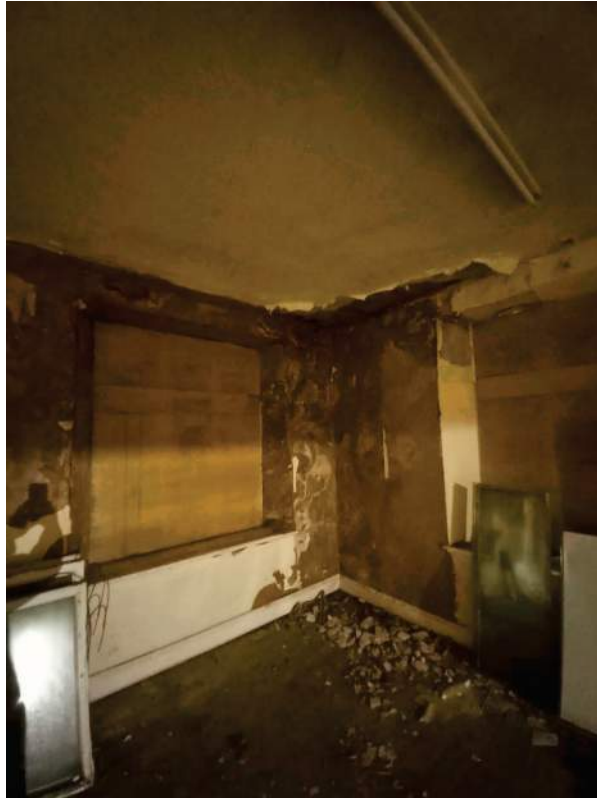
Area 3 – 1st Floor

Decay by the wet rot fungus (*Coniophora puteanea*) is evident to the floor/ceiling joist, full length of the room, to the front elevation as same as the floor above.

This is to the front bearing ends of the joist.

Defective wall plaster was evident to the same area as indicated on the enclosed sketch where pockets of wall plaster was removed to expose the front bearing ends of the joist and timber lintols to the left hand section and left hand gable wall.

The decay is most prominent to the front left hand corner and left hand section of the room.

The lintols above the three right hand windows appear to be of concrete construction rather than timber.

Also, a section of the ceiling/floor appears to have been replaced/repared by others in the past probably due to the wet rot fungal decay.

We could not access this area for inspection due to the repair carried out.

Peter Cox are to carry out **TREATMENT No.5** as follows:-

Prop the front bearing ends of the joist using scaffold planks and acro props.

- b) Remove sufficient floor boarding to allow the joist to be cut back to sound timber away from the wall and remove debris from site
- c) Renew the above stated timbers ensuring that all contact surfaces are coated with either a bituminous solution or 2 liberal brush coats of water repellent fungicidal fluid and capped or laid on PVC DPC membrane. All exposed timber used will be treated with our fungicidal fluid.

Replacement joist ends will be bolted and connected to the remaining sections.

- Remove all built in timber lintols to the front wall and left hand gable wall
- Replace window lintols with either concrete or steel lintols.
- Hack off all defective wall plaster.
- Re plaster to Peter Cox specifications as noted earlier.

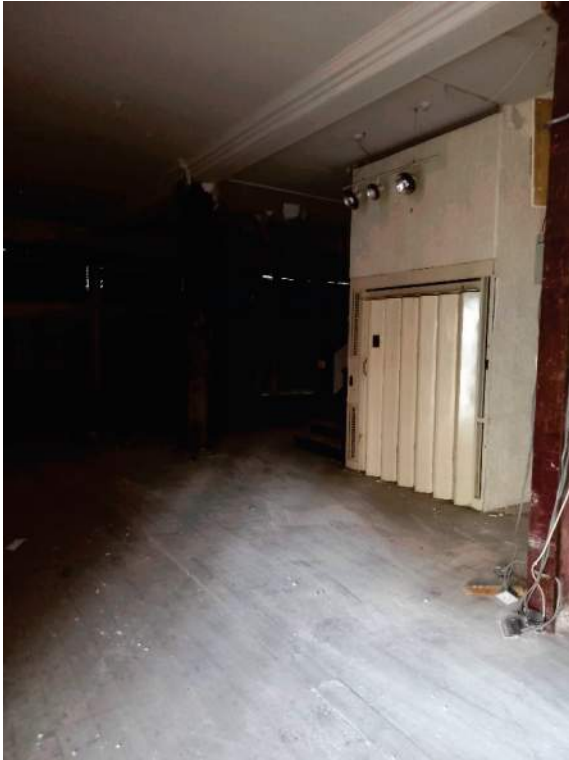
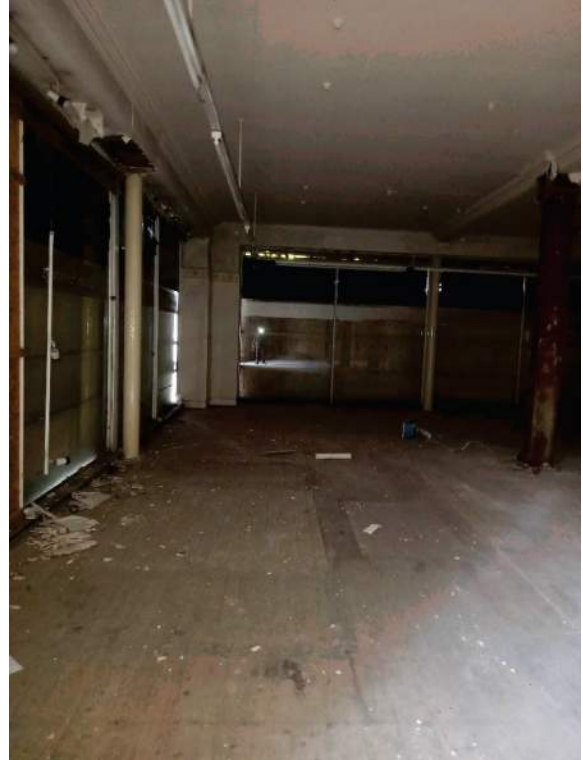
Area 4 – Ground Floor

The front elevation appears to have been “modernised” when renovation works were carried out in the past by means of installing large RSJ supporting steel across the front elevation which appear to support the floor joist above and therefore do not appear to be suffering from decay.

Note – Some of the walls have been lined over with timber panelling making the inspection limited.

We would recommend that pockets of flooring are removed so that a further inspection can be made to the joist/ceiling ends as a precautionary measure.

No works recommended to the ground floor at this time.

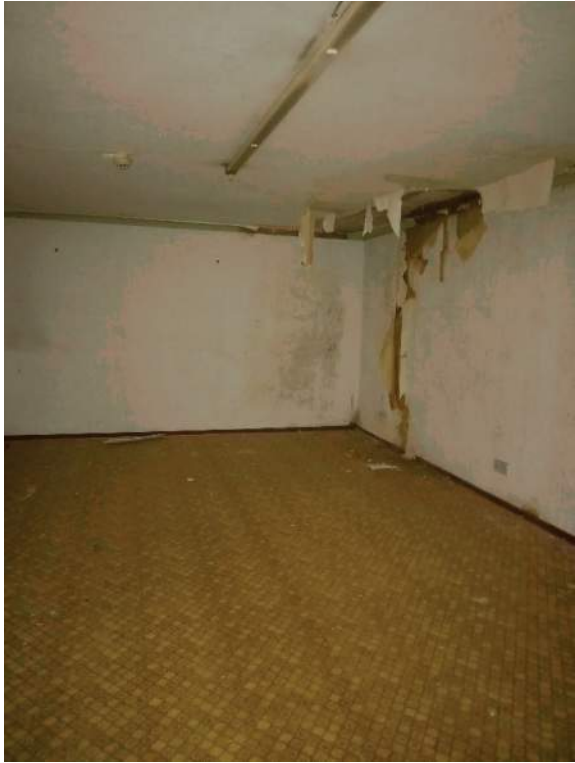
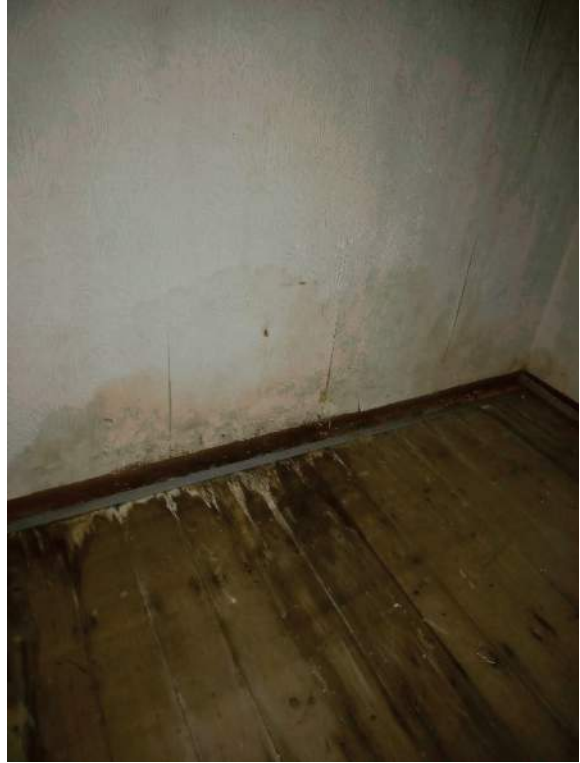
Area 5 – Basement

No inspection could be made to the timber floor due to lack of full access, but some minor wet rot decay was evident to floor boards.

The construction of the floor is unknown, but it is probably timber batten laid on the floor (On a membrane?) with floor boards laid on top of the battens.

The walls did appear damp in places indicating some water penetration due to the area being a basement and below ground level.

There is a sump pump fitted within the lift shaft pit but we cannot comment on its effectiveness.

Inspection to the ceiling/floor joist was not possible due to the walls being lined out with timber panelling so as noted above further exposure works to the ground floor is required.

If required, we would be happy to submit a separate report and quotation for waterproofing works to the basement and await your instructions if found necessary.

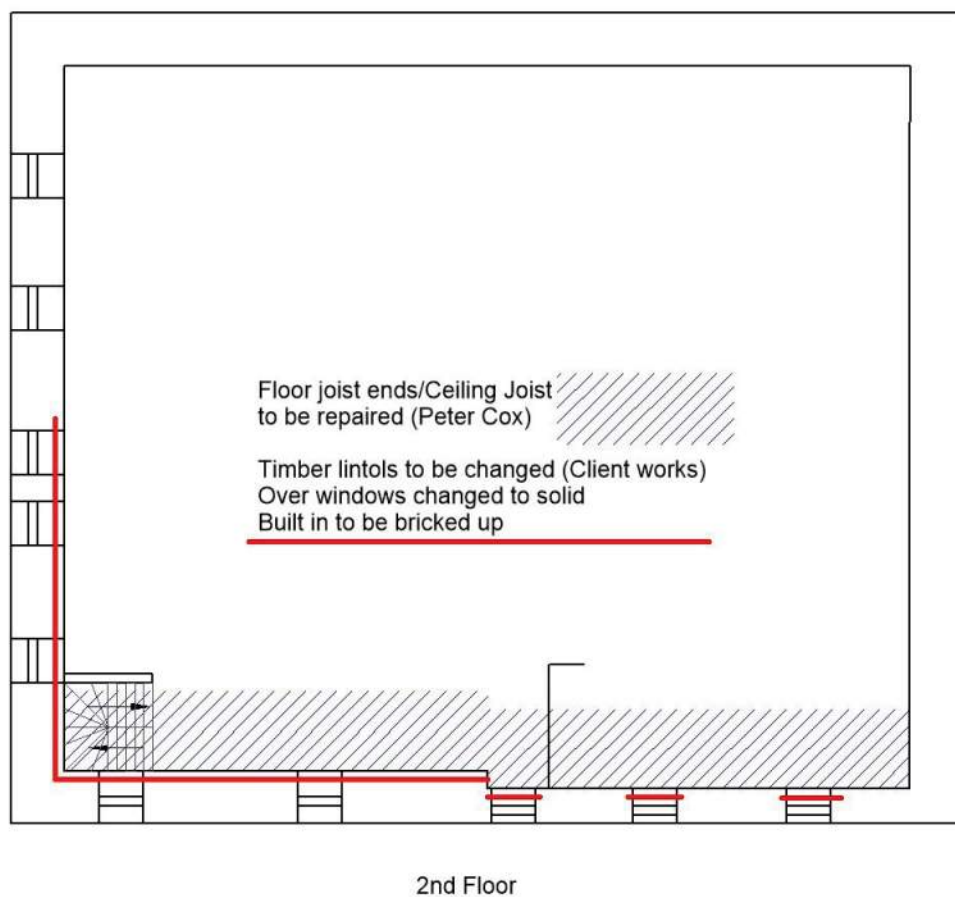
Floor joist run from front to back

Bolt and connect repairs to front bearing ends

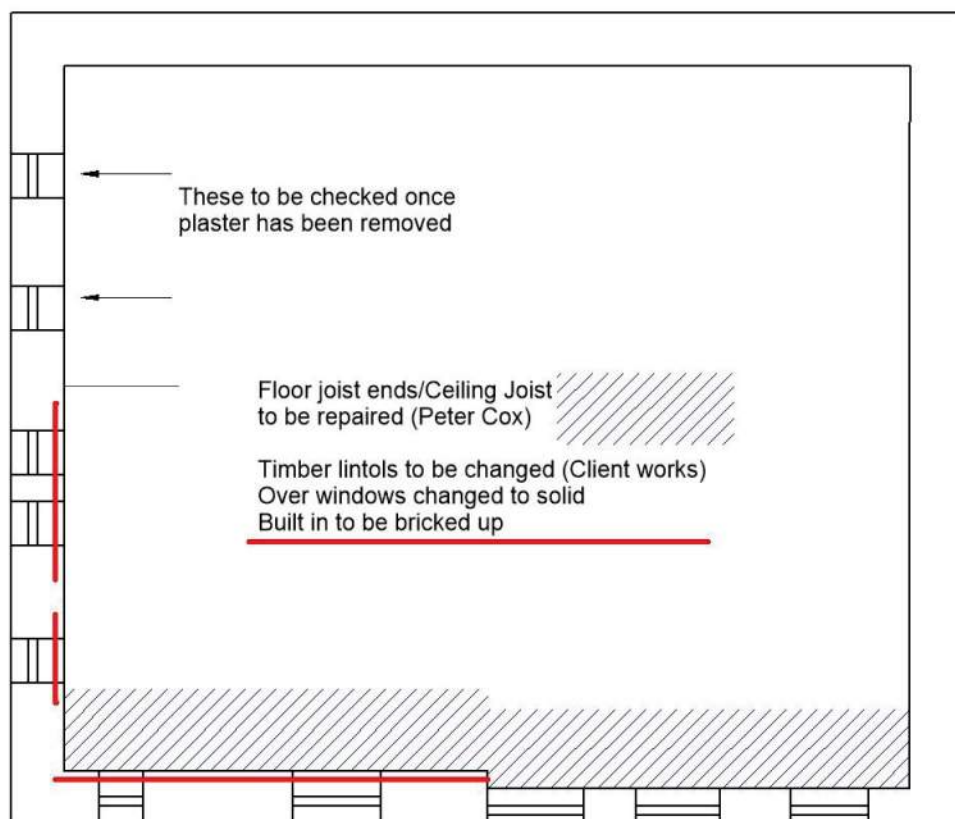
1st Floor

Floor joist run from front to back

Bolt and connectors repairs to front bearing ends
