## PLOT A INVESTIGATION PHOTOGRAPHS

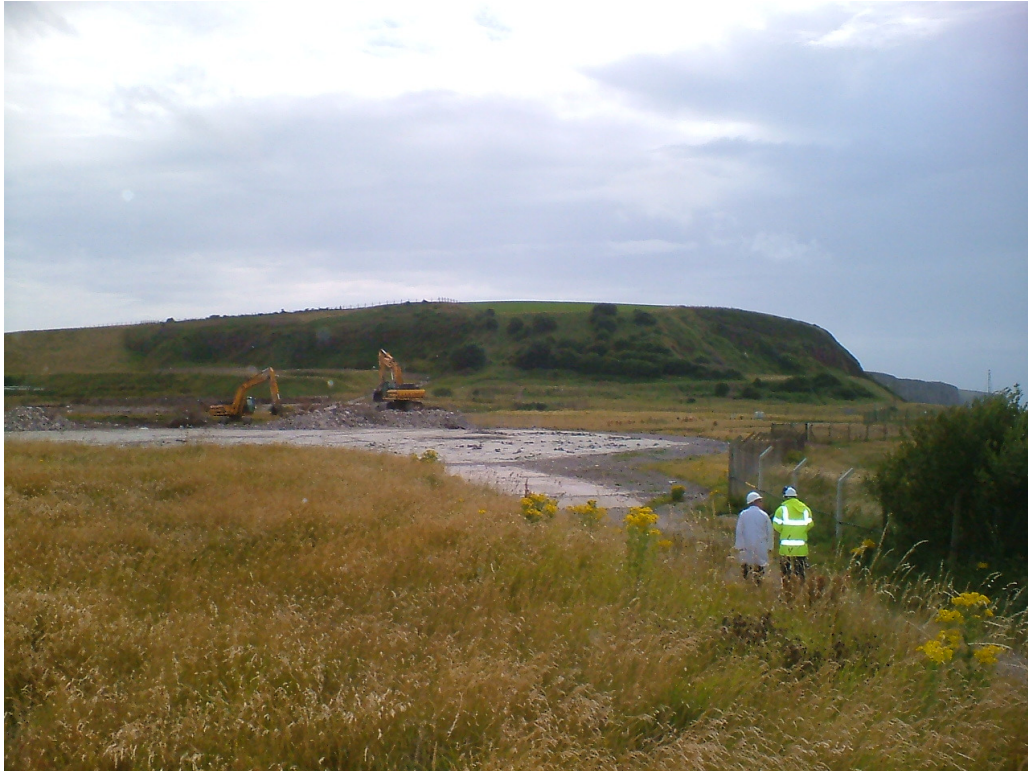
Photo 1 - View from TP601A looking southwest over the former Cathedral Area

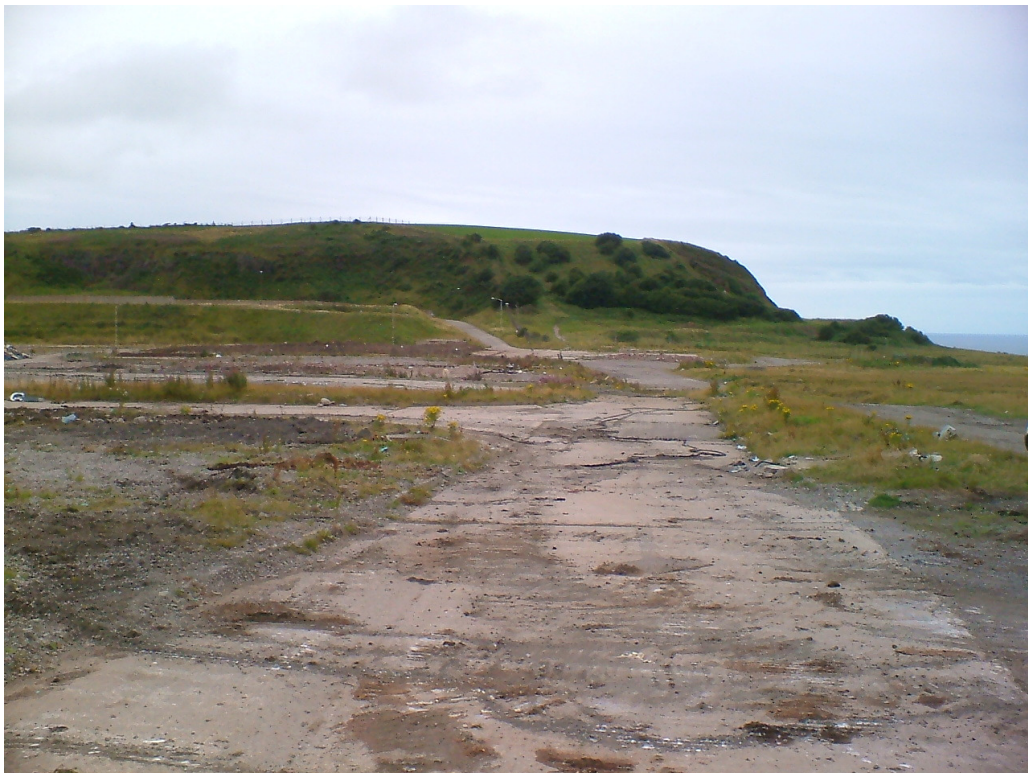
Photo 2 - View from TP615A looking southwest over former Plant Area

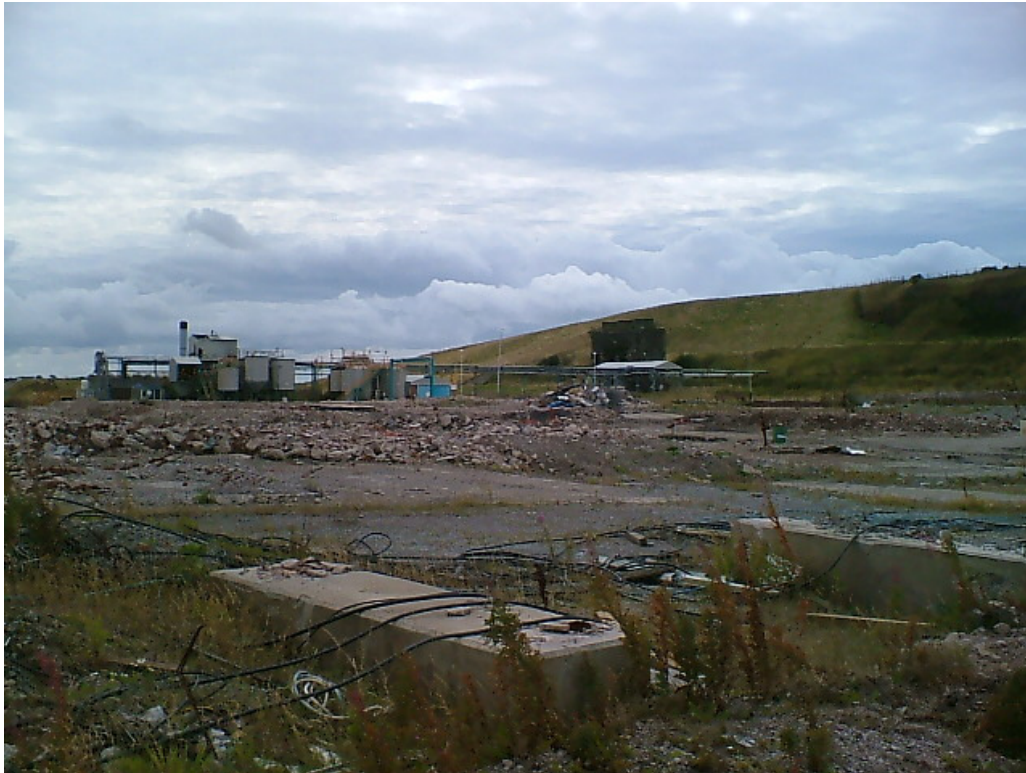
Photo 3 - View from WS503A looking southwest over former Fatty Alcohol Plant

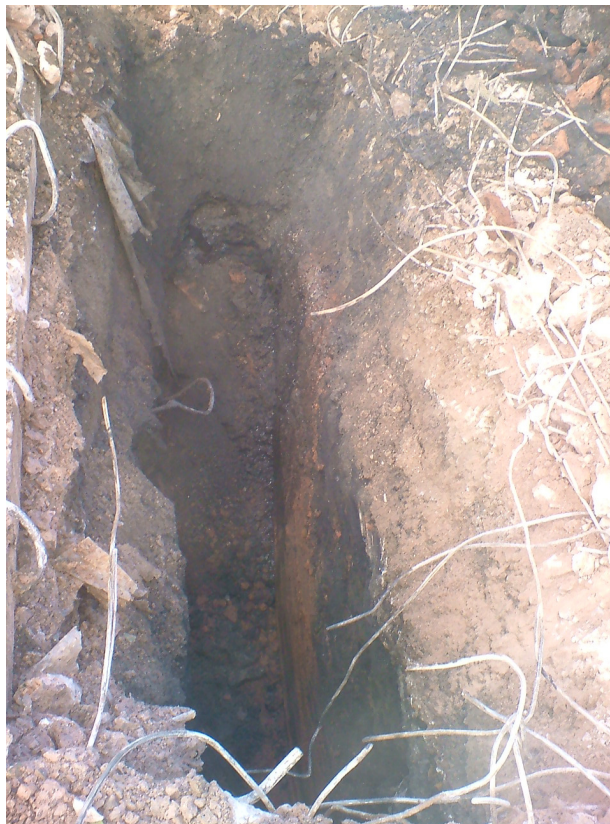
Photo 4 - TP607A – located in Cathedral Area, reinforced concrete and hardcore overlying Fill Material

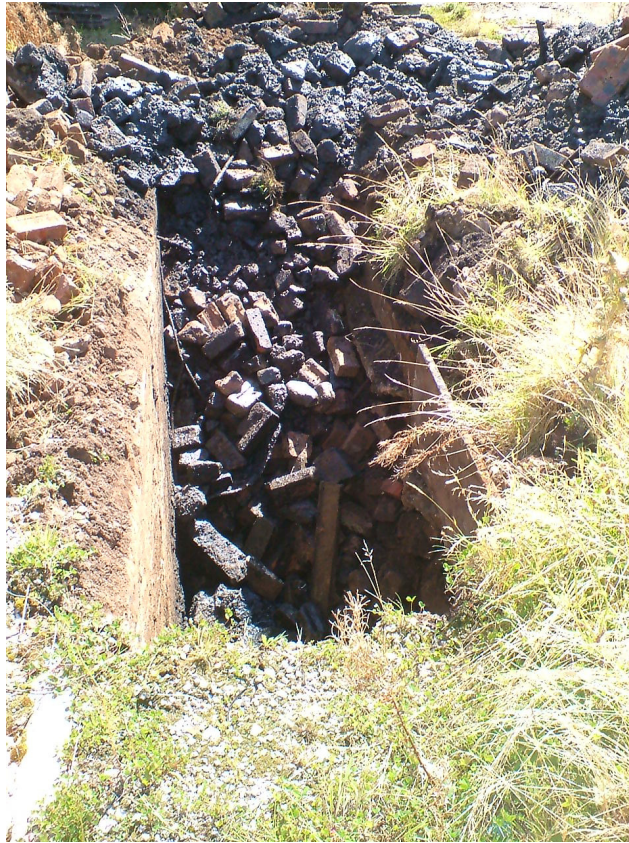
Photo 5 - TP615A – located in Plant Area, contaminated Fill Material between concrete foundations

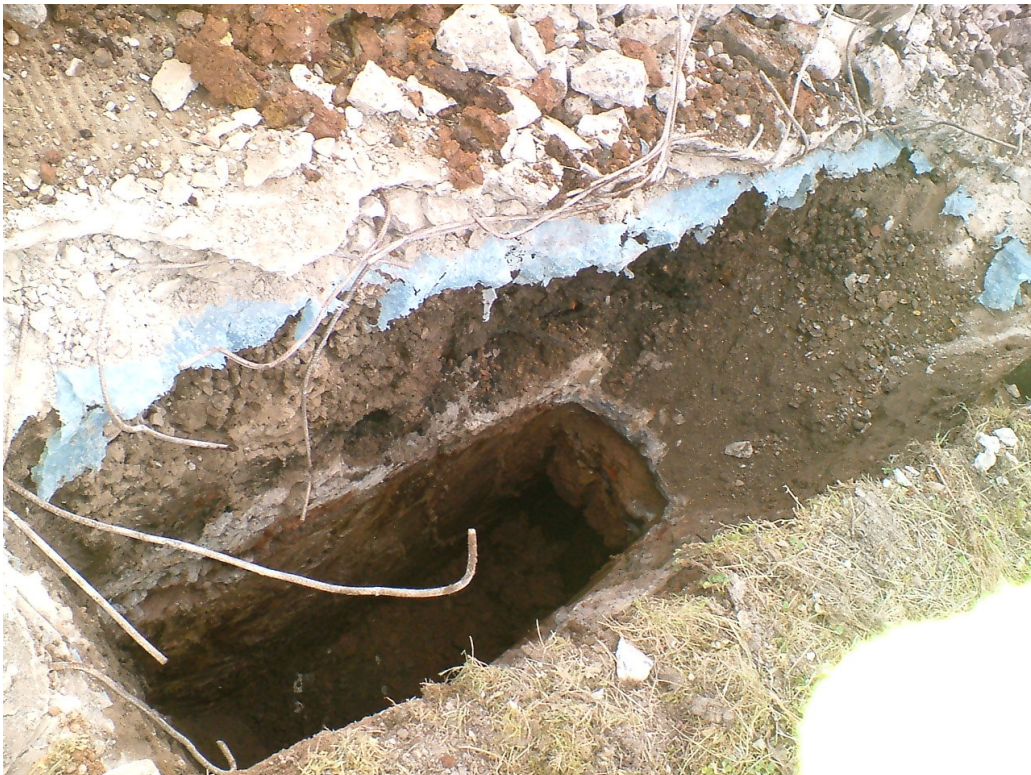
Photo 6 - TP616A –located in Plant Area, deep concrete foundations present at 1.0m bgl

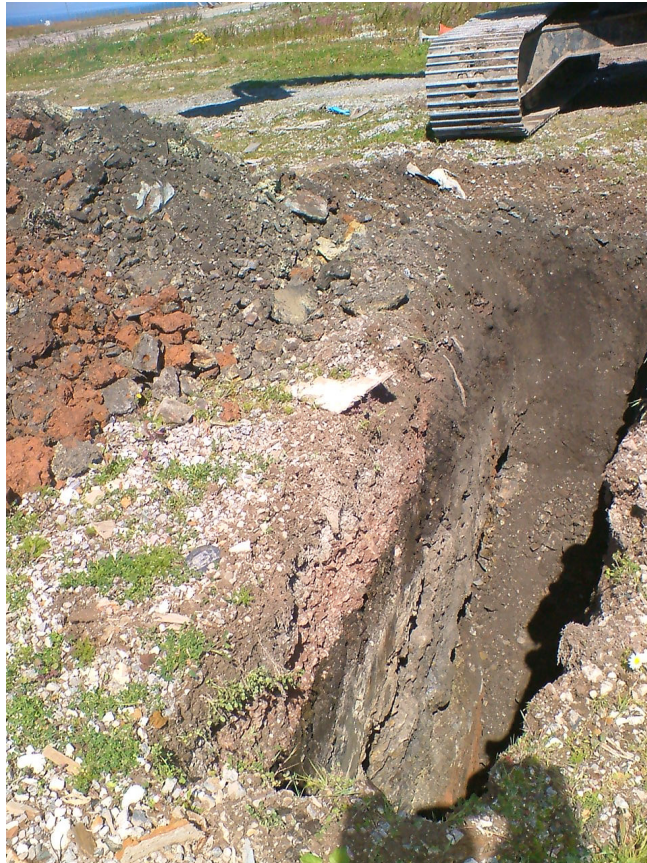
Photo 7 - TP622A – located in vicinity of former electrical substation, loose Fill Material

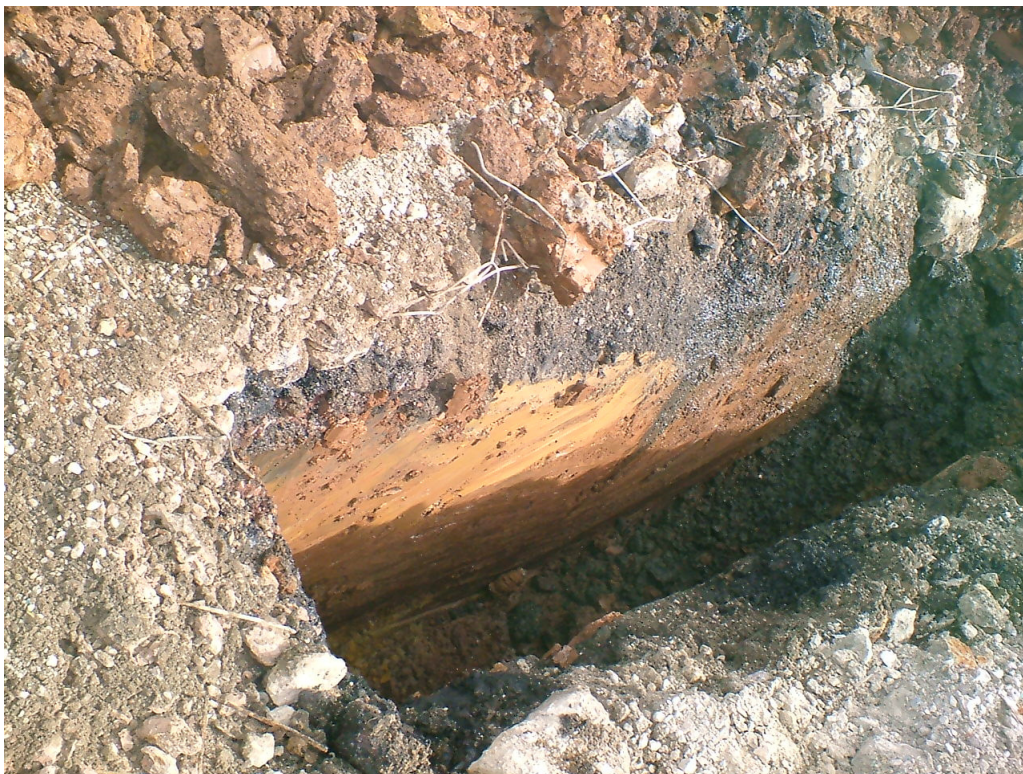
Photo 8 - TP628A – located in former Fatty Alcohol Plant, contaminated water running into trial pit through gravel Made Ground

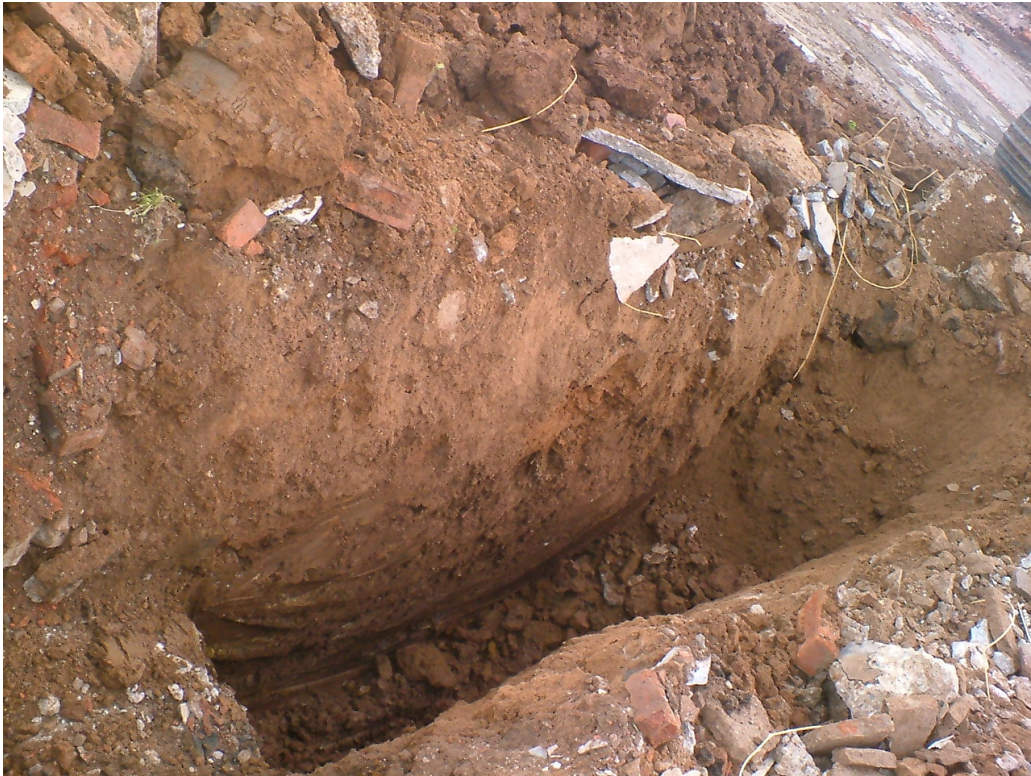
Photo 9 - TP630A – located in former Fatty Alcohol Plant, trial pit excavated into natural ground (Boulder Clay drift: firm red brown silt)
