Preliminary Roost Assessment

Government Buildings
St Georges Road
Millom
LA18 5BA

For
Northedge Architecture

Gritstone Ecology

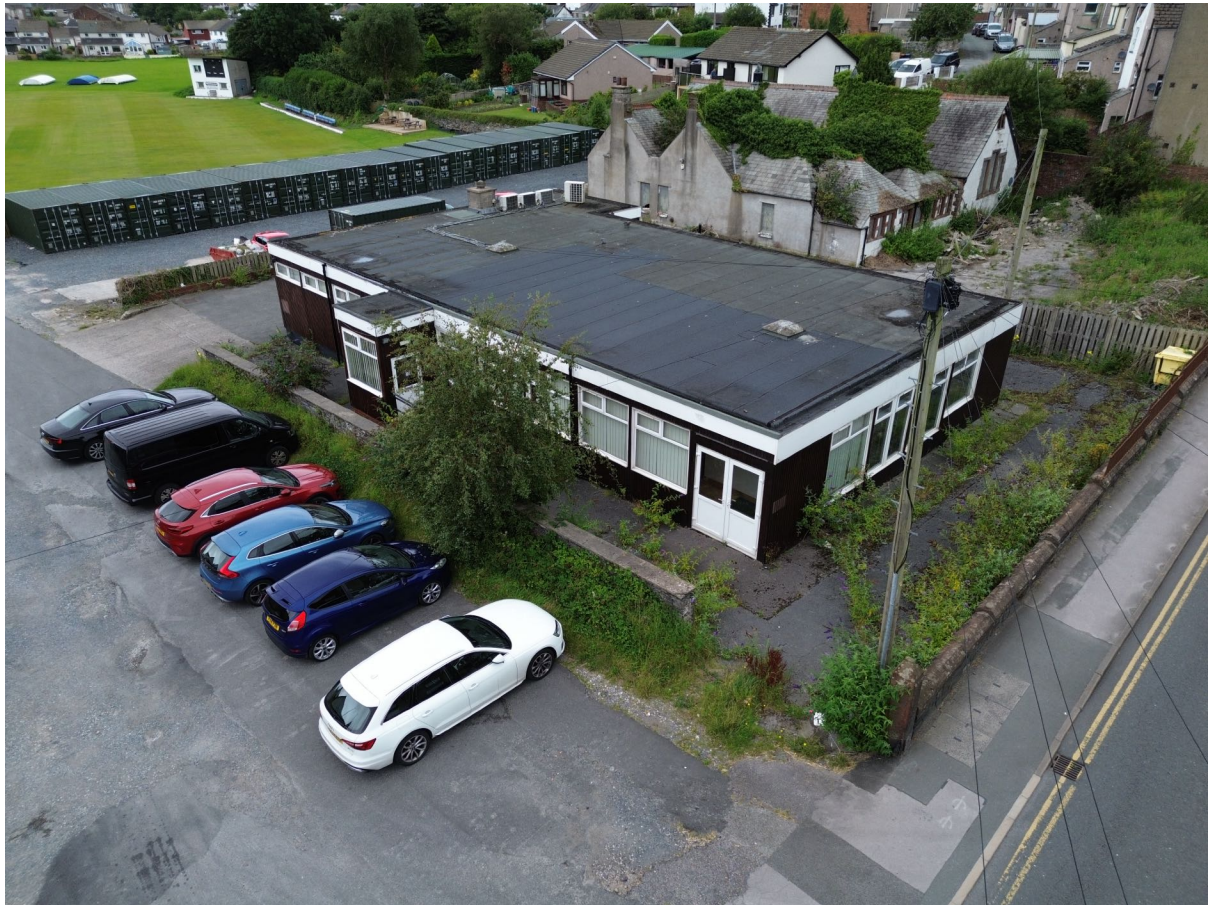
3.1a – The front of the building.

The building is well maintained, and in reasonable condition. Roofing felt, hidden gutters, and flues appear to be in good condition with no obvious gaps or holes in materials. Fascia boards are fitted tightly against the walls with no viable gaps. Walls and timber cladding are in good condition, with no missing or warped boards, which could give access to the crevice between external boards and internal blockwork.

There are no features externally which are likely be used by roosting bats, and no evidence of use by bats was present during the inspection.

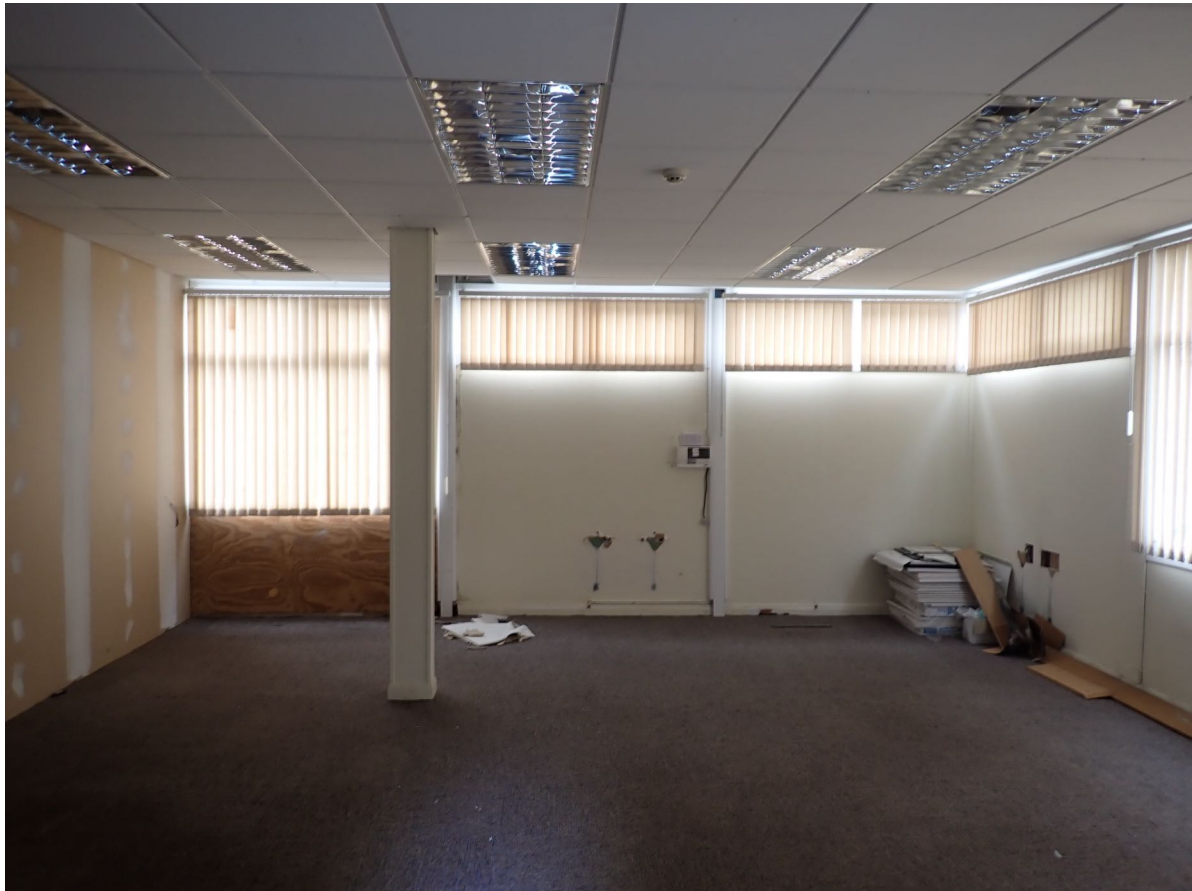
3.2a – Inside the building.

The building has no roof voids. However some areas have suspended ceilings, as pictured above. Where suspended ceilings were present, tiles were lifted and the small void above was checked.

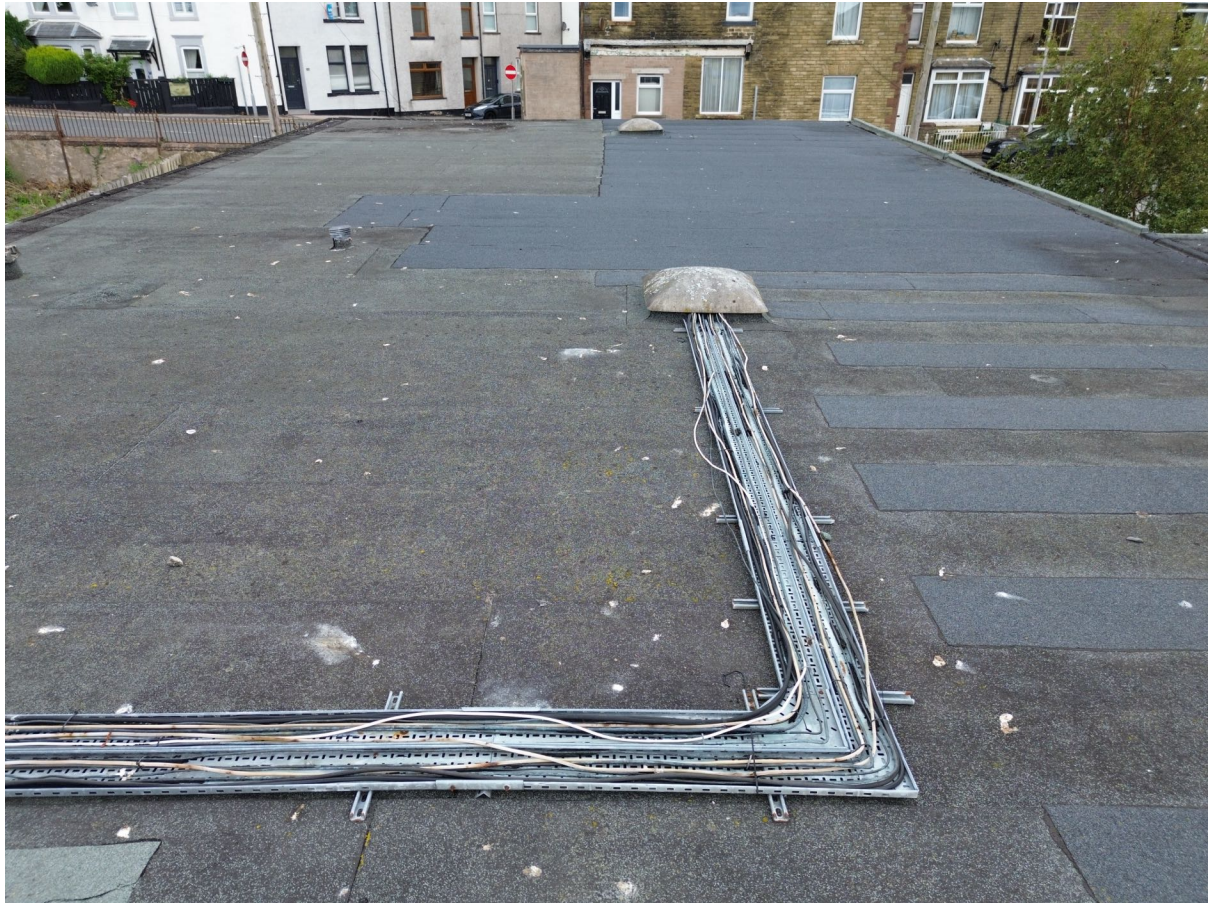
Roofing materials are in generally good condition. There are no gaps between roofing materials which could be used by roosting bats.

3 – The roof is in generally good condition with no obvious gaps between materials.

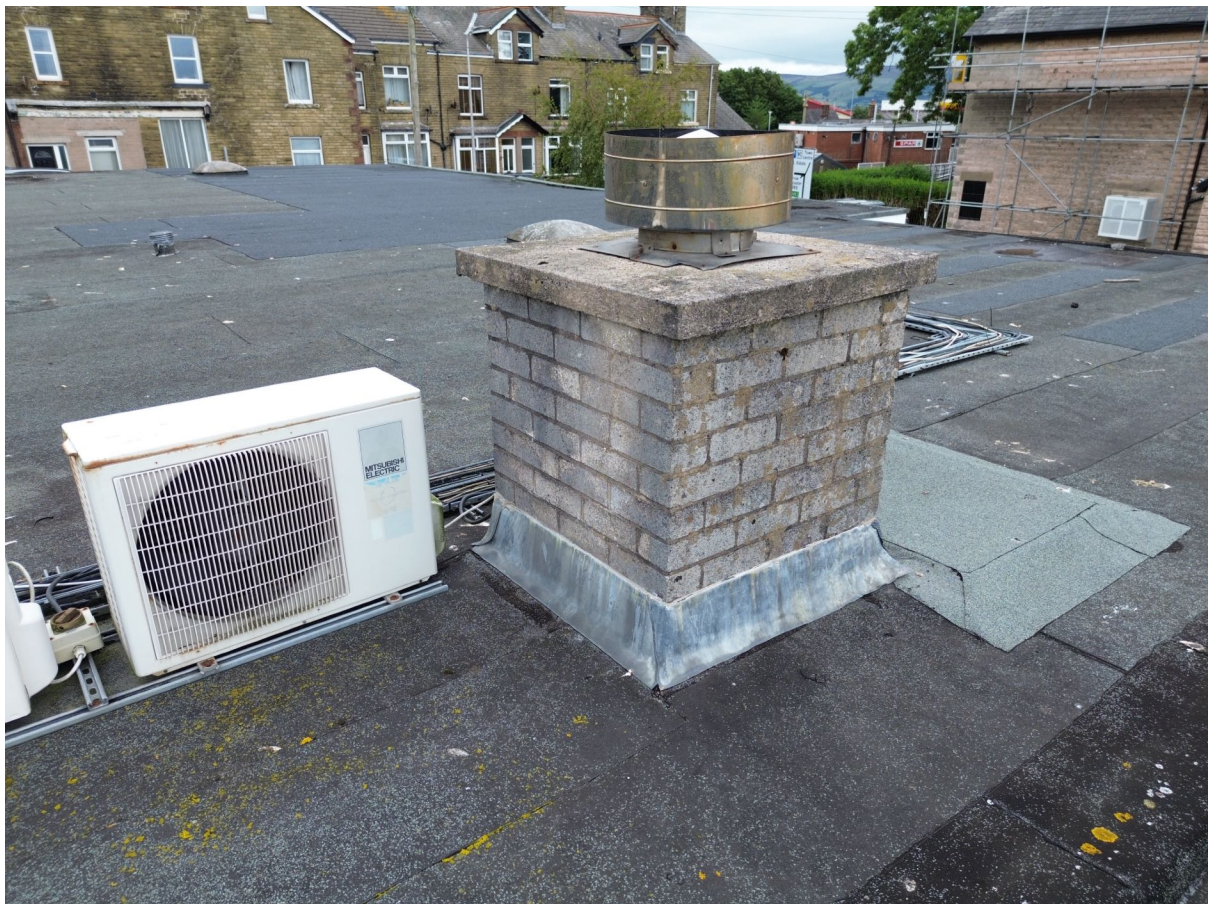
4 – Lead flashing is fitted tightly around chimneys and flues with no suitable gaps.

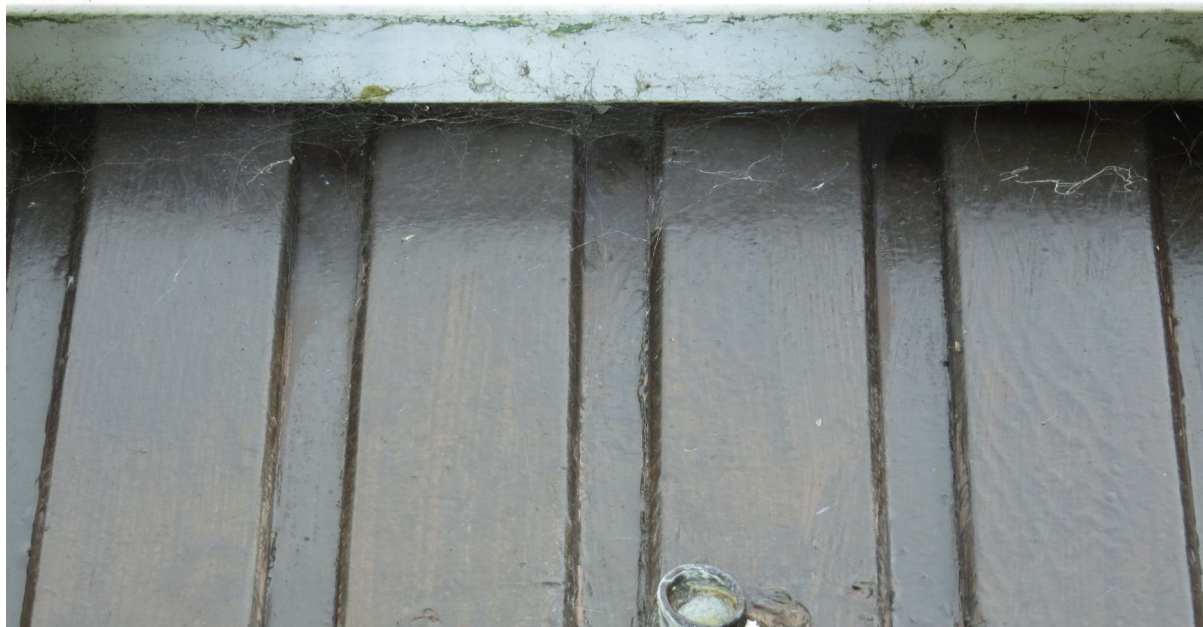
UPVC fascia boards at the eaves are fixed tightly against cladding boards and hidden gutters, with no suitable gaps between materials.

5 – Fascia boards are fitted tightly against cladding with no suitable gaps.

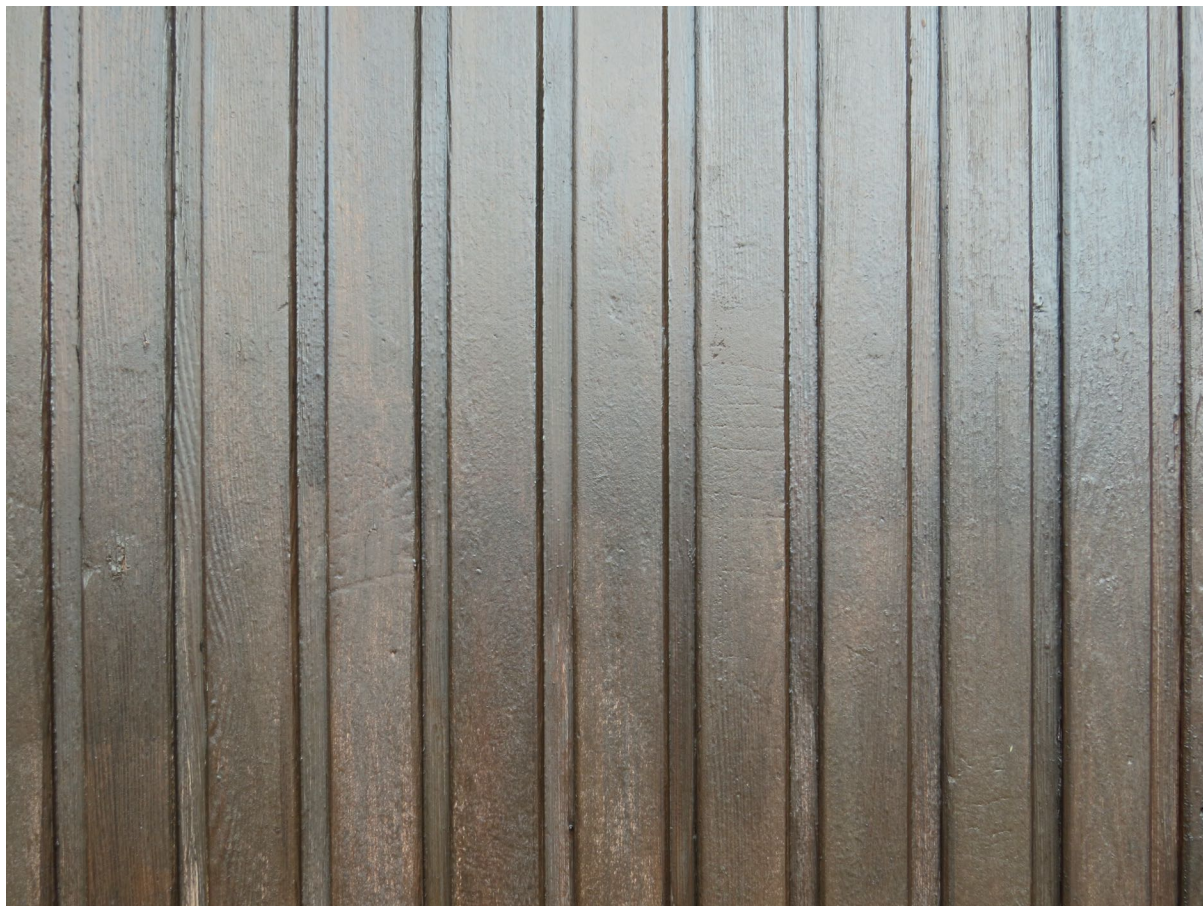
Walls are brick with an insulating cavity, covered with painted wooden vertical shiplap cladding. Walls are in good condition, with no warped or missing boards which could be used by crevice dwelling bats.

6 – Timber cladding is in good condition with warped or missing boards.

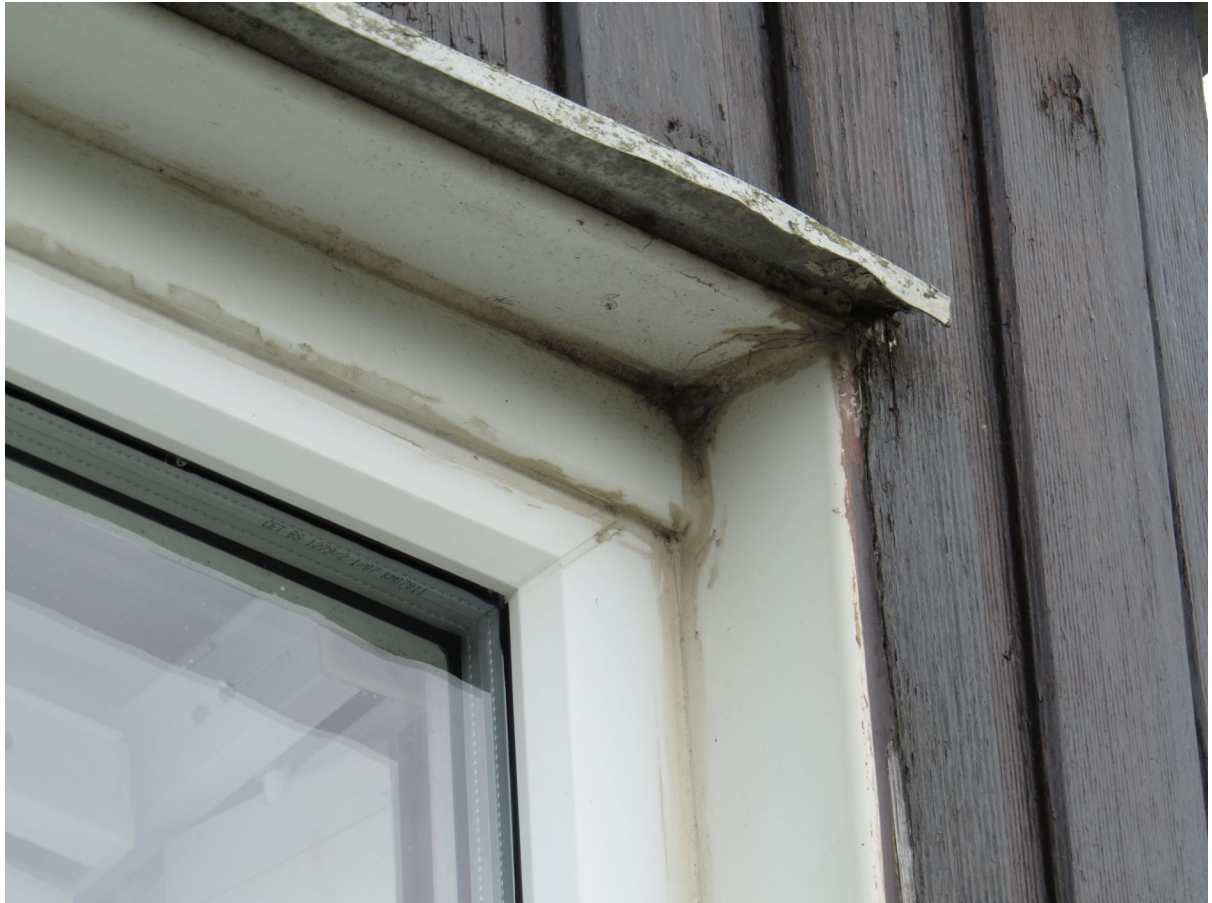
Window and door frames are fixed into the walls, gaps are filled with sealant, and offer no suitable roosting opportunities.

7 – Window and door frames are tightly sealed into walls with no suitable gaps.

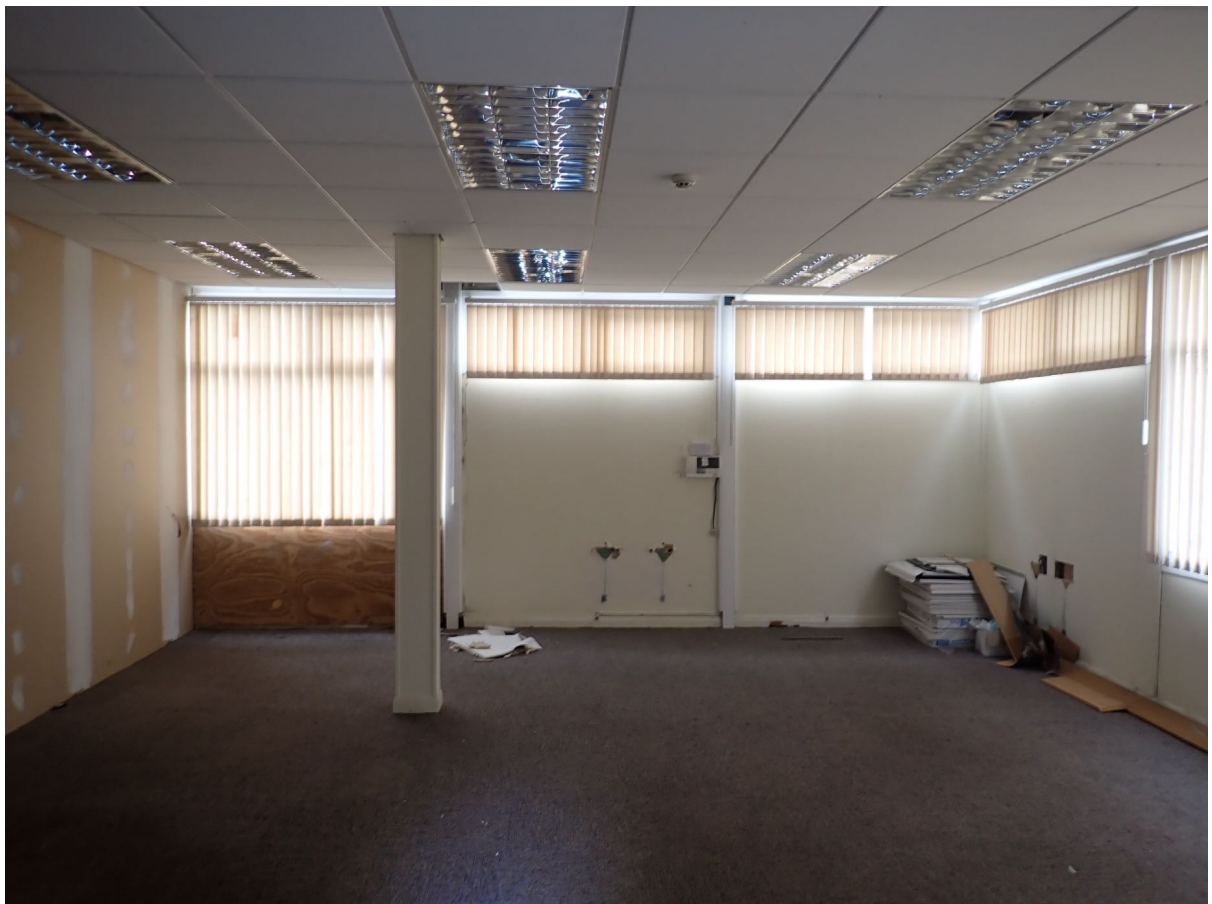
The building is divided into a number of rooms, the majority of which are well lit by natural light. Internal walls are sealed with plaster, and there are no crevices which are suitable for use by crevice dwelling species of bats.

8 – Internally the building is well lit by natural light.

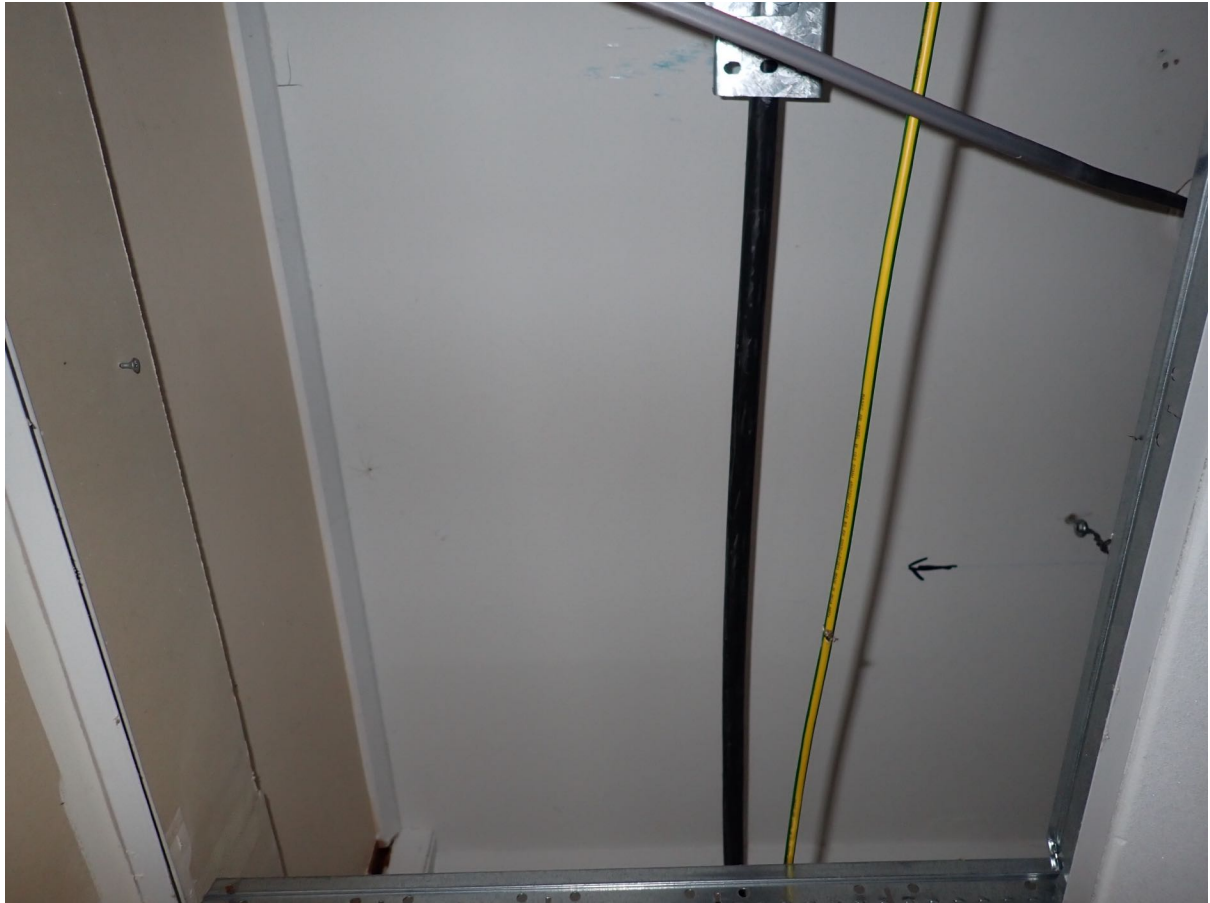
The small void between suspended ceilings and the underside of roofing materials were inspected in detail using a torch and endoscope. No droppings were found, and no suitable gaps were present which could give access, or shelter to roosting bats.

9 – The small void above suspended ceilings was inspected.
