# BLACKETT-ORD CONSERVATION ENGINEERING

**Our Ref: W63**

## **Structural Inspection of the Rear North Chimney**

I carried out a structural inspection of 115 Main Street, St Bees on Tuesday 23<sup>rd</sup> of November, 2021, following concerns with the condition of the chimney to the north side at the rear of the property.

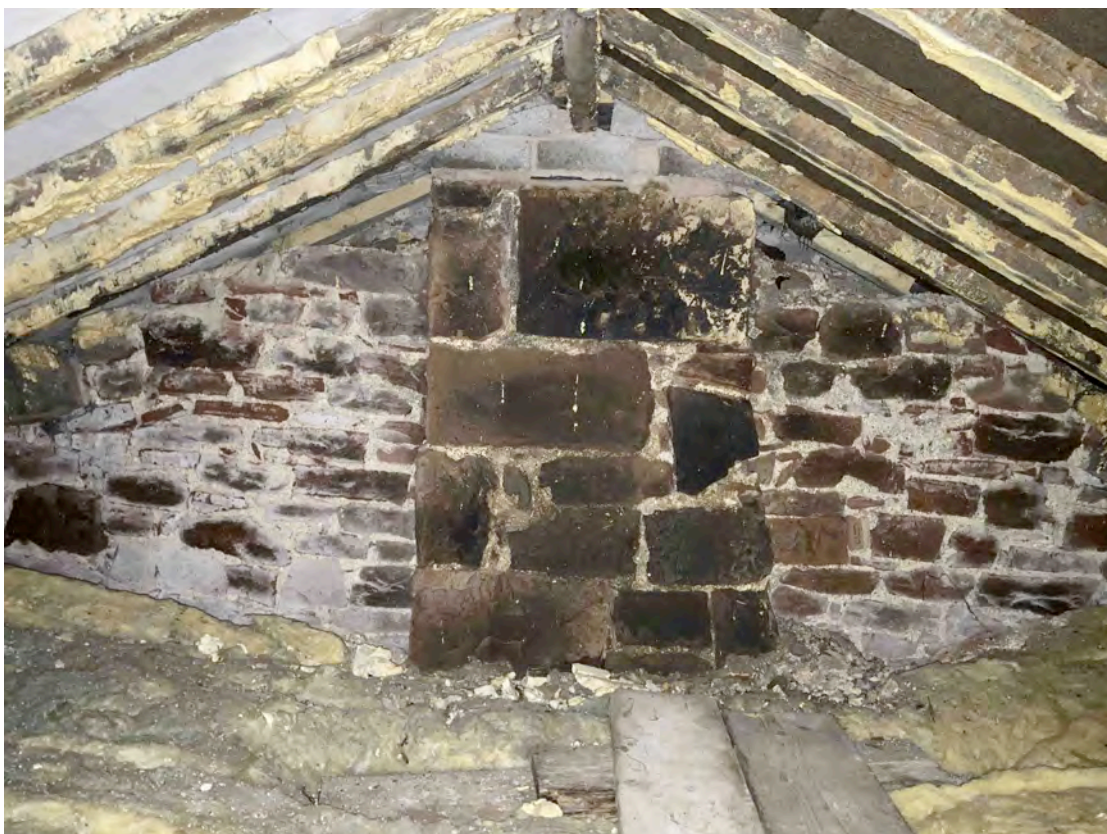
The sandstone chimney breast remains up to 1.2m above the ceiling joists in the attic, as indicated in photo 01. 2 no. courses of concrete blockwork have been built on slate up to the roof line, in cement mortar. Timber boards have been laid across the blockwork to cap the flues below. Concrete blockwork has then been built from the timber boards to form a stack which has a cement render. There are 2 no. clay pots.

Photo 01 – Stone chimney breast with 2 no. courses of blockwork within attic space.

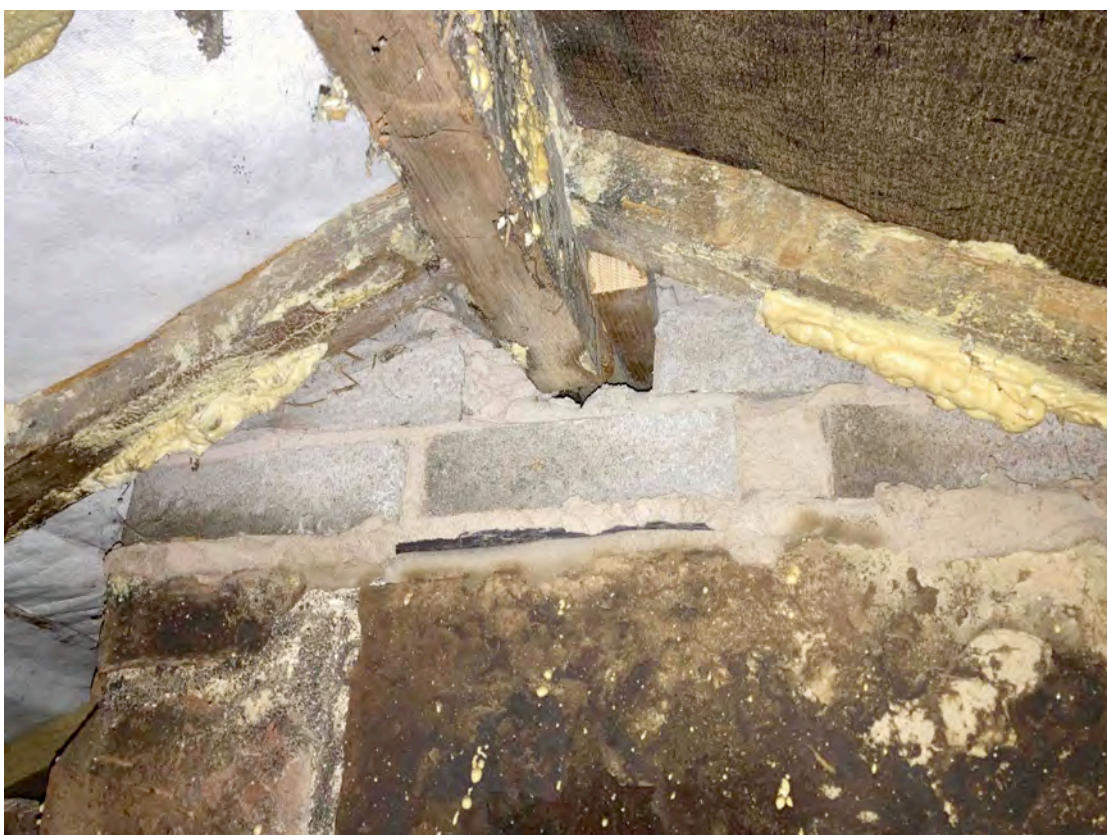
The following defects were identified, refer to photo 02:

- The mortar joints exceed the recommended nominal 10mm thickness.
- There are gaps in the mortar bed joints.
- The mortar hasn't been finished to a reasonable standard.
- The ridge beam is inadequately supported on 2 no. timber battens, 45mm square with screw fixings.

Photo 02 – Ridge beam inadequately supported at end bearing.

We would recommend installing a steel angle bracket to adequately support the timber ridge beam, refer to sketch Sk02. The steel angle bracket should be 50mm x 6mm thick, with a longer leg (225mm) secured to the chimney breast and the shorter leg (100mm) secured to the underside of the joist. Fixings to the chimney breast to be 2 no. 12mm Ø stainless steel threaded bar into the concrete blockwork and sandstone units, 125mm long set in a 2-part epoxy resin. Fixings to the underside of the ridge beam to be 2 no. 5.5mm Ø wood screws.

We would recommend that the support to the end of the ridge beam be improved, by installing a steel angle bracket.

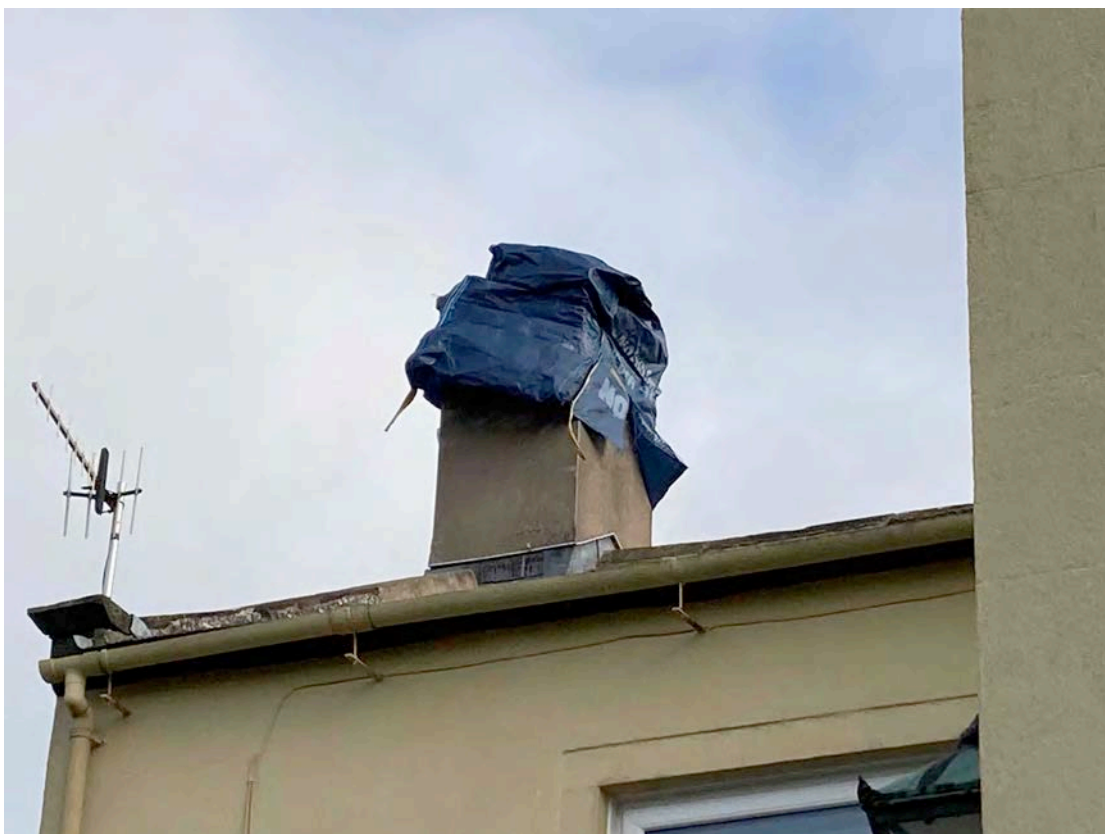
The chimney is in reasonable structural condition albeit the workmanship is of poor quality. The chimney is no longer in use and has been capped at roof level.

Photo 03 – Rebuilt chimney stack in blockwork with cement render (Nov 2021)

We would advise that if the chimney were to be brought back into use with a wood burning stove the chimney would need to be rebuilt. The blockwork would have to be carefully dismantled down to the original sandstone chimney breast within the roof void. The two clay pots should be set aside for reuse. The chimney should be reformed in brick bedded in lime mortar, with a flue sized appropriately for the wood-burning stove. The brickwork above roof level should be lime rendered and colour matched to the external render on the house. The clay pots can be reinstated.

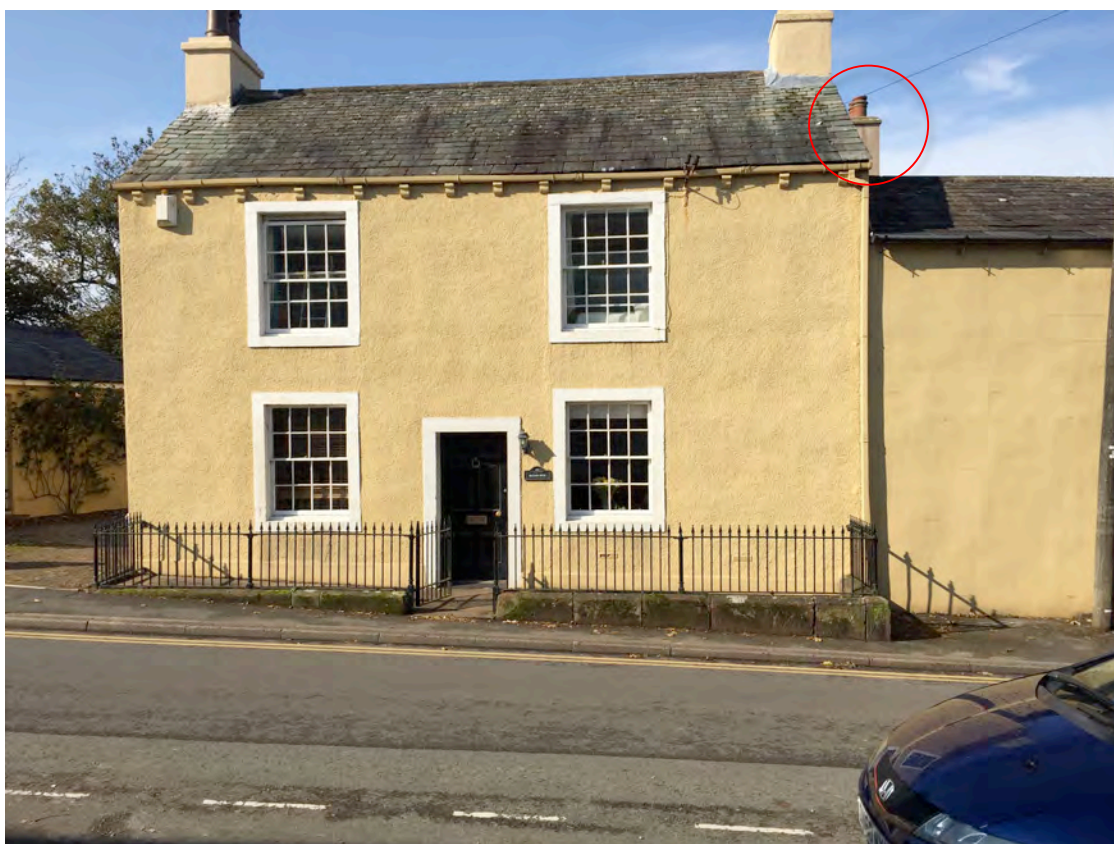
Photo 04 – Rebuilt chimney stack with clay pots (Sep 2020)
