**Plot 7
West End
Rheda Park
Frizington**

Memorandum

**Prepared for
Mr J. Copsey**

Treescapes Consultancy Ltd.

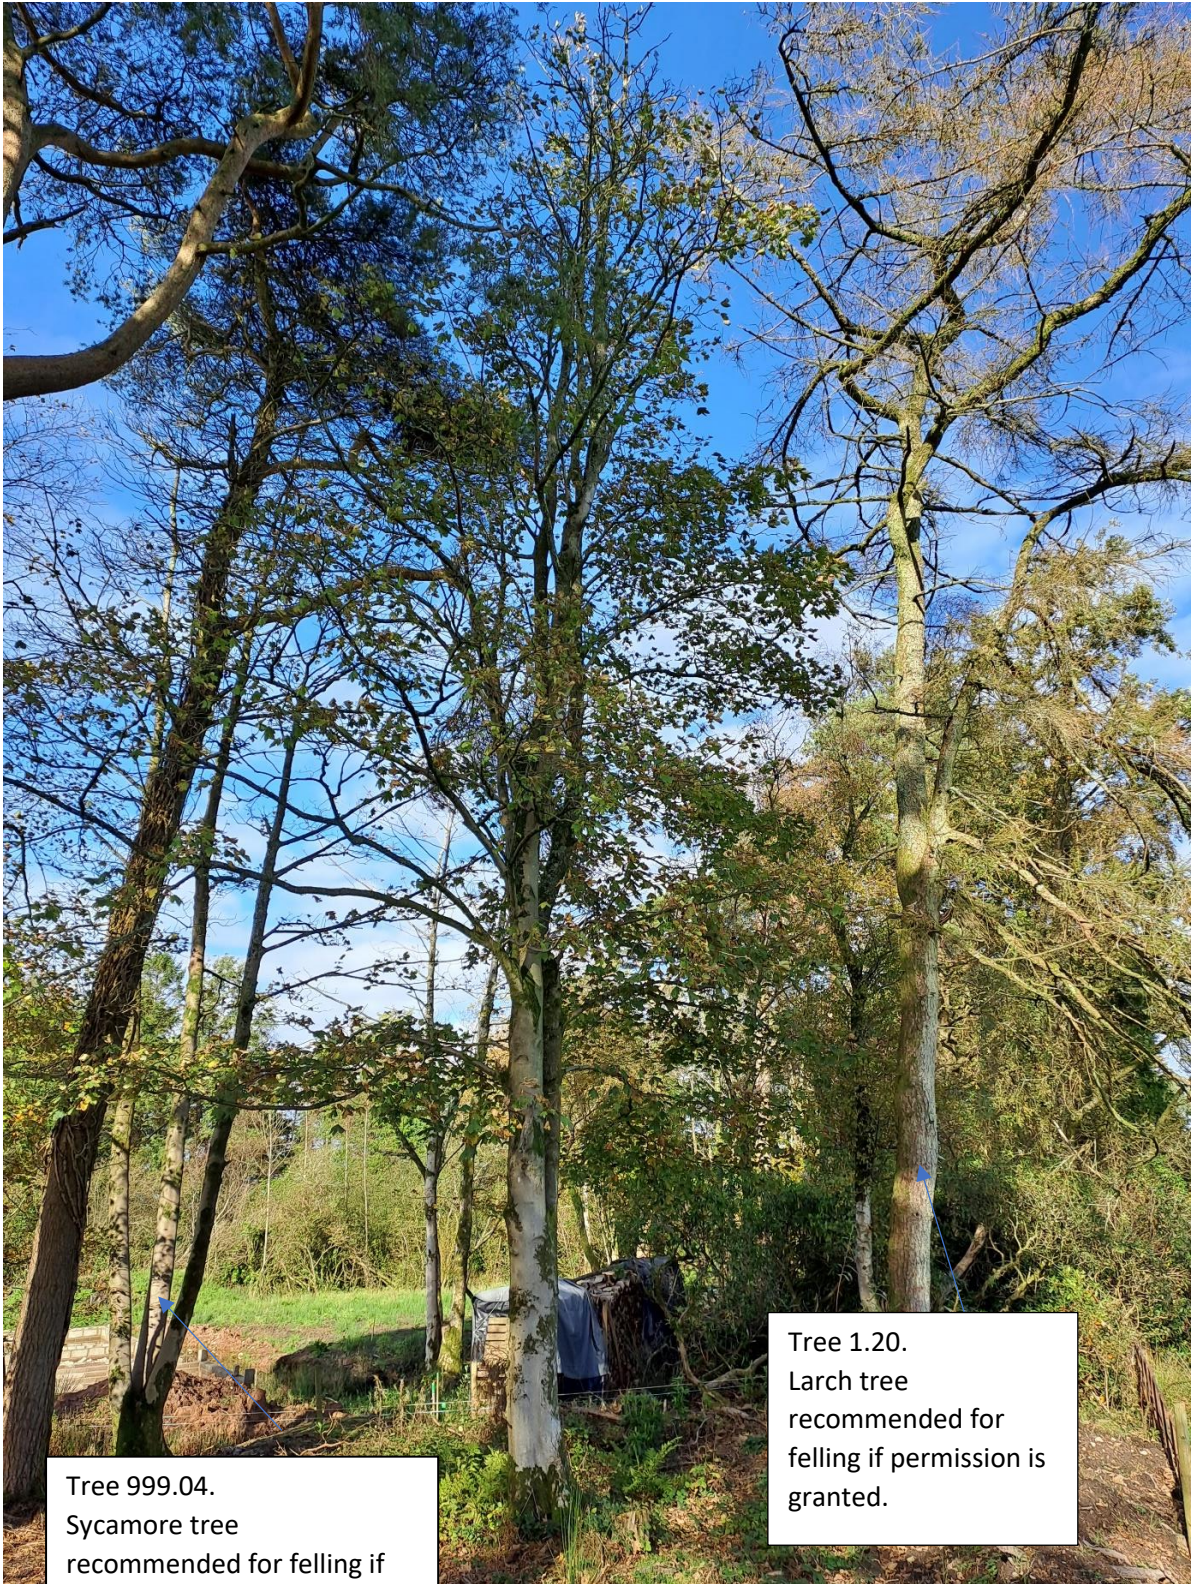
Photo 1. - 12/10/23.
Trees 1.20 and 999.04.

13. These further recommendations are recorded in the attached Tree Data Schedule, and I discuss some of them below:
 - **Tree 1.20** (Photo 1). Recommendation: Fell – If permission is granted.
A mature larch tree that is of only moderate quality that may become infected with *Phytophthora ramorum* disease of larch. This novel tree disease is endemic in the area and subject to statutory plant health controls. There is only a very low risk of significant harm arising from this tree, but any anticipated works might be done most easily and economically at the same time as other tree works in the plot.

- **Tree 999.04** (Photo 1). Recommendation: Fell – If permission is granted.
A young-mature sycamore tree that is growing close to the boundary with Plot 8, in which there are other buildings under construction. This tree has three co-dominant stems. Though the stem unions are currently non-acute, and apparently stable, it might reasonably be anticipated that this tree may be of sufficient concern in future to the occupiers of either plot that, if not now, they soon will be seeking permission to fell this tree. Such anticipated work(s) might therefore best be done most easily and economically soon, and at the same time as any other permitted tree works in the plot.

Tree 999.04.
Sycamore tree
recommended for felling if
permission is granted.

Tree 1.20.
Larch tree
recommended for
felling if permission is
granted.

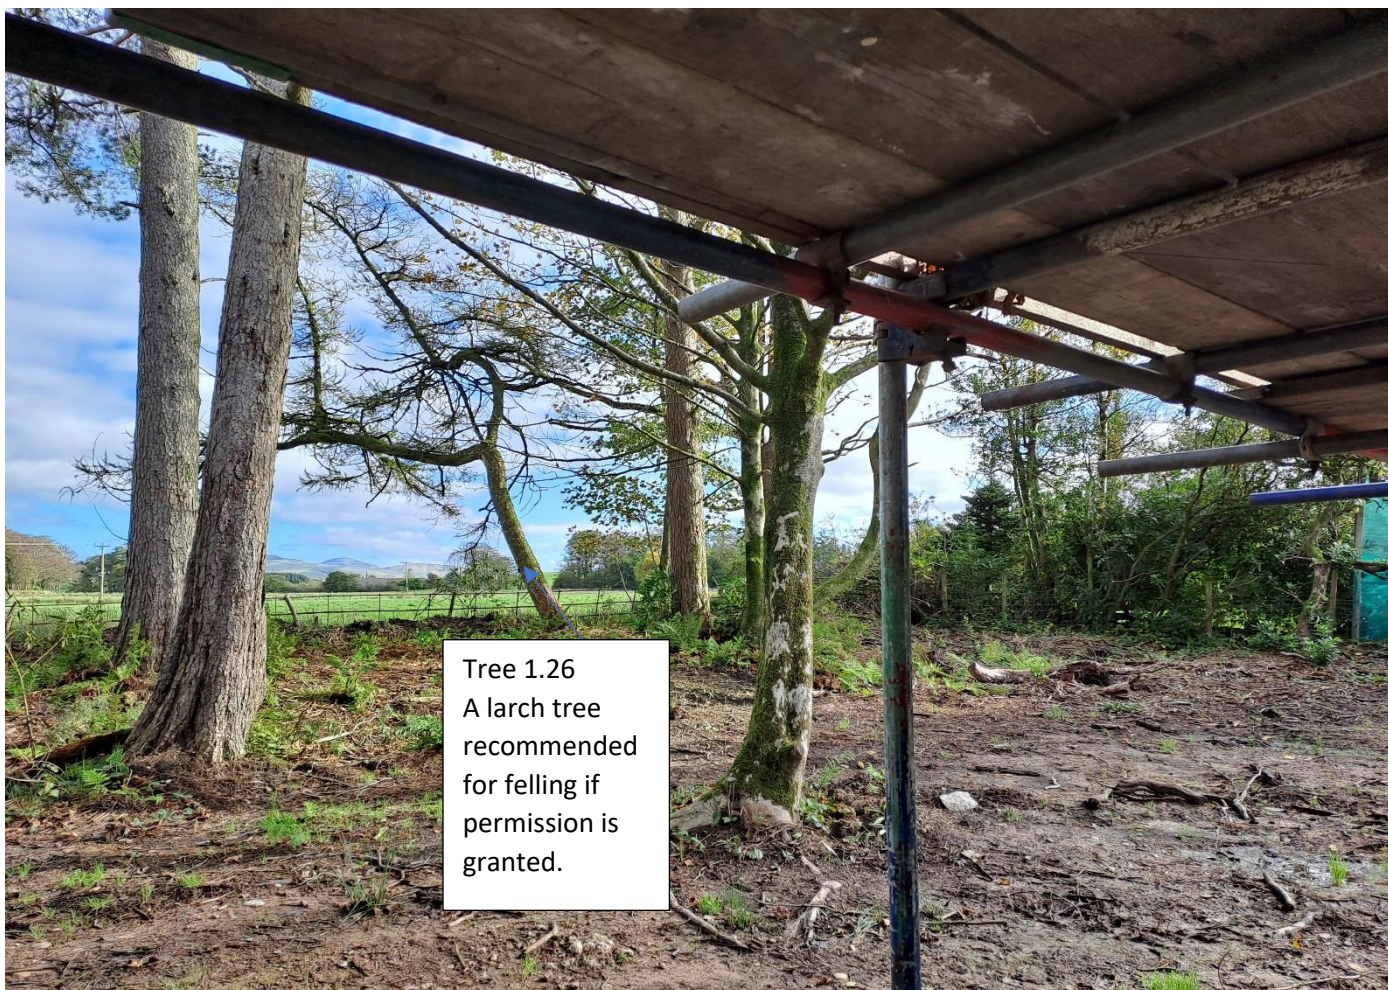
**Photo 2. - 12/10/23.
Tree 1.26**

- **Tree 1.26.** (Photo 2). Recommendation: Fell – If permission is granted.
A larch tree that is of only moderate quality and may become infected with *Phytophthora ramorum* disease of larch. This novel tree disease is endemic in the area and subject to statutory plant health controls. There is only a very low risk of significant harm arising from this tree, but any anticipated works might be done most easily and economically at the same time as any other permitted tree works in the plot.

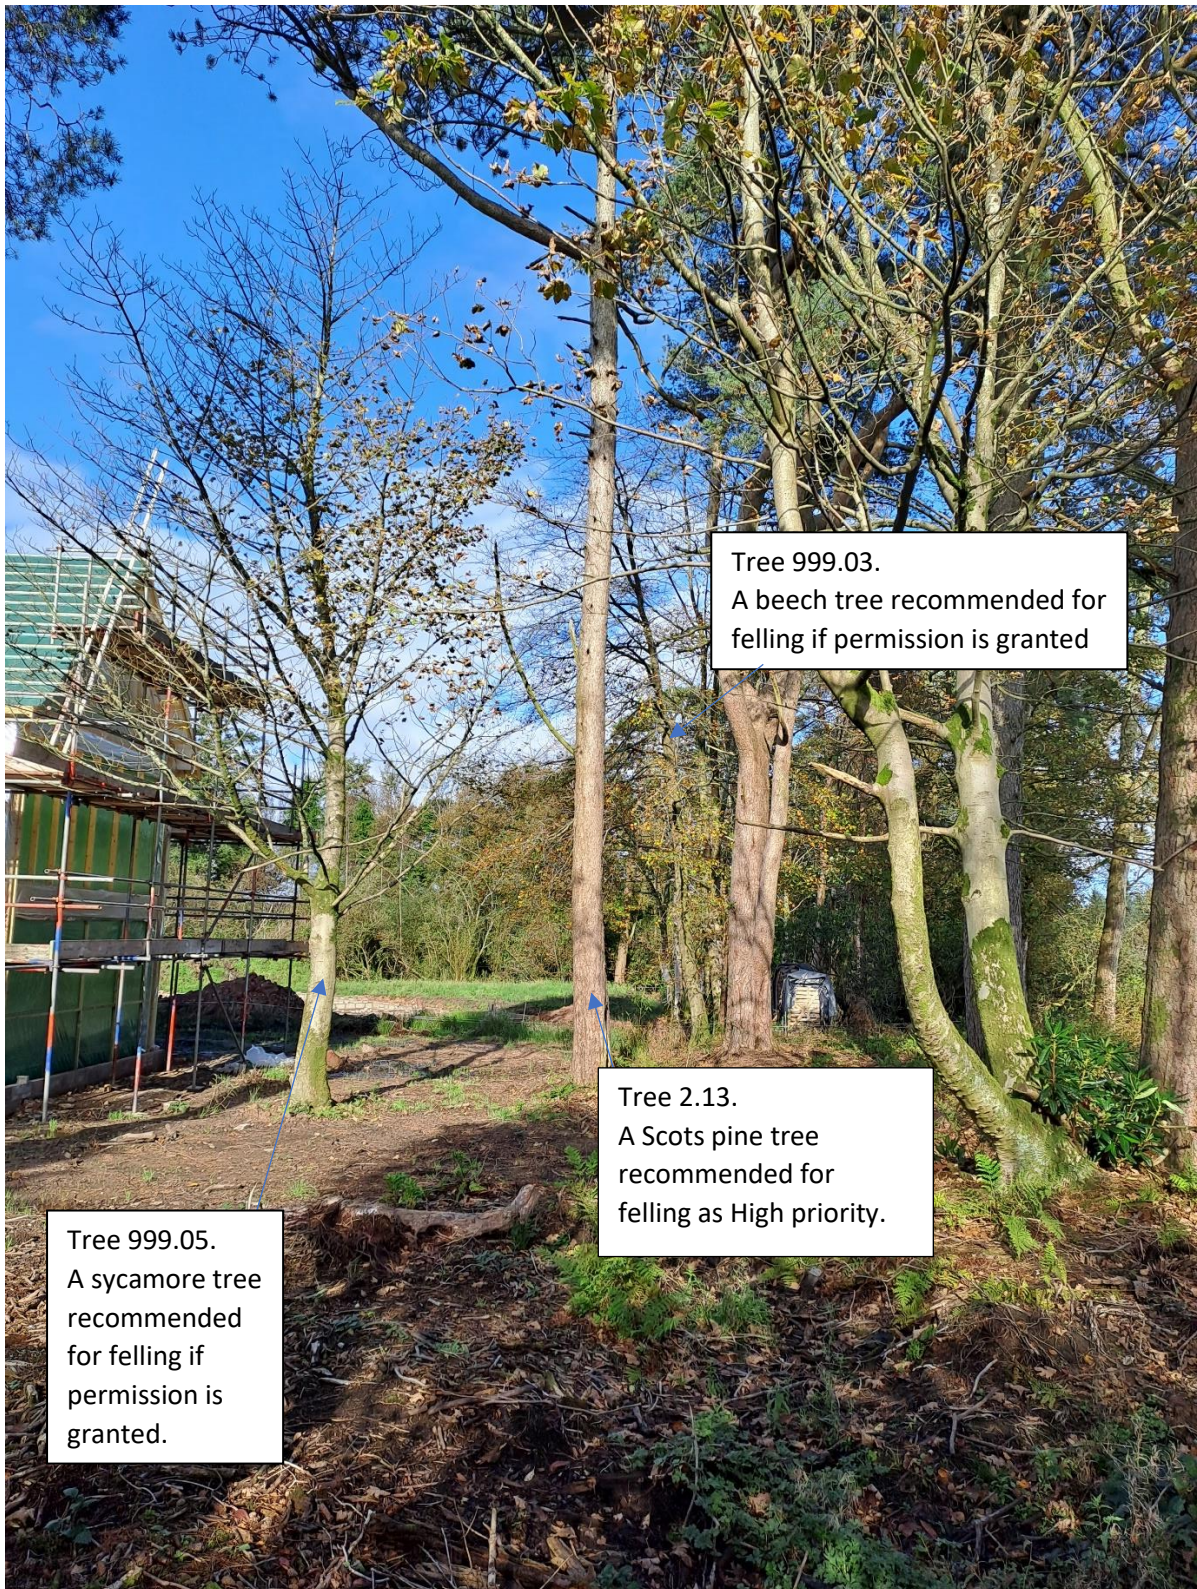
Photo 3. - 12/10/23.
Trees 2.13 and 999.05, and 999.03

- **Tree 999.03** (Photo 3). Recommendation: Fell – If permission is granted.
A young-mature beech tree that has grown under the canopy of the nearby mature Scots pine to develop a crown that is weight biased in the direction of, and within less than six metres of, the building now under construction.

- **Tree 2.13.** (Photo 3). Recommendation: Fell – High Priority.
An old-mature Scots pine tree that due to crown damage long ago is now weight biased in the direction of the building under construction. There is an old wound at the base of the trunk that I consider to be a major defect (Photo 4) because it will be affecting the wood tissues under tension there to oppose the tree's weight bias towards the new building under construction.

- **Tree 999.05** (Photo 3). Recommendation: Fell – If permission is granted.
A young-mature sycamore tree whose crown, on its west side, is already overhanging the building under construction. The overhanging foliage is at a

point where it might soon interfere with the structure of the building, and in places occupants might want not to be heavily shaded (e.g., a french, and other windows that are all facing morning light from the east).

Tree 999.05.
A sycamore tree
recommended
for felling if
permission is
granted.

Tree 2.13.
A Scots pine tree
recommended for
felling as High priority.

Tree 999.03.
A beech tree recommended for
felling if permission is granted

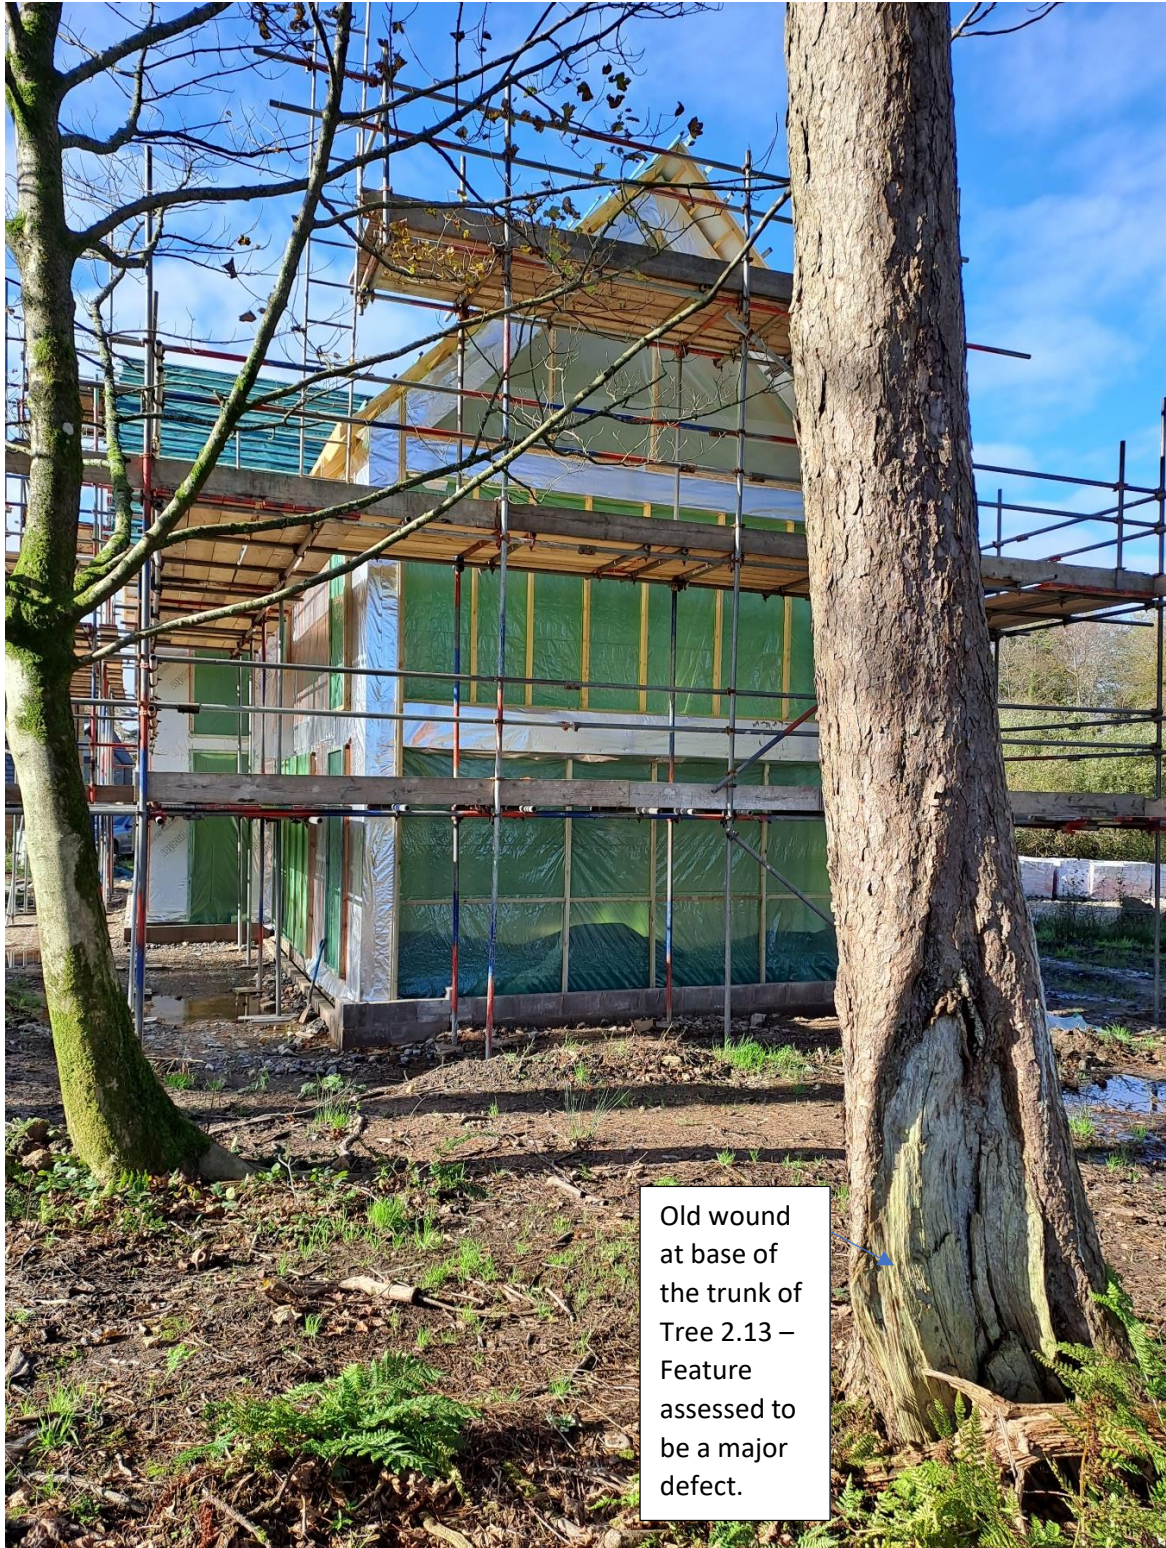
Photo 4. - 12/10/23.
Old wounding at base of Tree 2.13.

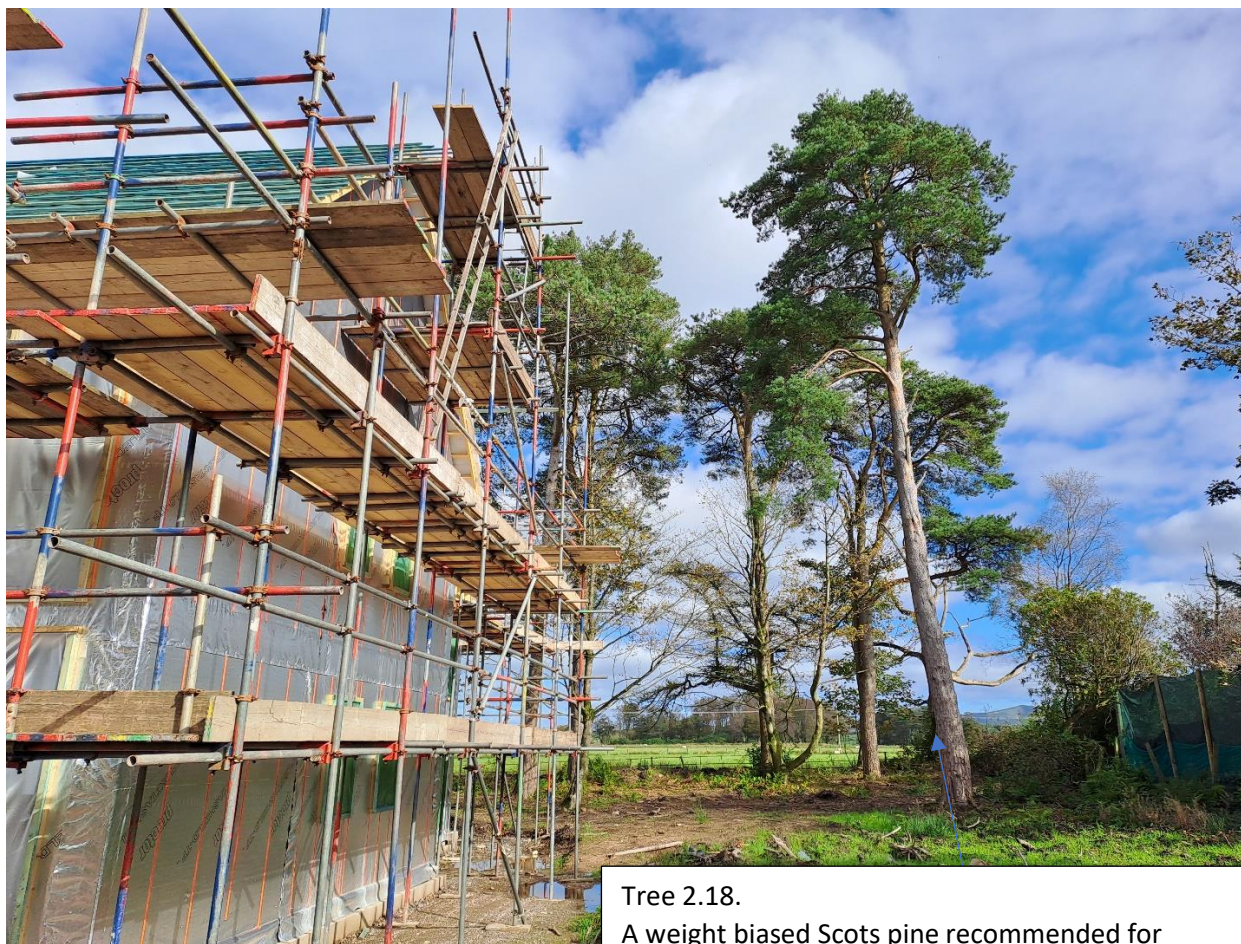
Photo 5 - 12/10/23.
Tree 2.18

A substantial, old-mature Scots pine tree that is weight biased to the north-east, and in the general direction of the building now under construction. Currently, there are not any obvious indications of the root plate being unstable, but I note that on this relatively wet site this tree was previously growing within the mutual shelter of other trees that have now been removed.

Tree 2.18.
A weight biased Scots pine recommended for felling if permission is granted

I recommend that, should this tree be felled, the nearby tree and shrub planting previously recommended be slightly extended and enhanced in mitigation.

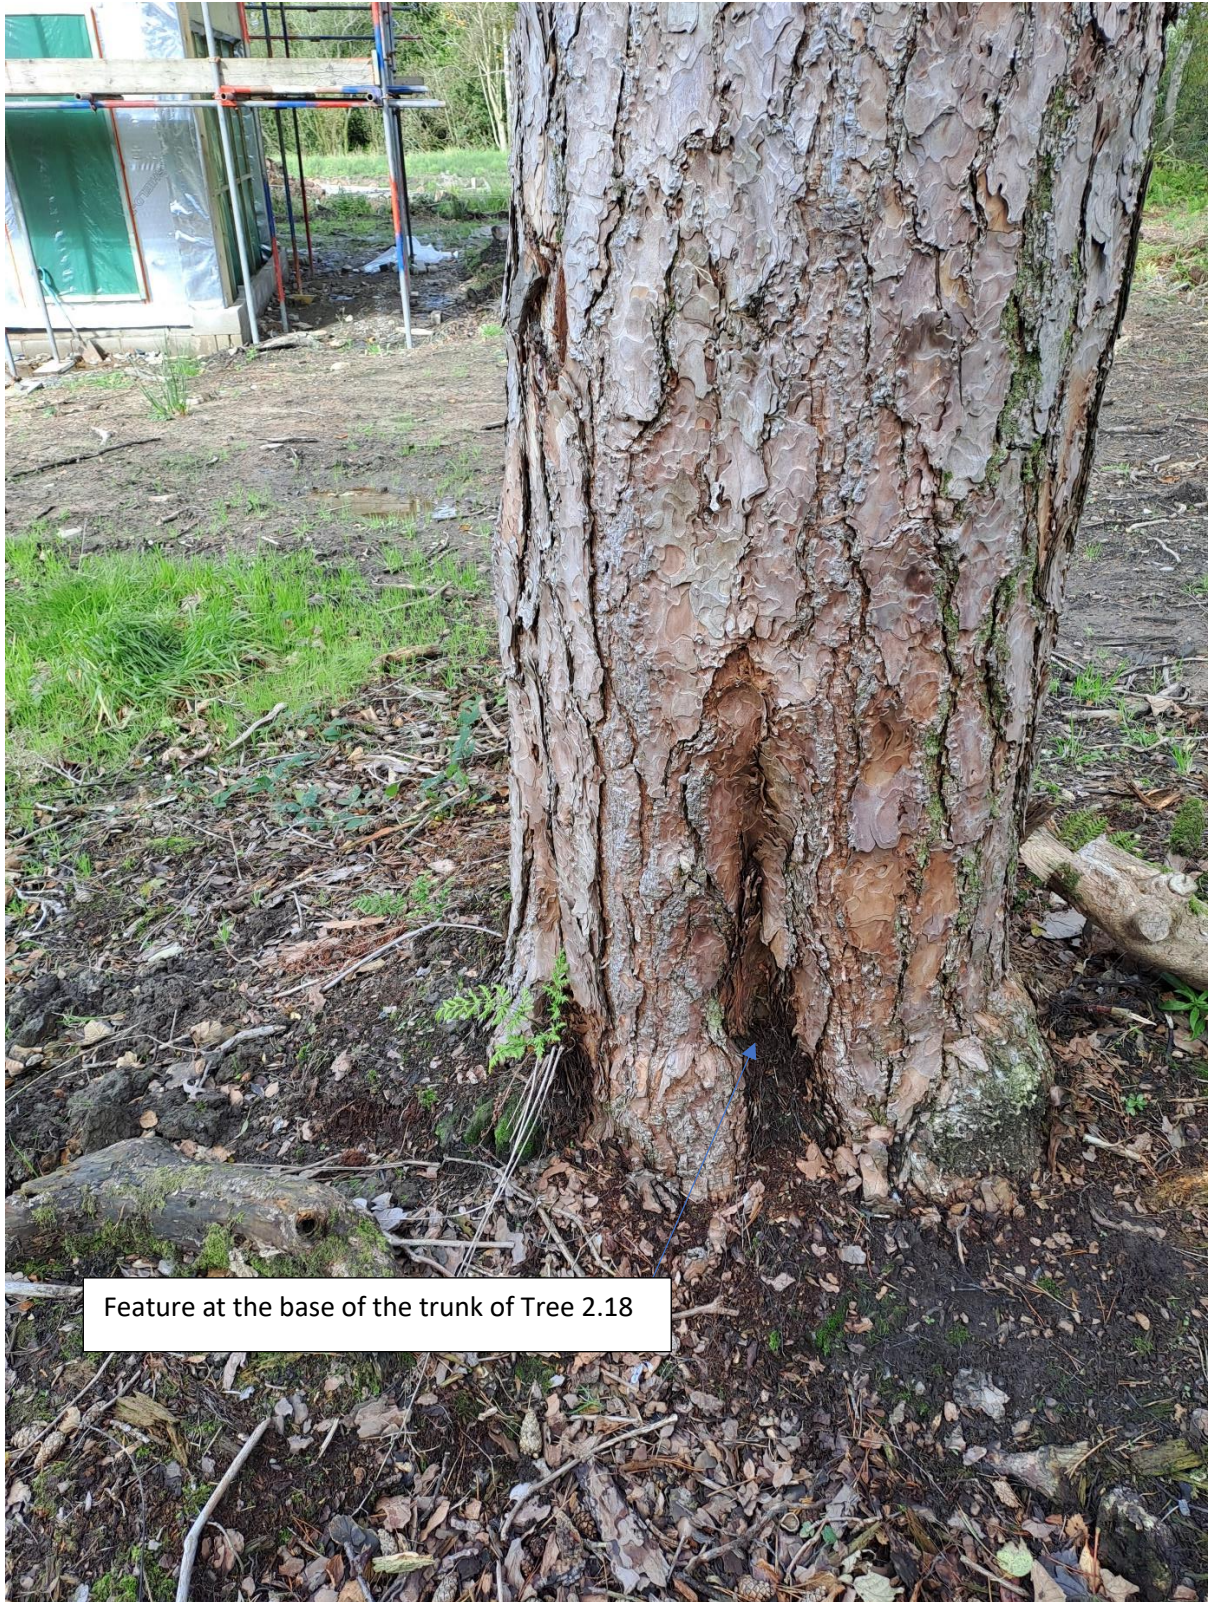
**Photo 6. - 12/10/23.
Base of the trunk of Tree 2.18.**

There is a feature at the base of the stem which may be either an old wound, or a natural separation space/flute between two buttresses (Photo 6). The significance of this feature I have therefore recorded as unknown.

Further assessment of this tree using techniques such as sonic tomography and/or load testing could be undertaken but, because of time and resources required to conduct such tests they are most appropriate for the assessment of large, mature trees with either high visual amenity and/or considerable historical, cultural, or ecological value. I consider, therefore, that felling this tree soon is most likely to provide, at most reasonable cost, the reassurance the owners and/or eventual occupants of the building currently under construction might always be seeking.

Feature at the base of the trunk of Tree 2.18
