**VISUAL STRUCTURAL INSPECTION**

**SCALEGILL HALL FARM HOUSE  
MOOR ROW  
CUMBRIA**

**THOMPSEN ESTATES**

**Reference - WDS/05/7017/REP01**  
**Date - 24/04/2021**

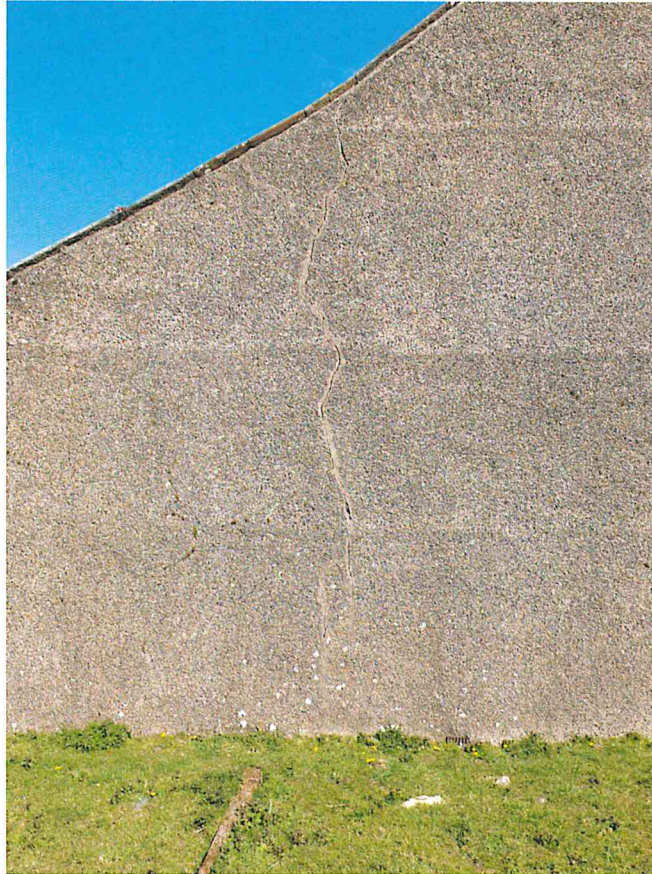
- 2.2** A significant crack is apparent on the left hand gable wall and also to the rear elevation of the extension (See photographs 02 and 03 attached). The cracks propagate from ground level up to eaves level. A crack is also apparent on the rear elevation of the main building adjacent to the extension. There is also a significant outward bulge to the rear wall of the left hand extension. The

location and orientation of the cracks suggests that the rear left hand corner of the property has suffered structural movement. It should be noted that the rear garden area is raised above the rear main road level with a retaining wall supporting the garden. It is likely that the ground behind the retaining wall may have settled and this movement has lead to movement of the properties foundations.

PHOTO 03 VIEW ON CRACKING TO LEFT HAND ELEVATION

- The cracked masonry needs tied by installing 750mm long Precast Concrete Spanlite Lintels into the wall across the crack location at 450mm vertical centres. The cracked masonry can then be filled with a non shrink cementitious grout and Expamet fixed to the wall face across the crack location prior to re-rendering. It is likely that when the render is removed other masonry cracks will be exposed and in each case these should be repaired as

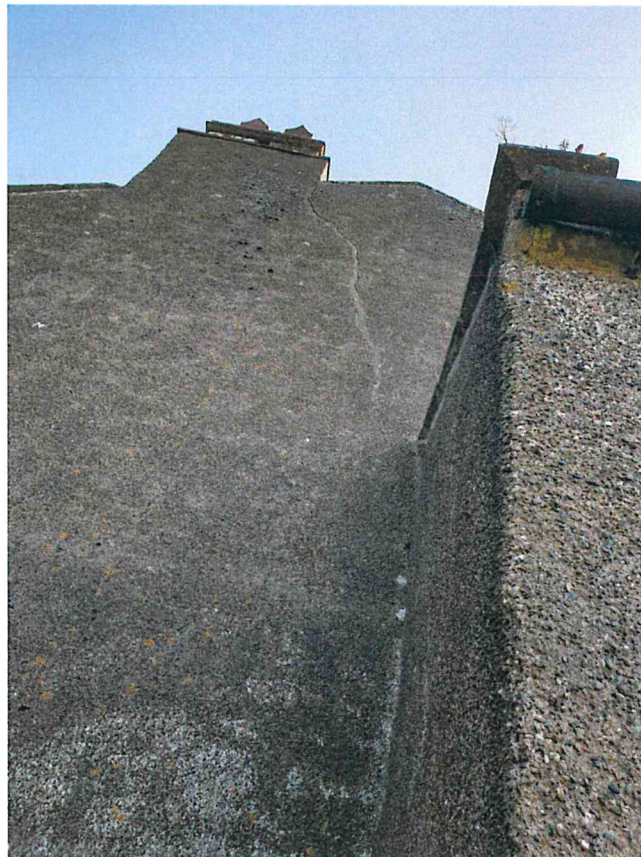
- 2.3 There is a vertical crack to the rear elevation which propagates vertically from ground level to eaves adjacent to the rear extension noted above. The crack has been caused by foundation movement as noted above. See photograph 04 attached.
- 2.4 The roof structure appears to be in an adequate condition however there is evidence of infestation and rot in areas.
- 2.5 The floor structures are in a very poor condition and need replaced throughout
- 2.6 The lintels over the windows are timber and some have been affected by infestation and rot and are in need of replacement.
- 2.7 The farm house is in a very poor state of repair throughout and is in need of total modernisation.

PHOTO 4 VIEW ON CRACK TO REAR ELEVATION MAIN HOUSE.

- The bowed wall to the rear elevation of the extension needs locally removed and rebuilt plumb off a new foundation.
  - The foundations to the rear left hand extension and rear wall of the main property need underpinned, we expect a length of over 20m of underpinning being necessary. The depth of underpinning will need confirmed when trial holes expose the existing ground conditions
