VISUAL STRUCTURAL INSPECTION

**SCALEGILL HALL FARM HOUSE
MOOR ROW
CUMBRIA**

THOMPSEN ESTATES

**Reference - WDS/05/7017/REP01
Date - 24/04/2021**

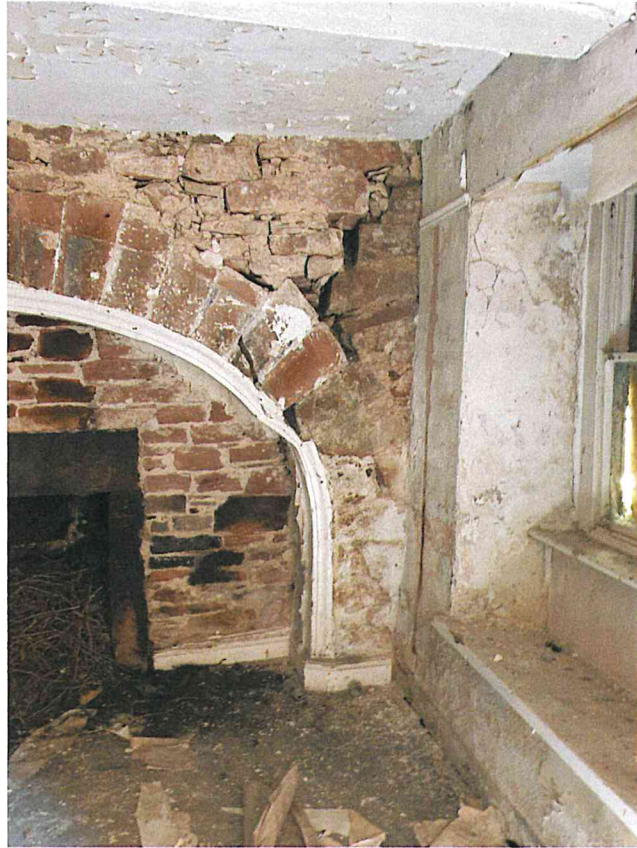
- 2.1** The front elevation of the property has a significant outward bulge centred at first floor level to the right of the front door, cracking is also apparent in the render at the bulge location. Internally the wall has pulled away from the internal fire place wall which has disturbed the archway masonry over the fire place area. There is a conifer tree located within 2.0m of the wall, this may have affected the wall footing locally which may have contributed to the wall movement noted. Photograph 01 in the appendix shows a typical view on the internal wall interface with the front wall.

PHOTO 01 VIEW ON FRONT WALL BOW & MOVEMENT TO INNER WALL

- 3.2 The bulging masonry to the front elevation is excessive and the wall is at risk of collapse should further movement occur. The wall needs locally taken down and rebuilt off a suitable foundation with the new masonry retied into the adjoining internal walls. The masonry arch to the inner adjoining wall will need fully propped during these works to protect the structure from failure once the outer wall is removed. The arch may also need some local rebuild. The conifer tree adjacent to the front wall needs removed in addition to all the Ivy growing up the wall.

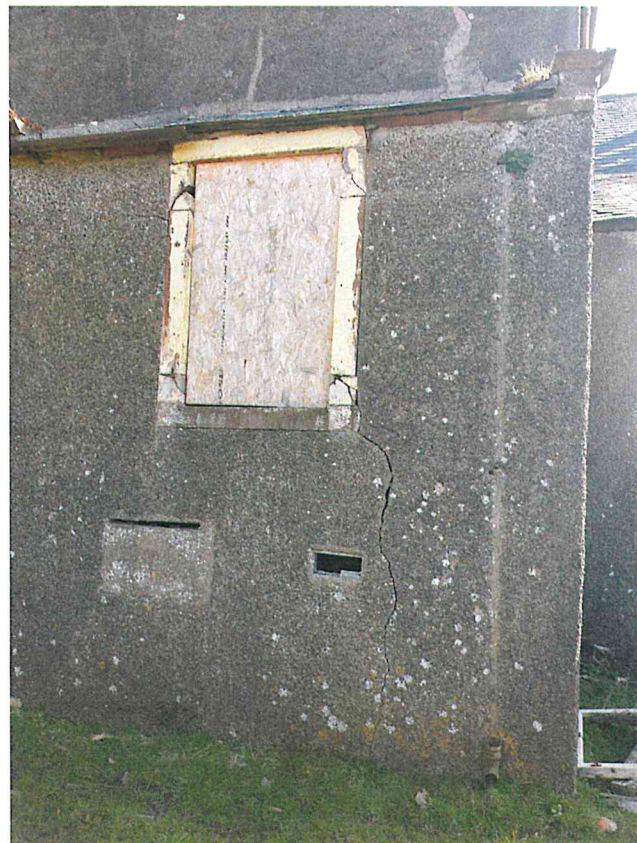
- 2.2** A significant crack is apparent on the left hand gable wall and also to the rear elevation of the extension (See photographs 02 and 03 attached). The cracks propagate from ground level up to eaves level. A crack is also apparent on the rear elevation of the main building adjacent to the extension. There is also a significant outward bulge to the rear wall of the left hand extension. The

location and orientation of the cracks suggests that the rear left hand corner of the property has suffered structural movement. It should be noted that the rear garden area is raised above the rear main road level with a retaining wall supporting the garden. It is likely that the ground behind the retaining wall may have settled and this movement has lead to movement of the properties foundations.

PHOTO 02 VIEW ON CRACKING TO REAR ELEVATION EXTENSION

- The bowed wall to the rear elevation of the extension needs locally removed and rebuilt plumb off a new foundation.
 - The foundations to the rear left hand extension and rear wall of the main property need underpinned, we expect a length of over 20m of underpinning being necessary. The depth of underpinning will need confirmed when trial holes expose the existing ground conditions

- The cracked masonry needs tied by installing 750mm long Precast Concrete Spanlite Lintels into the wall across the crack location at 450mm vertical centres. The cracked masonry can then be filled with a non shrink cementitious grout and Expamet fixed to the wall face across the crack location prior to re-rendering. It is likely that when the render is removed other masonry cracks will be exposed and in each case these should be repaired as

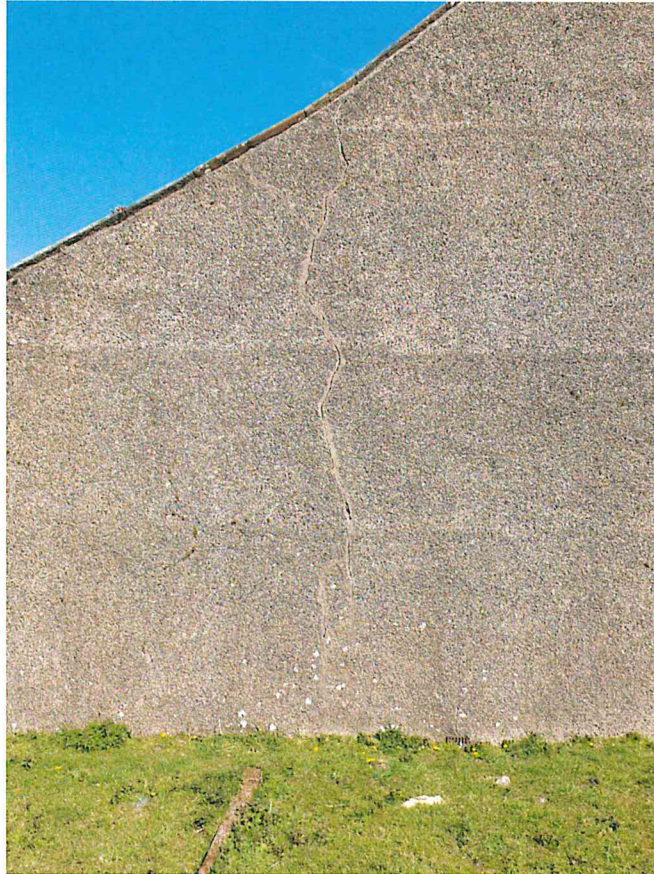
PHOTO 03 VIEW ON CRACKING TO LEFT HAND ELEVATION

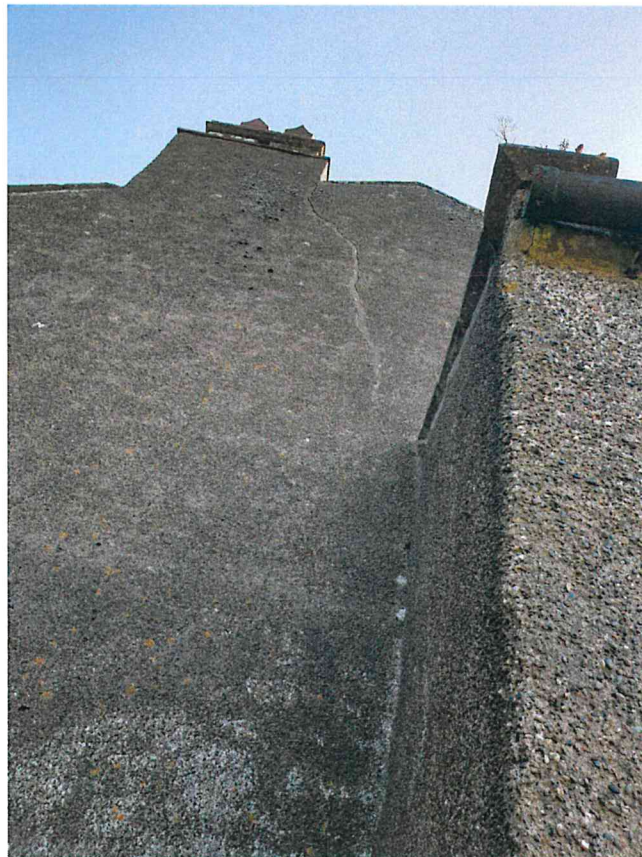
- 2.3 There is a vertical crack to the rear elevation which propagates vertically from ground level to eaves adjacent to the rear extension noted above. The crack has been caused by foundation movement as noted above. See photograph 04 attached.
- 2.4 The roof structure appears to be in an adequate condition however there is evidence of infestation and rot in areas.
- 2.5 The floor structures are in a very poor condition and need replaced throughout
- 2.6 The lintels over the windows are timber and some have been affected by infestation and rot and are in need of replacement.
- 2.7 The farm house is in a very poor state of repair throughout and is in need of total modernisation.

PHOTO 4 VIEW ON CRACK TO REAR ELEVATION MAIN HOUSE.
