## **Septic Tank Report Documentation**

Ian Kitching,  
Middle Fell Croft,  
Lamplugh,  
Workington,  
Cumbria. CA14 4SQ

Please find below the findings from the survey carried out at Middle Fell Croft.

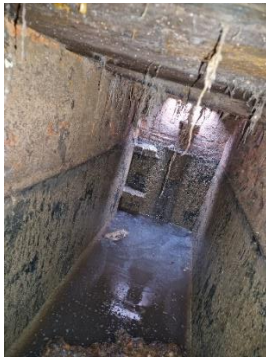
The Septic tank located in the front lawn is of block/brick design with render and the internal condition is good. The condition of the inspection chamber frames and covers is good.

Image from left to right: ST1 internal; ST1 inlet; ST1 outlet.

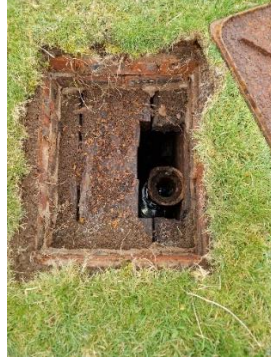
Evidence that surface water drains were discharging into this septic tank was found, confirmed by dye testing and CCTV camera investigation. There is a single surface water gully located at ground level to the left of the porch that must be diverted away from this system.

The inlet pipe size to tank is 110mm.

Using the supporting evidence found during the survey, the brick built septic tank serving Middle Fell Croft is of sufficient capacity and discharges to ground. There is currently a single surface water gully connected to this septic tank which must be diverted to allow the system to meet the general binding rules.

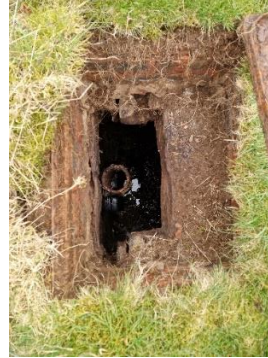
The discharge pipe from tank is 110mm.

There was no sampling point downstream from the tank, therefore we were unable to make a CCTV survey of the outfall from this septic tank. There was no evidence found of discharge to the nearby stream/ditch, therefore it is reasonable to assume that this septic tank discharges to a drainage field or soakaway.

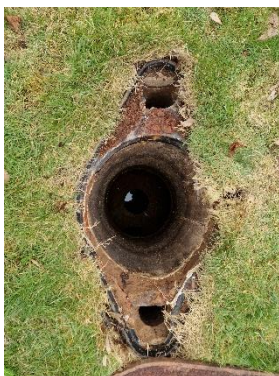
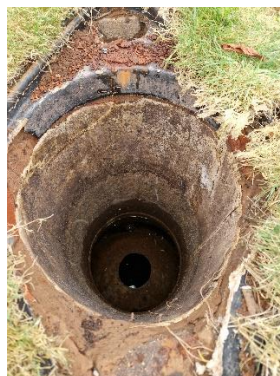
#### TANK INTERNAL PICTURES

The second septic tank is located on the lawn to the rear of the property. This septic tank is of fibreglass construction and although there are signs of cracks at the top of the riser, the general condition of the body of the tank is good.

This tank is of an 'onion' shaped design.

There is no evidence of surface water draining to this tank.

The inlet pipe size to this tank is 110mm.

The tank is approximately 2m deep from the base of the riser. Following consultation with the engineer that emptied the tank it can be estimated that the volume of the tank is approximately 5.5m<sup>3</sup>/5500 litres.

**Septic Tank 2/Cesspit** is of sufficient size to serve the property attached to Middle Fell Croft, which is currently one-bedroom. There is no evidence that this tank has a discharge outlet so it should be classed as a cesspit

The fibreglass septic tank, which is effectively a cesspit is of sufficient size and is in an acceptable condition. Cesspits are not subject to the same general binding rules as a septic tank that discharges to ground, however, it is a requirement to ensure that the tank is maintained and regularly emptied to ensure that it does not leak or overflow.

Pending percolation tests, it should be feasible to install a drainage field from the fibreglass cesspit to convert it to a working septic tank, if required.
