**CCTV Inspection Report**

**FOUL AND SURFACE WATER OUTFALLS FROM SITE COMPOUND  
WEST CUMBERLAND HOSPITAL  
HOMWOOD ROAD  
WHITEHAVEN**

**11/02/2022**

**Job Number: SK-S 160/21 WCH GRAHAMS (updated 11/02/2022)**

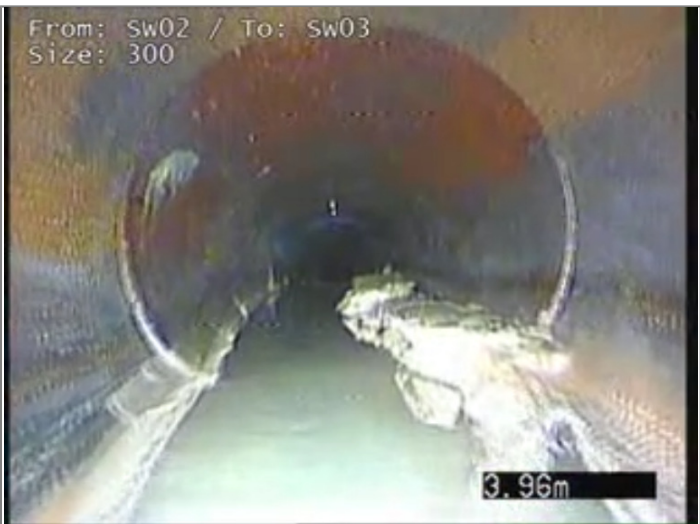
Crack circumferential from 9 to 11 o'clock at joint

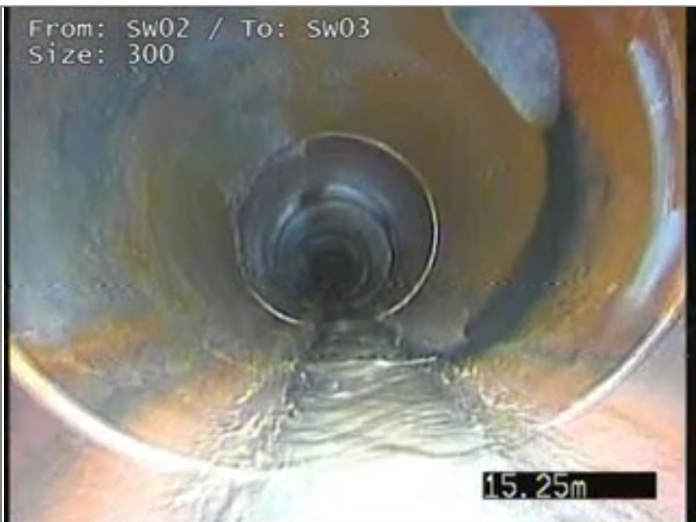
Crack circumferential from 1 to 3 o'clock at joint

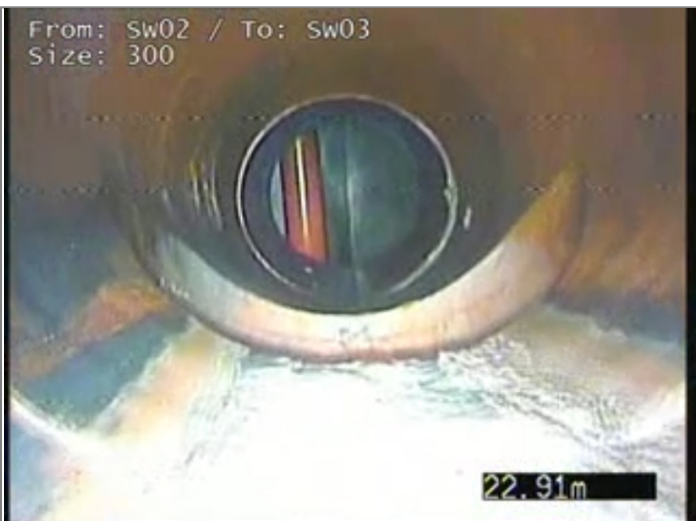
Crack circumferential from 1 to 4 o'clock at joint

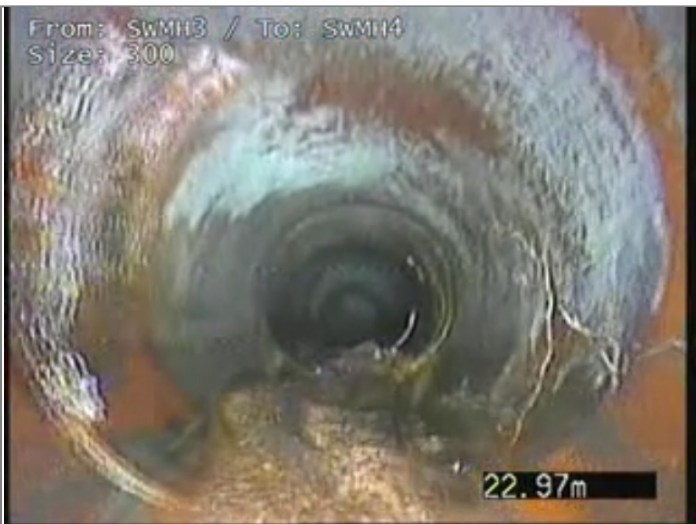
Crack circumferential from 2 to 5 o'clock at joint

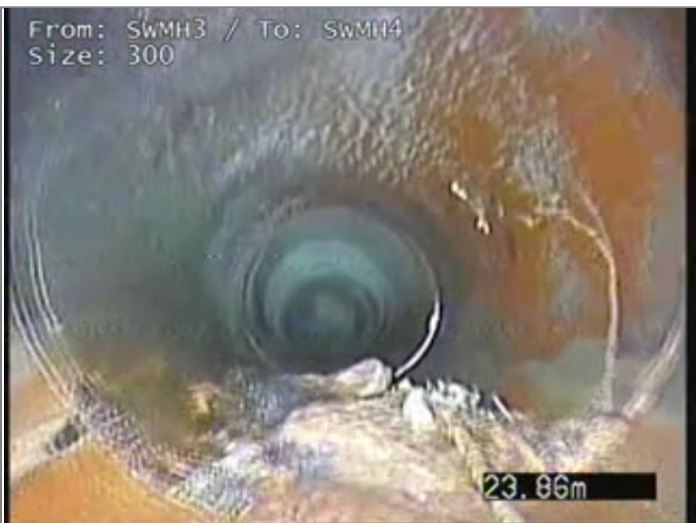
Roots mass 25% cross-sectional area loss at joint

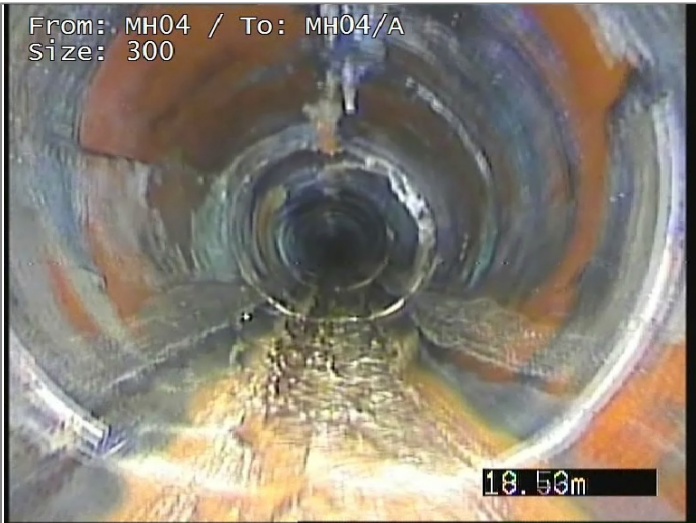
Roots mass 20% cross-sectional area loss, Finished

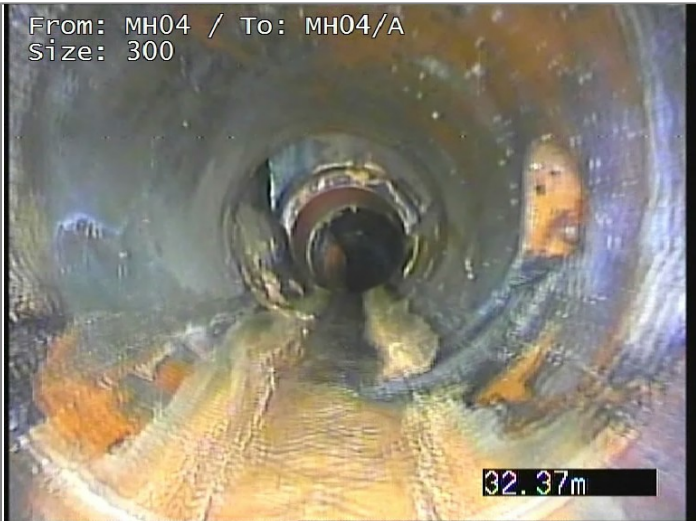
Fracture multiple from 12 to 12 o'clock, Finished

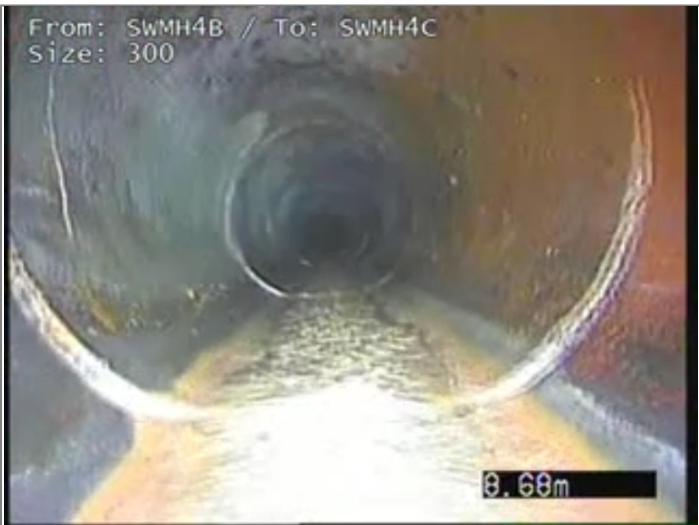
Attached deposits, encrustation from 1 to 6 o'clock 5% cross-sectional area loss at joint

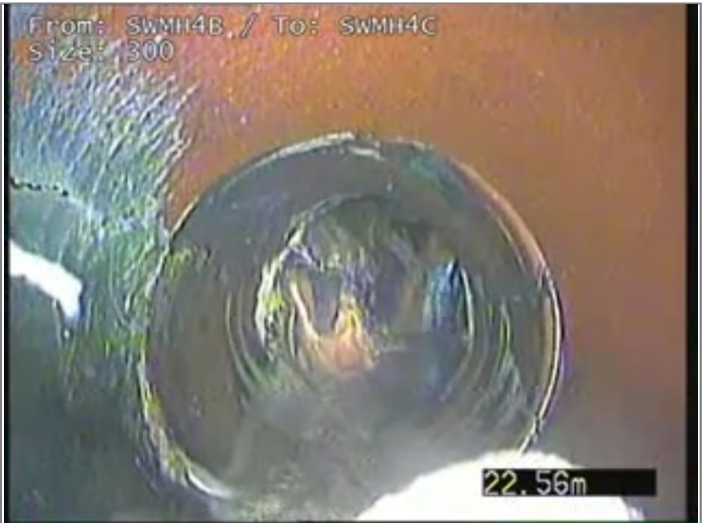
Other obstacles, other from 4 to 8 o'clock 40% cross-sectional area loss -  
Remark: DEBRIS OR SIMILAR RESTRICTING FLOW.

SEVERAL DEFECTS NOTED. THE SURTVEY WAS ABANDONED AT 23.3M AS THE CAMERA COULD NOT PASS THE OBSTRUCTION. THE MANHOLE CAN BE SEEN IN THE DISTANCE. ACCESS TO SWMH4C WOULD BE REQUIRED SO JET VAC CLEANING CAN BE CONDUCTED.

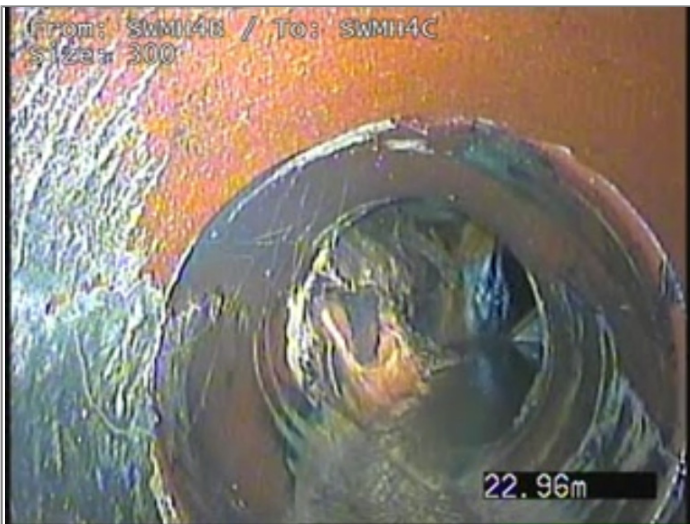
Fracture longitudinal at 9 o'clock

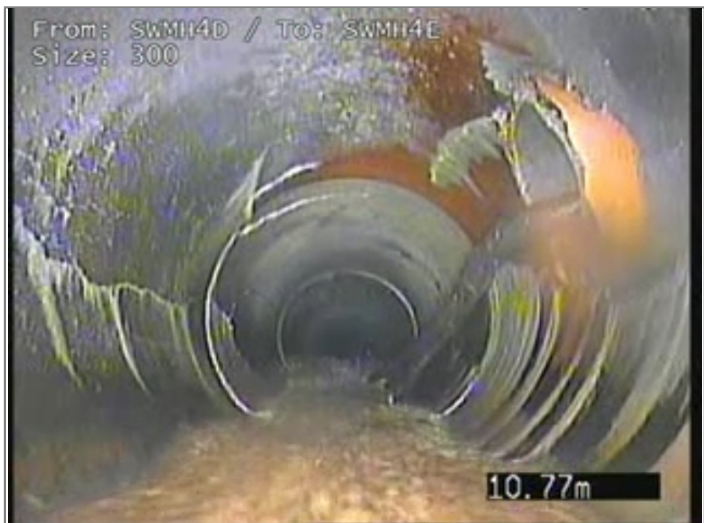
Fracture multiple from 12 to 12 o'clock

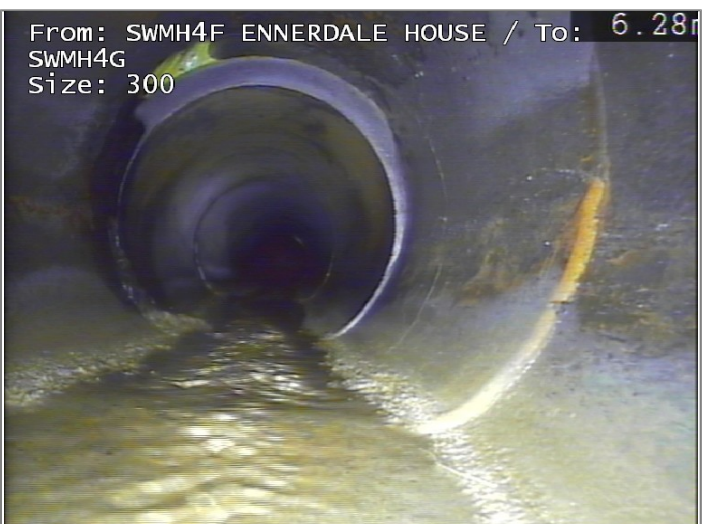
Broken pipe from 10 to 1 o'clock, at joint

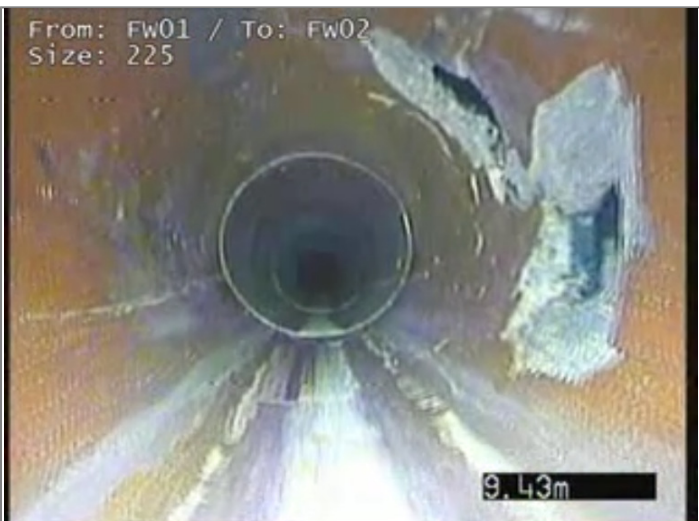
Hole in drain/sewer from 2 to 4 o'clock

FWMH02 IS UNDER THE BUILDING. TWO HOLES NOTED AT 9.43M AND 9.61M. RECOMMEND LINING THIS SECTION.

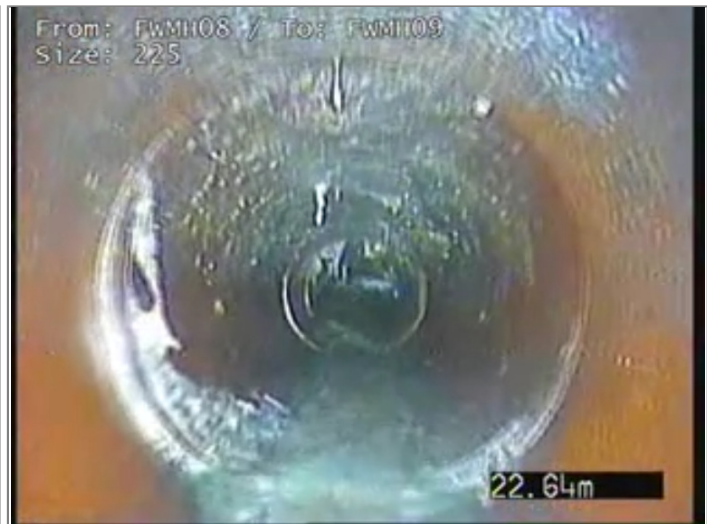
Fracture circumferential from 2 to 4 o'clock

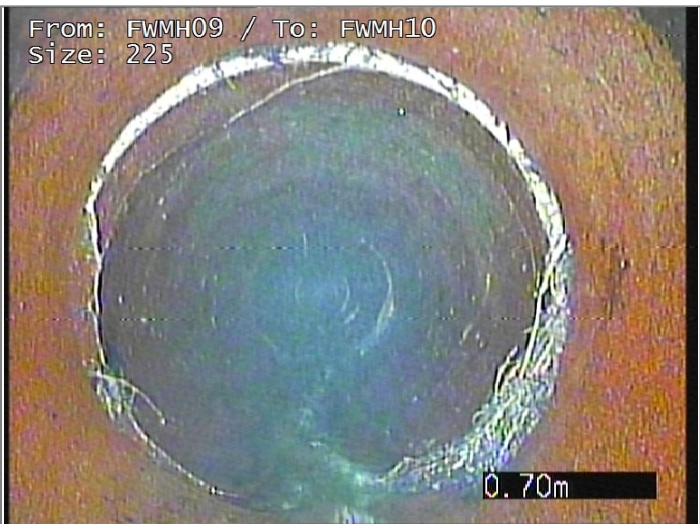
Roots tap at joint - Remark: SOME ROOT REMAINING AFTER ROOT CUTTING.

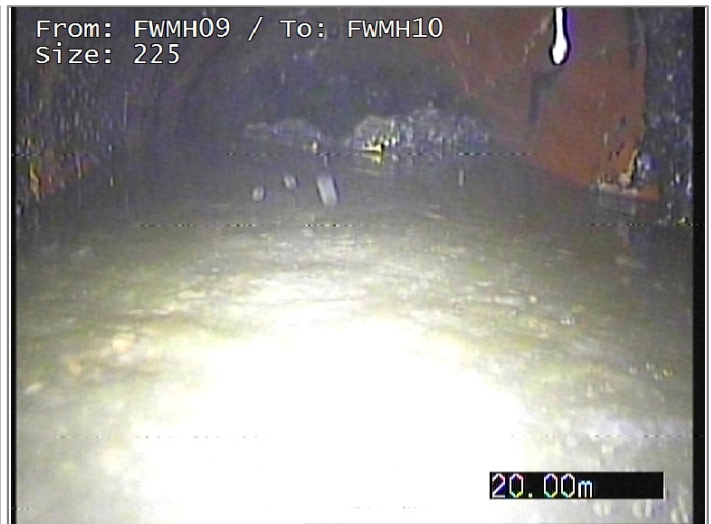
Broken pipe from 3 to 9 o'clock

Survey abandoned - Remark: UNABLE TO CONTINUE WITH ROOT CUT AND CCTV REPAIRS WILL NEED TO BE MADE TO LINE

SURVEY ABANDONED AT 20.0M DUE TO A PARTIALLY COLLAPSED PIPE. SEVERAL DEFECTS NOTED UPTO THIS POINT. THE RECOMMENDATION WOULD TO INSTALL LOCALISED STRUCTURAL REPAIR LINERS AND CONTINUE ROOT CUTTING.

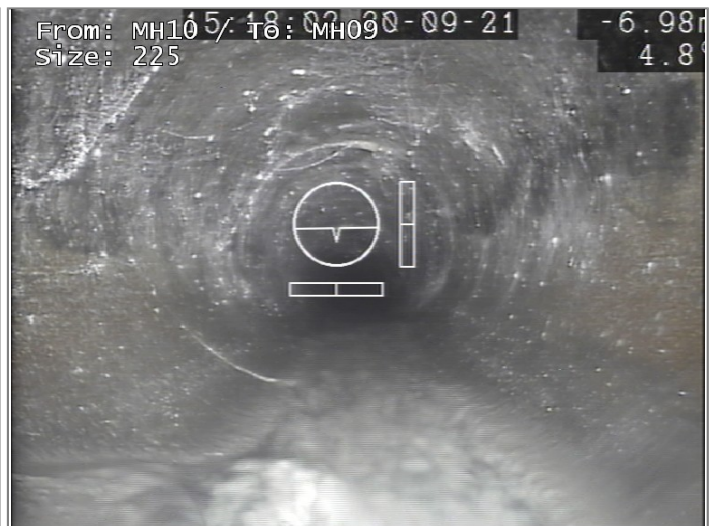
Broken pipe from 12 to 11 o'clock

ATTEMPTS MADE TO TRAVEL UPSTREAM FROM MH10 - MH09. SURVEY ABANDONED AT 6.99M DUE TO A SEVERE DEFECT. RECOMMEND INSTALLING A LOCALISED STRUCTURAL REPAIR LINER TO STABILISE PIPE BEFORE A TOTAL COLLAPSE OCCURS.

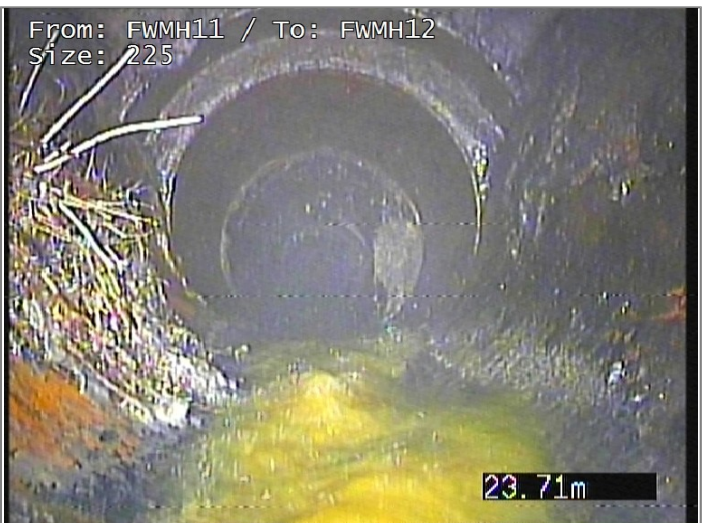
Fracture multiple from 12 to 12 o'clock, Finished
