Structural Appraisal

Scalegill Hall

Thomsen Estates

October 2022

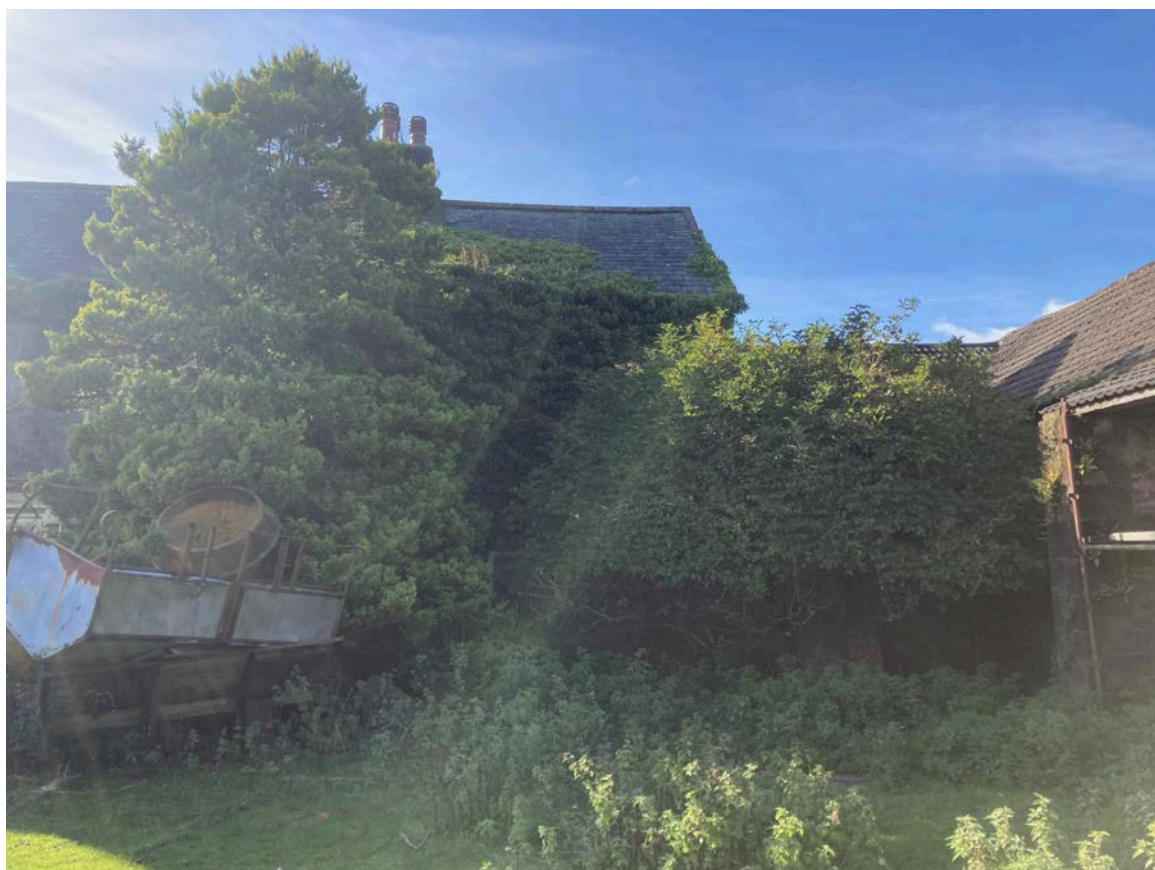
- There is a high level vertical crack to the north gable elevation. The crack extends through the full width of the wall and is visible internally.
- The front elevation is covered in ivy and vegetation. The vegetation has penetrated through the masonry walling and has blocked the gutters.

Photo 2 - Vegetation growth to south elevation of main house

The ivy to the east elevation should be cut back and all roots removed, or stumps left and poisoned. The scrub to the vegetation to the north west garden should be cleared and land drainage installed to improve the soil conditions.

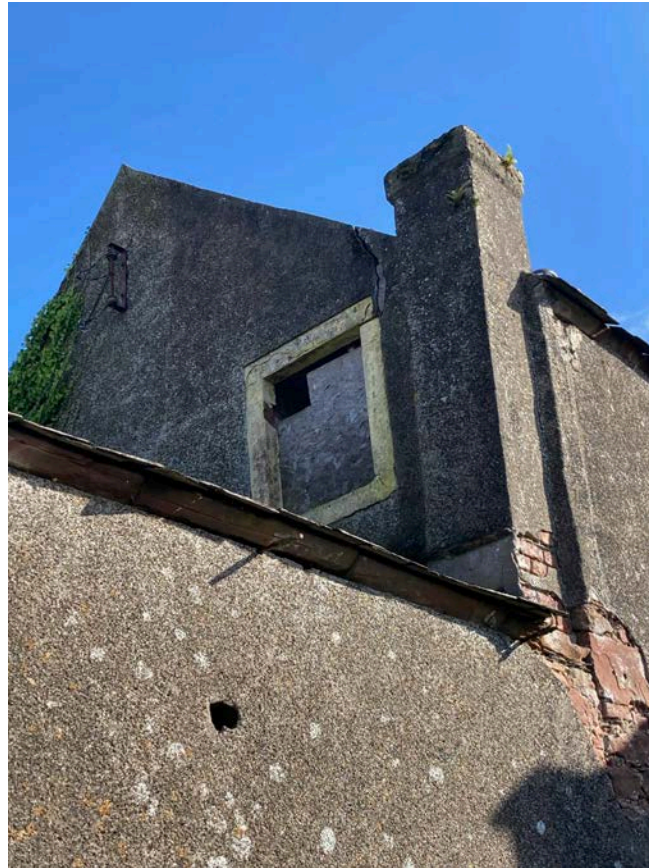
- The hard external cement render is non-breathable and can cause damp build up internally.
- The render has cracked on all elevations and has failed locally on the west elevation adjacent to the chimney flue.

Photo 3 - North gable with vertical crack near window opening and failed cement render

- Removal all rotten embedded timber to store / bathroom and build up inner leaf of masonry.
- Stitch cracked arch voussoir stone and diagonal crack in masonry above, using stainless steel bar set in epoxy resin, or proprietary crack stitching system.
- Replace rotten timber lintel over door opening in hardwood timber.
- Remove corroding iron band and replace timber lintel in new hardwood timber over window opening.
- Remove rotten timber beams over stone staircase and replace in steel, with a 152 x 152 x 23 UC steel beam, Grade S355.
- Install a proprietary crack stitching system to the high level crack on the north gable.
- Patch repair any failed cement render in lime render.

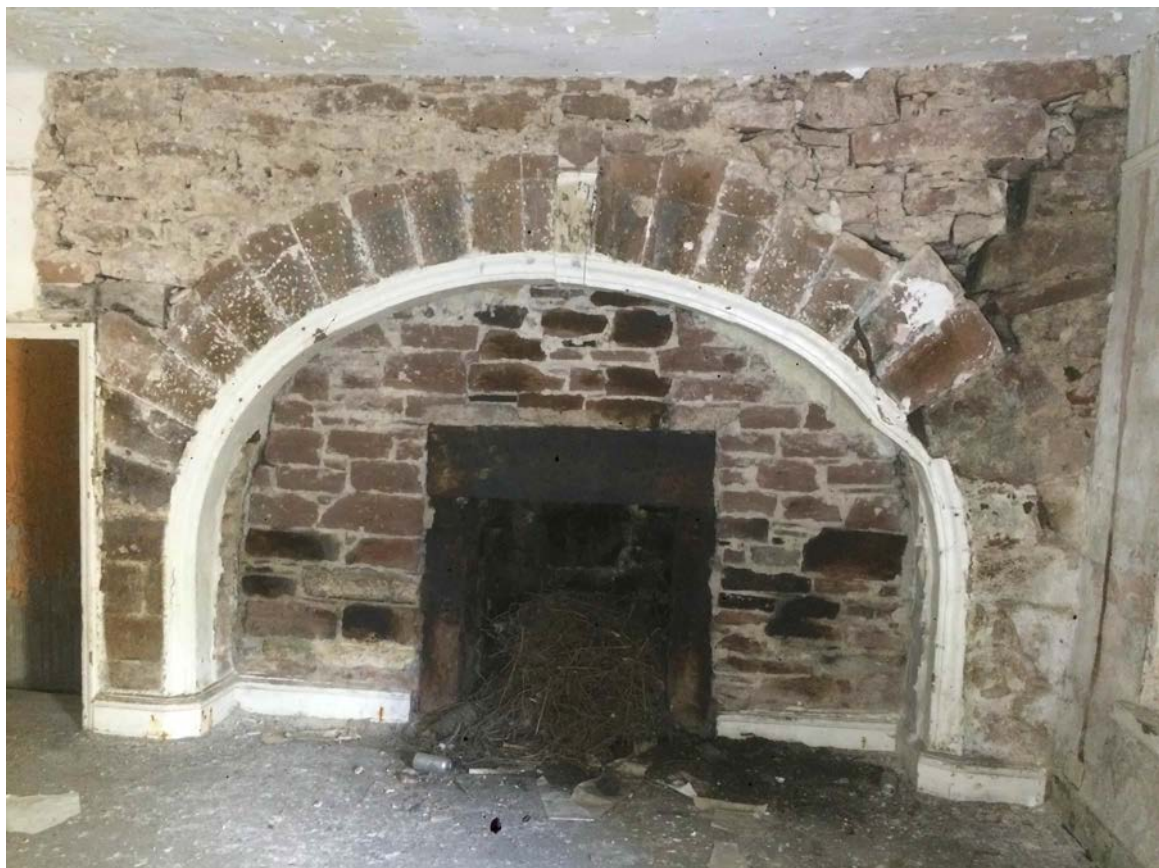
- There is a sandstone arch over the fireplace in the dining room. 1 no. arch stone has a shear failure which has displaced the masonry above and caused a diagonal crack.

Photo 4 - Stone arch with shear failure to voussoir stone

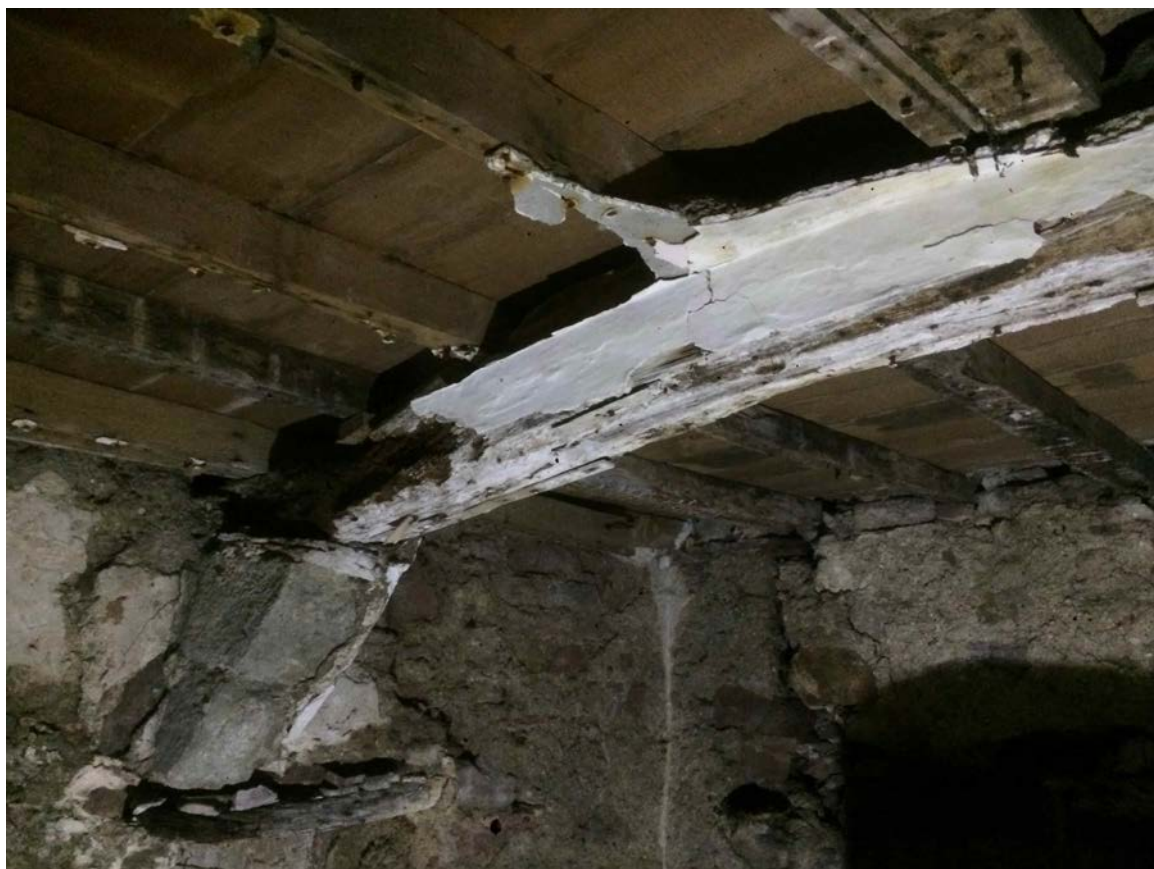
Overall, the first floor structure is in reasonable condition with localised defects. The floor over the ground floor store and bathroom has partially collapsed caused by rot and loss of section to the main timber floor beam. The first floor joists over the store in the link building are undersized and have split at their mid-point.

Photo 5 - Failed first floor timber beam over store

The first floor structure over the store and bathroom, and the link building, will require full replacement. New joists to be 63mm x 190mm deep at 400mm centres spanning the full width, no requirement for intermediate support. The joists can be fixed to a new timber wall plate secured to the masonry wall using stainless steel threaded bar set in 2 part epoxy resin. Timber to be Grade C24 softwood.

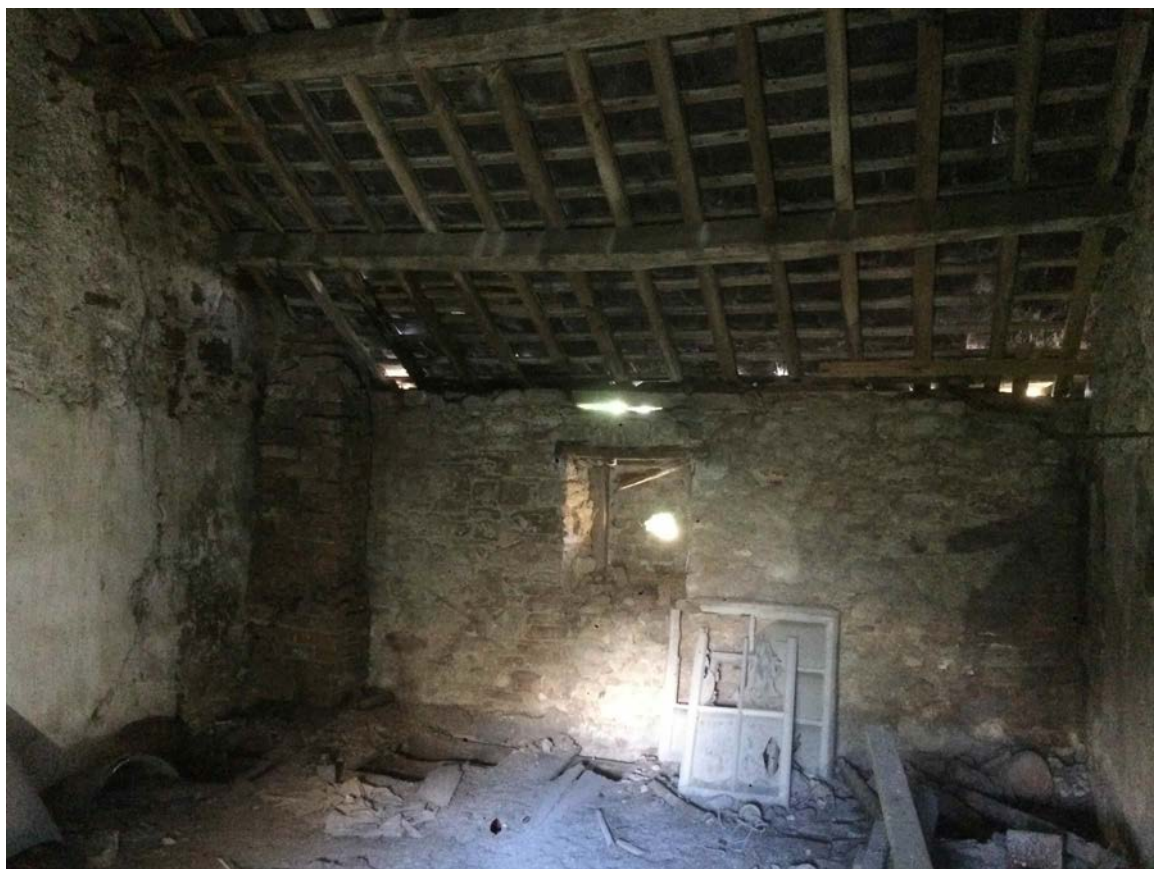
The roof is in good structural condition with 1 no. notable defect to the roof structure over the link building. There is 1 no. purlin with a rotten end.

Photo 7 - Roof over link building with rotten purlin end

A traditional scarf end repair should be carried out to the rotten roof purlin over the link building.

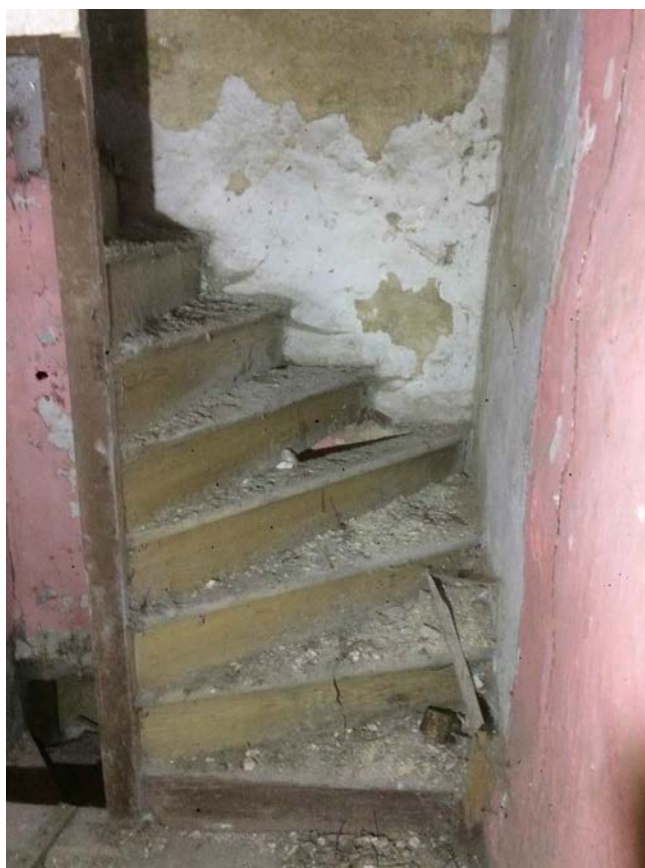
The stone treads to the main staircase have worn away and are uneven. The timber winder staircase is in poor condition. The lower flight has collapsed and there are splits in the timber treads to the upper flight. The external stone staircase to the link building has uneven and moss growth on the treads. The balustrade is inadequately fixed and loose.

Photo 8 - Timber treads to second floor staircase in poor condition

The timber winder staircase will require full replacement. The external stone staircase should be cleaned down, removing all moss growth and all gaps between the treads should be packed and pointed in lime mortar. A new balustrade should be installed.

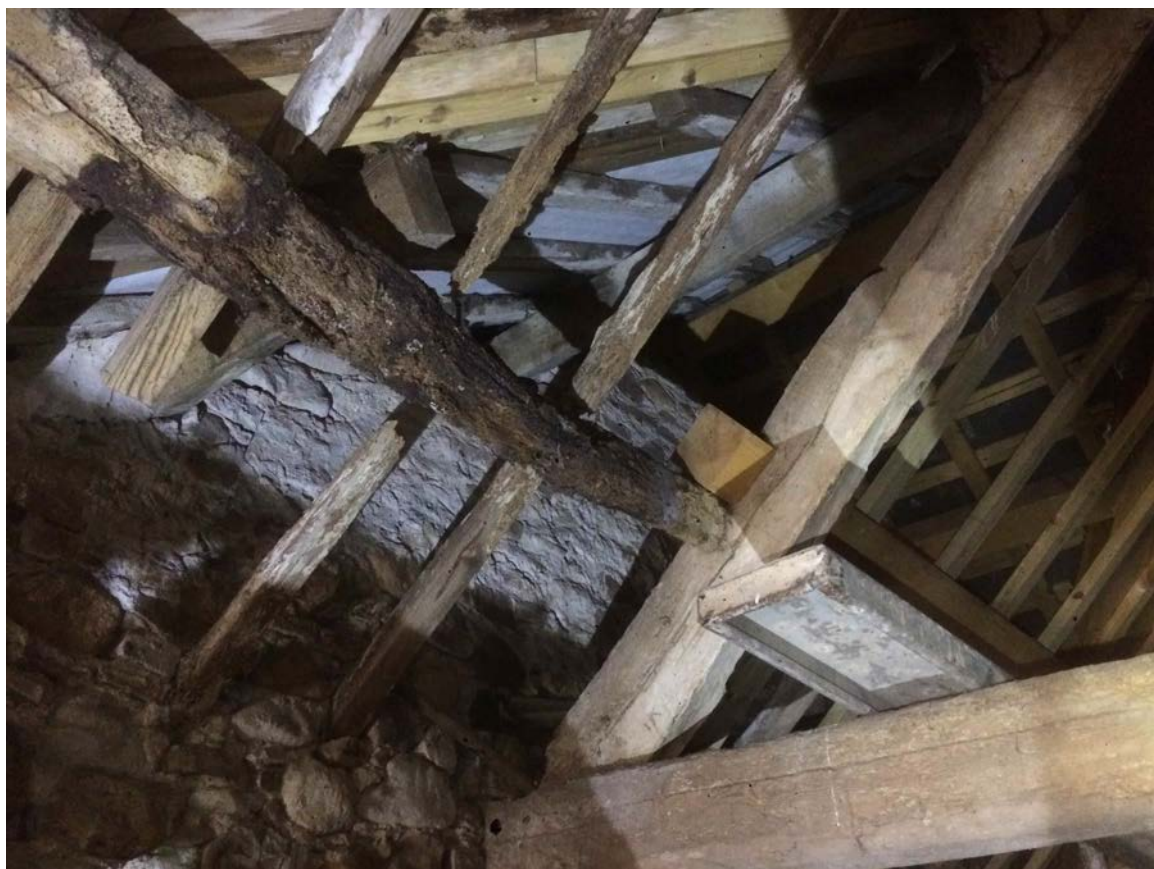
The roof structure is in reasonable condition with localised areas of missing and slipped roofing tiles and isolated structural defects. There are 2 no. truss tie beams with rotten ends and loss of section. There is 1 no. rotten purlin with significant loss of section supporting a series of rotten common rafters.

Photo 11 - Rotten purlin and common rafters

- Traditional scarf end repair to tie beam on 2 no. trusses.
- Full replacement of rotten purlin and common rafters, in hardwood timber.
- Refix any loose slates to prevent further water ingress.

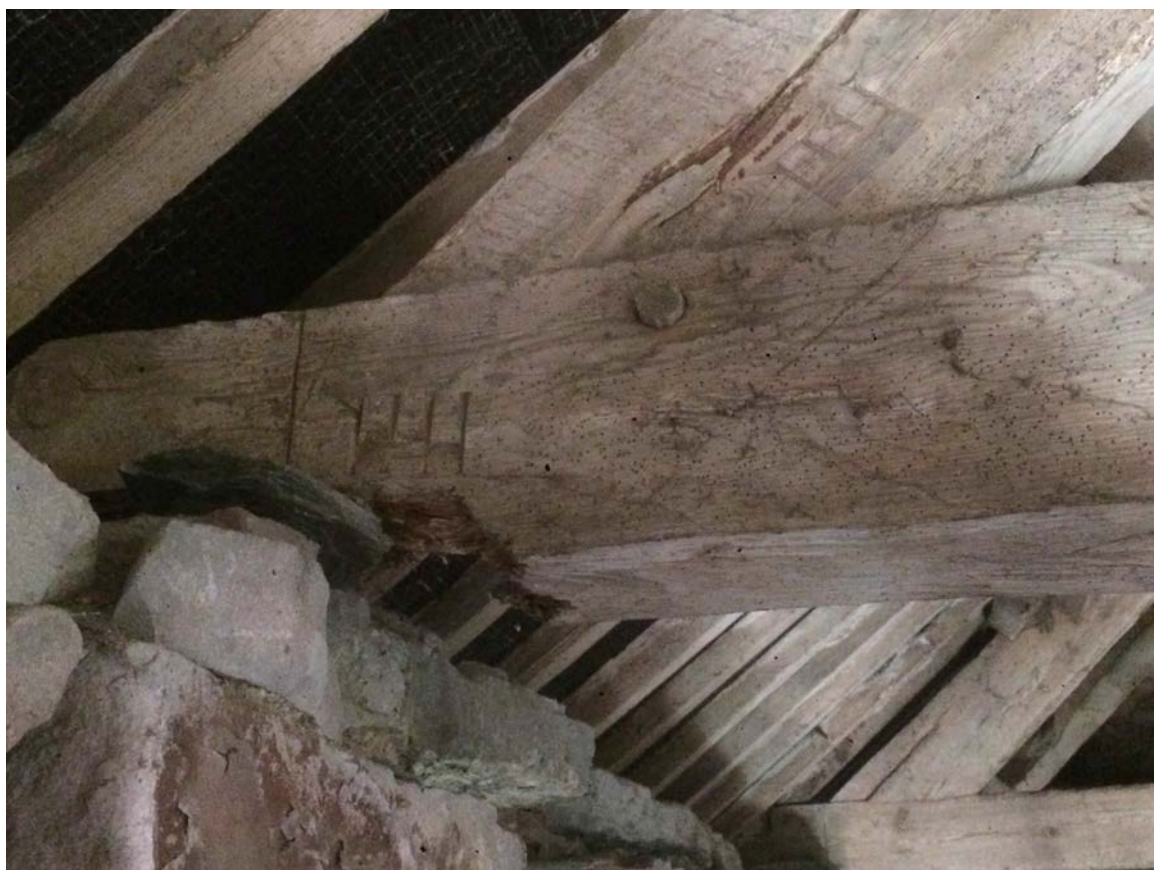
Photo 12 – Truss tie beam with rotten end

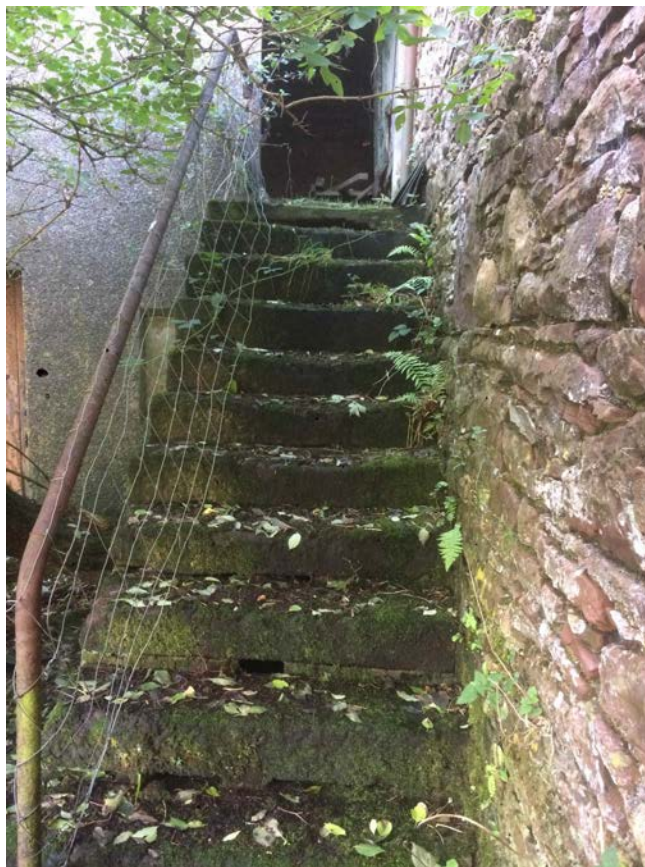
Photo 13 - External staircase with vegetation growth on treads and loose balustrade

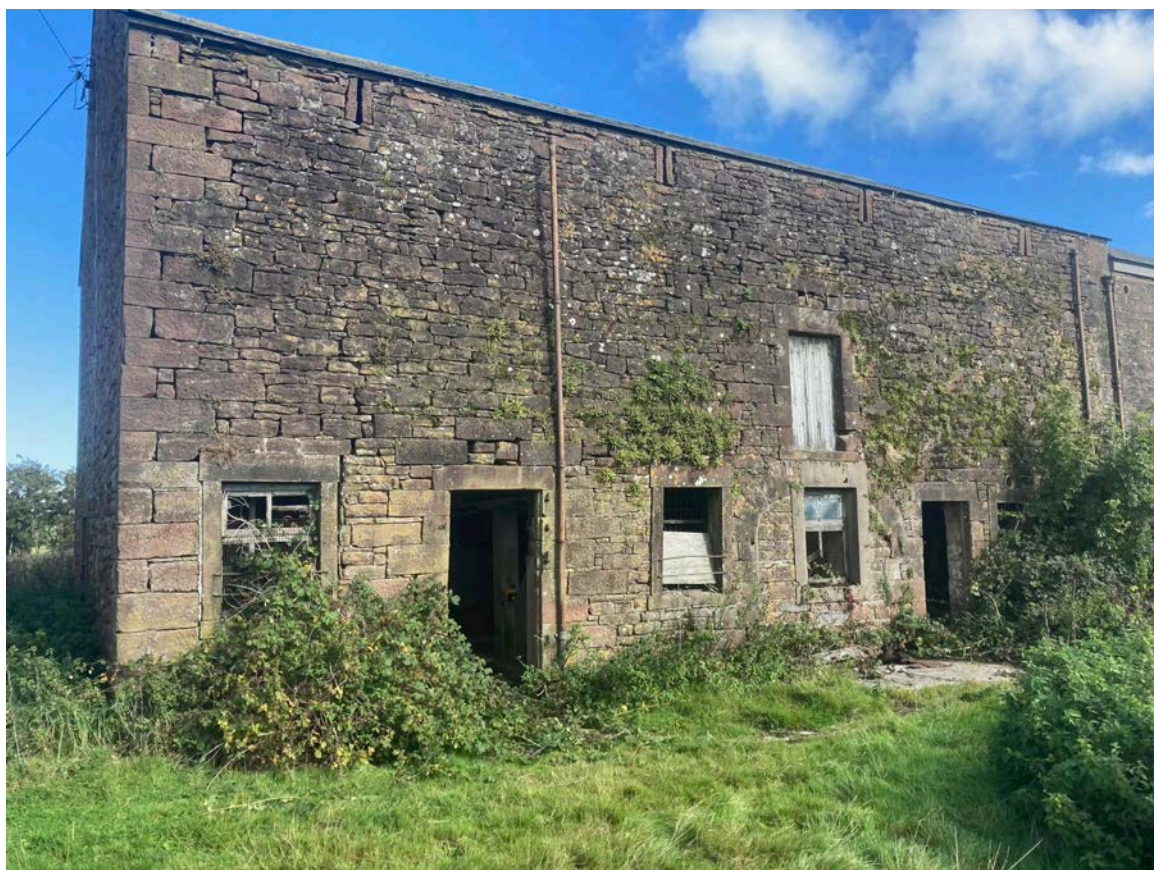
Overall, the masonry is in reasonable condition. The main concern is the bulging masonry to the south elevation. There is an outward bulge from ground floor level to first floor level and diagonal cracking in the stonework. In addition, there are 2 no. rotten timber lintels, 1 no. inner timber lintel over a ground floor window opening to the south elevation and 1 no. outer timber lintel over the cart shed opening on the north elevation. The masonry above the cart shed opening has displaced. There is minor vegetation growth to the south elevation.

Photo 14 - South elevation of barn with outward bulging masonry

The bulging masonry to the south elevation will require rebuilding, from ground floor to first floor, as indicated on the drawing. The masonry above will need to be adequately propped before the stonework is carefully taken down. The rebuilt stonework should be adequately tied into the existing stonework using proprietary wall ties.

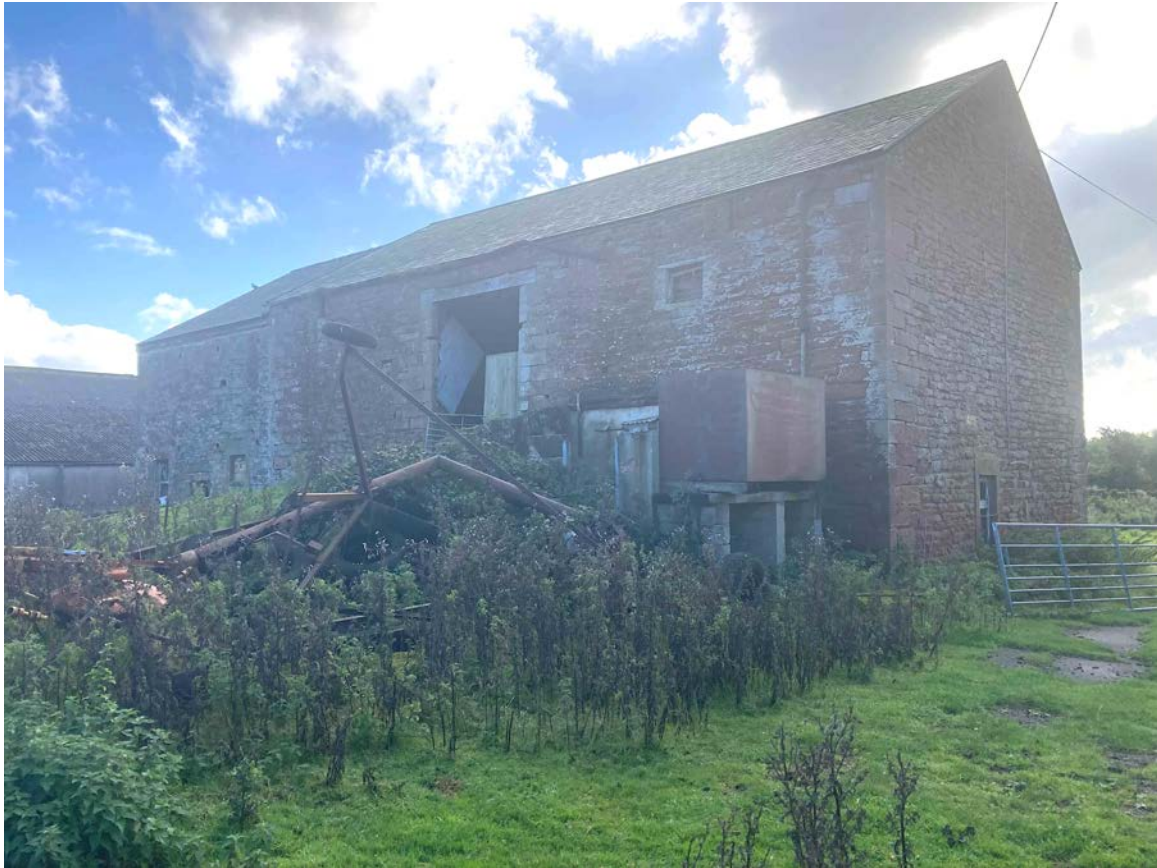
Photo 15 - North elevation of barn with rotten timber lintel over cart shed

The rotten lintel over the cart shed opening should be removed and replaced in hardwood timber. The masonry above requires consolidating and repointing in an appropriate lime mortar. A new timber lintel is required over the central ground floor window opening. This should be replaced in hardwood timber or precast concrete.

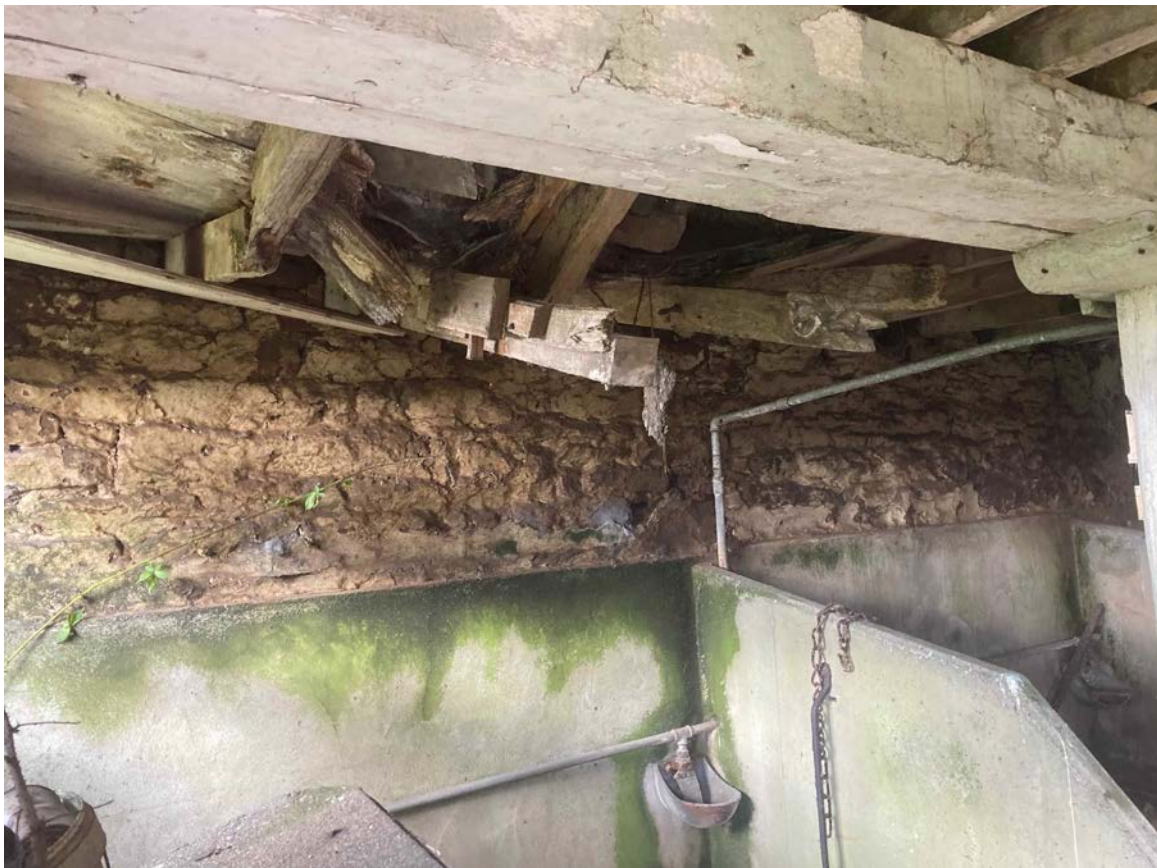
The first floor joists are in poor condition. The joists to the first bay have collapsed and have split at their mid-point. The joists to the second and third bay have been strengthened with additional joists slotted between the existing. The joists to the fourth bay have collapsed adjacent to the front elevation. There are also voids and loose stones to the rear elevation, which is retaining the higher external ground levels, this is allowing water to ingress through the masonry and rot the joist ends. The first floor structure over the east end of the barn has collapsed.

Photo 16 - Collapsed first floor joists in barn

The defective and collapsed first floor joists require renewal, refer to Section 6 for details on converting the barn to domestic.

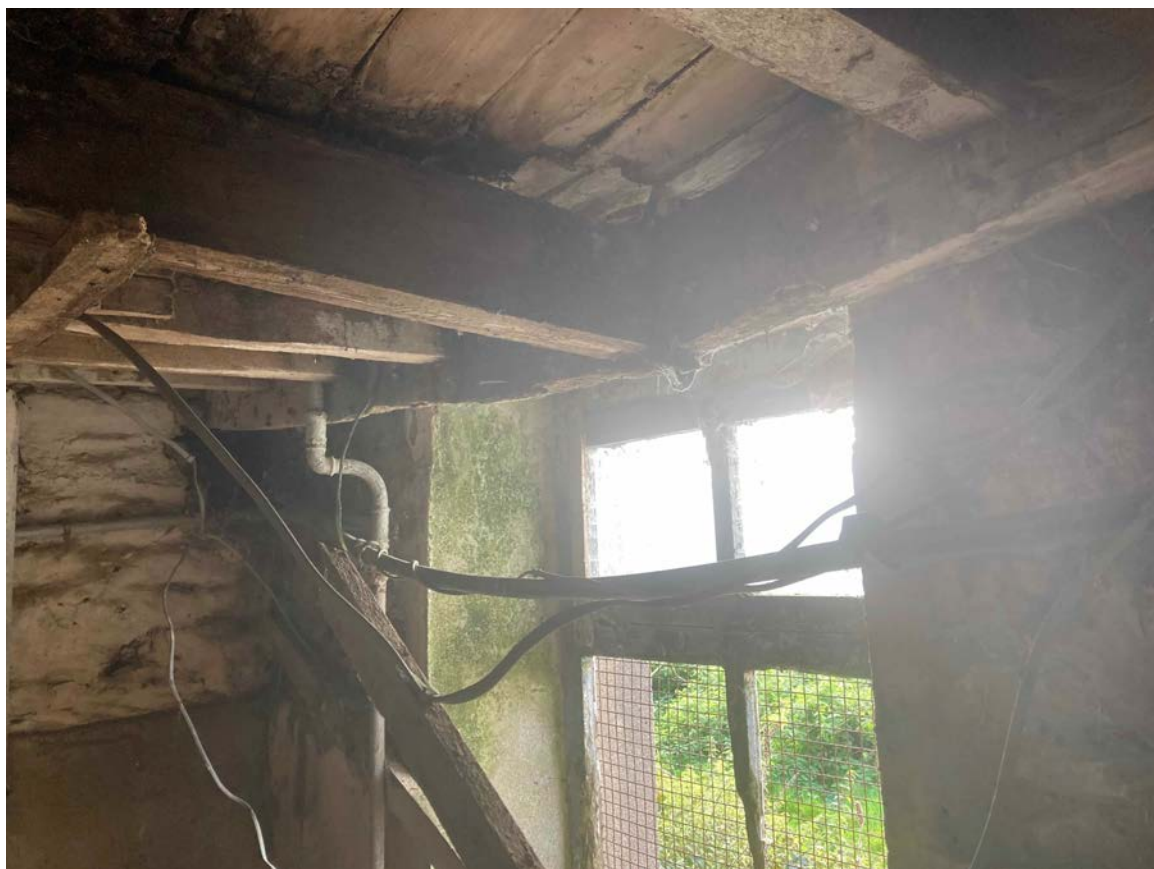
Photo 17 – Collapsed first floor joists and rotten wall plate

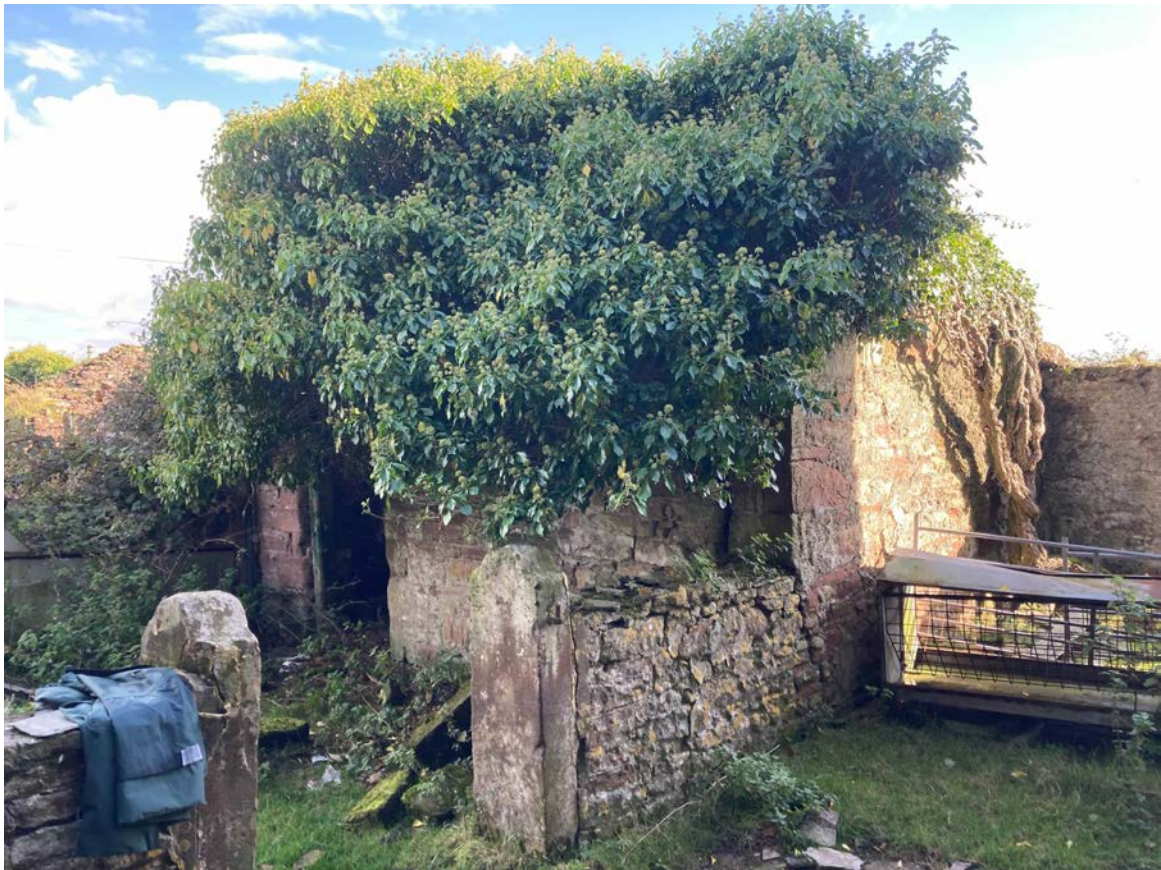
Outbuilding no. 1's masonry walls are complete up to eaves level. There is significant vegetation growth, with well established trees growing within the west room and ivy growth to the west gable and internal cross wall. The wall heads are exposed, causing wash out of mortar and loose stonework.

Photo 19 - Vegetation growth to Outbuilding No.1

All vegetation should be removed from the 3 no. outbuildings. Any vegetation rooted into the masonry should be carefully taken out, any loose masonry to be consolidated and repointed in an appropriate lime mortar.

The wall heads should be consolidated using an appropriate lime mortar to protect from further deterioration.

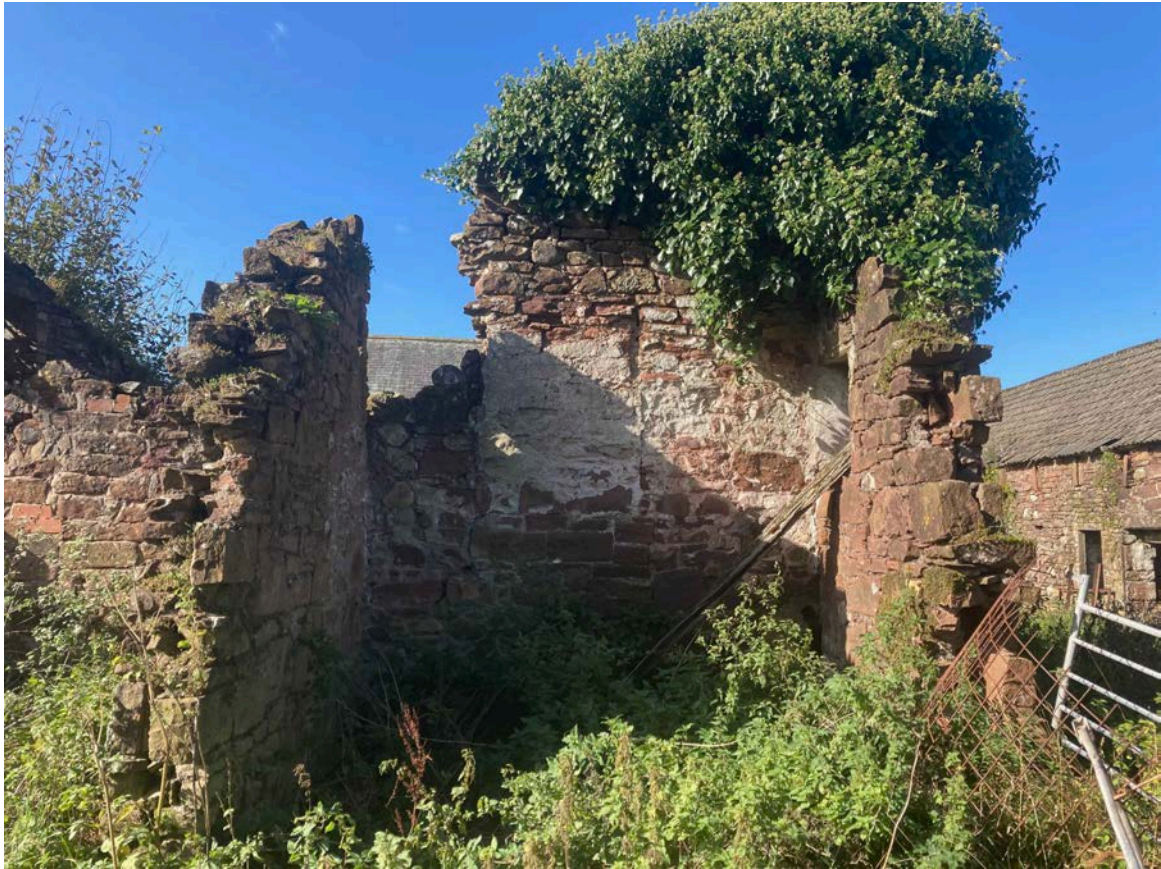
Outbuilding no. 2 has missing masonry walls, including the front and rear elevation. There is vegetation growth to the north elevation and internal cross wall. The exposed wall heads have loose stonework caused by mortar wash out.

Photo 20 - Vegetation growth and exposed masonry wall heads to Outbuilding No. 2
