STRUCTURAL INSPECTION REPORT

LOCATION: MILL FARM BARNS, THE GREEN, MILLOM,
CUMBRIA, LA18 5HL

CLIENT: MVC DESIGN LTD

JOB No: 25184

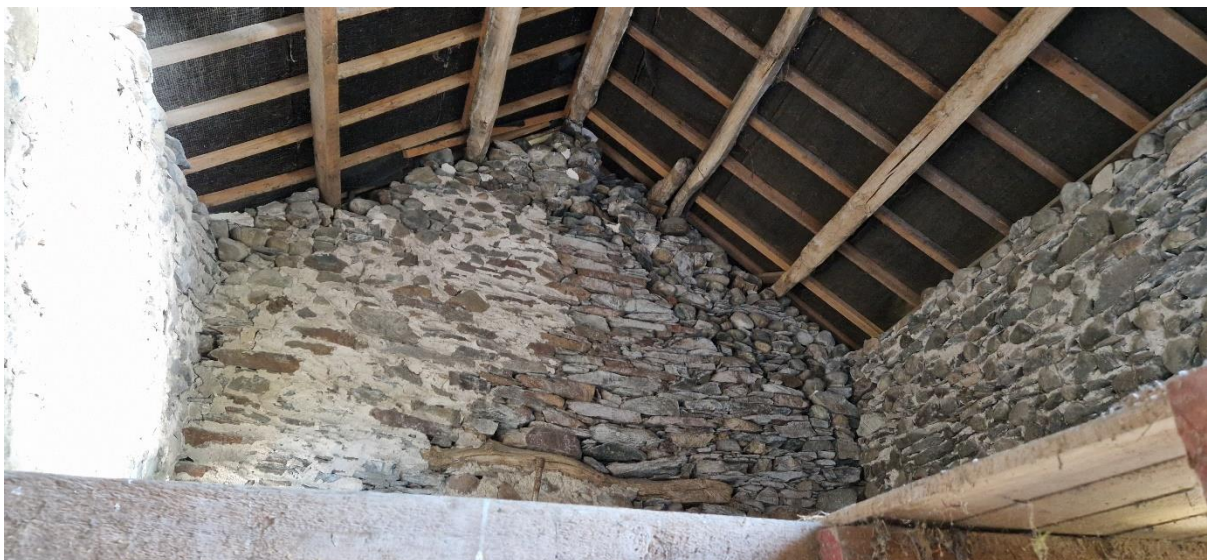
Barn 1 is located at the southern end and contains a timber first floor. The roof structure consists of an intermediate triangular timber truss with two side purlins each side and a ridge. It has been re-roofed historically with a membrane installed over the rafters. The timber generally appears to be in reasonable condition with no obvious water ingress present.

There is a mixture of timber and stone lintels about openings. The walls are generally straight and true with limited signs of lateral movement. There is some loose stone present towards the peaks of the gable ends. There is render present in part containing several cracks and the lime mortar is old and has deteriorated generally.

Photo 1 - Gable End and Roof of Barn 1

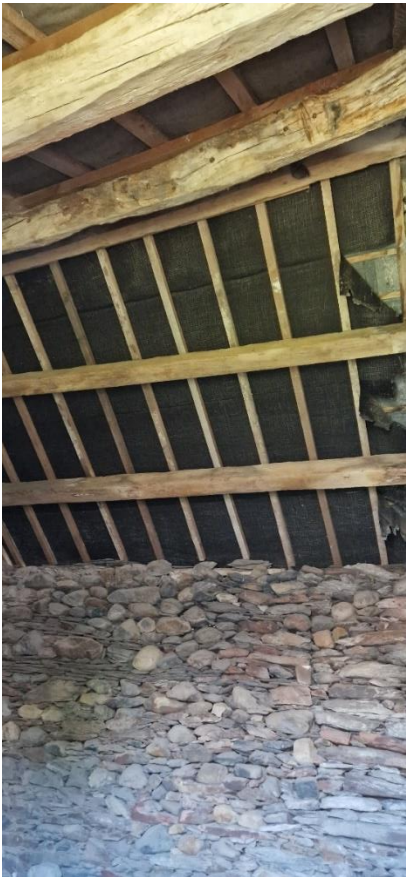
Barn 2 was not accessible at ground floor level but ladder access to the first-floor hay barn was available. The roof was again traditional with purlins spanning between gable walls. It had also been re-roofed. The timber generally appears to be in reasonable condition with no obvious water ingress present.

The first floor had severely deflected and needs to be removed during any conversion works

Photo 2 - Roof and Western Wall of Barn 2

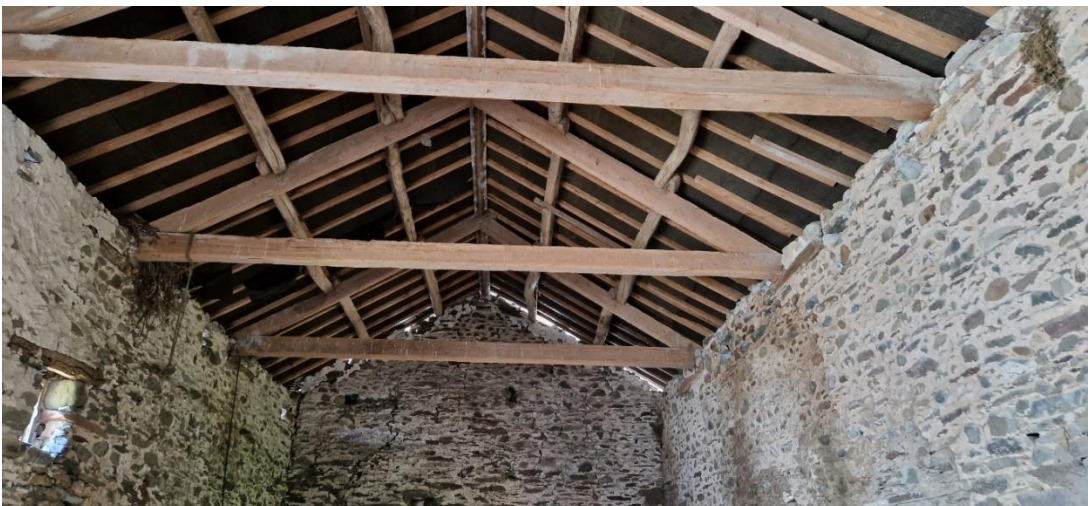
Large single storey open barn containing 5 intermediate triangular trusses with two side purlins each side. It has again been re-roofed. The timber generally appears to be in reasonable condition with no obvious water ingress present.

Photo 3 - roof of Barn 3

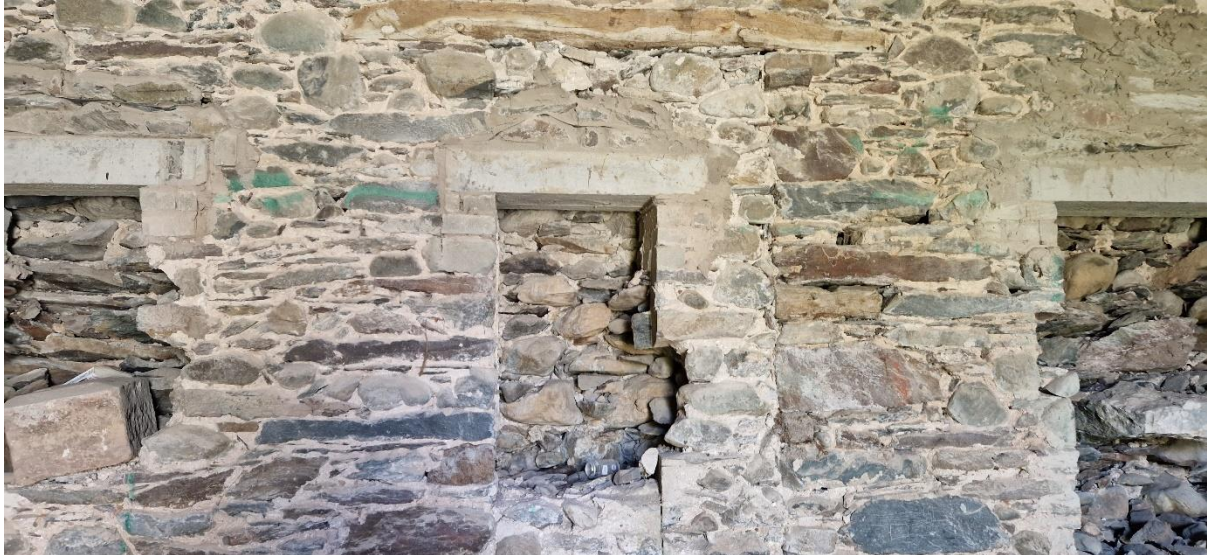
It appears that conversion works have previously commenced with new lintels installed internally. The gable end to the north has in part been rebuilt in blockwork and the ground floor has been removed and reduced in level. Some of the reduced level excavations are now lower than the foundation stones but at this stage hasn't resulted in any substantial undermining.

Photo 4 - Barn 3 - Lintels Installed Internally

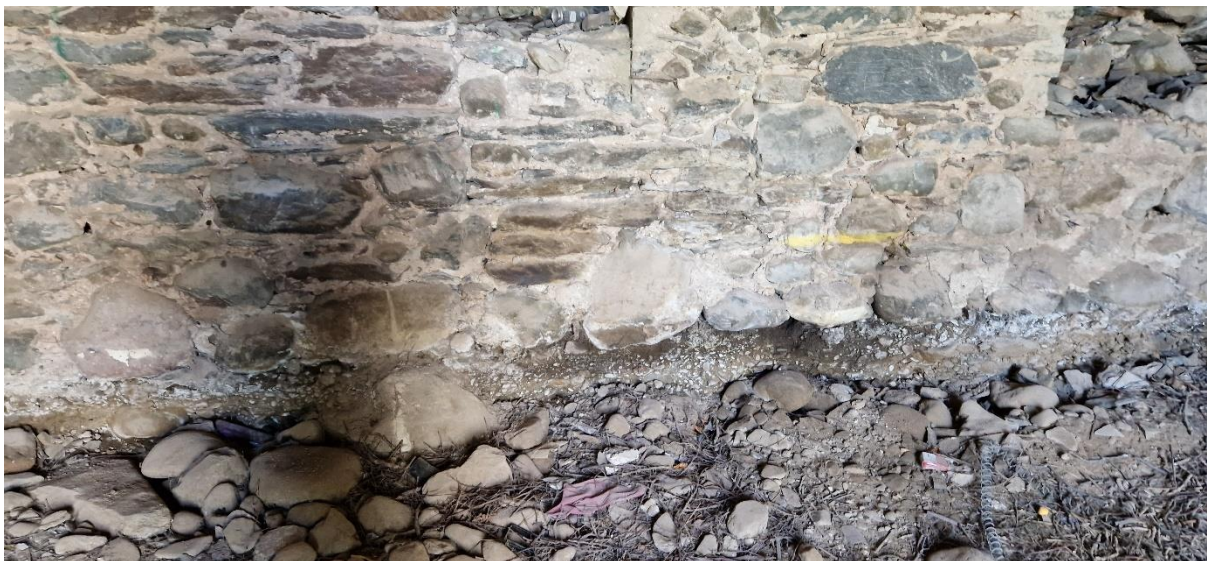
Photo 5 - Barn 3 - Excavations Below Foundation Stones

8. Barn 3 where previous floor level has been reduced should have the new floor installed as soon as possible to avoid potential undermining and slippage of the walls.

9. All walls undermined during the works (provision of new ground floors, lowering ground levels etc) shall be underpinned.

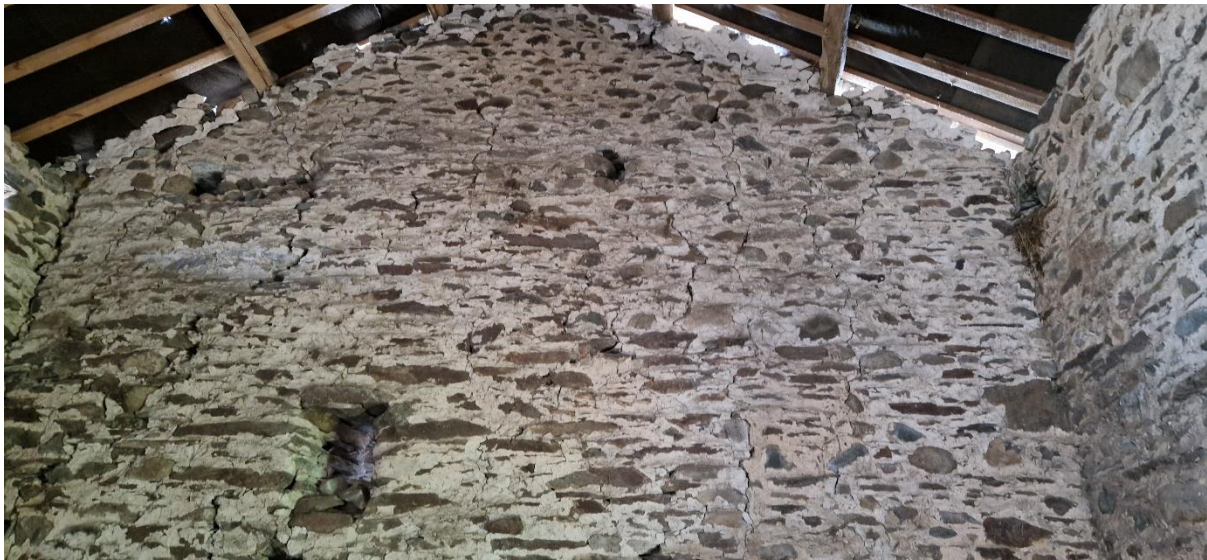
The gable end adjacent to barn 2 to the south previously had a first floor which has now been removed. Where the joists were removed from the wall there is loose stonework and there are several vertical cracks in the wall generally. The mortar to this elevation is original and has deteriorated. The external walls do not appear to be suffering from excessive lateral movement.

Photo 6 - Barn 3 - Southern Gable Wall

5. The internal gable wall to the south of Barn 3 is to be demolished in part based on the proposed layout. The remainder of this wall will need to be rebuilt in part to achieve the proposed layout removing many of the defects noted here. The remaining stone will need to be repointed and stitched using Helifix or similar proprietary helical bars. An internal goal post arrangement may be required to restrain the corner.

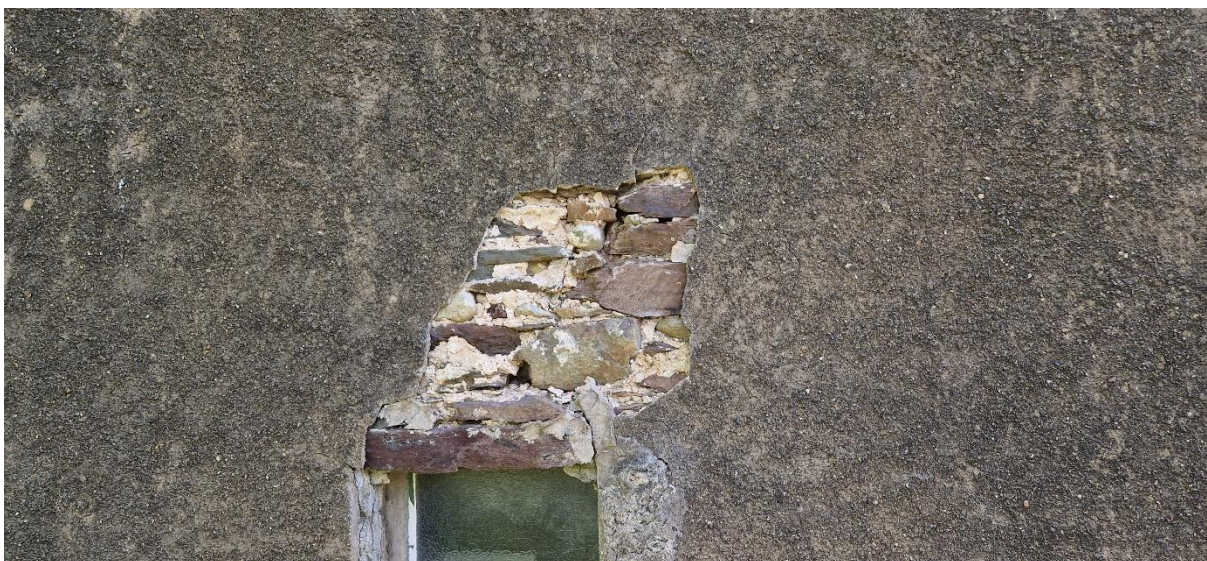
Barn 3 has had some repairs undertaken to the render around the northern corner. The render is old and contains several full height vertical cracks. There are also missing patches of render exposing the stone behind. The lintel on the only opening has no bearing and needs to be replaced. The elevation is suffering from some minor lateral movement. The roof line is relatively straight with no obvious undulation present.

Photo 7 - West Elevation - Lintel Bearing

2. Timber lintels, because of damp, being undersized, creep etc over many years have deteriorated and should be replaced generally with PCC lintels where hidden and decorative lintels when seen in keeping with the existing barns.

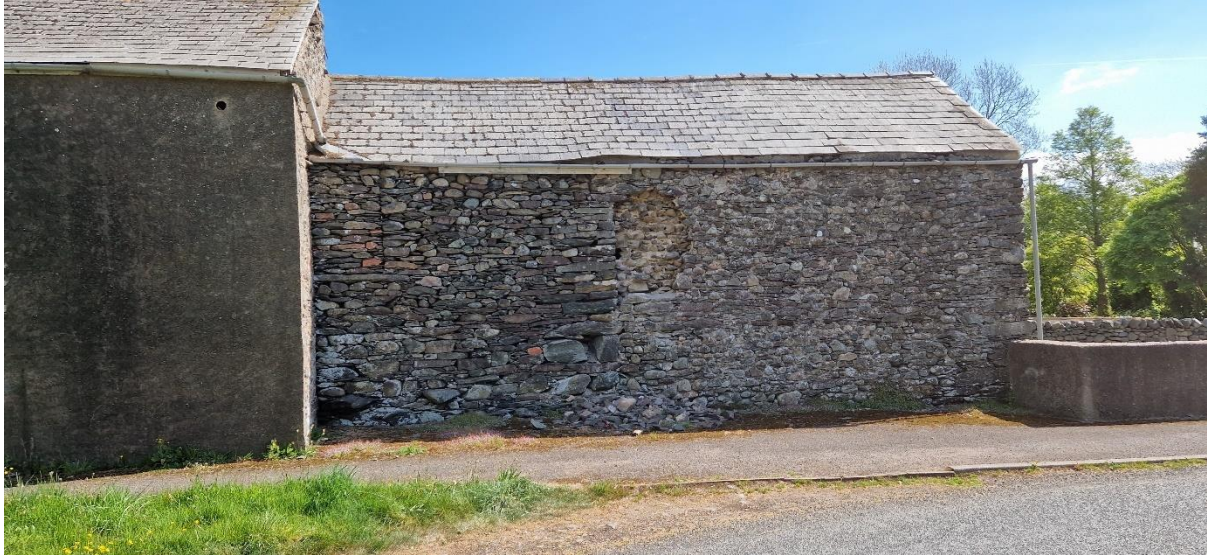
The roof line to Barns 1 and 2 is undulating. There is a section of wall where the outer leaf of stone has collapsed onto the footpath below. The remainder of the elevation doesn't appear to be suffering from overt lateral movement.

Photo 8 - Barn 1 & 2 - Collapsed Wall

6. The external collapsed section of wall to the west elevation of barns 1/2 will need to be rebuilt.
7. The property is generally suffering from minor lateral movement, and the walls will therefore need to be tied to the proposed first floors and at roof level to provide adequate lateral restraint.

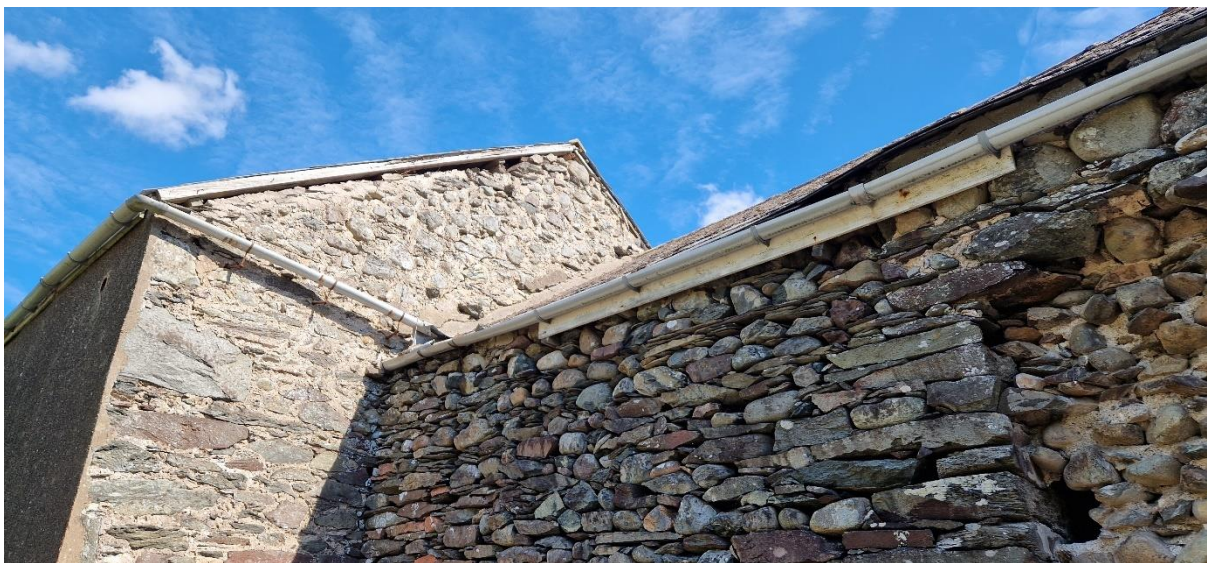
The gable end of barn 3 where visible contains several vertical and diagonal cracks at high level.

Photo 9 - South Elevation of Barn 3

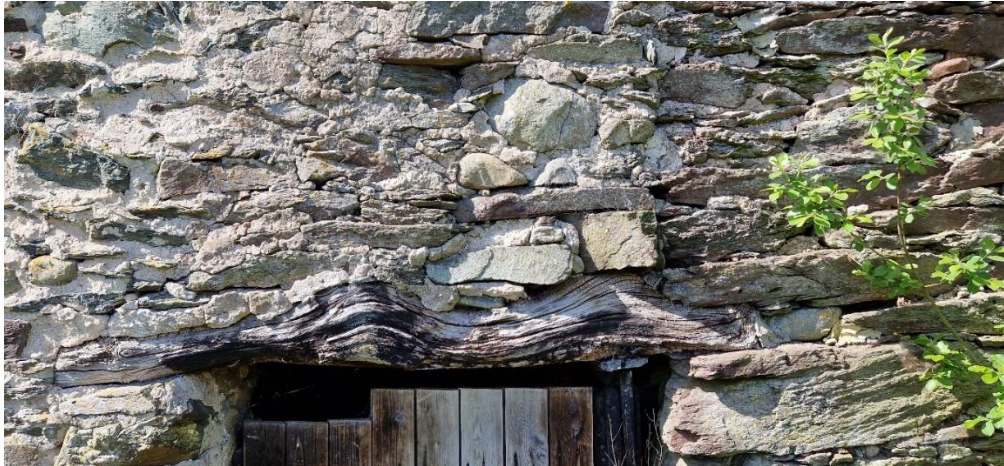
Barns 1 and 2 are suffering from some minor lateral movement particularly at high level and there is some minor movement in the stone above old timber lintels.

Photo 10 - East Elevation of Barn 2 - Movement Above Lintel

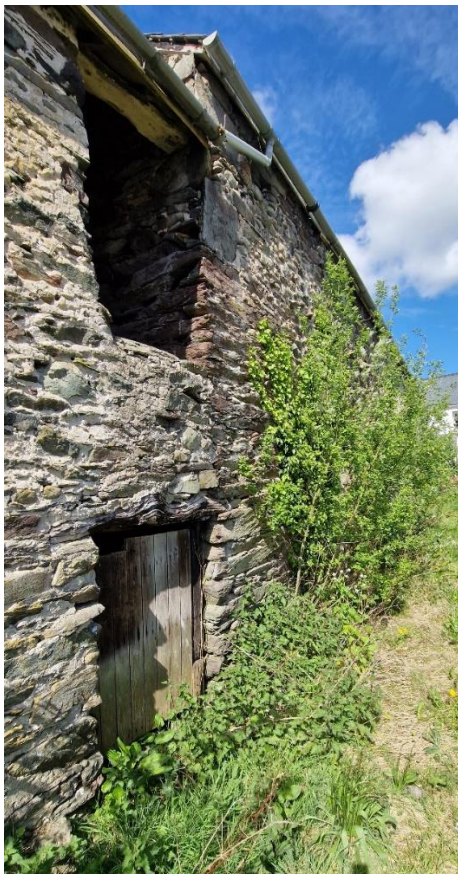
Barn 3 contains some minor movement/cracking in and around the mortar beds and the stone quoins of the southern corner. The wall has suffered from lateral movement with a distinct lean on this wall which would need to be tied back during any conversion works.

Photo 11 - east Elevation of Barn 3 - Lateral Movement
