Visual Structural Inspection
of
Barn at Low Wath Cottage
For
Mr K Yorke

Reference - 2025.397 rep001 Rev -
Date - 25/06/2025
Author - Paul Crooks BEng CEng MICE
ICE membership No: 48526190

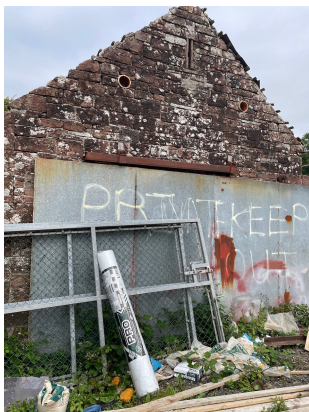
photo 3.1a

The gable elevation is generally in good condition. There is a blockwork infill panel visible internally (see photos 3.1a & 3.1b). The walls will require repointing.

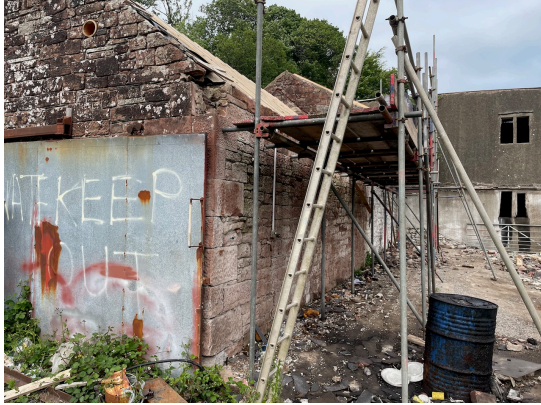
photo 3.2a

Mortar has been lost to a significant number of joints externally towards the gable end (see photo 3.2a). The corner stone at roof level is missing (see photo 3.2b).

- repointing of stonework through out using a non-cementitious mortar.
- replacement of timber lintels.
- repairs or partial rebuilding of the party (north) wall
- installation of a new first floor.

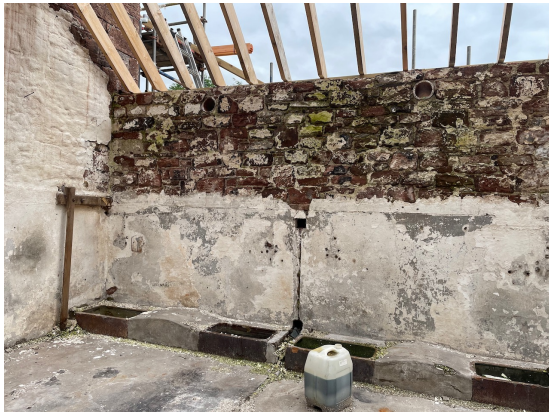
photo 3.2c.

Internally the walls are in good condition with no evidence of movement (see photos 3.2c & 3.2d)

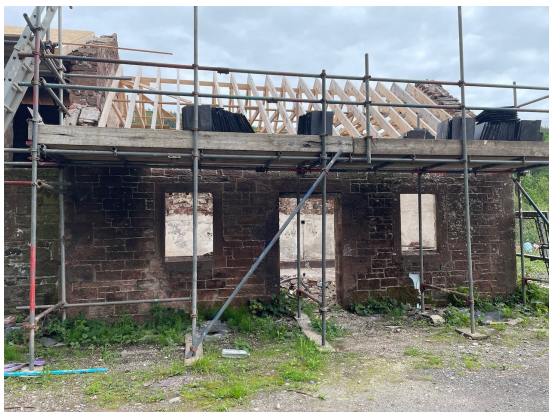
photo 3.3a

Externally the wall is generally good condition with limited loss of mortar to the stonework joints. (see photo 3.3a). Internally the walls have been plastered/lime washed in places. There is no evidence of movement or cracking to the structure (see photo 3.3b)

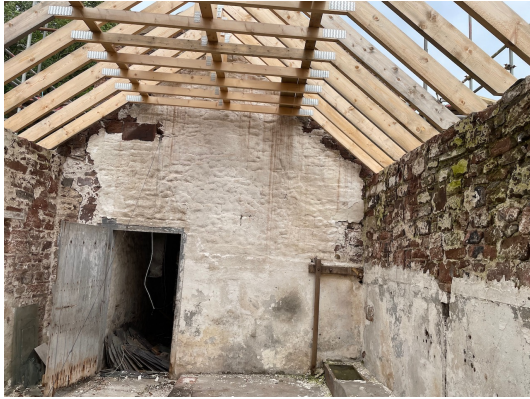
photo 3.4a

The majority of the south elevation of the cross wall have been plastered/lime washed and is in good condition (see photo 3.4a). The north elevation has been lime washed to the ground floor level only. Cracking to the mortar joints is visible to the joints of the random boulder stonework above first floor level (see photo 3.4b).

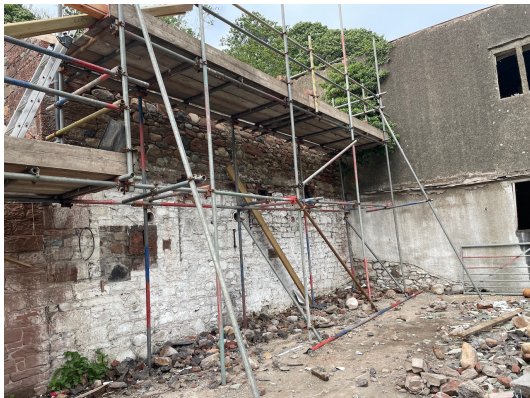
The external elevation is in reasonably good condition at the lower level. Loss of mortar from the joints is visible to the random boulder stonework above first floor level (see photos 3.5a).

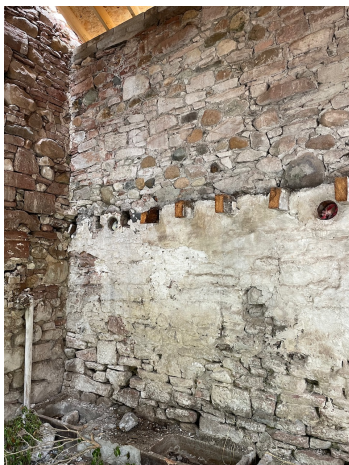
photo 3.5b

Internally loss of mortar from the joints is visible throughout, particularly above first floor level and towards the northern end (see photos 3.5b to 3.5d).

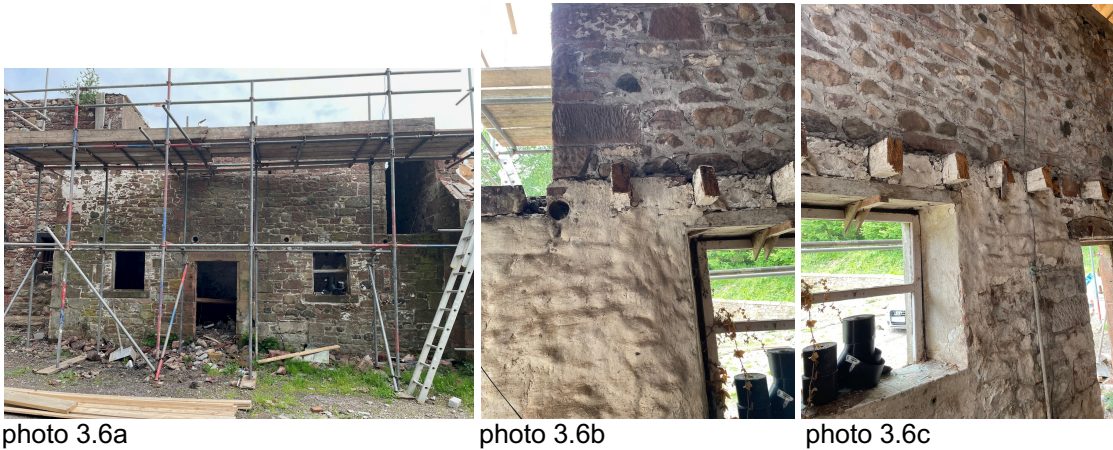
This wall is in good condition with no visible signs of movement (see photos 3.6a to 3.6c)

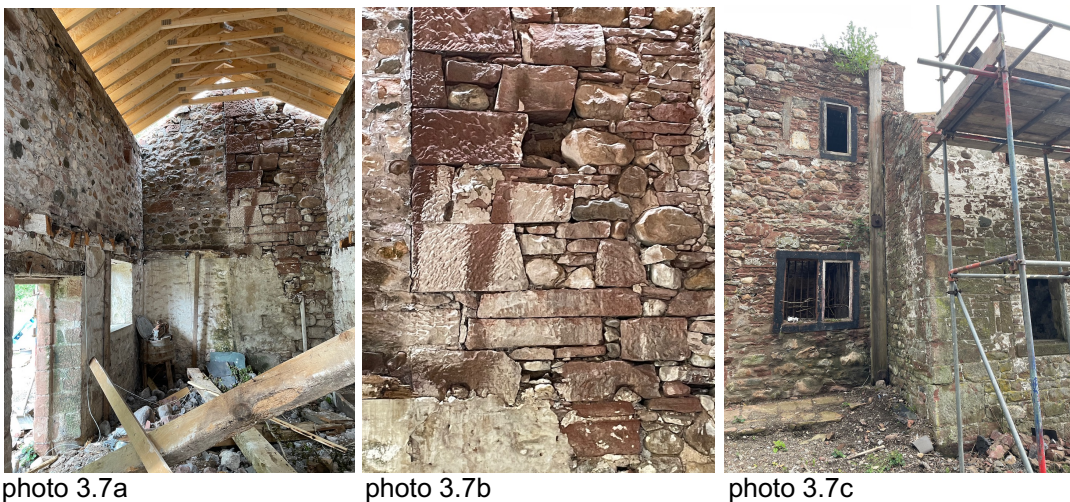
It is apparent that the barn is an addition to an earlier 2 storey stone building with a distinctive joint between the 2 buildings. The older structure is much poorer condition (see photos 3.7a to 3.7c).
