VISUAL STRUCTURAL INSPECTION

**5-6 HIGH STREET
CLEATOR MOOR
CUMBRIA**

Reference - WDS/05/8466/REP01

Date - 04/12/2023

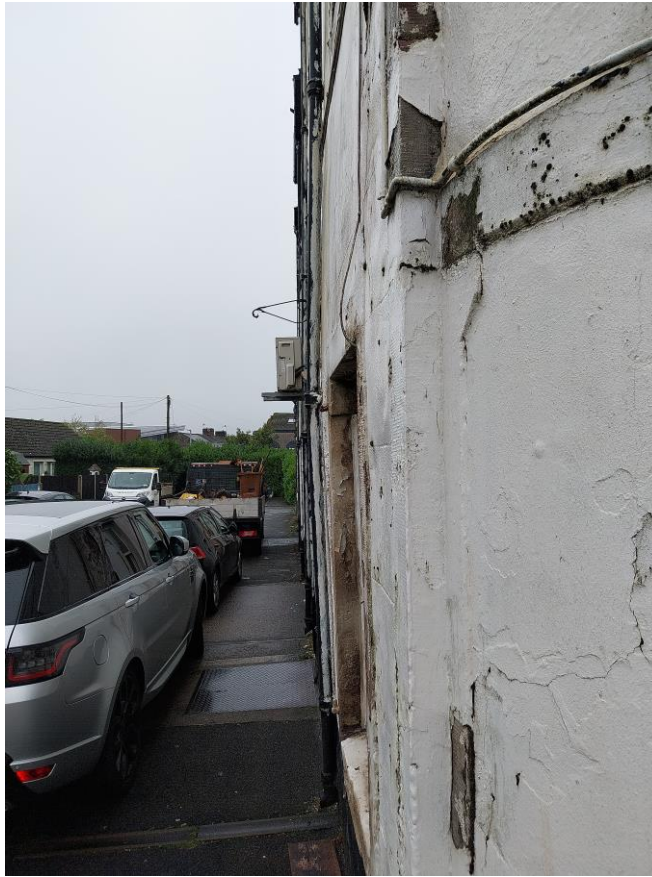
PHOTO 01 VIEW ON LHS WALL

- 2.1** There is cracking to the render throughout the elevations. The masonry walls to all the elevations are out of plumb, especially the front and left hand elevations. It appears that there is a lack of tie in between the external walls and the internal walls and floor joists structures. The cracking apparent and wall movement is historic and not due to active structural movement. Photographs 01-03 show typical views on the elevations.

- The external walls need strapped/tied back to the floor structures at first and second floor level. In addition the internal walls need retied to the external. This is to restrain the external walls from the potential for further movement.

- Cracks to the walls need tied/stitched using the Helifix Ltd crack repair system or similar.
 - The wall heads adjacent to the water ingress locations may need locally rebuilt where water damaged. The damaged parapet to the front left hand corner needs rebuilt where damaged.

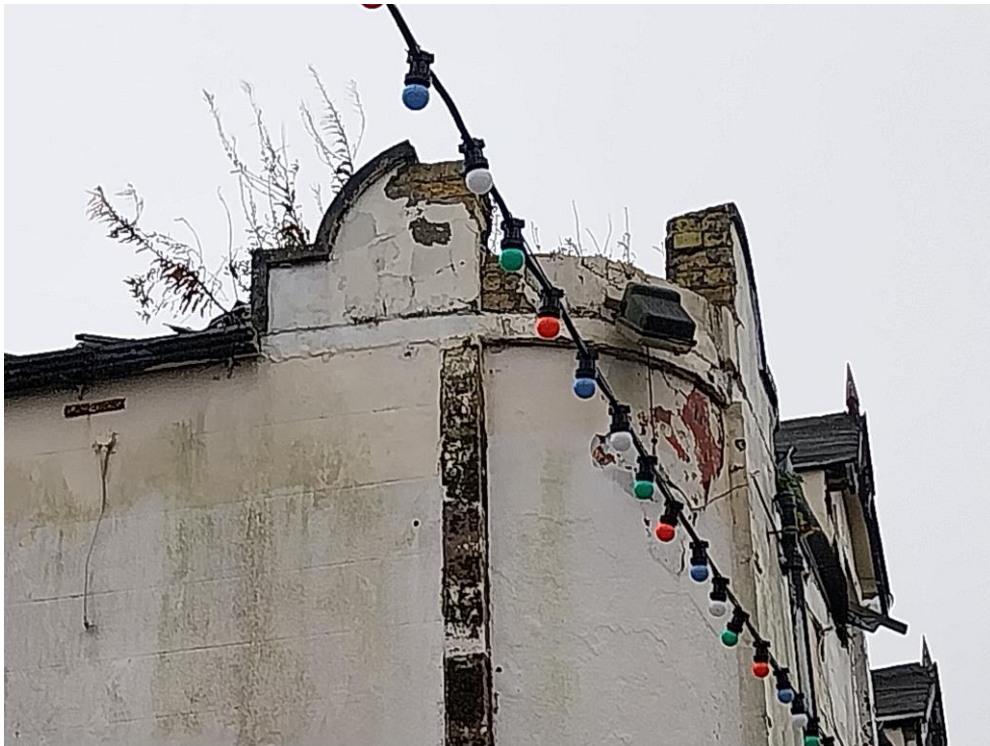
PHOTO 04 VIEW ON FRONT LHS PARAPET

- 2.2** There is cracking to the internal walls especially where internal walls meet the external walls. The tie between the two walls has been compromised by the movement of the external walls. The front left hand corner roof parapet feature has been damaged and has been part removed, see photograph 04 attached.
