## **VISUAL STRUCTURAL INSPECTION**

**SANDY ACRE  
DRIGG  
CUMBRIA**

**AVISON YOUNG**

**Reference - WDS/05/8680/REP01 MOD A**

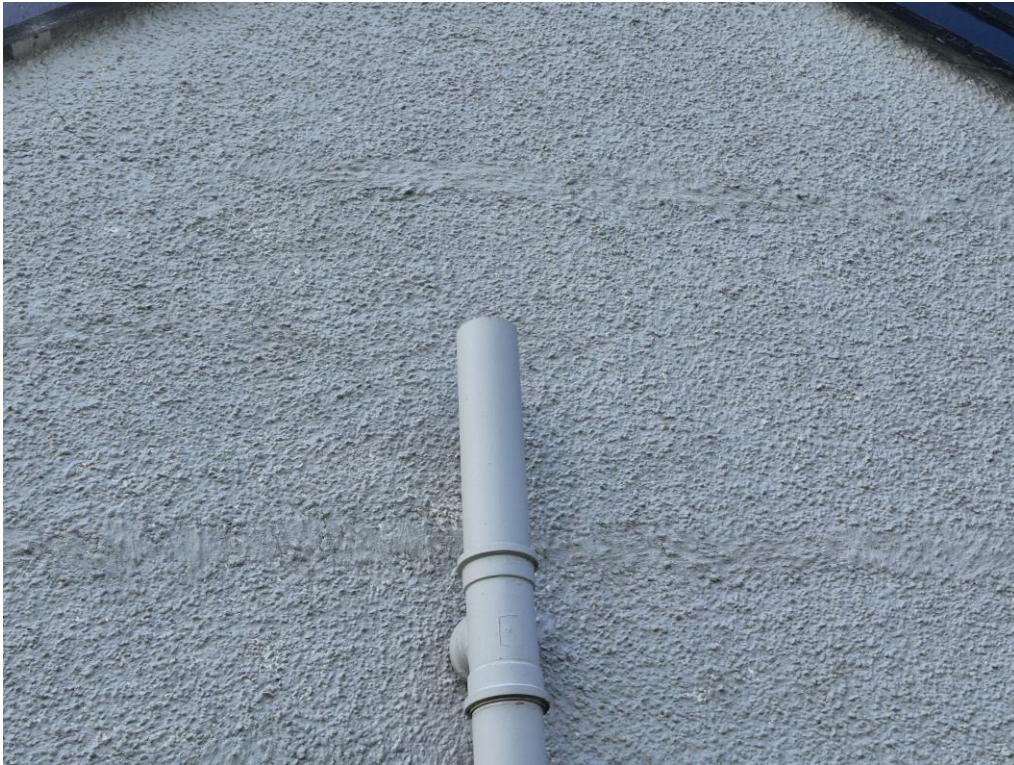
- The right hand gable wall has horizontal cracks at regular vertical centres which is indicative of cavity wall tie failure. See photograph 01 attached.

PHOTO 01 VIEW ON CRACKING TO RIGHT HAND GABLE

- The attic floor to the original property needs strengthened as does the timber beam over the rear kitchen.
- The beam over the front bay windows needs exposed and assessed.
- The right hand gable needs checked for cavity wall tie failure.
- The chimney breast over the front living room needs fitted with a suitably designed beam to replace the timber beam and corbelled masonry. The cracking to the chimney stack needs tied.
- The flat roof lean-to off the right hand gable needs weatherproofed and roof flashings installed.
- The attic roof needs suitably insulated; this may necessitate the roof purlins to be strengthened.
- The rear lean to extension is substandard and needs demolished. As do the outbuildings.
- The left hand garage conversion needs the roof strengthened.
- The left hand extension needs suitably damp proofed and insulated.
- The boundary fence needs replaced.

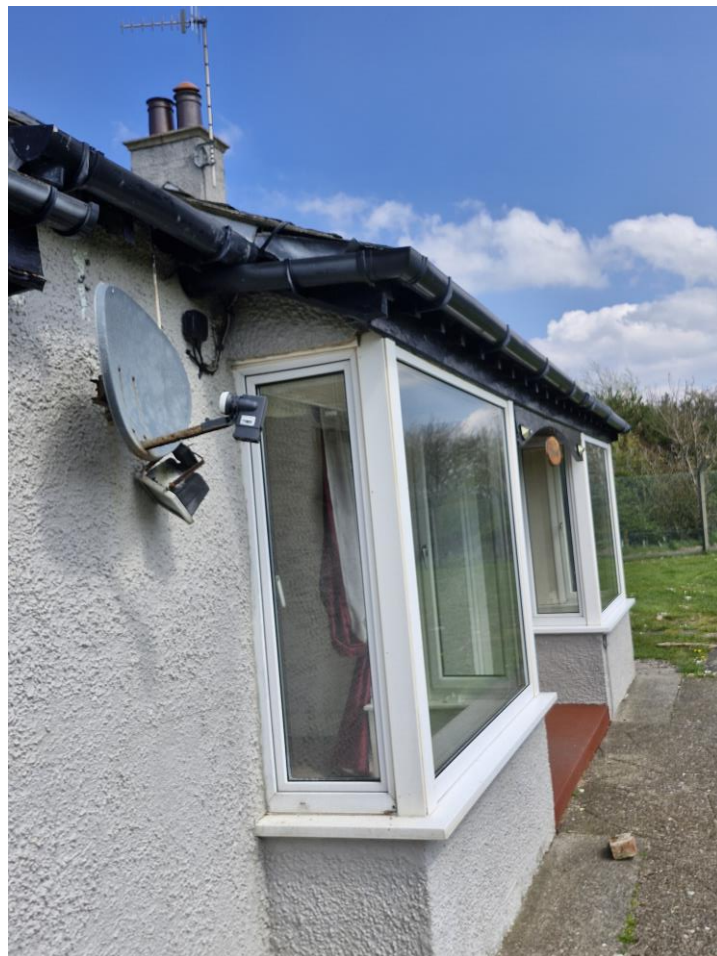
- It appears that there is inadequate support to the floor and roof structure over the bay windows. See photograph 02
  - The roof and floor support beam over the kitchen is inadequate see photograph 03 attached.

PHOTO 02 VIEW ON FRONT BAY WINDOWS

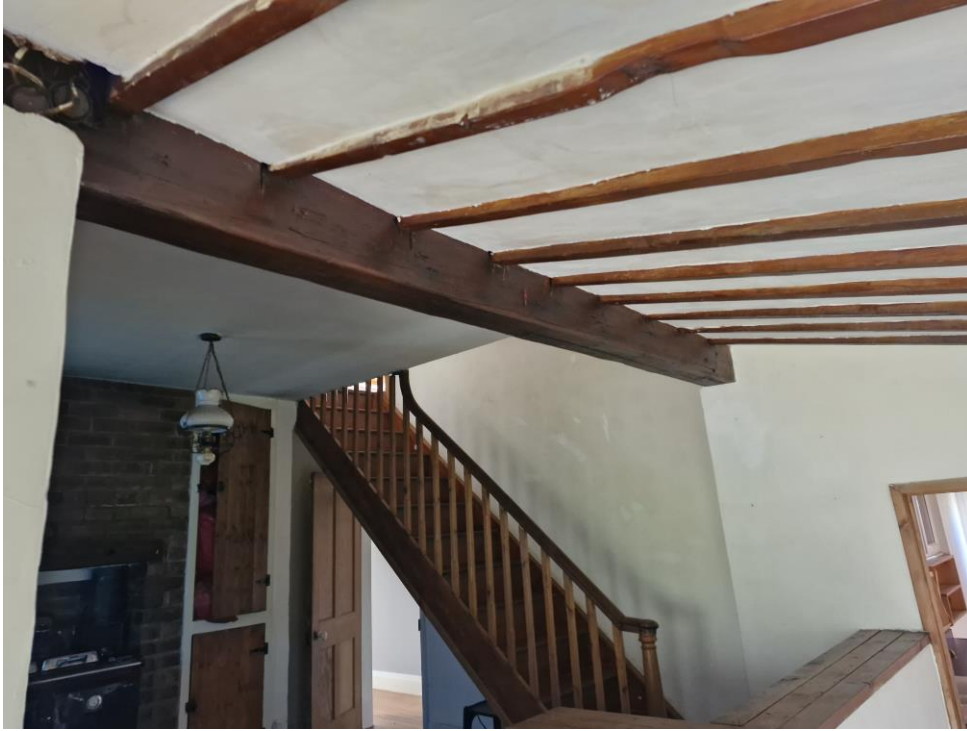
PHOTO 03 TIMBER BEAM OVER KITCHEN

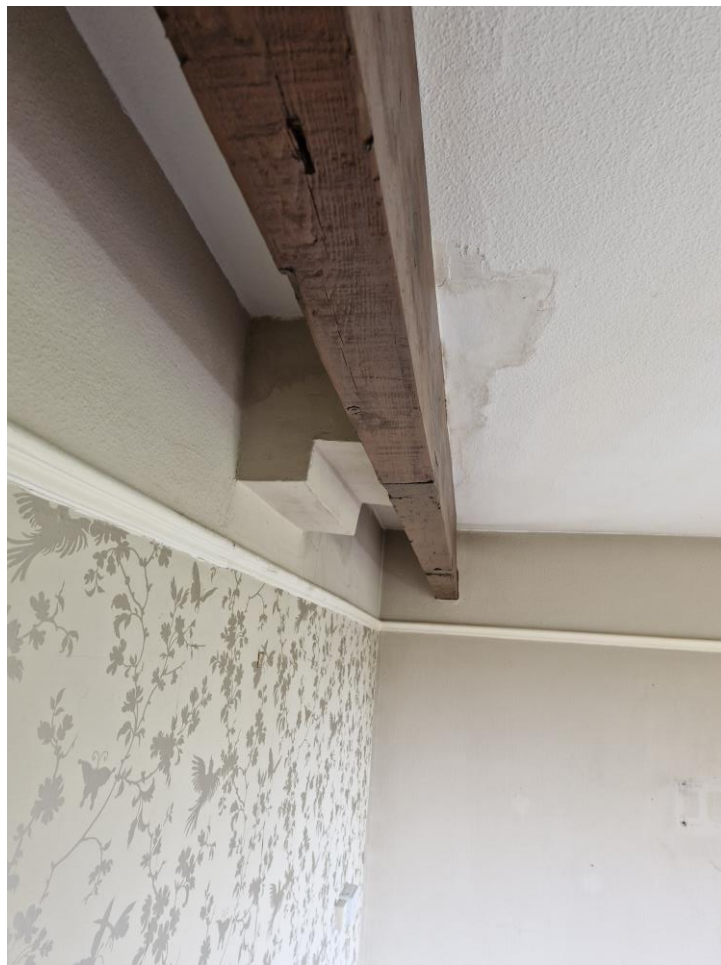
- The chimney breast to the front living room has been removed and the remaining breast above has been supported off corbels set in the internal

kitchen wall and a timber beam which spans adjacent to the kitchen wall. See photograph 04 attached.

PHOTO 04 CHIMNEY BREAST SUPPORTS.

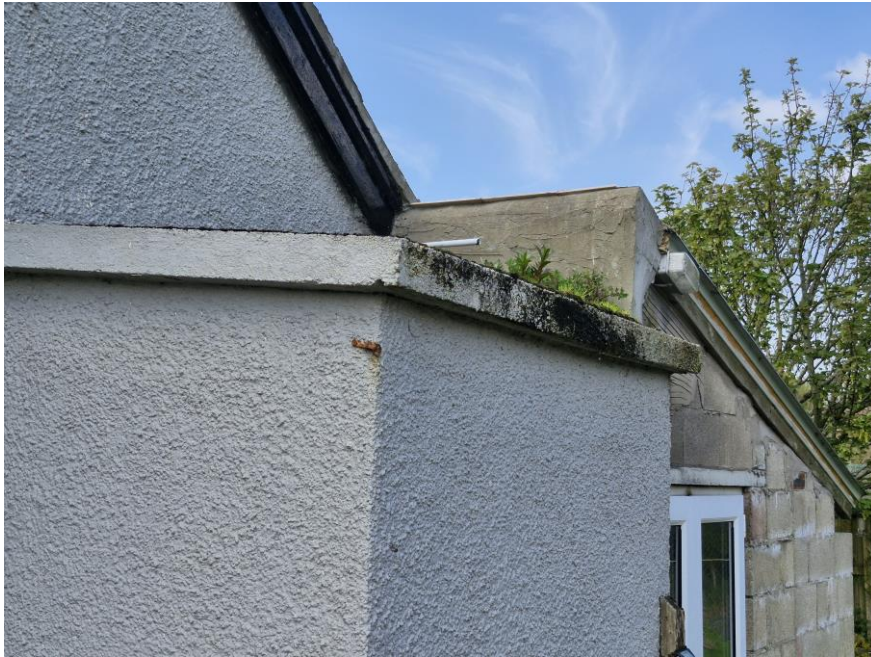
- The floor joists to the attic rooms deflect excessively when walked on. These are over spanned and not suitable. The roof is also inadequately insulated. It is unlikely that the loft conversion works were carried out with Building Control involvement.
- The concrete flat roof extension off the right hand gable is not suitably flashed into the main gable and the roof has no suitable water proofing. Furthermore the rear extension has not been suitably tied into the main original bungalow wall and no vertical damp has been inserted which is allowing damp entry into the property in the kitchen. See photographs 05 and 06 attached.
- The render generally is in a poor condition.
- The chimney stack is cracked, this may be associated with movement of the breast below when the front portion was removed and inadequately supported. See photographs 07 attached.

PHOTO 05 VIEW ON RHS FLAT ROOF EXTENSION ROOF

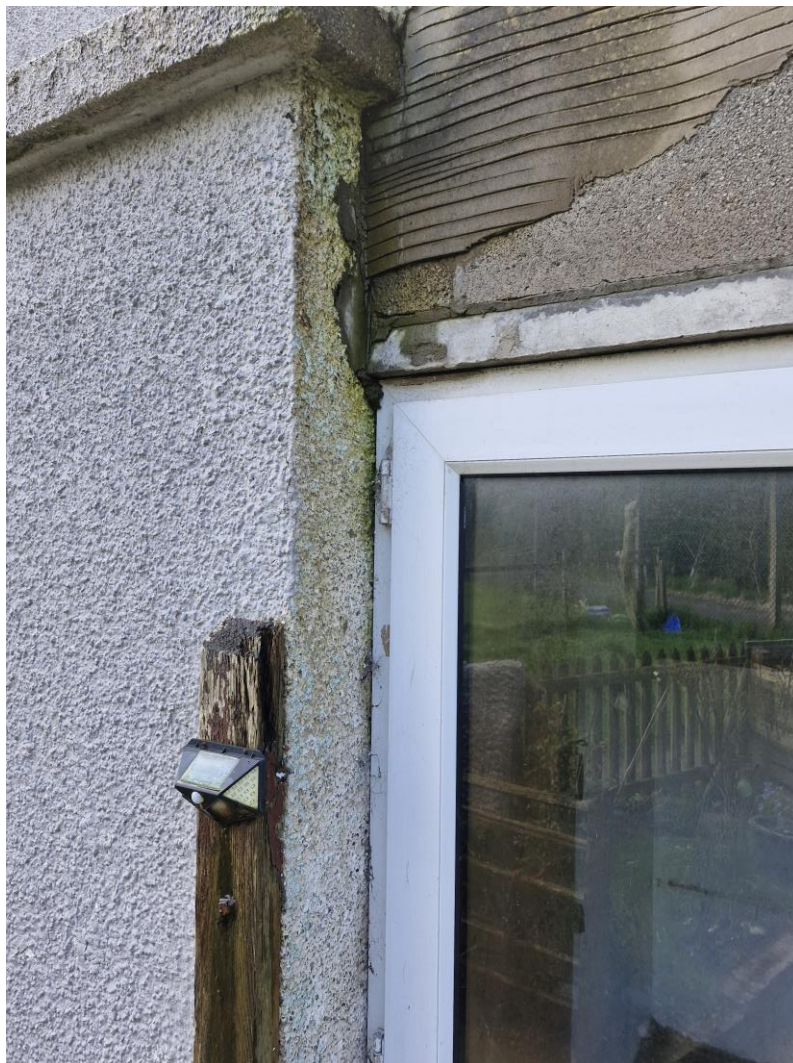
PHOTO 06 INADEQUATELY FLASHED IN REAR EXTENSION

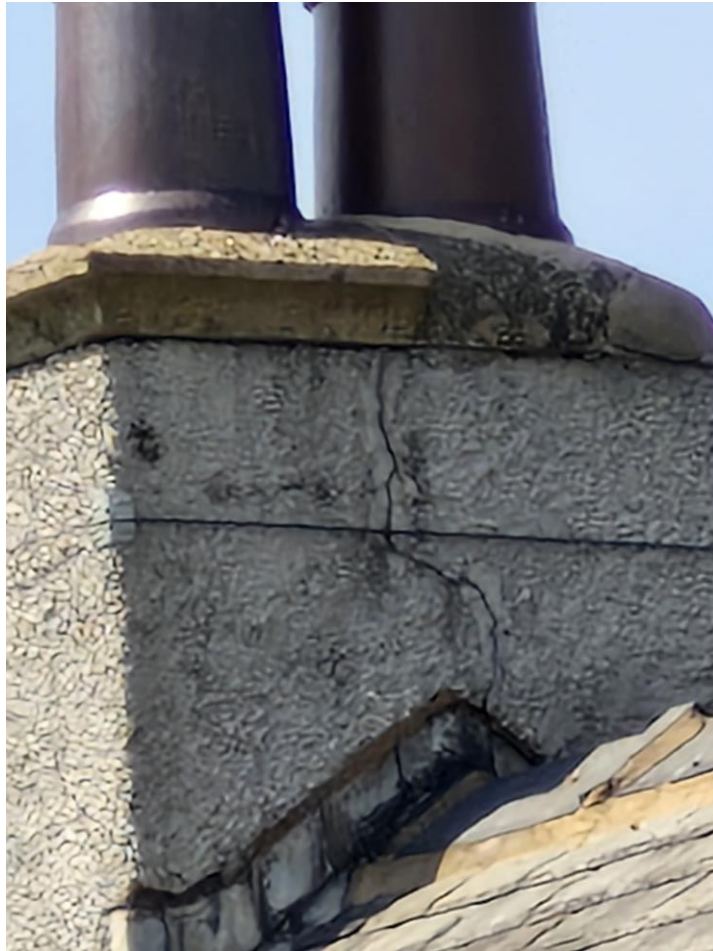
PHOTO 07 CRACK TO CHIMNEY STACK

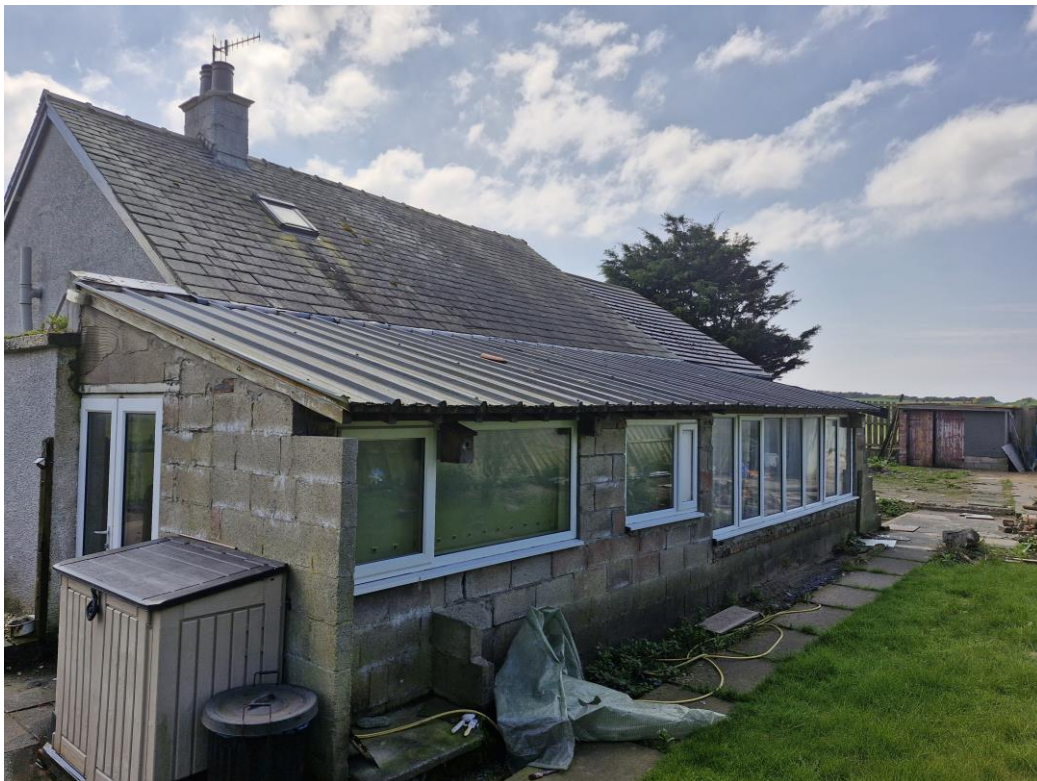
**2.2** The rear lean-to comprises single skin block construction with a timber rafter and purlins roof structure which supports a profiled metal cladding roof finish, see photograph 08 attached. In terms of structural defects please note the following:-

PHOTO 08 VIEW ON REAR EXTENSION

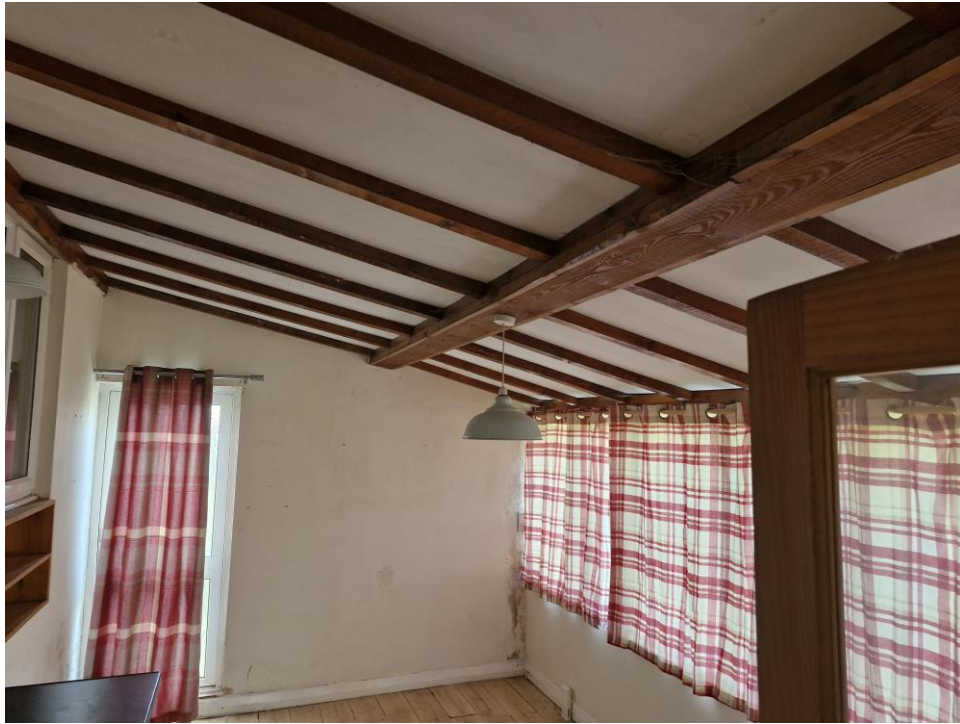
- The roof structure is inadequate. The purlins are over spanned and the timber beam over the rear window is showing signs of rot. The roof is not suitably insulated and the roof drainage is incomplete. See photograph 09 attached.
- The single skin block walls are structurally inadequate and are not in accordance with Building Regulations. They are not suitable to withstand expected wind loading and they are not suitably damp proofed or insulated. See photograph 10 attached. This portion of the building has been erected without any Building Control involvement.

PHOTO 09 VIEW ON REAR EXTENSION ROOF

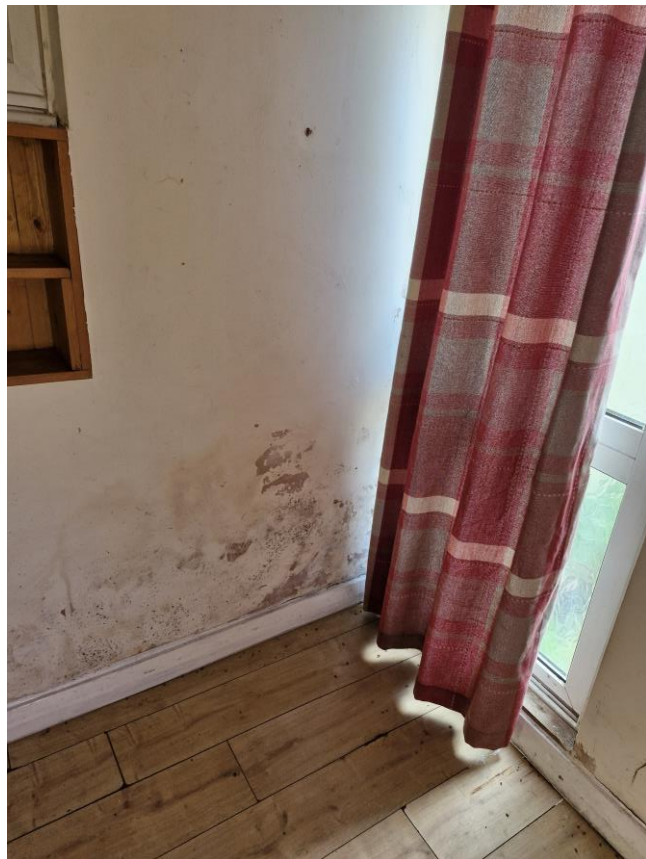
PHOTO 10 VIEW ON DAMP TO REAR EXTENSION

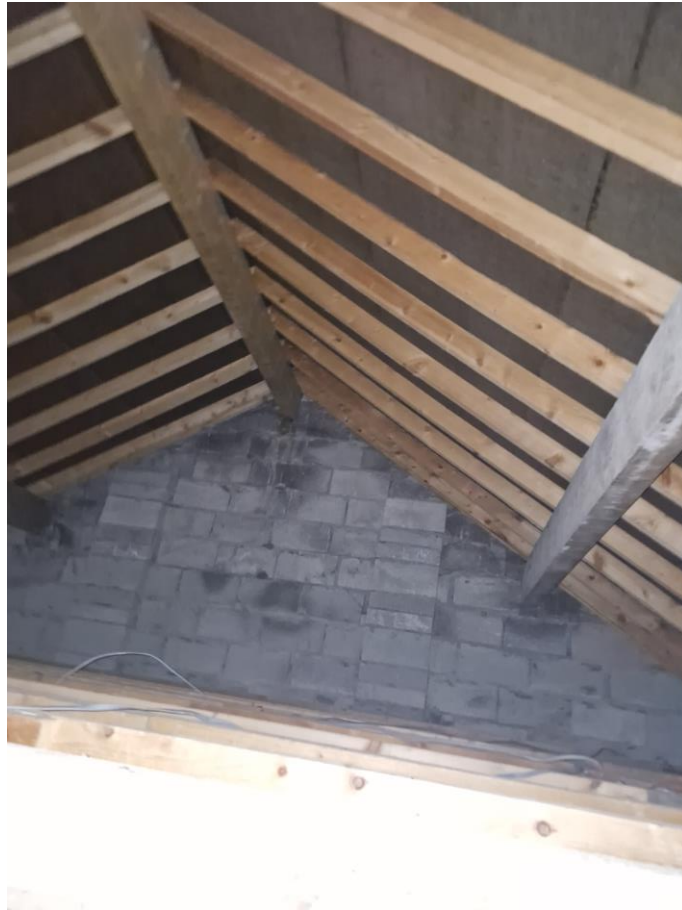
- The render is at the end of its life, cracking is apparent to all elevations.
- The roof purlins and ridge beam are over spanned and not to standard. See photograph 11 attached.
- The roof flashing into the original house gable is sub standard. See photograph 12 attached.
- Internally the extension is inadequately damp proofed and also not suitably insulated.
- It is unlikely that the original garage conversion scheme was carried out with Building Control involvement.

PHOTO 11 VIEW ON LHS EXTENSION ROOF

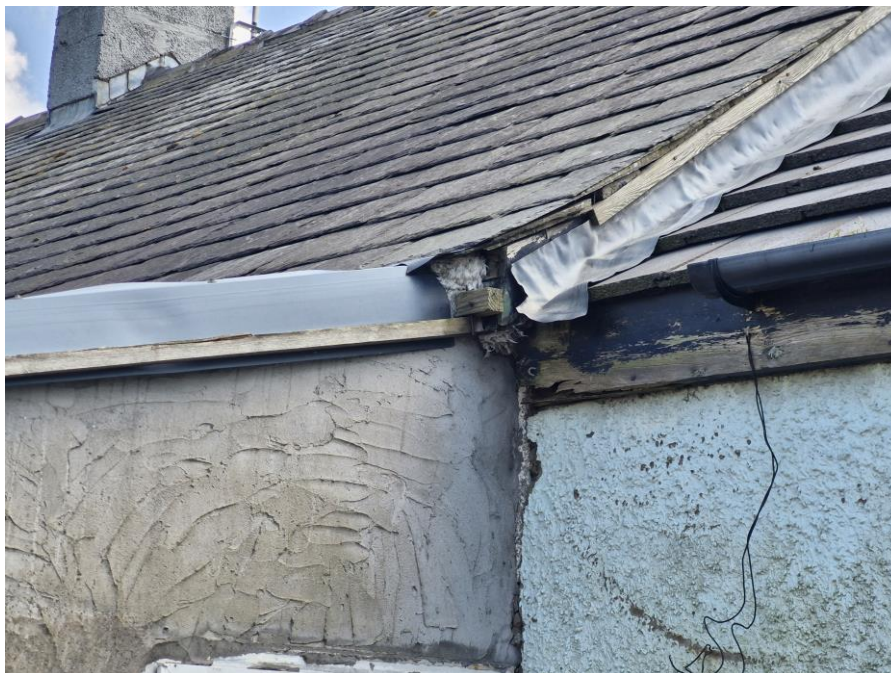
PHOTO 12 VIEW ON ROOF FLASHING TO LHS EXTENSION

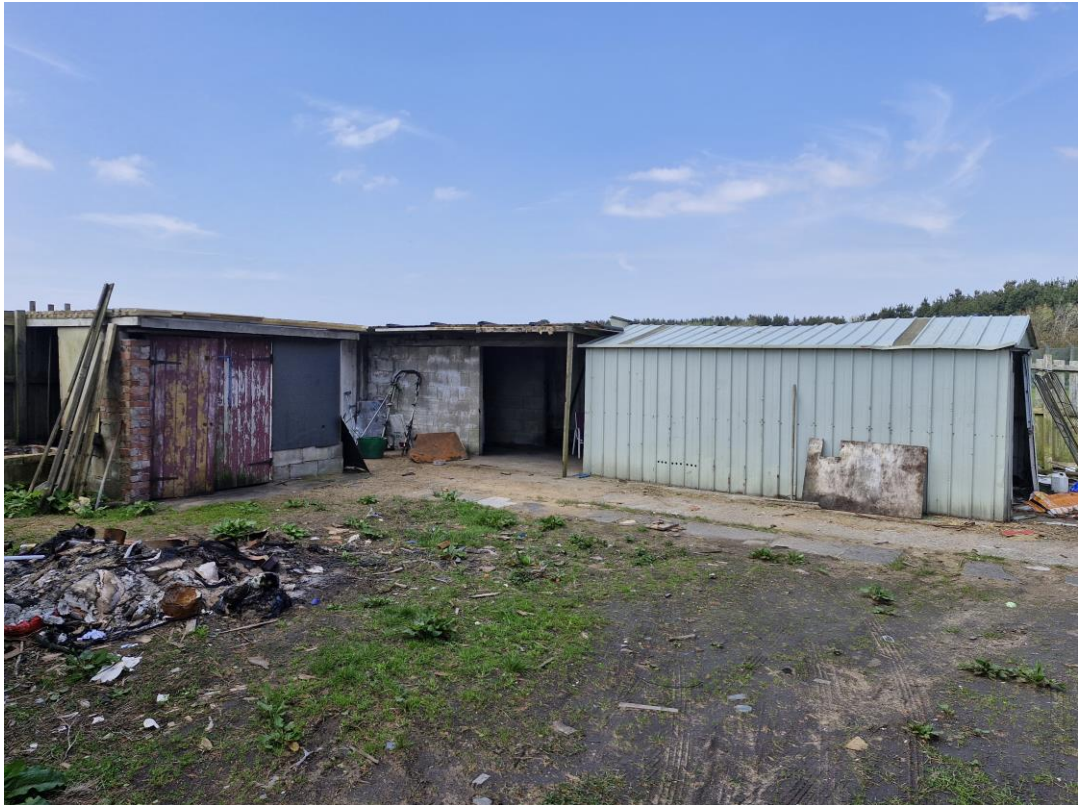
**2.4** The outbuildings comprise a combination of block masonry walls and timber and steel structure supporting the steel and timber roof structures, see photograph 13 attached. In terms of structural defects please note the following:-

- The outbuildings are structurally inadequate. The walls are not suitable to withstand expected wind loading and the roofs are at risk of being blown off.
- The boundary timber fence has failed and has blown over. See photograph 14 attached.

PHOTO 13 VIEW ON OUTBUILDINGS

The property could be made weathertight and left unused, however this will still require the rear extension and outbuildings to be removed as these are unsafe. There is a real risk that the roof cladding sheets could become detached in high winds and impact the adjacent security fence or the public using the adjacent road or surrounding field. The rear of the original bungalow will need boarded up where access was made into the rear extension to keep the property secure; the windows and doors will also need boarded.

In our opinion the most cost effective solution is to demolish all the buildings. This will also leave the plot safe and secure without any future care and maintenance being necessary.

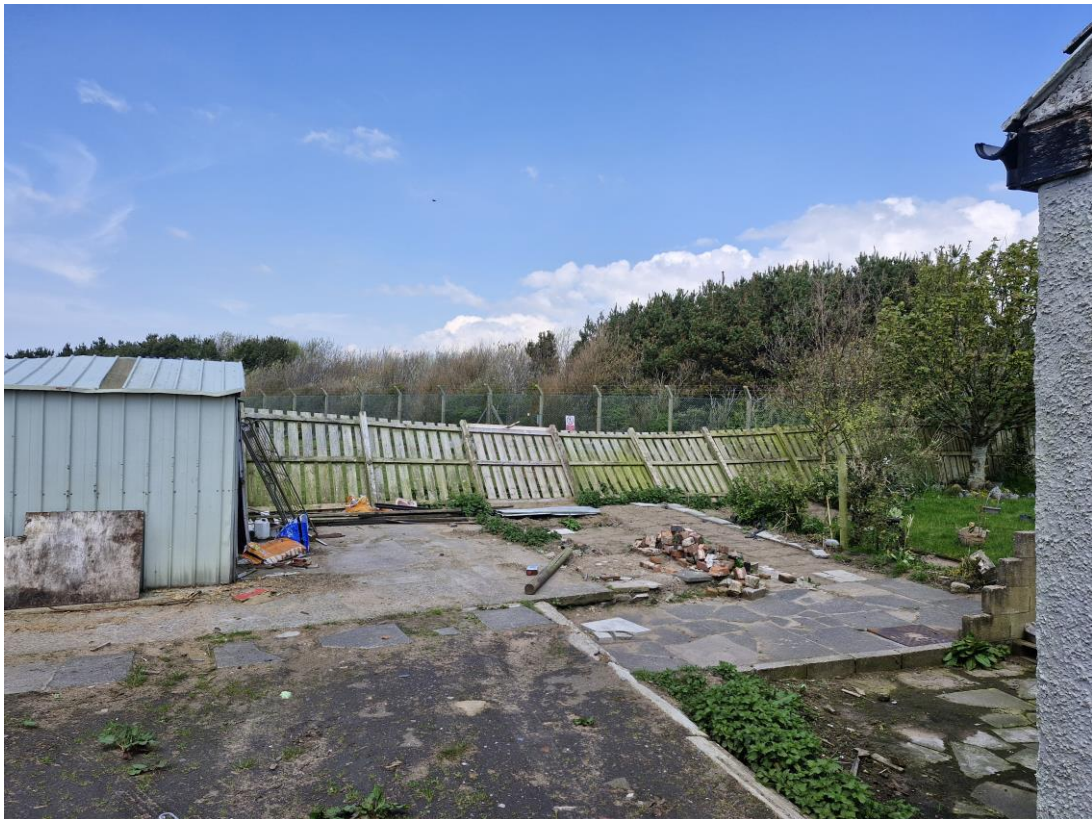
PHOTO 14 VIEW ON BOUNDARY FENCE

The boundary fence needs reinstated where wind damaged. This will help keep the site secure regardless of which option noted above is adopted.
