**WHINBARROW DESIGN
SERVICES LIMITED**

Our Ref: WDS/05/9043/LETT001

RE: 27-29, Hugh Street Bransty, Whitehaven. Damaged properties

As requested I carried out a structural inspection of the properties noted above which were damaged by an explosion on 31st December 2024 and note the following:-

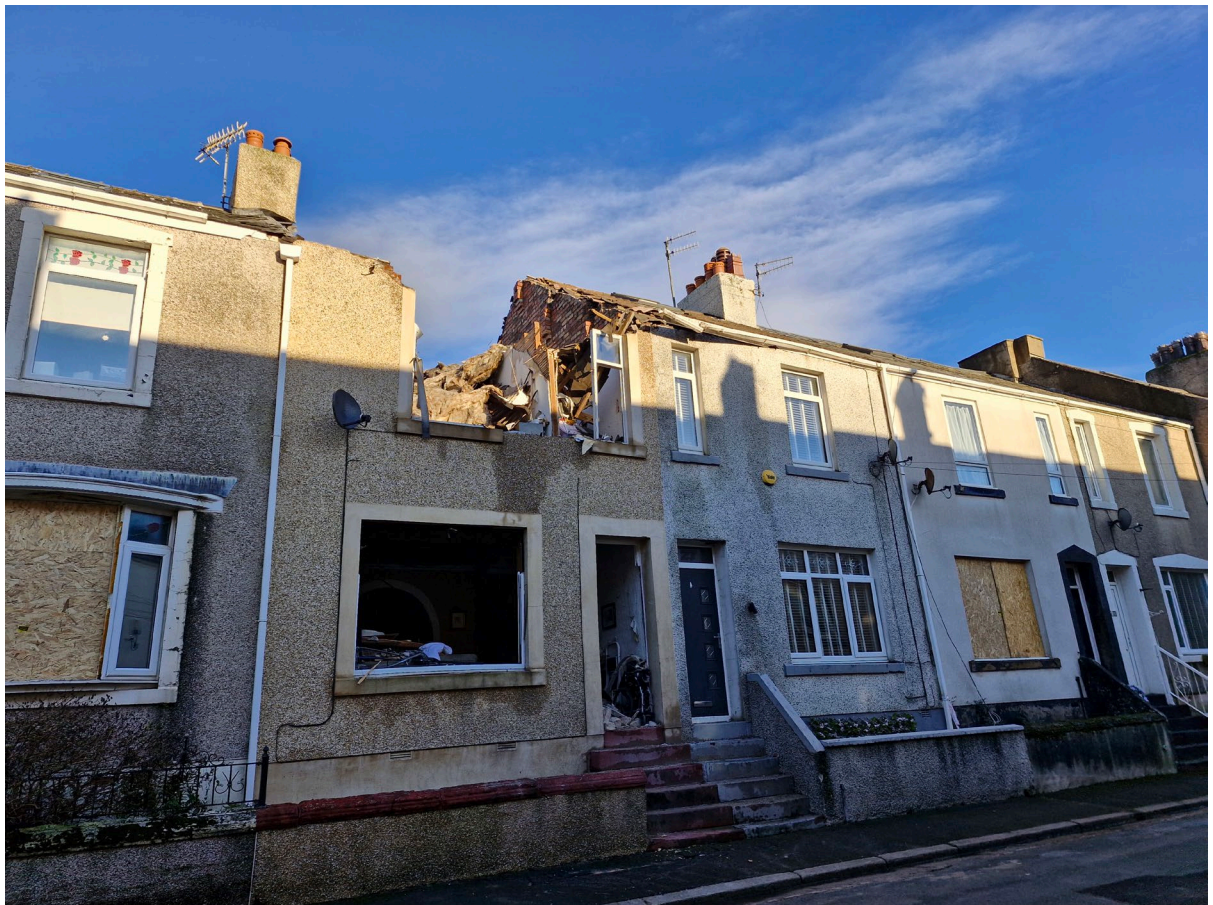
3. There has been an explosion in No 28 which has resulted in extensive damage to the three properties. Photographs 01 and 02 attached show views on the front and rear elevations of the properties. At the time of our inspection the whole street had been cordoned off and the residents decanted until the properties are made safe.

- The explosion has blew the roof off No 28 and caused the front wall to bow outwards and partially collapse. This has resulted in the front elevation becoming detached from the party walls. Furthermore the internal ground floor hall wall has collapsed to No 28. The rear extension has collapsed. The party wall with No 27 has suffered significant lateral movement during the explosion which has resulted in extensive cracking particularly evident within No 27. The structural integrity of the party wall has been compromised. (See photographs 03 and 04 attached). The property is at risk of further collapse which may lead to further damage to the adjoining properties,

PHOTO 01 FRONT ELEVATION

1. The front, rear and internal walls of No28 needs taken down to first floor level. The remainder of the extension also needs taken down (not the party wall) as does the yard wall with No 29. The wall removal needs carried out with long reach plant, no access is to be made into the property or beneath the walls.

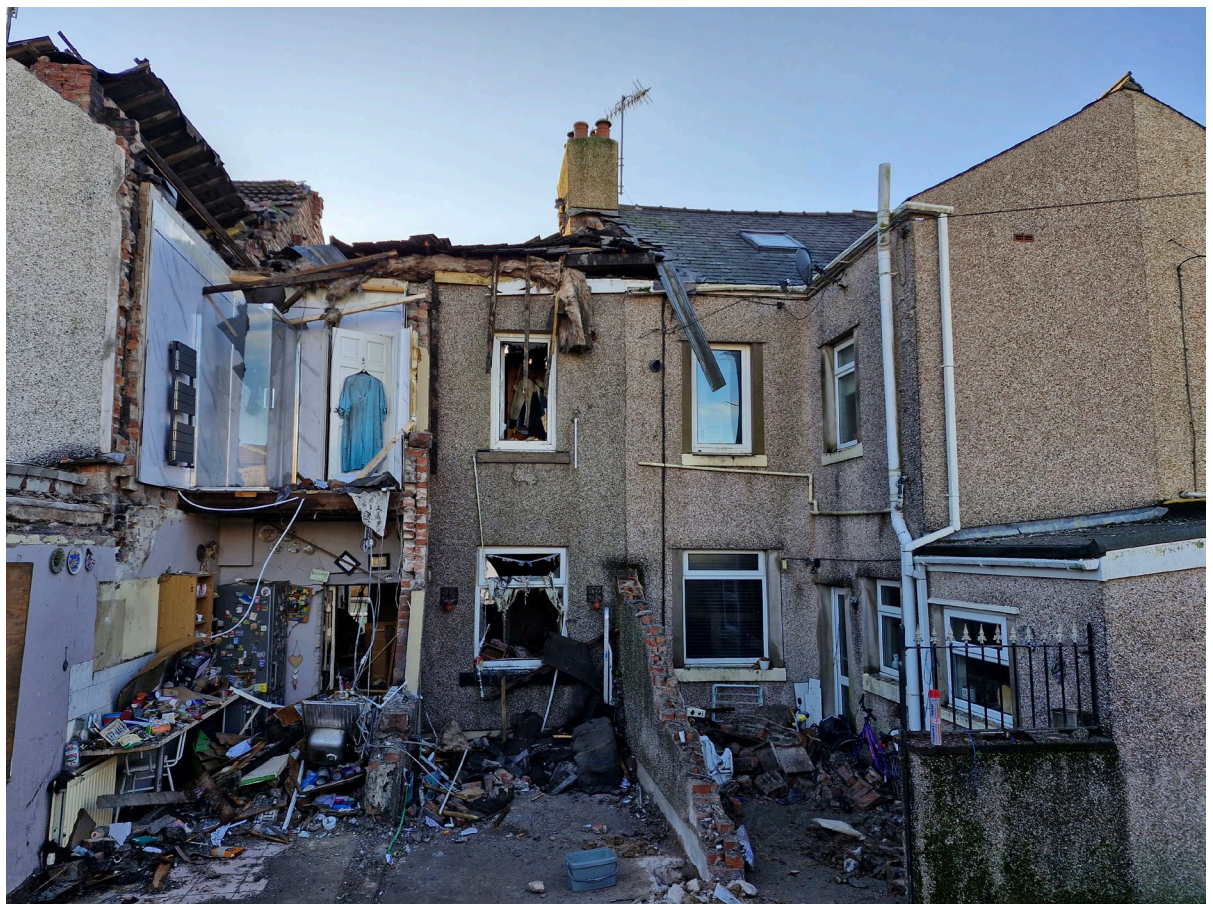
PHOTO 02 REAR ELEVATION

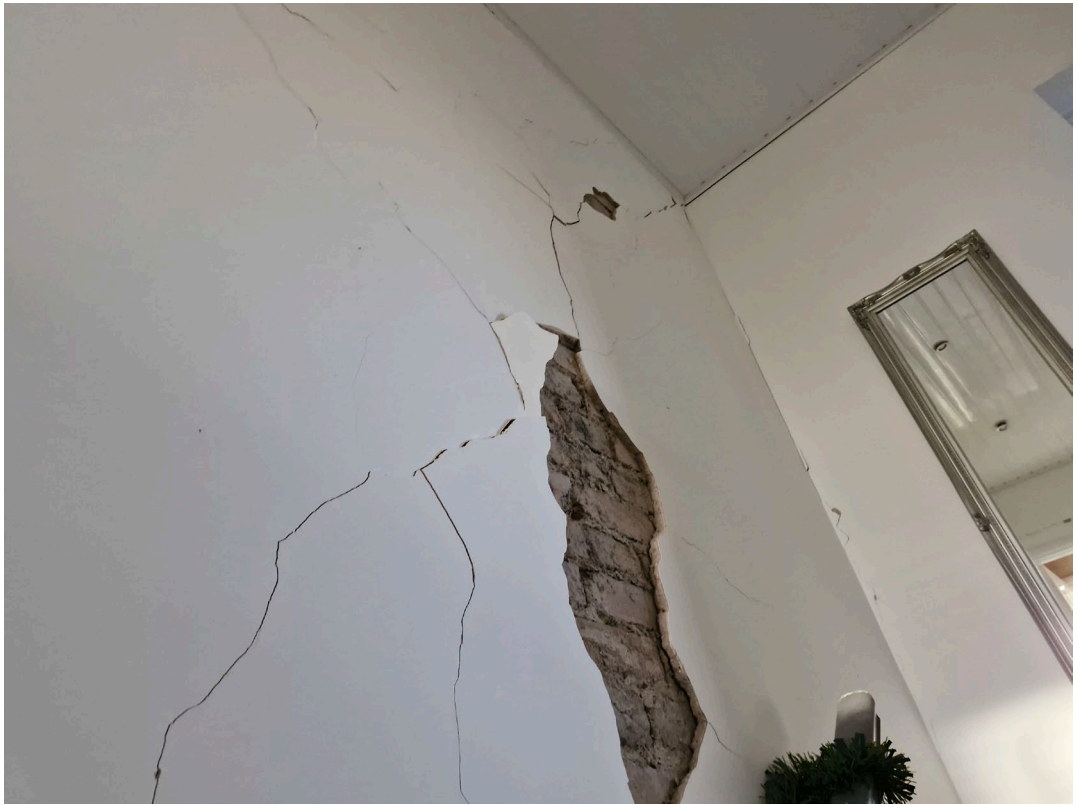
- The roof to No 27 has been damaged where it abuts the party wall with No 28, The party wall as noted above has been significantly damaged and is unsafe. The internal wall between the hall and living room has also been seriously affected with extensive cracking apparent (see photograph 05 attached). The hall wall noted supports a first floor beam which spans over the living room and supports the first floor structure; should be hall wall collapse then the first floor structure will also collapse.

PHOTO 03 DAMAGE TO PARTY WALL No 27/28

2. The roof to No 27 needs removed, this is due to the party wall, which supports the roof, being compromised by the explosion. Access into the property should not be made as noted above and hence long reach plant should be used. Upon removal of the roof the front and internal walls to No 27 and party wall with No 28 need taken down to first floor level; the rear wall can remain. Again the works need carried out using long reach plant to keep operatives away from the collapse envelope of the building. The extent of demolition proposed to No 27 is based on the potential for the party wall to fail and the significant safety hazard to operatives accessing the area should the party wall collapse

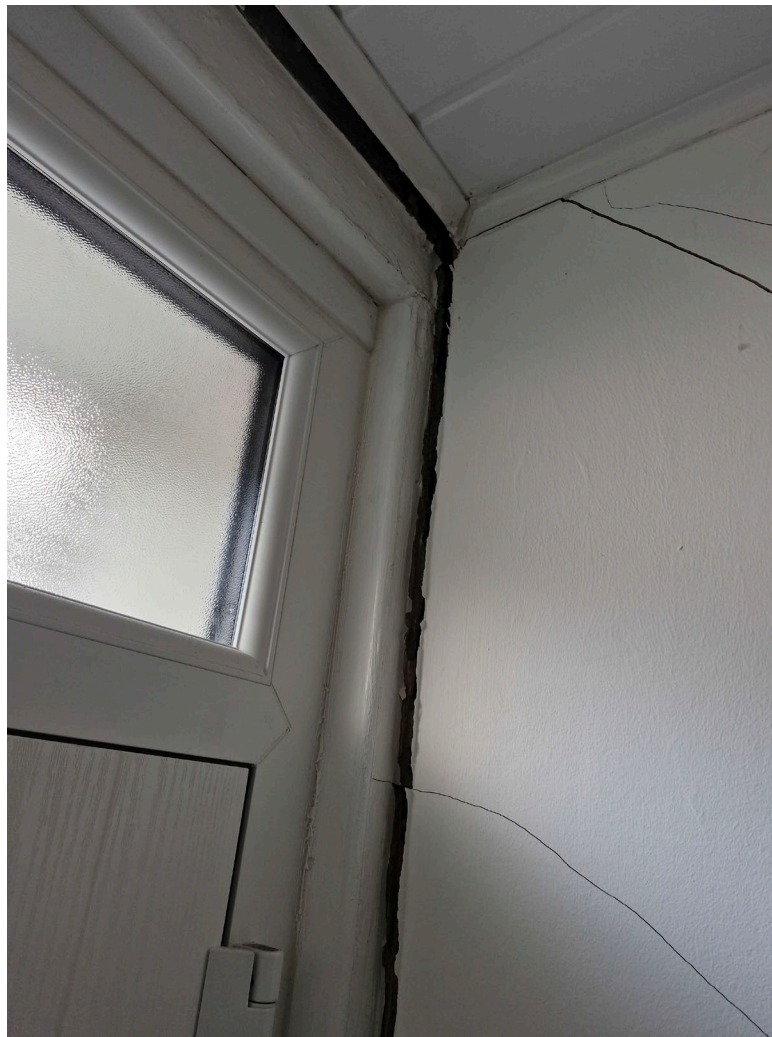
PHOTO 04 FRONT WALL/PARTY WALL No 27/28

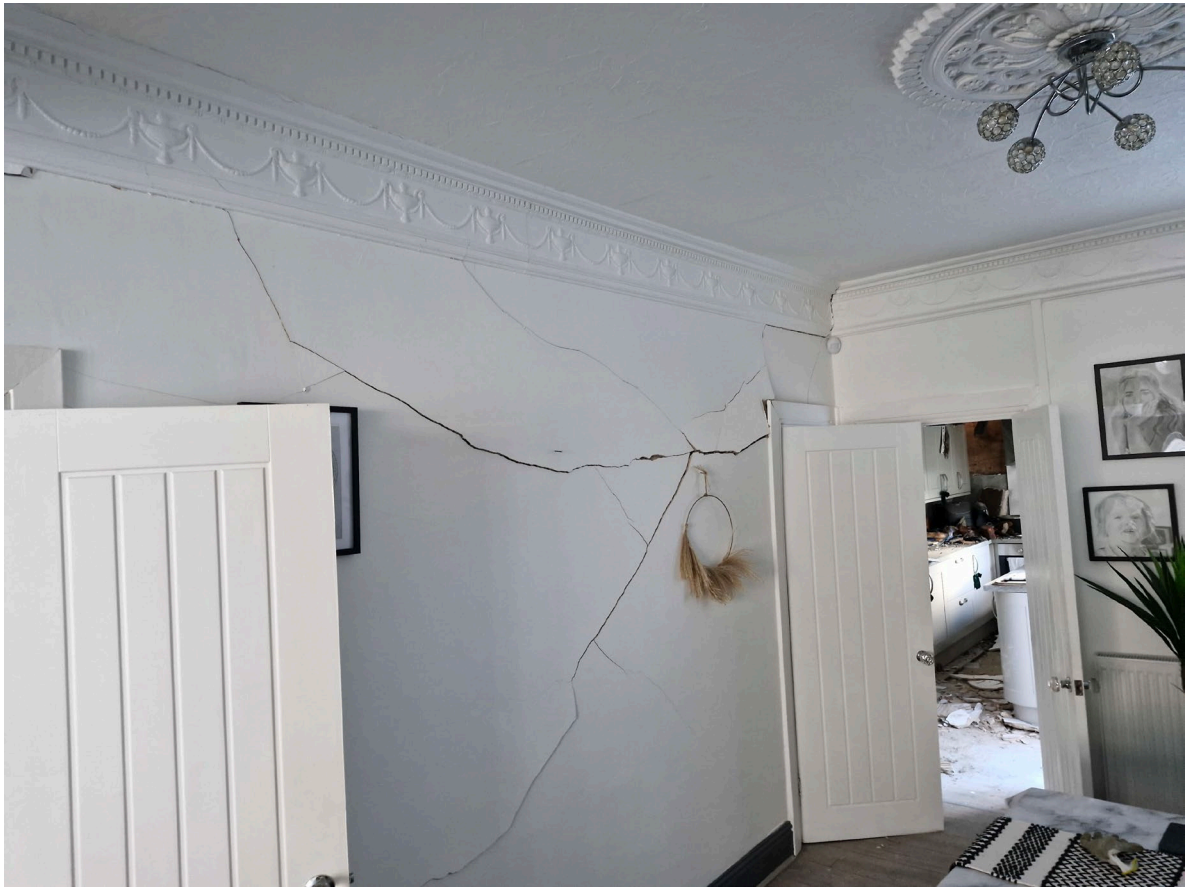
PHOTO 05 HALL WALL N^o 27 LOOKING FROM LIVING ROOM

27 should not be made until a further inspection of the ground floor walls is carried out by an Engineer following completion of the demolition works.
