Structural Inspection of Existing
Hay Loft Barn Building at
Ghyll House Farm
Egremont
Cumbria
CA22 2UB

8th June 2026

Inspection

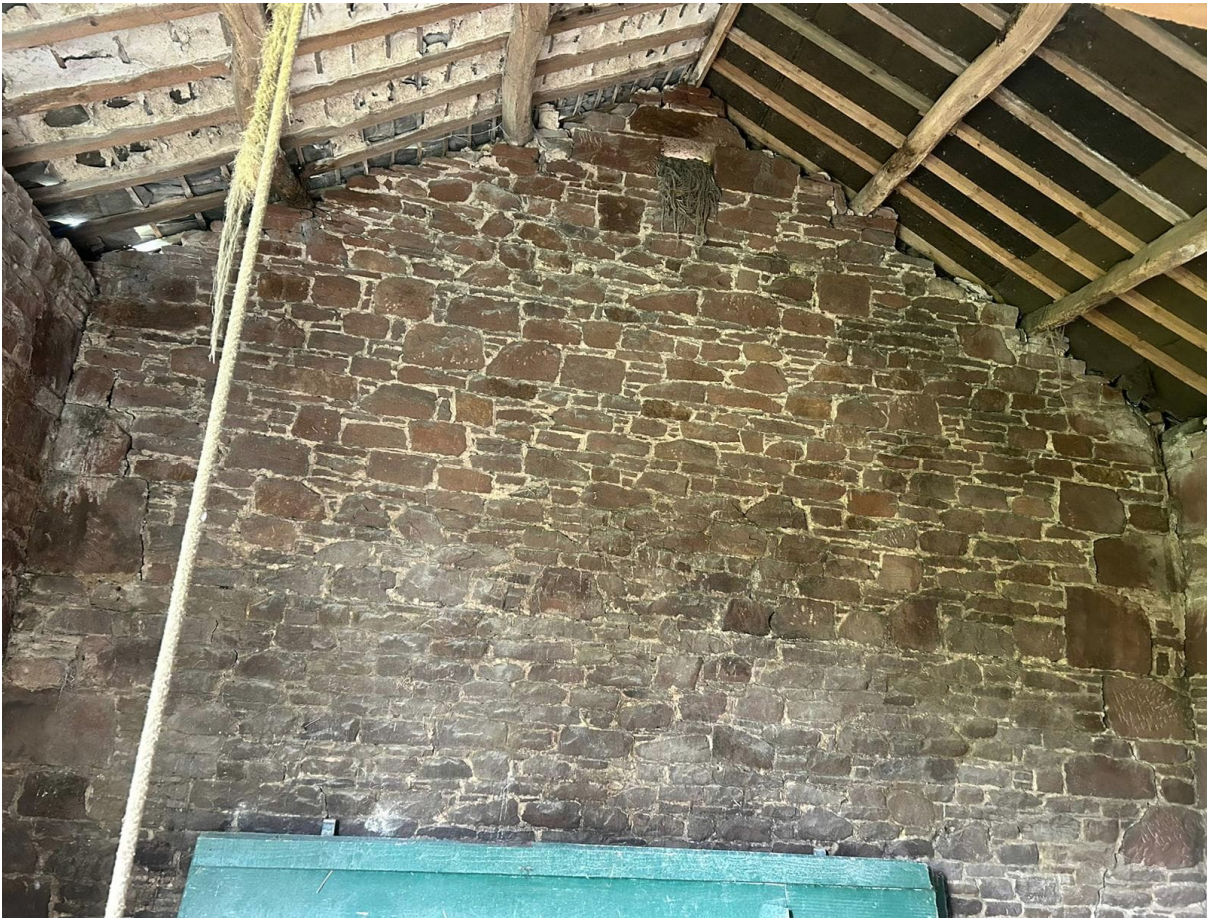
The existing roof appears to be in a relatively sound condition with no evidence of any sagging of the roof members. All roof timbers appeared to be in a sound condition with no signs of rot or excessive deflection. The majority of all slates appeared to be present and in tact with some minor areas where holes have appeared however, no signs of any severe water ingress was evident. One section of the roof appeared to have been recently repaired.

Fig 1 Photograph showing existing roof with repaired section.

As part of the proposed development, the existing roof, sub-standard first and ground floors will be removed and replaced with new to current building regulation standards. In addition to this proposed construction works, the following remedial works are recommended:-

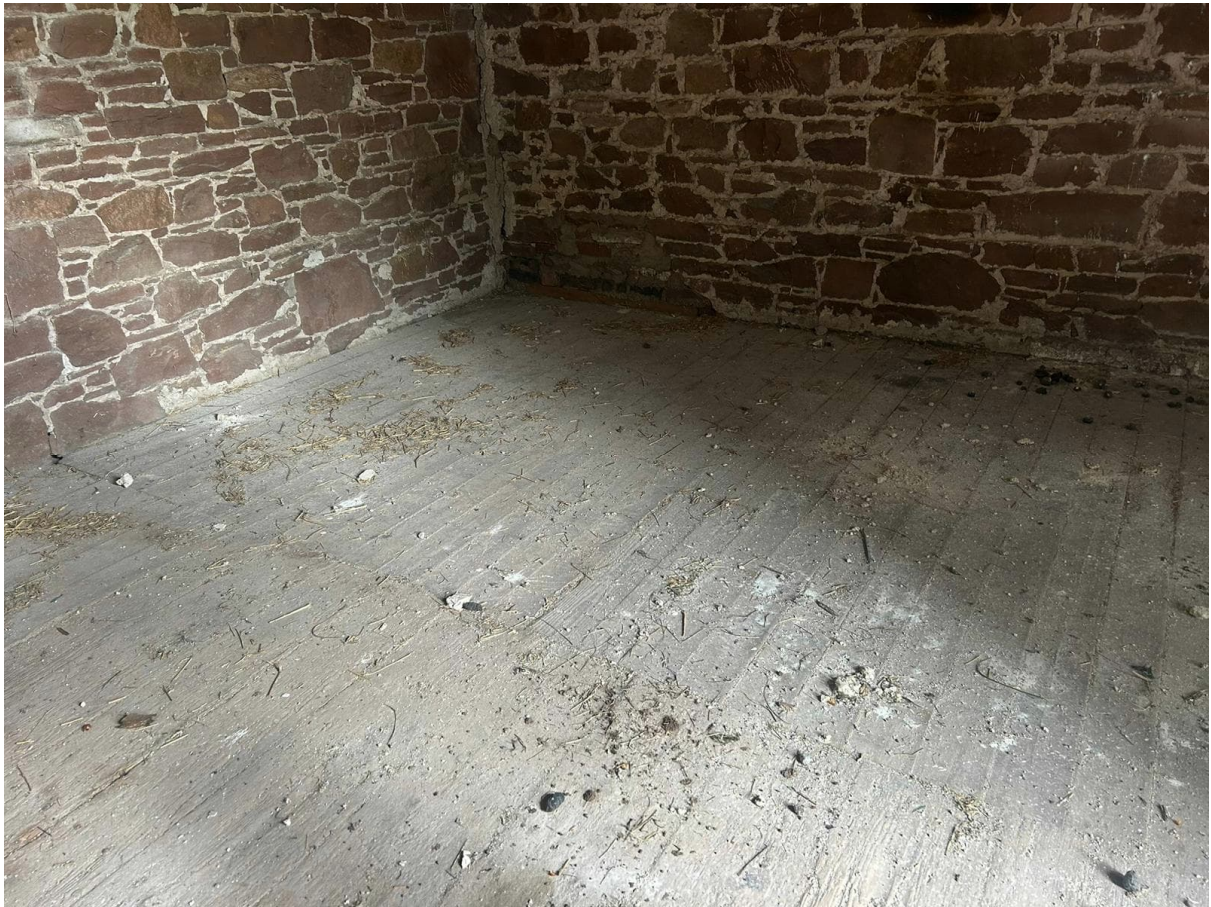
The timber first floor appeared to be in a reasonable condition with exception of one area directly adjacent to the arched opening where the boards have collapsed resulting in a large hole approx. 0.6m x 0.6m.

Fig 2 Photograph showing existing timber first floor within hay loft

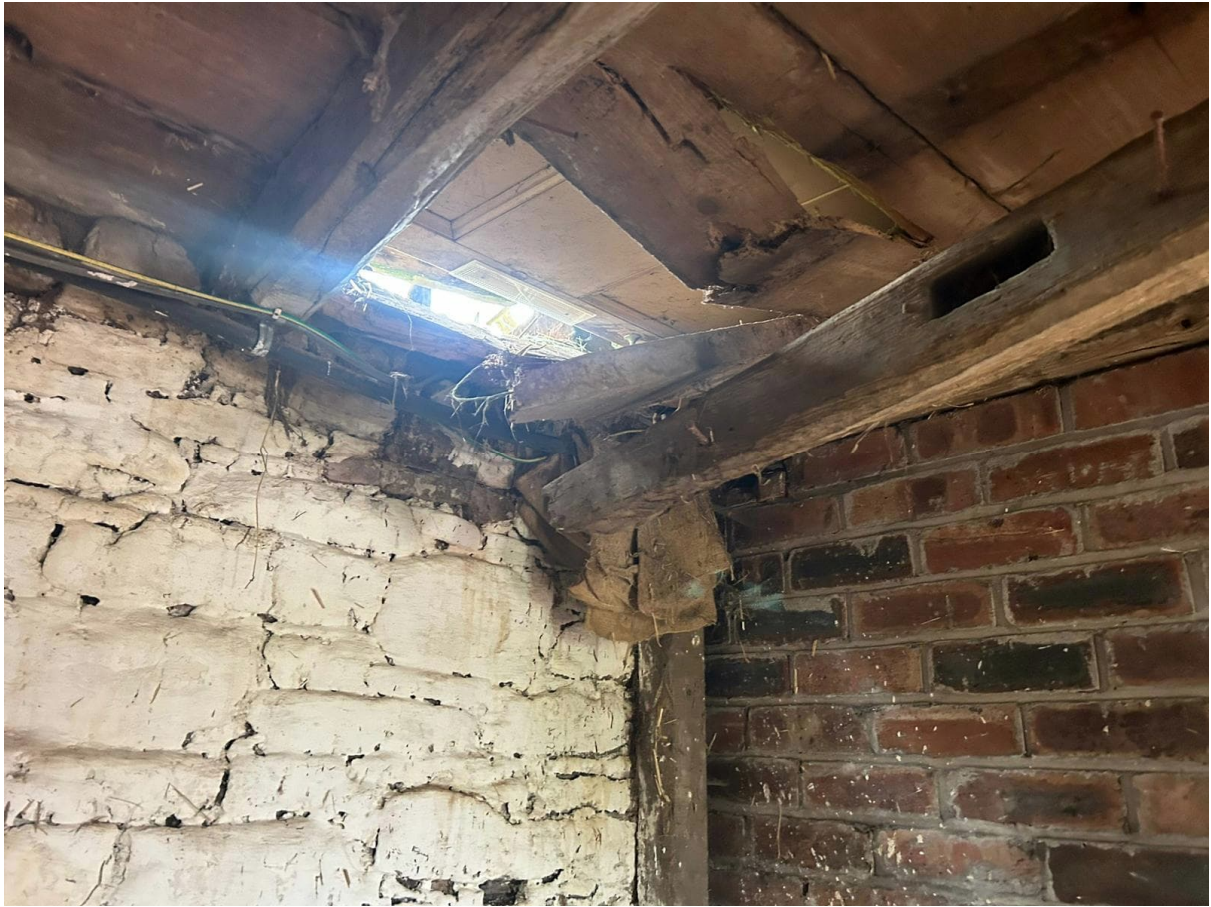
Fig 3 Photograph from underside of first floor showing collapsed section over store room.

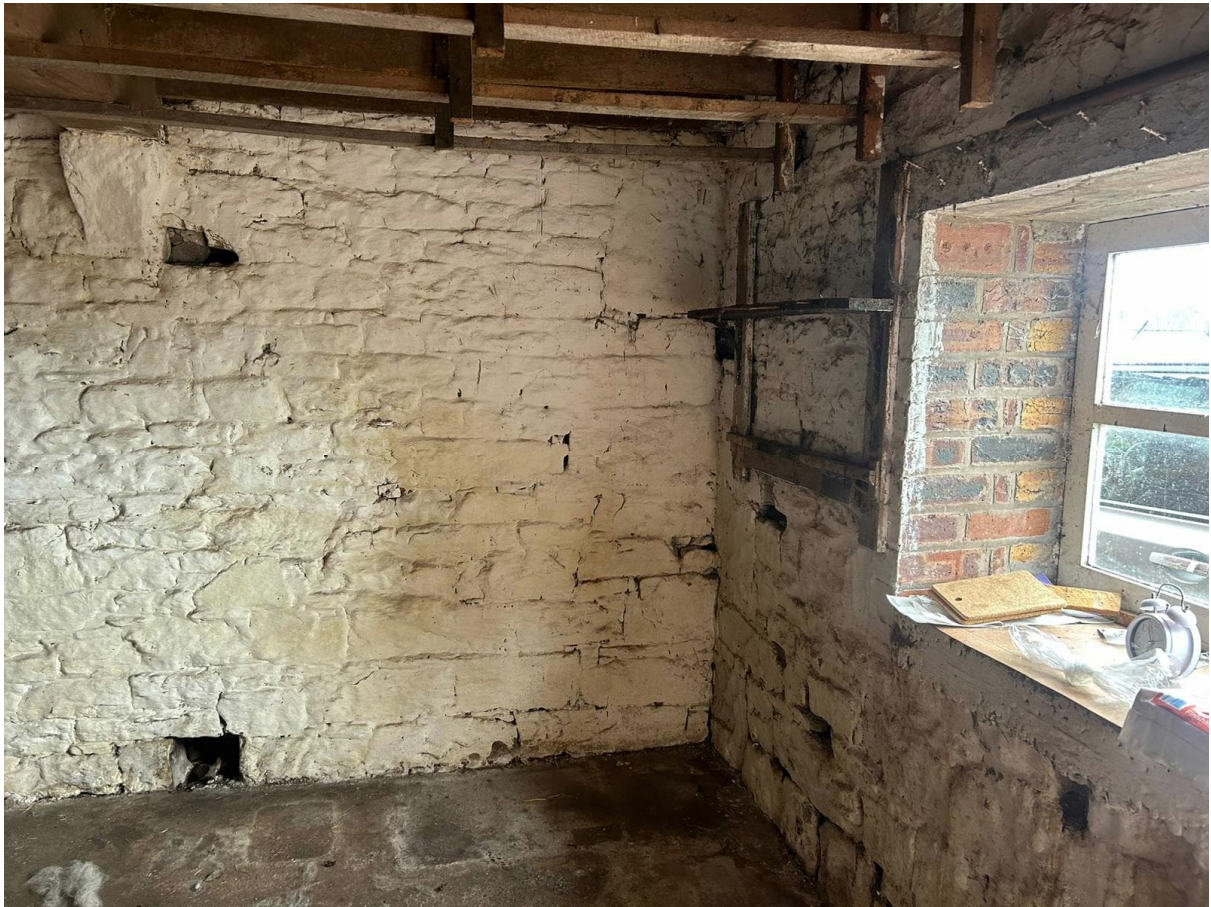
The stone ground floor within the storage area appeared to be in a reasonable condition with no evidence of any cracking. The ground floor within the utility room and hall could not be inspected as these were covered with carpets. The floor level within the utility room has a large cross fall from back to front.

Fig 4 Photograph within store room showing internal wall, underside of timber first floor and stone ground floor.

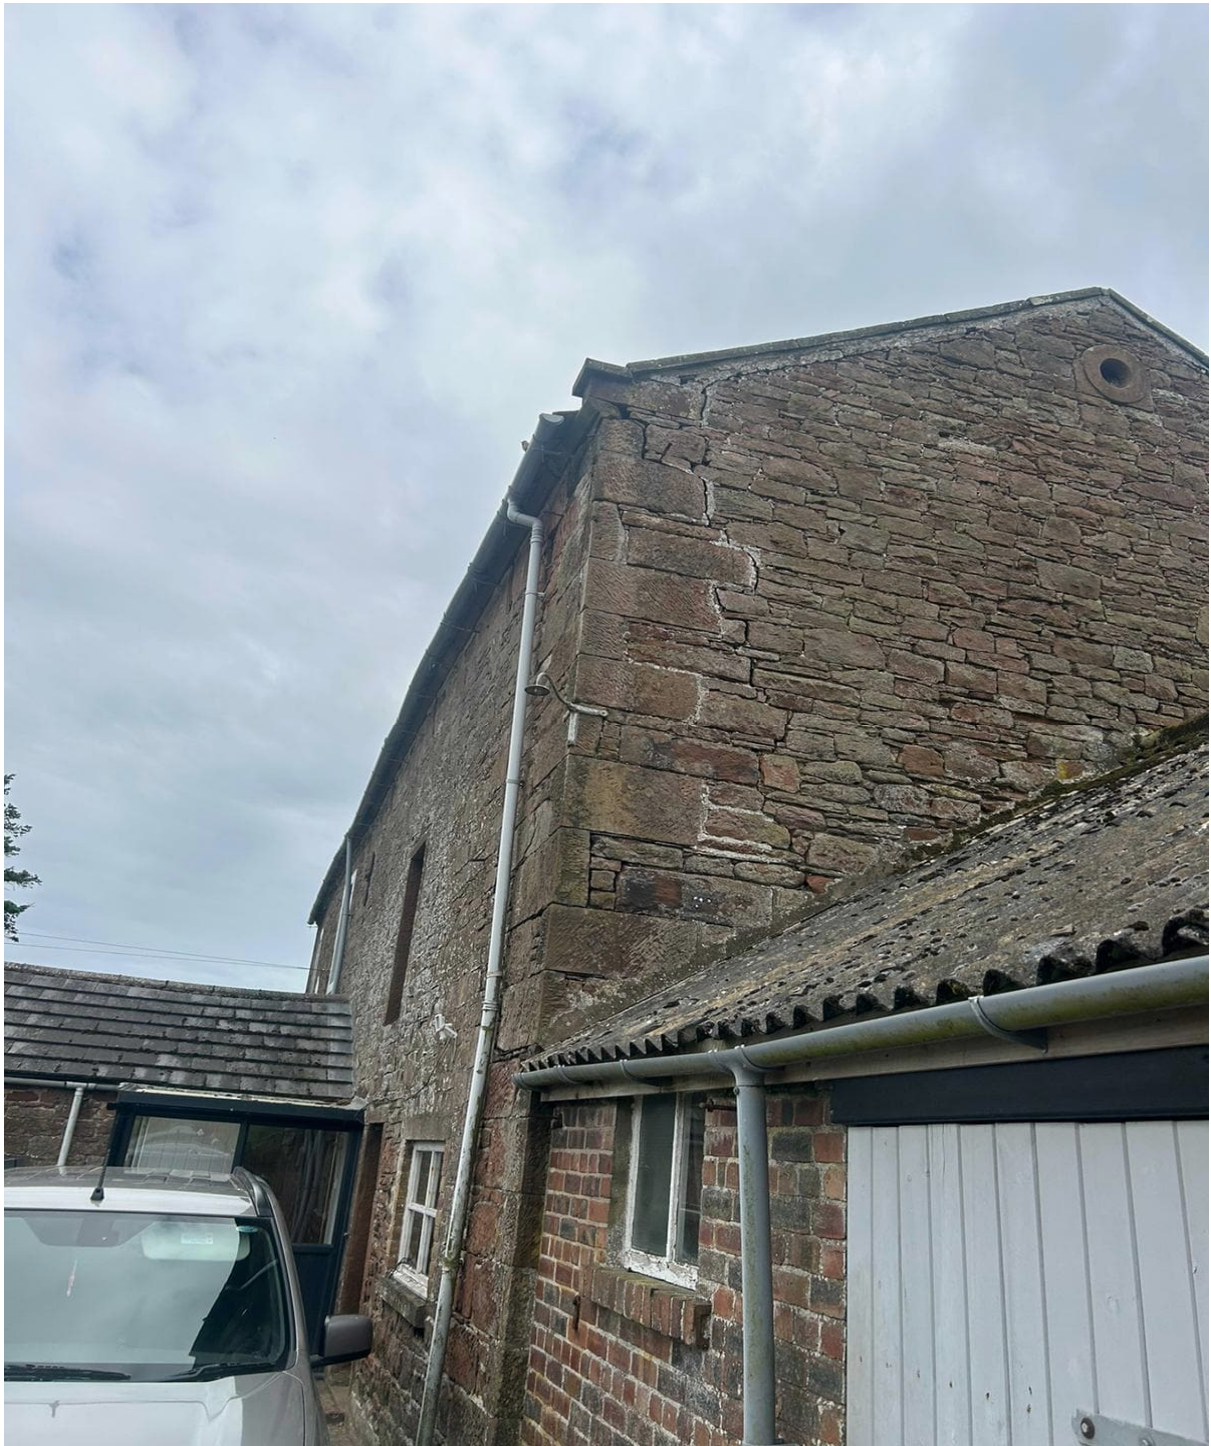
With the exception of localised vertical cracking to the bed joints at the front and rear sides of the gable end, the external walls are generally in a sound condition with no evidence of any movement or settlement.

Fig 5 Photograph of vertical cracking to front side of gable end wall

On completion of roof removal all areas of vertical cracking to the gable end shall have the bed joints fully raked out and re-pointed as necessary. Any loose sandstone shall be carefully removed and re-bedded as necessary.

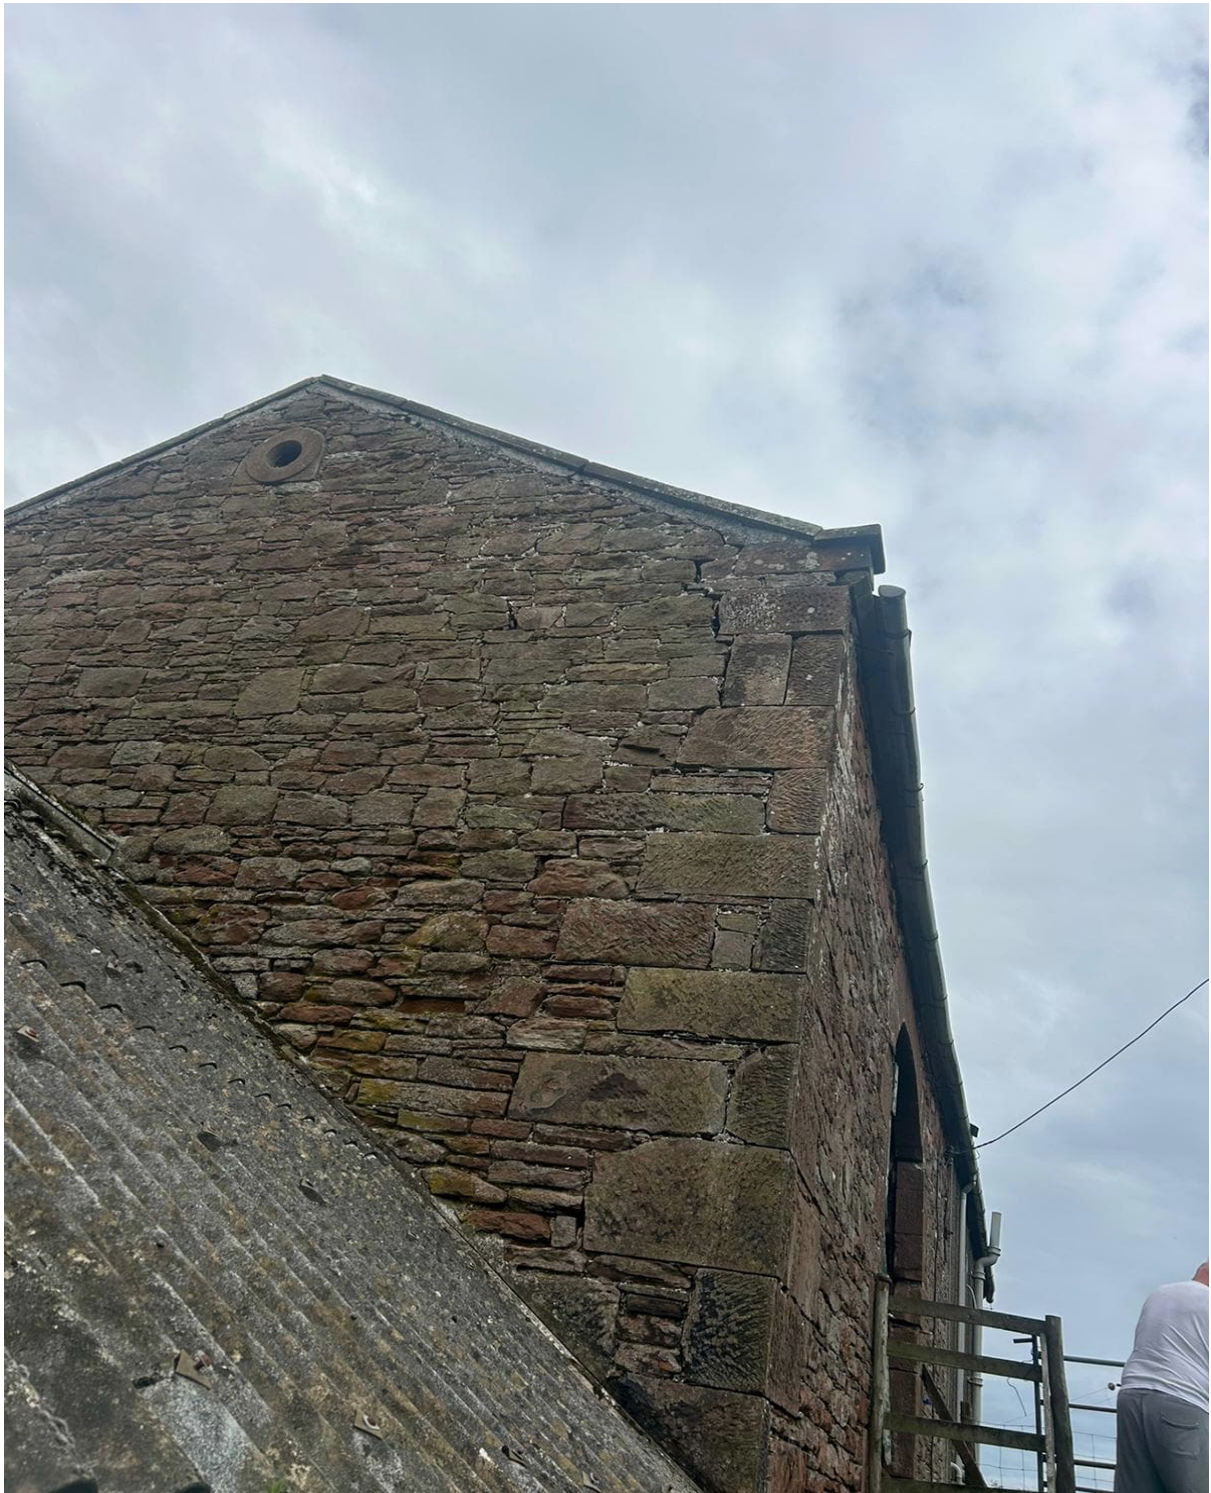
Fig 6 Photograph of vertical cracking to rear side of gable end wall

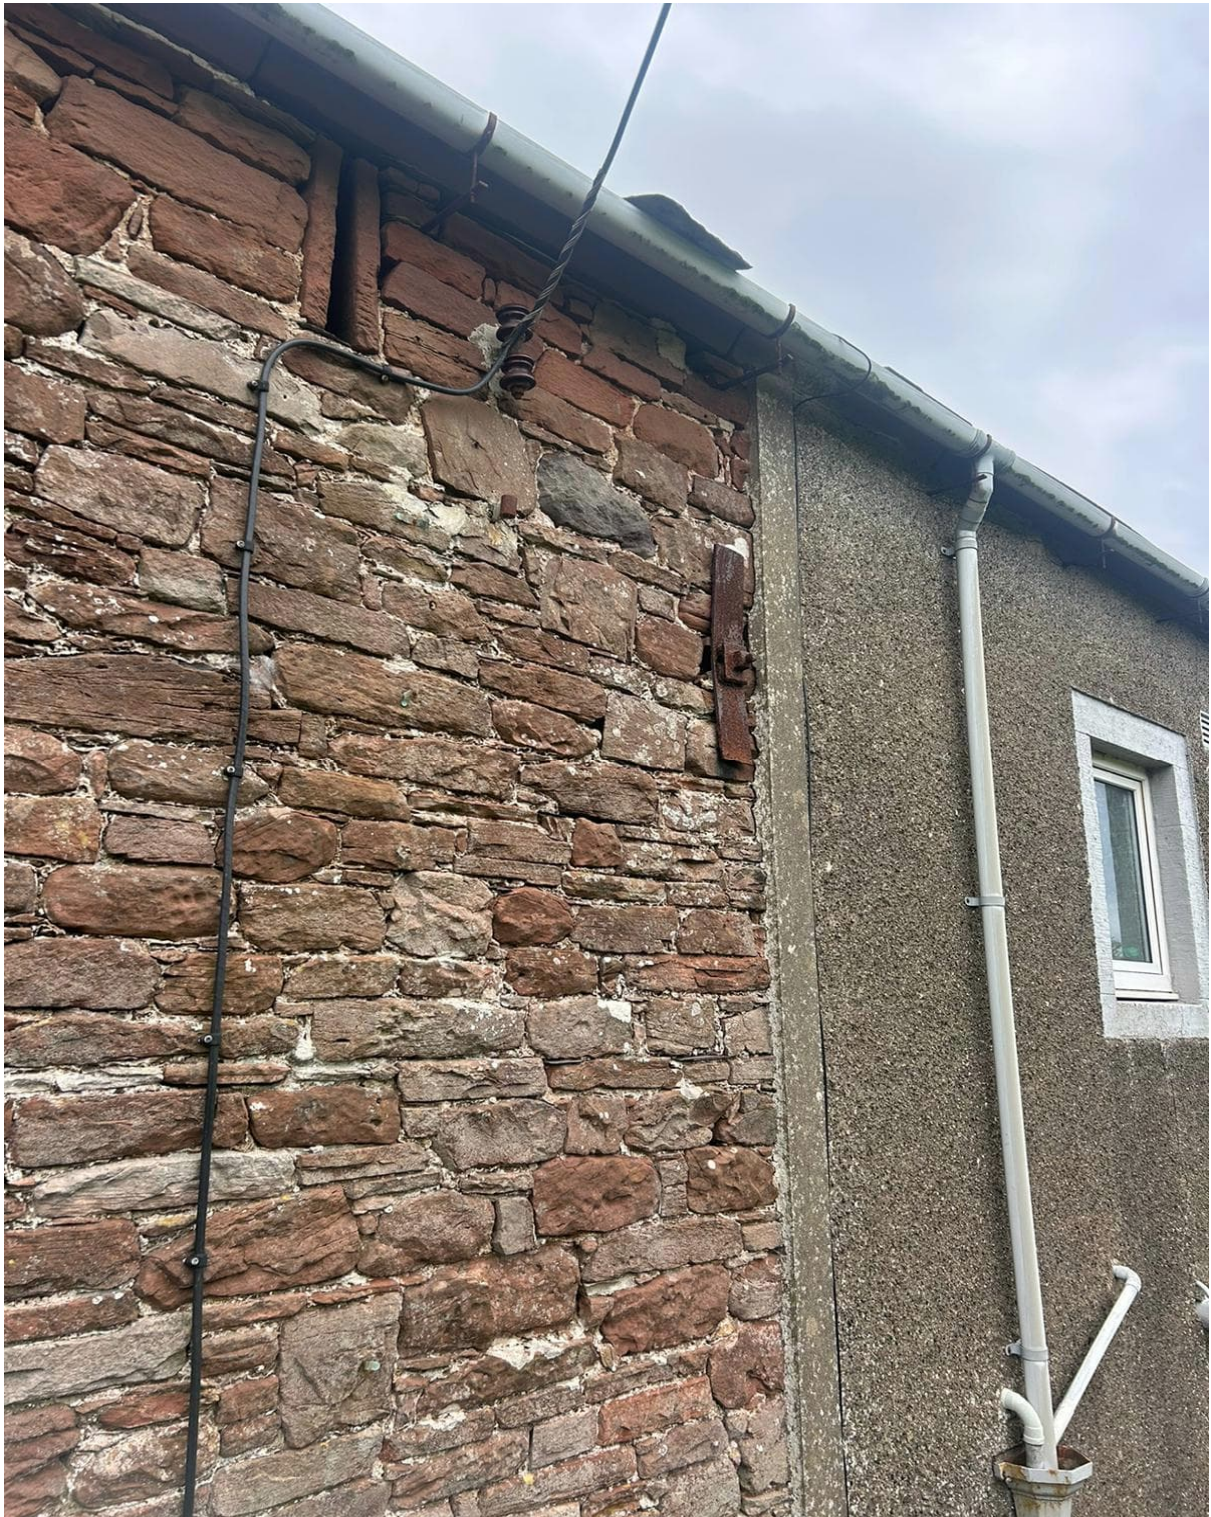
A steel round bar tie member running from front to back walls has been installed at some point in the past however there were no signs of any cracking or deformation of the walls both locally or globally. The external plates of the tie member are showing signs of corrosion. Localised loose sandstone is evident local to the rear tie plate on the rear elevation.

Fig 7 photograph showing external tie member plate on rear elevation

The existing horizontal tie member shall be wire brush cleaned free from rust and debris and painted one coat zinc rich primer and 2 coats gloss. The tie member should be boxed out as necessary as part of the proposed development. All loose sandstone local to the existing face plates shall be re-bedded as necessary.

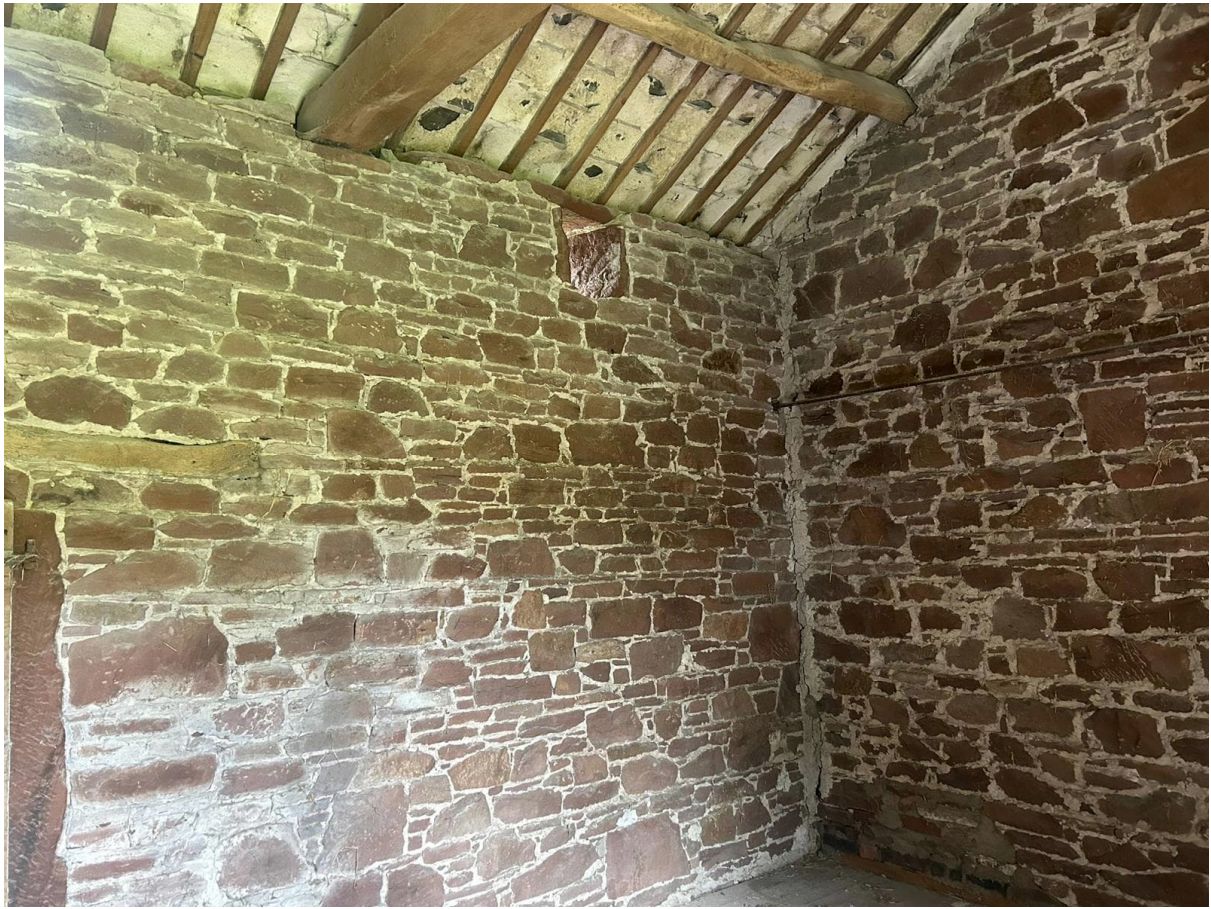
Fig 8 Photograph showing tie member within barn.
