**VISUAL STRUCTURAL INSPECTION**

**LONGLANDS FARMHOUSE & COTTAGE  
GOSFORTH  
CUMBRIA**

**AVISON YOUNG**

**Reference - WDS/05/7082/REP01  
Date - 02/06/2021**

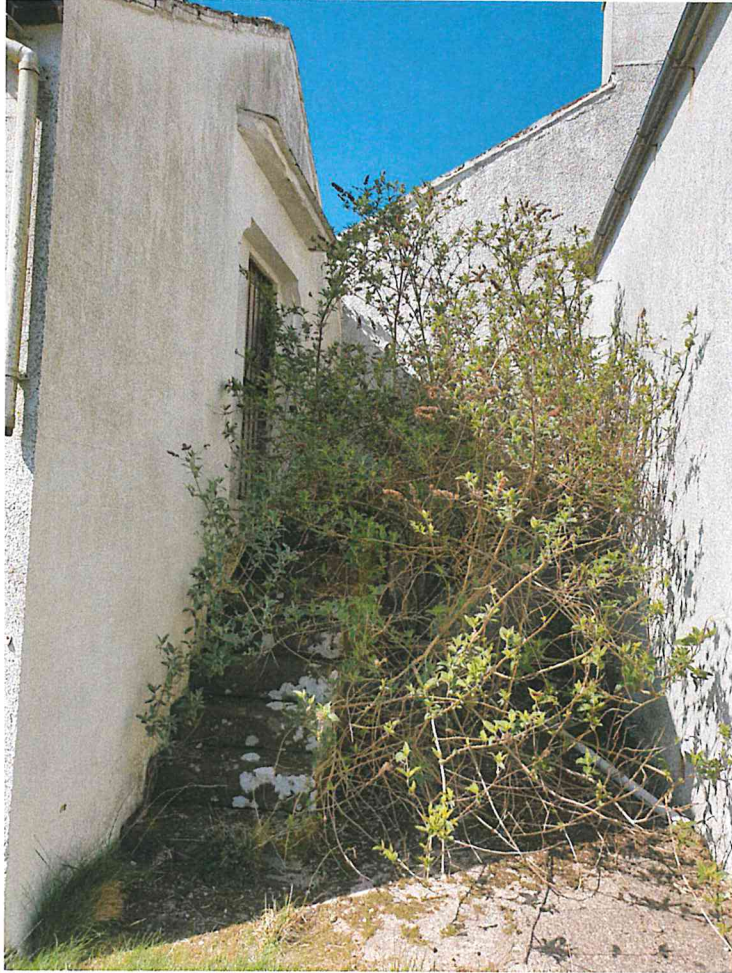
**2.4** Vegetation growth is prevalent around the property with tree saplings and bushes growing near to the house walls. If left these will cause damage to the property and their roots may lead to foundation issues. (See photograph 01)

Photo 01 Typical View On Vegetation Growth Against The Building

- The vegetation needs cleaned out from around the property with all bushes and tree saplings removed to a minimum of 10m from the building walls.
- Suitable signage needs erected to warn anyone accessing the property in the future of the dangerous floor to the ground floor area and first floor as noted above. Alternatively the floors can be replaced in a like for like manner where affected.
- A timber specialist needs appointed to inspect the timbers throughout the property to check for active wood worm and rot. Where required suitable treatment should be applied to protect the timber structures from deterioration.
