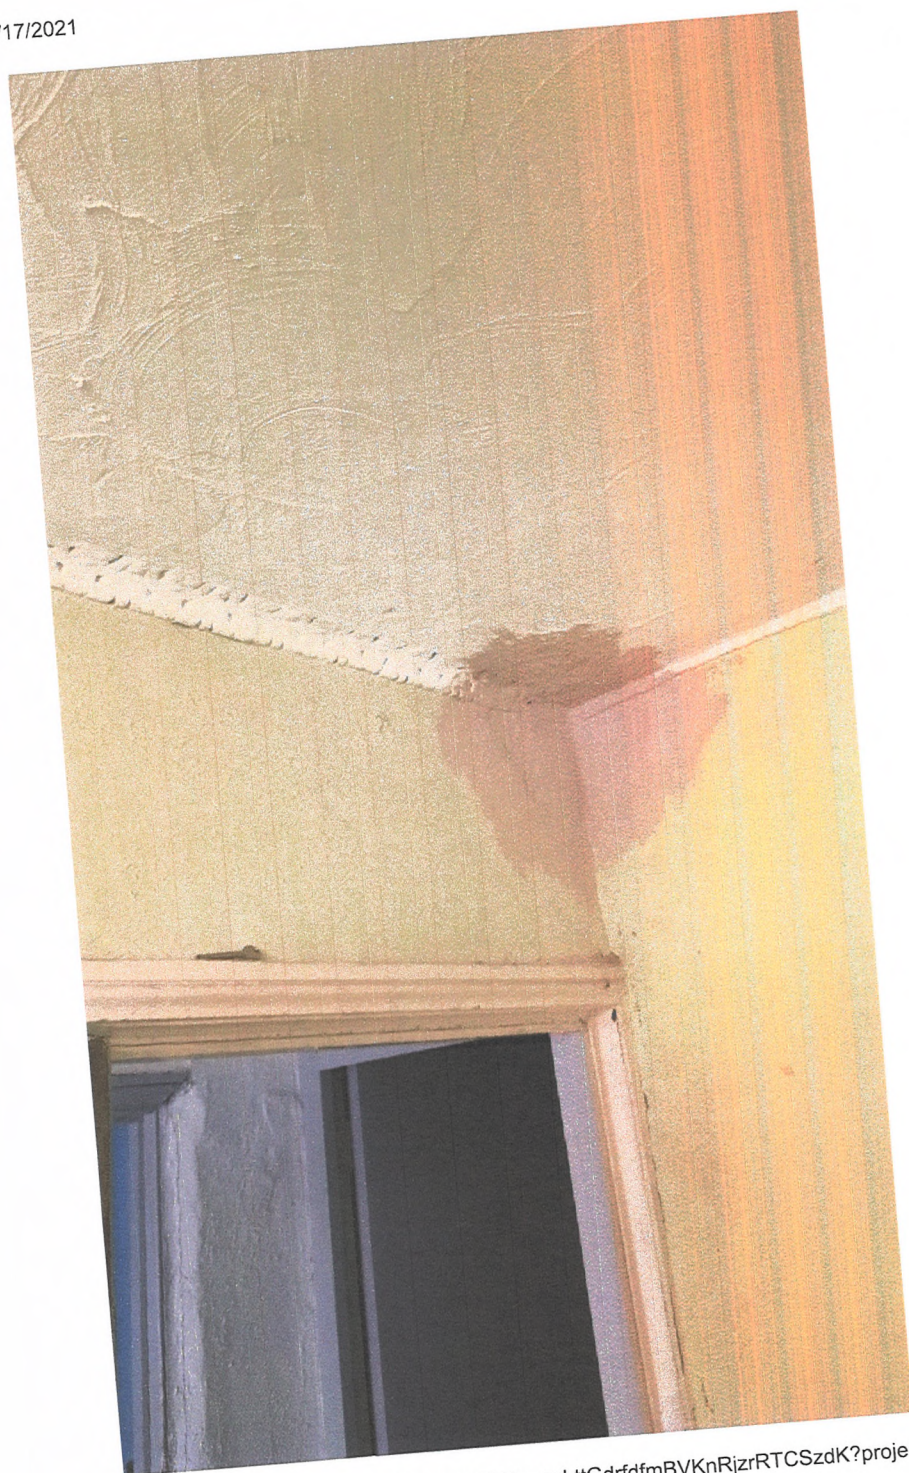
①

Photograph of Poor  
Condition of Cornicing  
to downstairs ground  
floor dining room (front room)  
before further investigation  
works

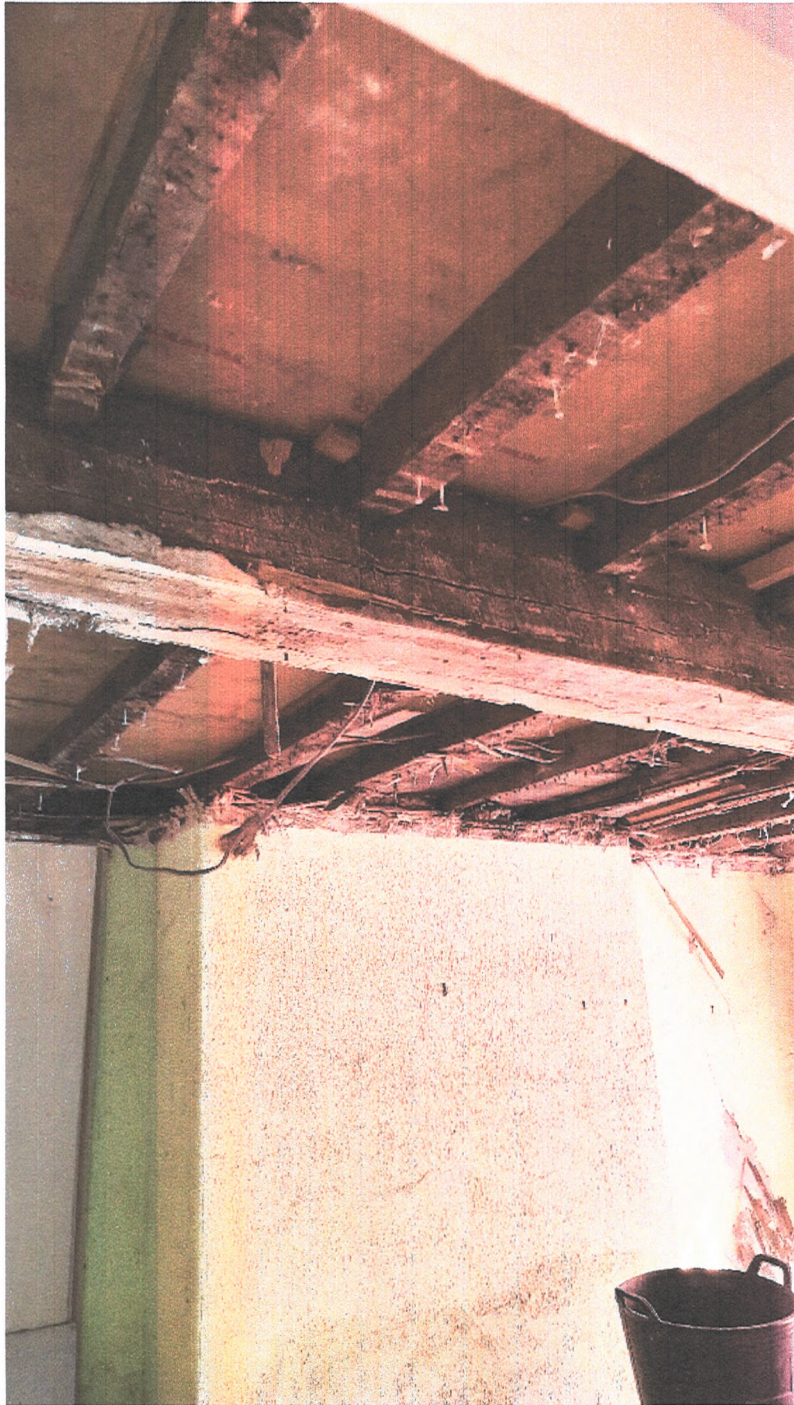
(2) -

Further Investigation into  
Condition of Joists. After  
Consultation with Tom Short.

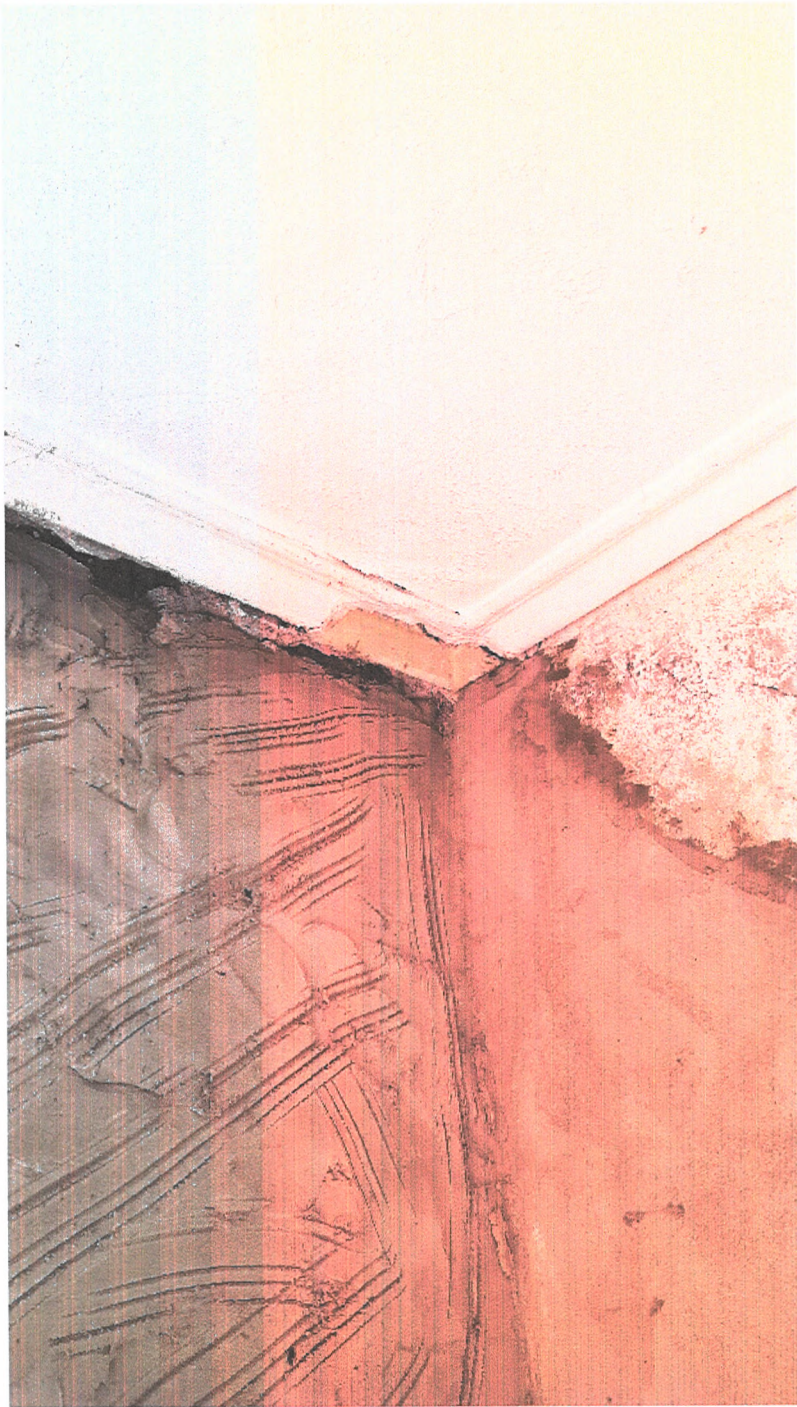
③.

Photograph of  
First floor Corning Condition.

Also showing Poor Condition  
of Walls, before any

Investigations.

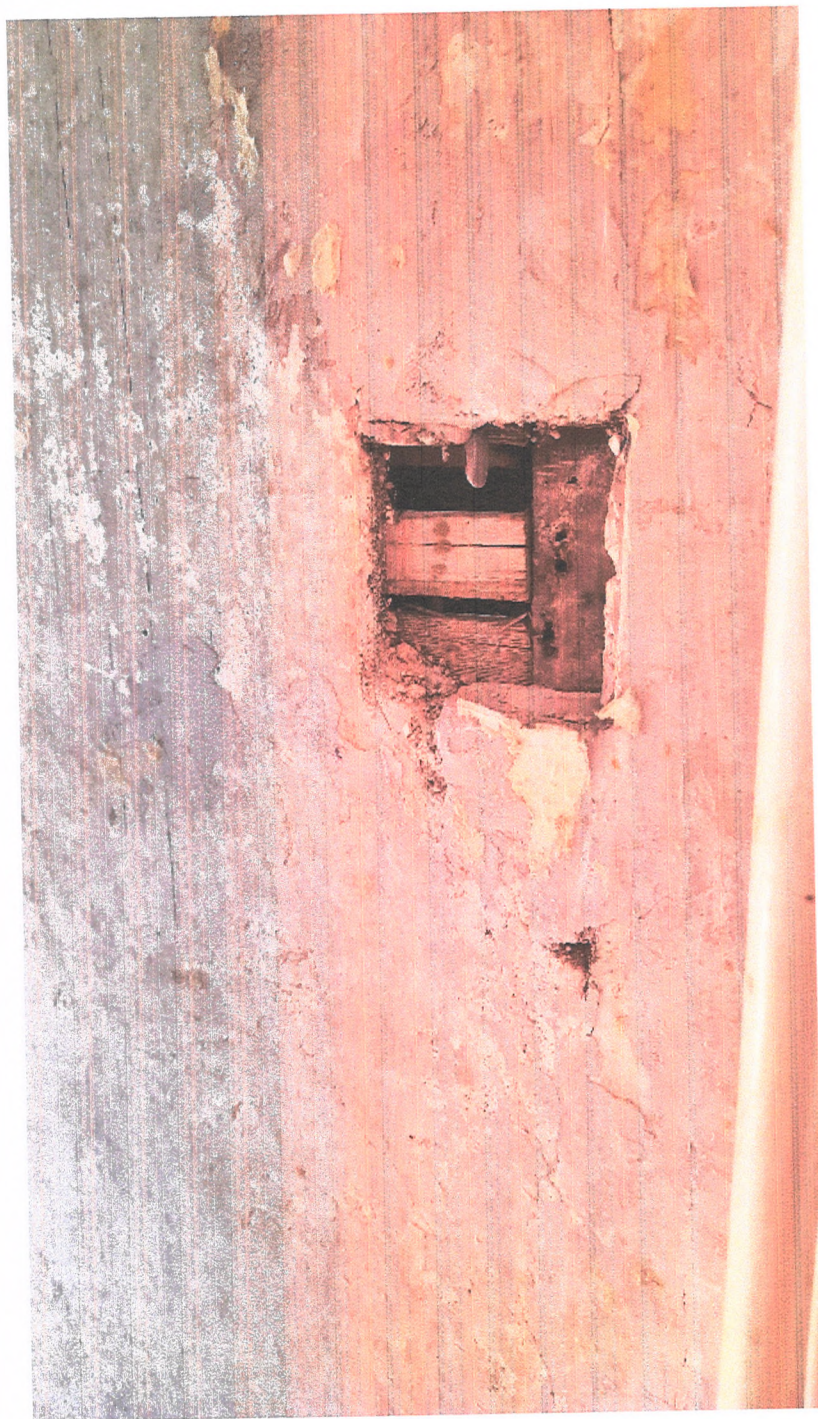
(4)

Evidence of small  
hole in wall

where you can see  
lath & Plaster.

NO Investigation Works  
needed.

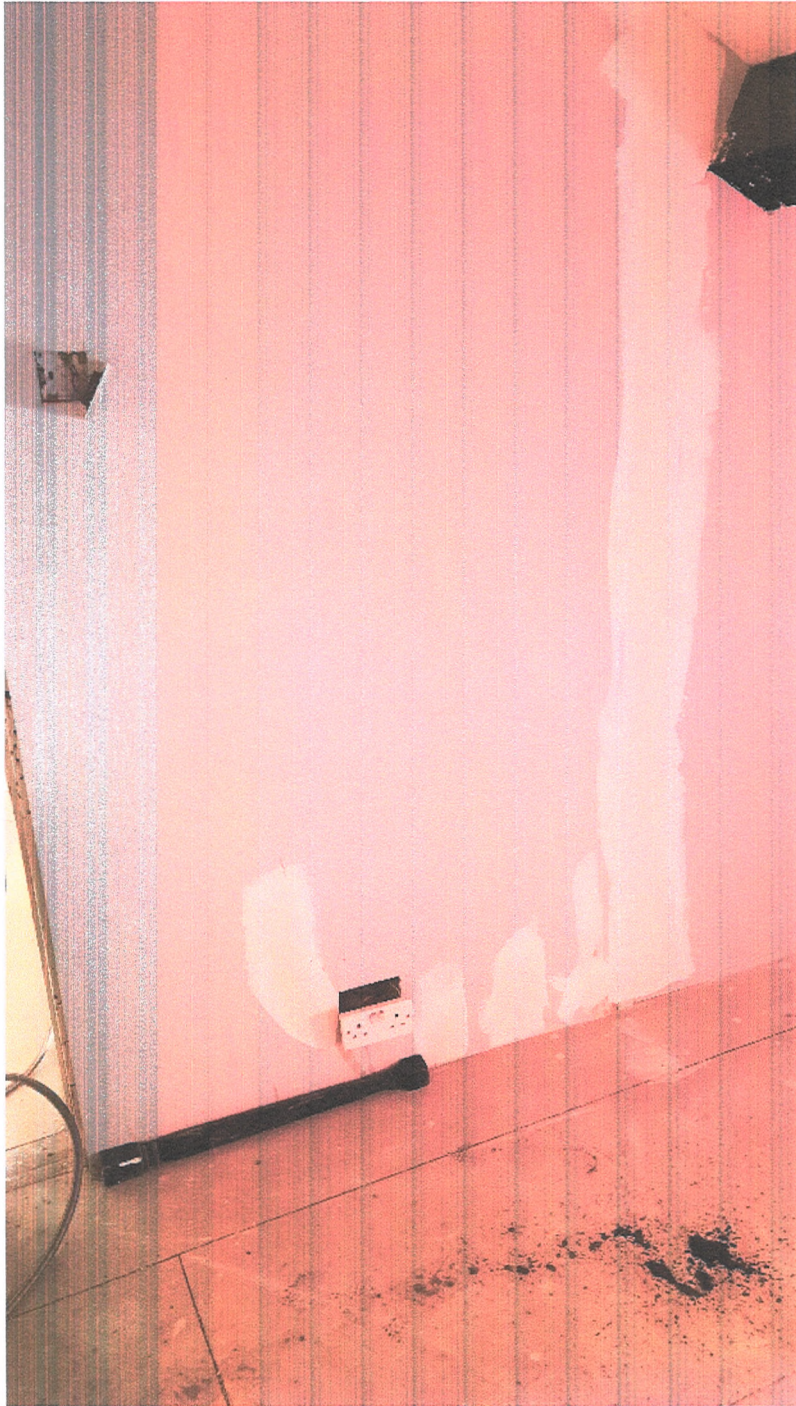
(5) .

Photograph of typical  
wall that has Plaster  
board - to all main  
areas and most bedrooms.
