VISUAL STRUCTURAL INSPECTION

**TARN HEAD FARM
FARM HOUSE & BARN
SELLAFIELD
SEASCALE
CUMBRIA**

AVISON YOUNG

Reference - WDS/05/6133/REP01

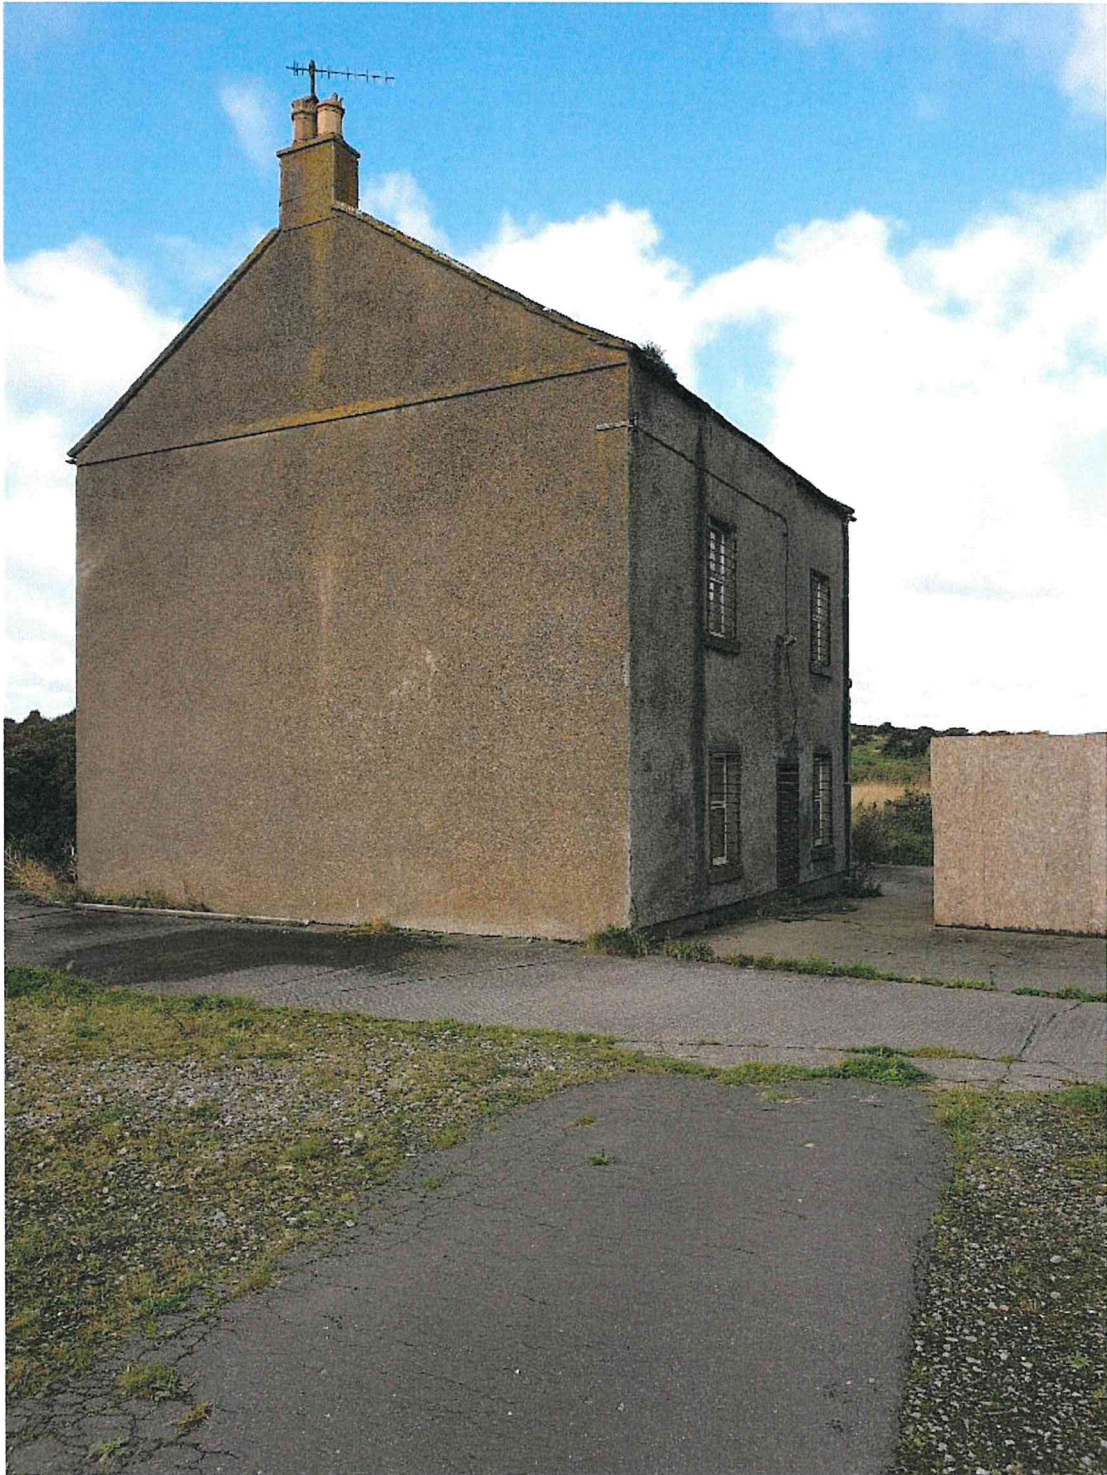
PHOTOGRAPH 1 FARM HOUSE

- 3.1** The farm house is in need of total refurbishment and modernisation with all the internal finishes in need of replacement.
- 3.2** There is a full height crack to the rear elevation which propagates from ground level up to eaves through the ground and first floor window reveals. The crack suggests the left hand gable of the property has been subject to some structural movement.
- 3.3** The floor joists throughout the property deflect excessively when walked on. The joists are in need of replacement.
- 3.4** The timber lintel to the rear living room window is rotten and needs replaced. It is likely that the lintels over the other doors and windows will be a similar detail and may have suffered similar deterioration.
- 3.5** The rear chimney stack has been rebuilt in block masonry in recent times. The wall beneath the stack is cracked and the render is in a poor condition.

- 4.2** The farm house is in need of total refurbishment. The presence of rot and wood worm in addition to the inadequate structural size of the roof and floor timber elements will necessitate the roof and floors to be removed throughout. Furthermore the ground floor slabs will need lifted to allow a DPC and insulation to be inserted and any slag fill beneath to be removed. The cracks apparent will need tied throughout. In essence the farm house will merely be the shell and with the requirement to replace timber lintels it is likely that much of the random stone masonry above will need replaced as part of this work. With this we would suggest that a more cost effective approach would be to demolish the farm house also.

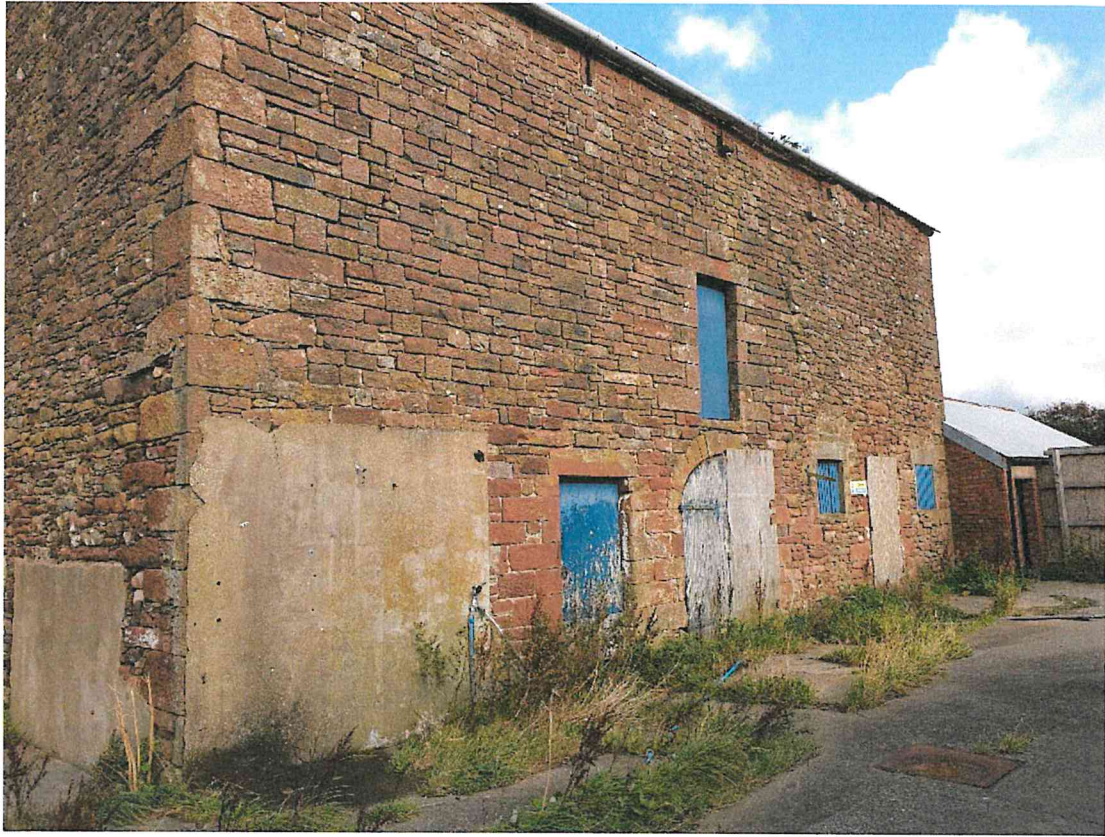
PHOTOGRAPH 2 DETACHED BARN FRONT ELEVATION

- 2.1** The main two storey barn structure is in a very poor condition. The front elevation has a significant outward bulge. Part of the front elevation has been rebuilt adjacent to the bulging area suggesting some partial collapse in the past. There is a significant full height crack to the right hand gable and a similar crack to the left hand gable suggesting structural movement has/is occurring with the front wall moving differentially to the rear portion of the barn. The front wall is at risk of localised collapse. The internal walls are not suitably tied to the external and the walls at the corners are not suitably keyed in.

- 4.1** The main two storey barn structure is in a very poor condition with the front wall at risk of localised collapse. The first floor structure is unsafe and the internal walls and main building corners need suitably tied in. Considering the condition of the barn and the fact that it is unused I would recommend that it is demolished.
