## **Tree Survey at Croft Lodge Beckermeth**

**3rd June 2022**

**Matthew Jones  
Bsc (Honours) For, Cert.Arb (RFS)**

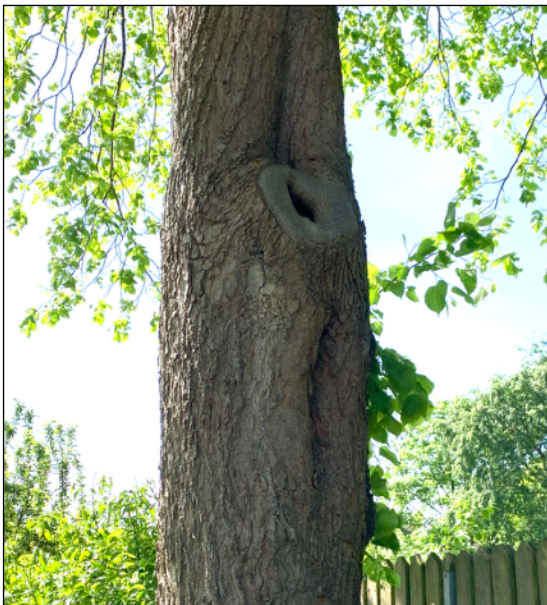
The trunk has had a number of large branches removed in the past that have left some large wounds. Some of these have not occluded well to the west due to poor pruning cuts. To the north the occlusion of these wounds has occurred normally.

Figure 3 - Old pruning wound with decay

I would recommend that this tree is removed given its proximity to people and property.

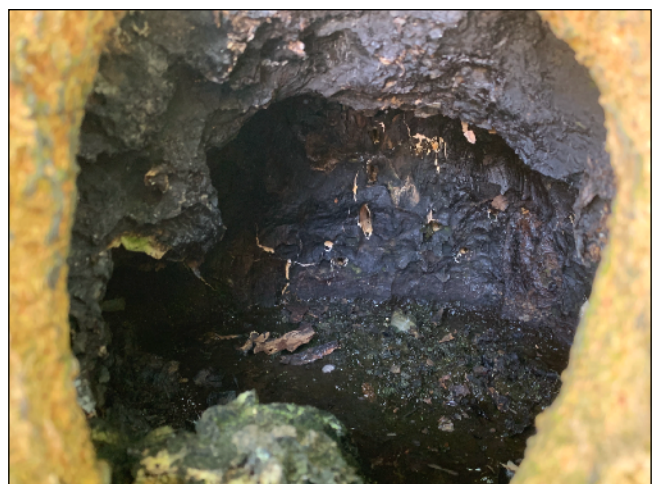
Figure 4 - Extensive cavity and decayed wood

The wound to the north from the ground appeared to have some decay within it. Upon further inspection this decay is extensive and with a probe measured 750 mm in depth. On the west of the tree there are coalescing wounds and above this the decay has spread out from the cavity into the main stem wall. On this side the decay extends some 500 mm into the cavity.

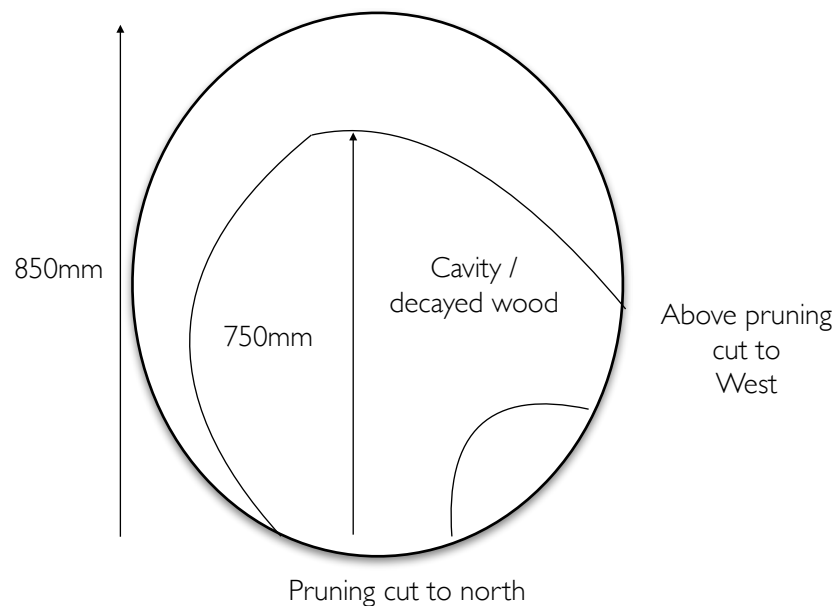
This decay has also spread through the main stem wall above the original pruning wound to the north.

Figure 5 - Cross sectional analysis of the stem

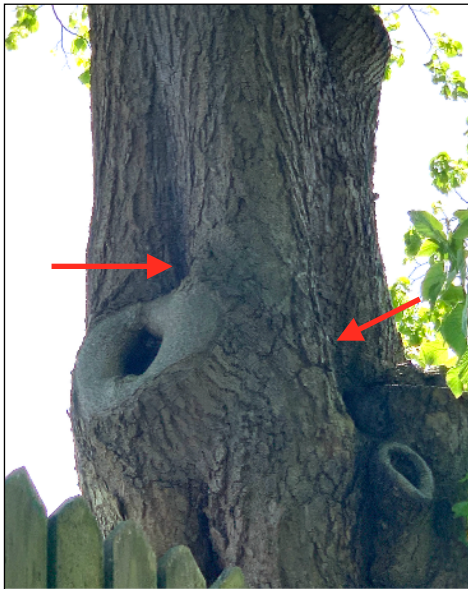
Figure 6 - Points where stem wall is decayed

Lime compartmentalises decay poorly unlike an Oak that can produce barrier zones that effectively zones the decay off from spreading through the stem. Given that the decay has broke through the main stem walls and has moved up and down the stem and radially then it is clear that there is little resistance to its spread.

It is most likely to cause two open cavities in the main stem wall to the west and to the north above the pruning cut. Even though there are signs of adaption wood on the stem from a long term perspective the risk of failure of this stem will magnify over time.

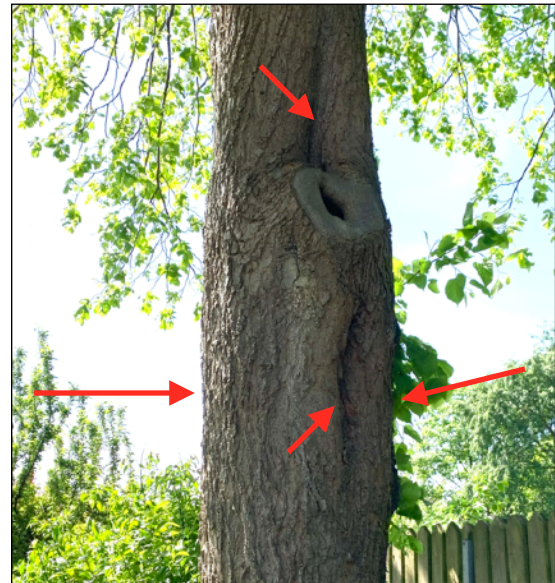
Figure 7 - Middle arrows show decayed areas above and below pruning cut and side arrows indicate stem thickening

Initially this decay would have been confined to a small area and in many trees it remains confined and zoned off limited in its spread throughout the main stem. In this case the decay is now becoming more expansive and has started breaking through the main stem walls. There are some signs of adaption / compensatory wood that can be seen on the trunk by increased stem thickening as identified in figure 7. This is caused when the tree senses increased bending stresses and attempts to allocate wood to areas of increase loading, in this case around the decay.

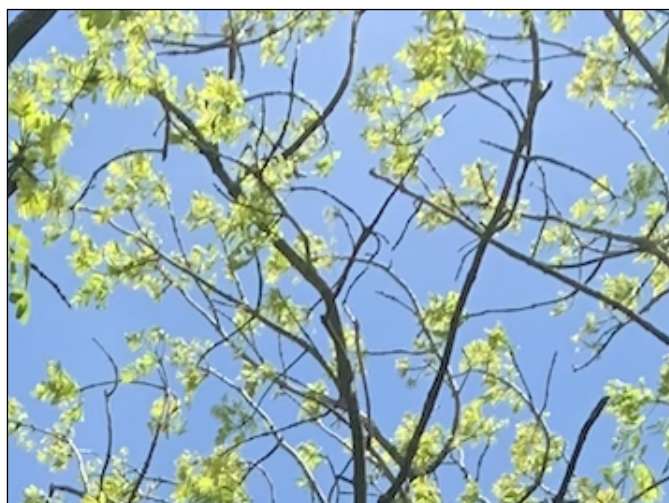
The tree has an average level of vitality. The tree has been infected by die back and this is evident in the crown. Although at present this is not severely infected.

Figure 9 - Dead shoots in crown typical of Ash die back

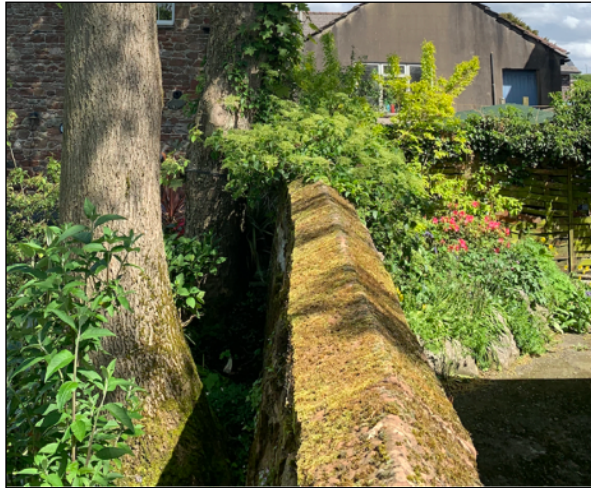
The boundary wall has been lifted by the proximity of the stem and roots to the foundations. The wall is not a safety hazard but has a definite bow in it and is cracked to the east of the tree. This will need to be monitored to ensure this does not worsen. Trees optimise themselves wherever they are growing and it is likely that the roots from this tree are situated to the east, west and the north within the garden of croft lodge.

Figure 10 - Ash and proximity to boundary wall causing movement

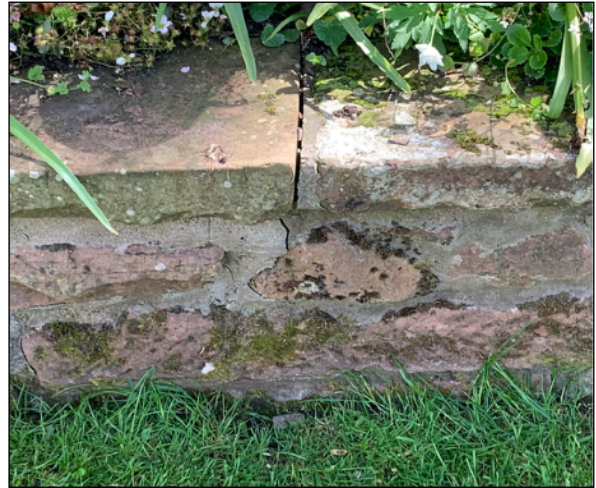
Figure 11 - Crack in retaining bed wall

There is also a crack in the small retaining wall on the flower bed. This is likely to be caused by root expansion as the roots grow under the wall into the lawn.

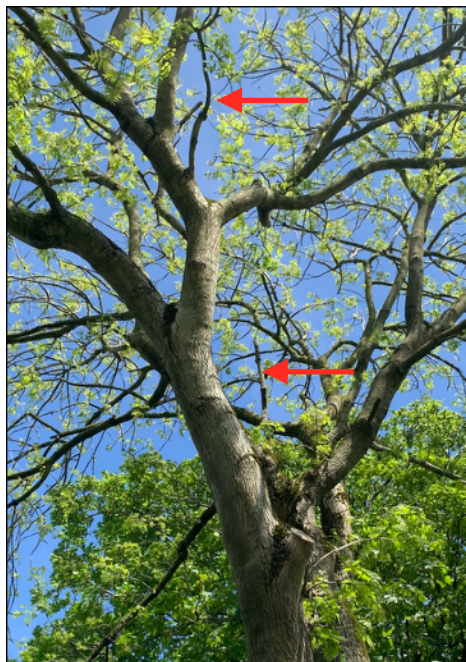
There are some pieces of dead wood in the canopy that could fall onto the adjacent property potentially damaging roof tiles. This would be better removed.

Figure 12 - Example of dead wood in Ash

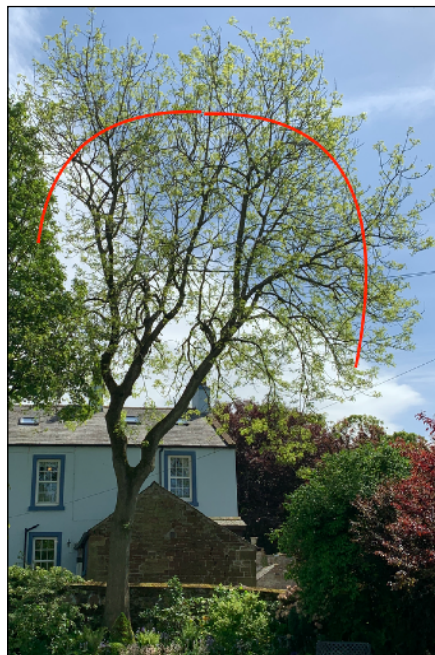
Figure 13 - Recommended reduction if desired to maintain the size of the tree

Given the position of the tree, there are some overhanging branches particularly over the neighbouring outbuilding. These could be pruned back by 2-2.5 m to give some clearance from the outbuilding and to prevent significant shading. The canopy of the Ash could also be reduced if its size is to be maintained by 1.5 m as indicated in the photo below. I would not recommend a more significant reduction in crown size at present. The tree is infected with Ash die back that affects vitality, it is infected but not in a severe condition. A minimal reduction is all I would recommend due to the likelihood of a more significant reduction combined with the Ash die back leading to a drop in vitality.

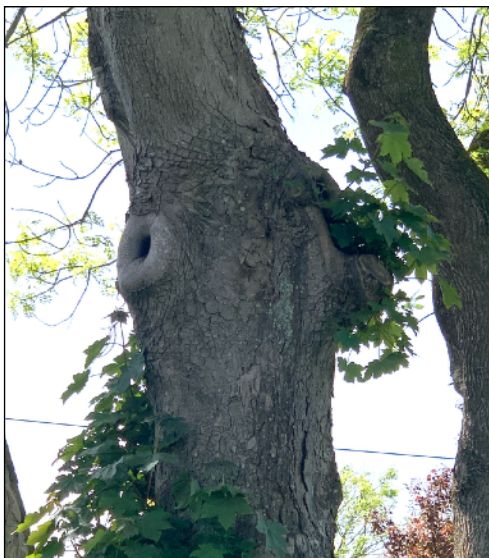
In the past the tree was crown lifted to a height of approximately 5-6 m. Where these branches were removed, there are some wounds on the stem, some with superficial decay. Wounds that do not occlude fully can be prone to decay. At present the decay within these wounds is acceptable and is superficial as to not affect tree stability in any way.

Figure 14 - Pruning wounds in close proximity to each other with some decay

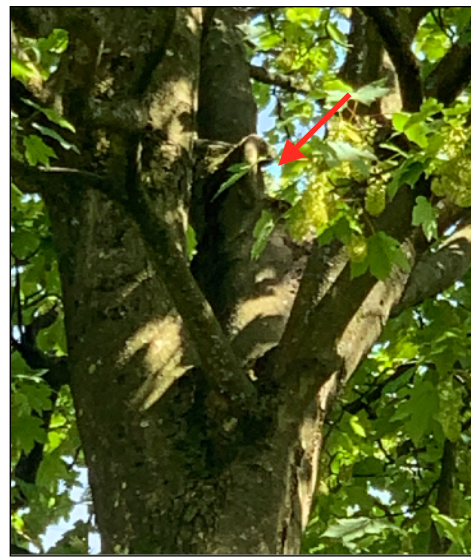
Figure 15 - Decayed branch in crown

There is also some decay in a branch in the crown at the main stem union this shows signs of adaption wood given its size is not considered a risk at present.

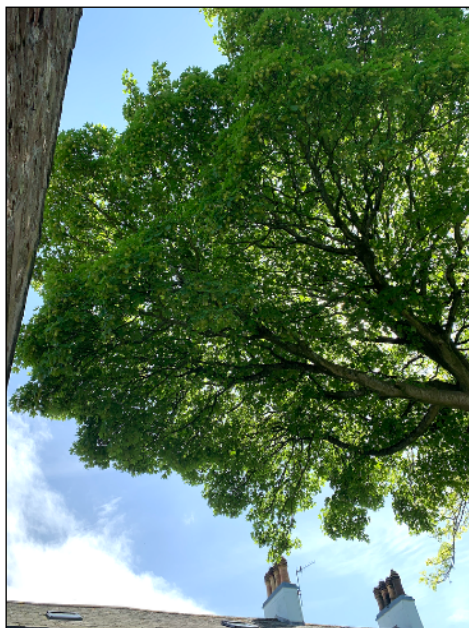
Figure 16 - Crown over hanging neighbouring property

Similarly to the Ash the canopy of this tree is overhanging the adjacent property. The Sycamore has had a minor impact on the wall compared to the Ash.

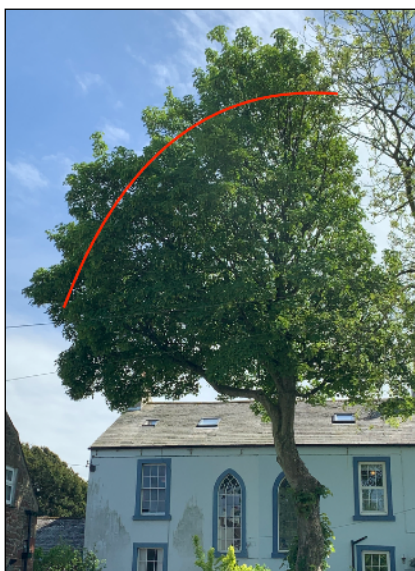
Figure 17 - Recommended reduction of Sycamore

This tree has been crown lifted significantly and therefore if size control is desired or pruning back of over hanging branches from the adjacent property to the south then this needs to be carried out as minimally as possible. A reduction of 1.5 m branch length over the crown is recommended with 1.5 - 2 m on the south side to reduce back over hanging branches as shown in the photos below.

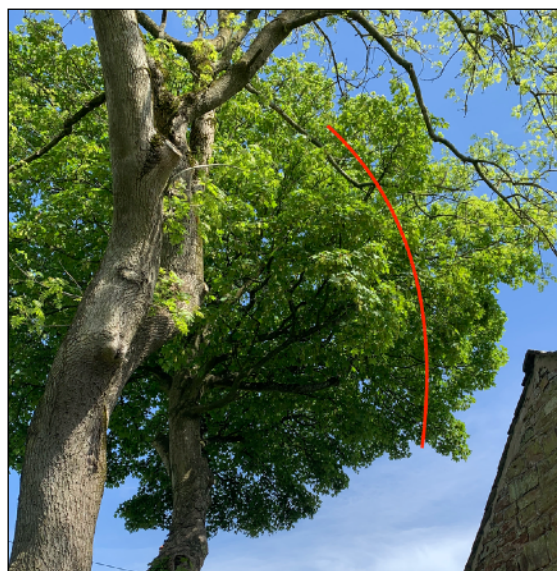
Figure 18 - Recommended reduction of Sycamore of overhanging branches from west
