**Project Name:** MEP Penrith - Flaxworks Cleator Mills - Cleator - 2025\_07\_18  
**Project Description:** CCTV  
**Project Number:** 2413  
**Project Status:** Complete  
**Project Date:** 18/07/2025  
**Inspection Standard:** MSCC5 Sewers & Drainage GB (SRM5 Scoring)

Flaxworks Cleator Mills.

We cleaned and surveyed the combined water drains around the building and identified that the drains our reference on the survey is MH11 discharges into the united utilities manhole reference 9602.

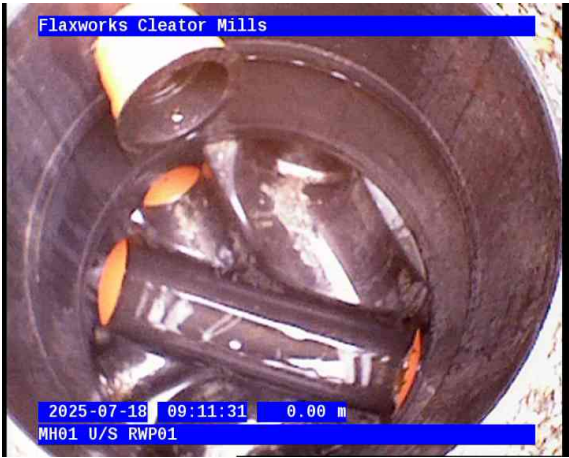
MH01-RWP01-18-07-2025-001.png, 00:00:00, 0.00 m  
Start node, manhole, reference: MH01

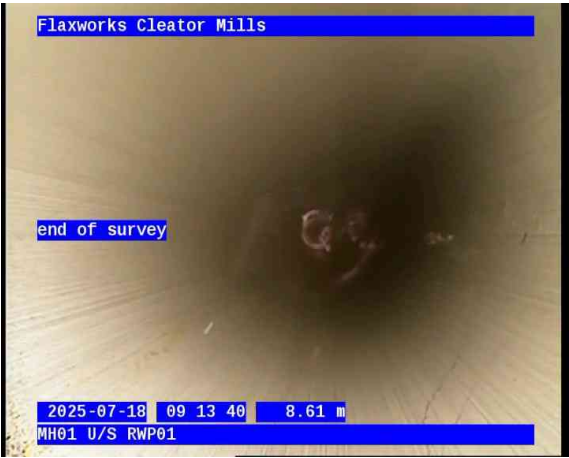
MH01-RWP01-18-07-2025-002.jpg, 00:01:38, 8.61 m  
Finish node, other special chamber, reference: RWP01, end of survey

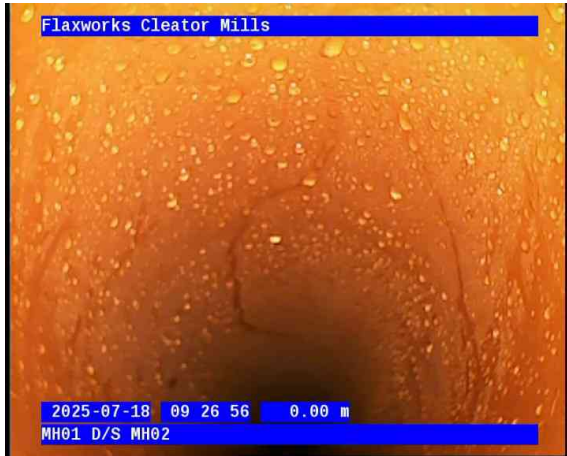
MH01-MH02-18-07-2025-003.jpg, 00:00:00, 0.00 m  
Start node, manhole, reference: MH01

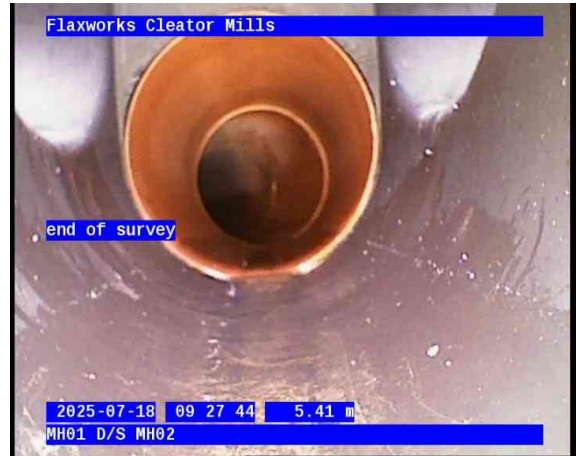
MH01-MH02-18-07-2025-004.jpg, 00:00:48, 5.41 m  
Finish node, manhole, reference: MH02, end of survey

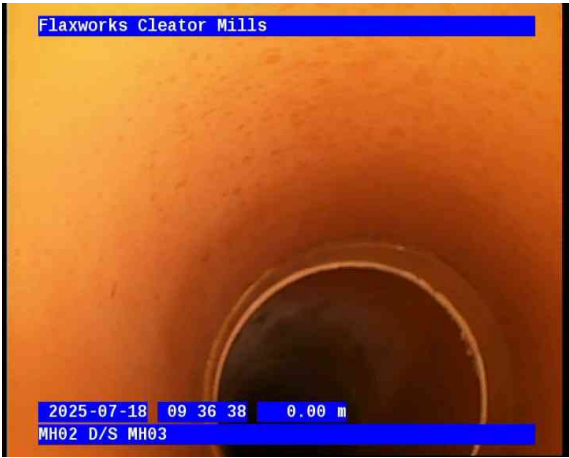
MH02-MH03-18-07-2025-005.jpg, 00:00:00, 0.00 m  
 Start node, manhole, reference: MH02

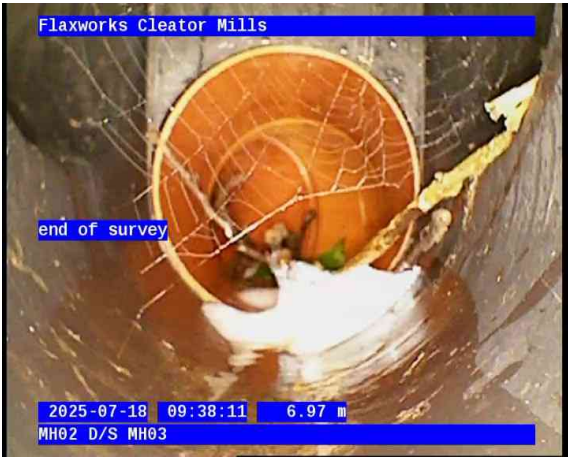
MH02-MH03-18-07-2025-006.jpg, 00:01:32, 6.97 m  
 Finish node, manhole, reference: MH03, end of survey

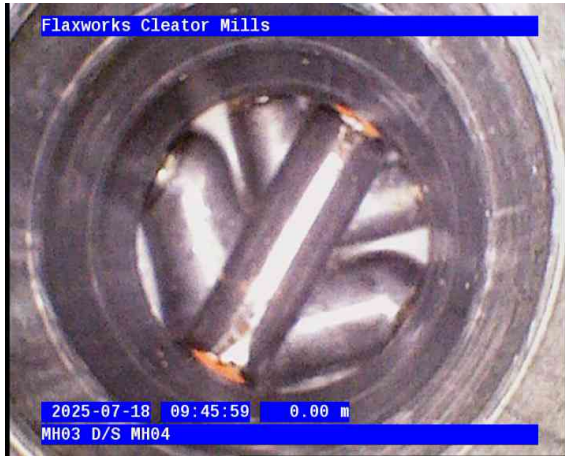
MH03-MH04-18-07-2025-007.png, 00:00:00, 0.00 m  
Start node, manhole, reference: MH03

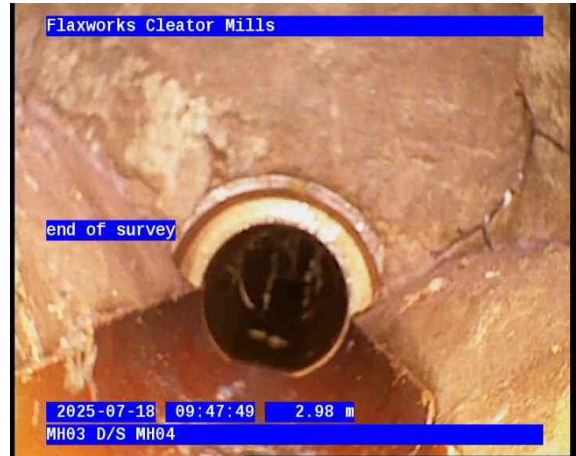
MH03-MH04-18-07-2025-008.jpg, 00:00:27, 2.98 m  
Finish node, manhole, reference: MH04

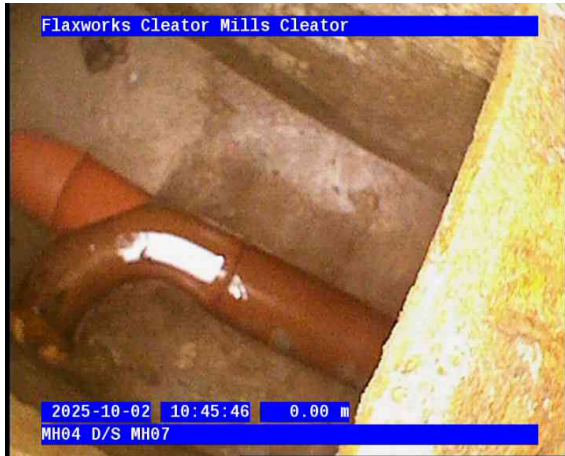
MH04-MH07-02-10-2025-009.png, 00:00:00, 0.00 m  
 Start node, manhole, reference: MH04

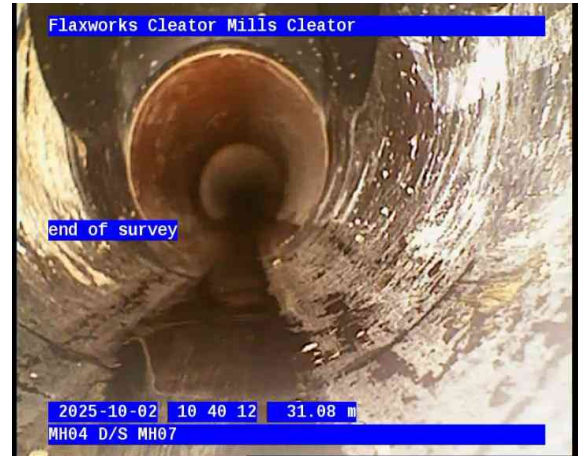
MH04-MH07-02-10-2025-010.jpg, 00:02:00, 31.08 m  
 Finish node, manhole, reference: MH07, end of survey

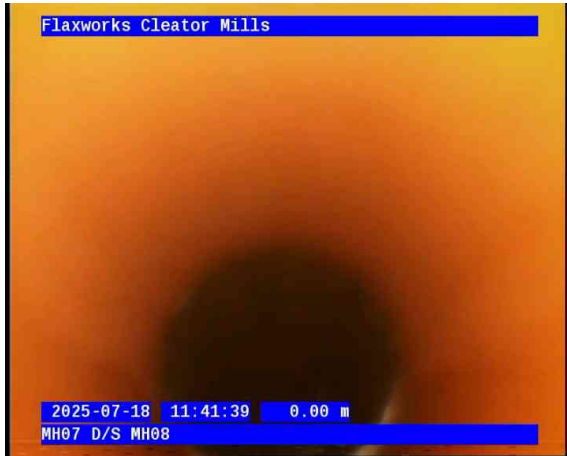
MH07-MH08-02-10-2025-011.jpg, 00:00:00, 0.00 m  
 Start node, manhole, reference: MH07

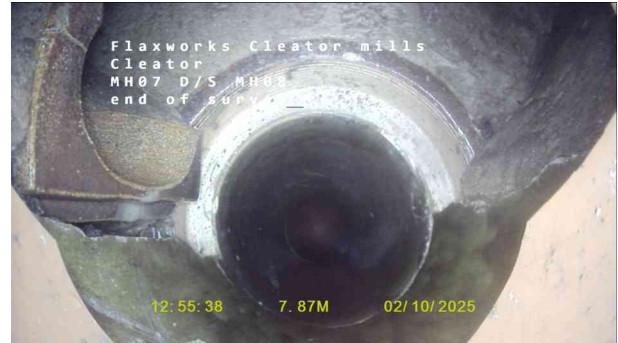
MH07-MH08-02-10-2025-012.jpg, 00:01:34, 7.87 m  
 Finish node, manhole, reference: MH08, end of survey

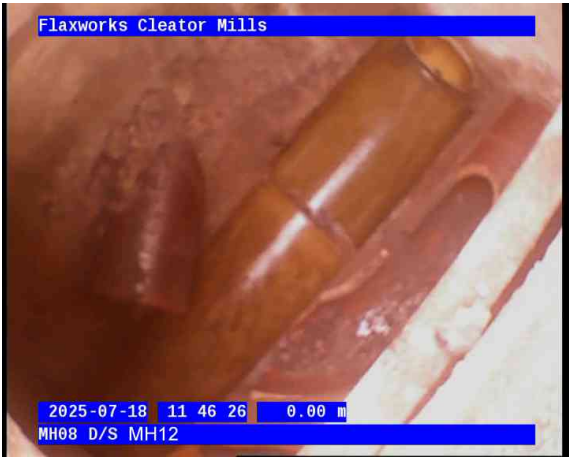
MH08-MH12-21-08-2025-013.png, 00:00:00, 0.00 m  
Start node, manhole, reference: MH08

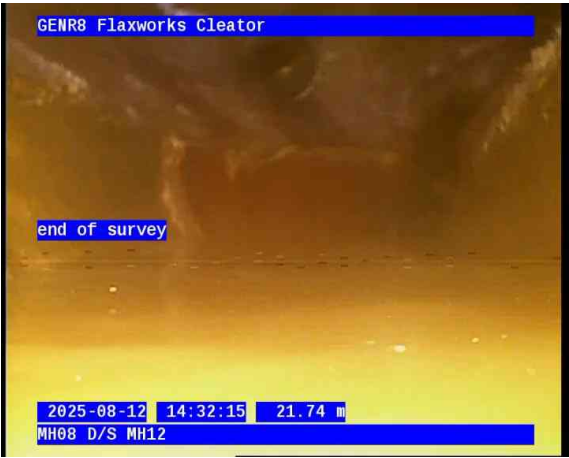
MH08-MH12-21-08-2025-014.jpg, 00:06:53, 21.74 m  
Finish node, manhole, reference: MH12, end of survey

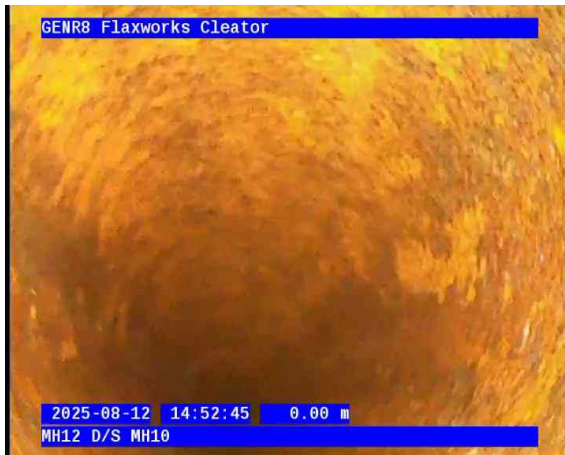
MH12-MH10-13-08-2025-015.jpg, 00:00:00, 0.00 m  
Start node, manhole, reference: MH12

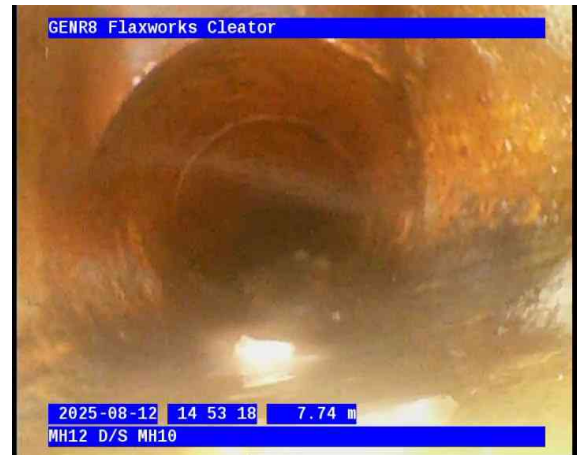
MH12-MH10-13-08-2025-016.jpg, 00:00:43, 7.74 m  
Junction at 3 o'clock, 150mm dia

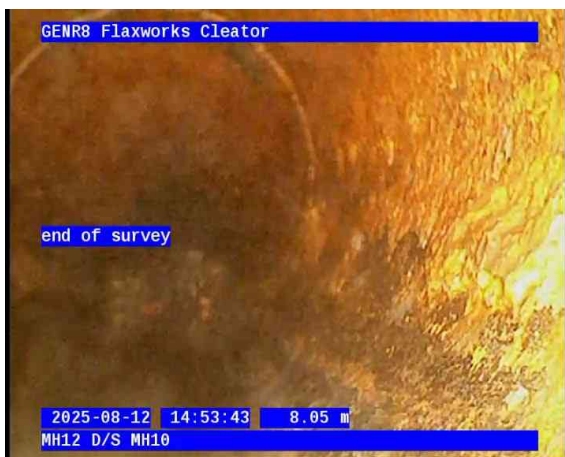
MH12-MH10-13-08-2025-017.jpg, 00:00:58, 8.05 m  
Finish node, manhole, reference: MH10, end of survey

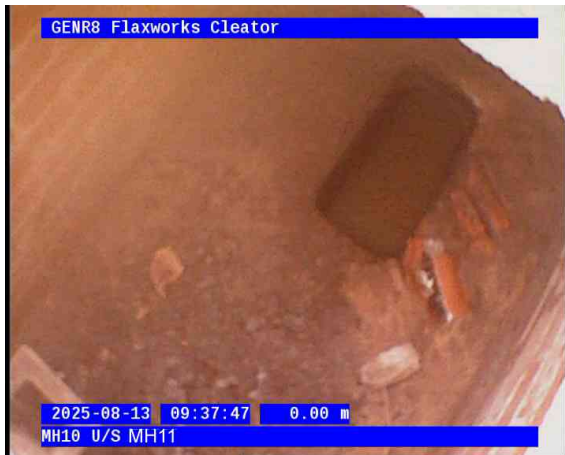
MH10-MH11-02-10-2025-018.png, 00:00:00, 0.00 m  
Start node, manhole, reference: MH10

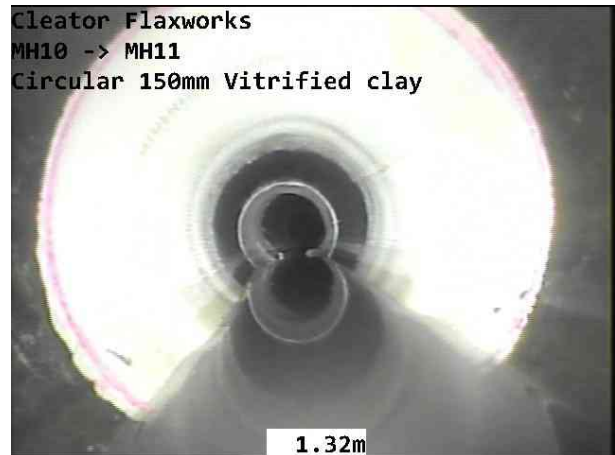
MH10-MH11-02-10-2025-019.jpg, 00:00:29, 1.32 m  
Pipe material changes to epoxy at this point, patch liner

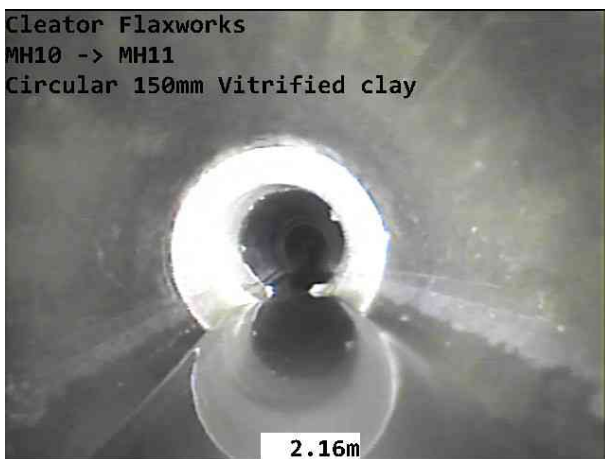
MH10-MH11-02-10-2025-020.jpg, 00:00:36, 2.16 m  
Pipe material changes to vitrified clay at this point

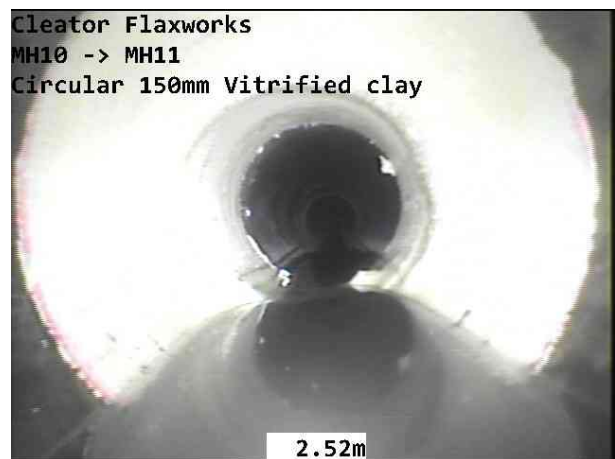
MH10-MH11-02-10-2025-021.jpg, 00:00:40, 2.52 m  
Pipe material changes to epoxy at this point, patch liner

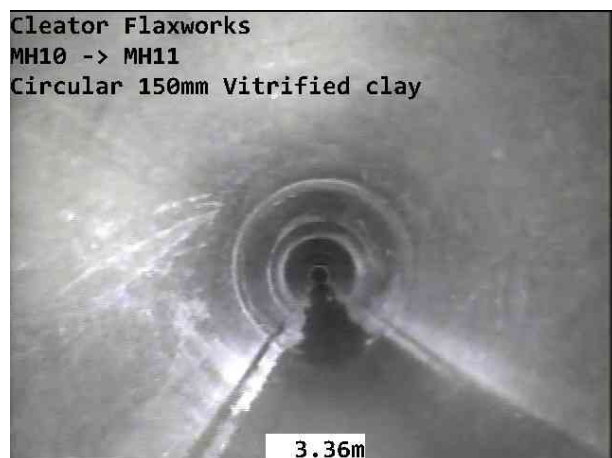
MH10-MH11-02-10-2025-022.jpg, 00:00:48, 3.38 m  
 Pipe material changes to vitrified clay at this point

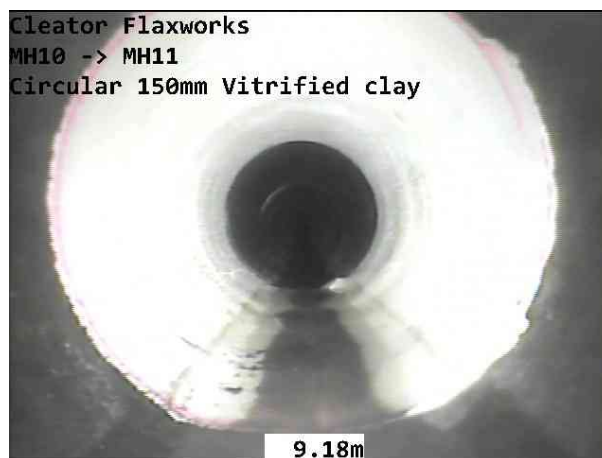
MH10-MH11-02-10-2025-023.jpg, 00:01:49, 9.18 m  
 Pipe material changes to epoxy at this point, patch liner

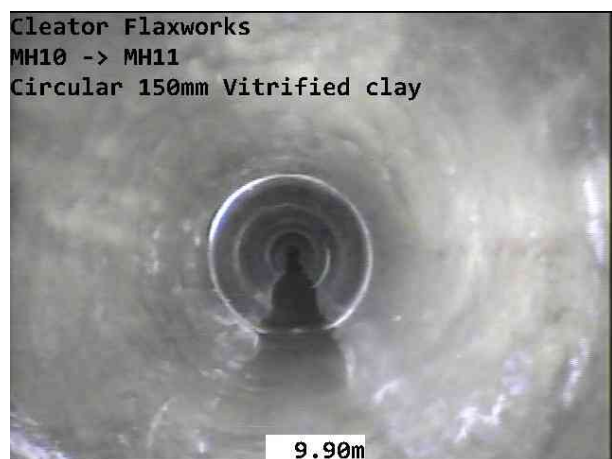
MH10-MH11-02-10-2025-024.jpg, 00:01:57, 9.90 m  
 Pipe material changes to vitrified clay at this point

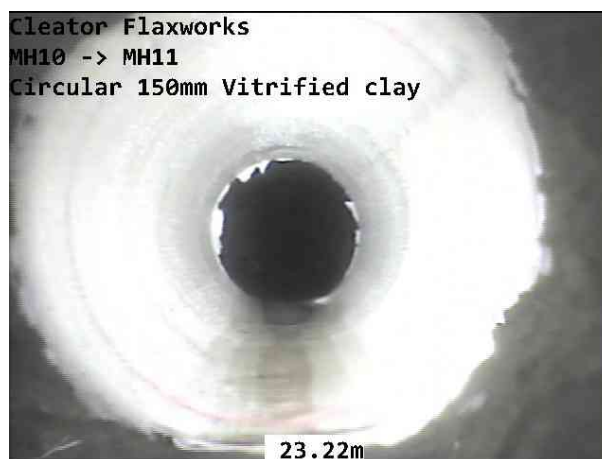
MH10-MH11-02-10-2025-025.jpg, 00:04:10, 23.22 m  
 Pipe material changes to epoxy at this point, patch liner

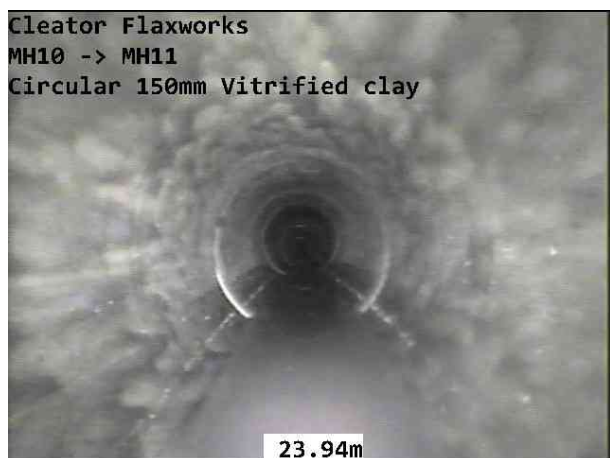
MH10-MH11-02-10-2025-026.jpg, 00:04:17, 23.94 m  
 Pipe material changes to vitrified clay at this point

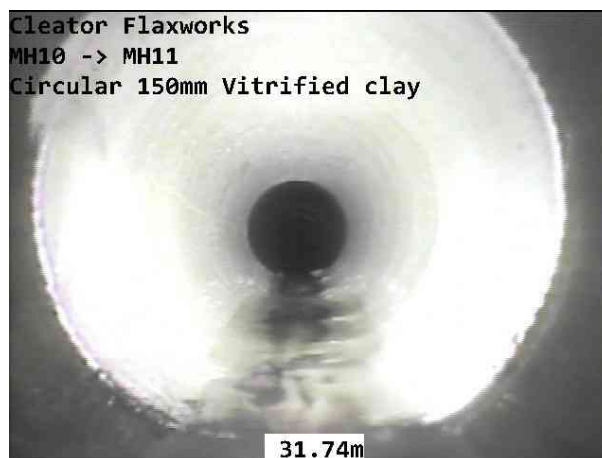
MH10-MH11-02-10-2025-027.jpg, 00:05:41, 31.74 m  
 Pipe material changes to epoxy at this point, patch liner

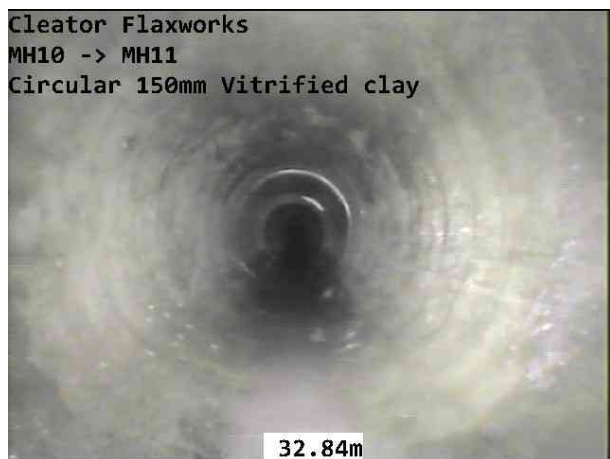
MH10-MH11-02-10-2025-028.jpg, 00:05:53, 32.84 m  
 Pipe material changes to vitrified clay at this point

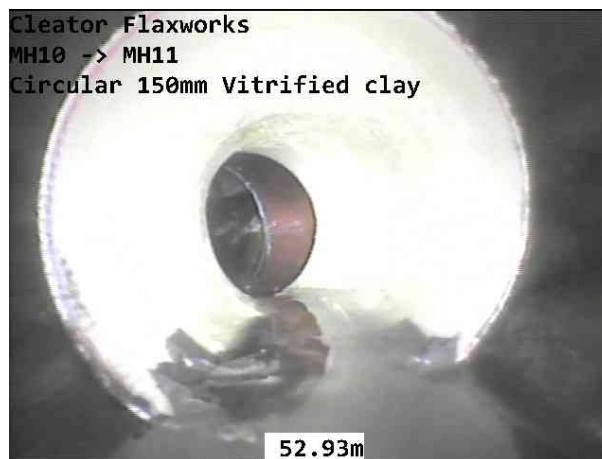
MH10-MH11-02-10-2025-029.jpg, 00:09:47, 52.93 m  
 Pipe material changes to epoxy at this point, patch liner

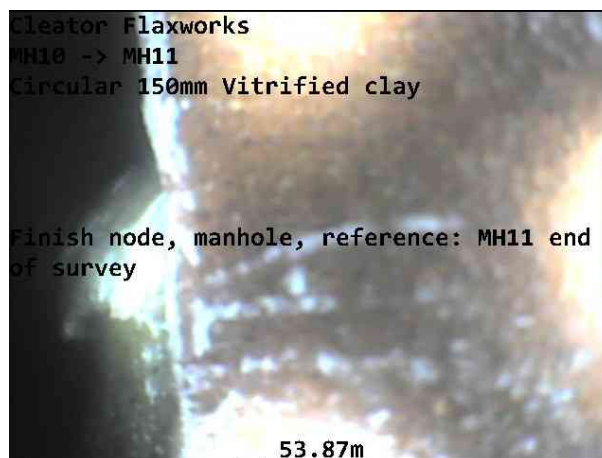
MH10-MH11-02-10-2025-031.jpg, 00:10:07, 53.87 m  
 Finish node, manhole, reference: MH11 - UU 9602, end of survey
