TREE RETAINED PLAN

Project Motor home and log cabin site with shop.

Client Mr & Mrs Usher. Partfield Park, Drigg.

DRAWING TYPE. PLANNING CONDITIONS (PC)	DRWG No. USH.CS.1222. PL.LDSCP3				
DATE 25.10.24	REV 0				
SCALE A1 1:200

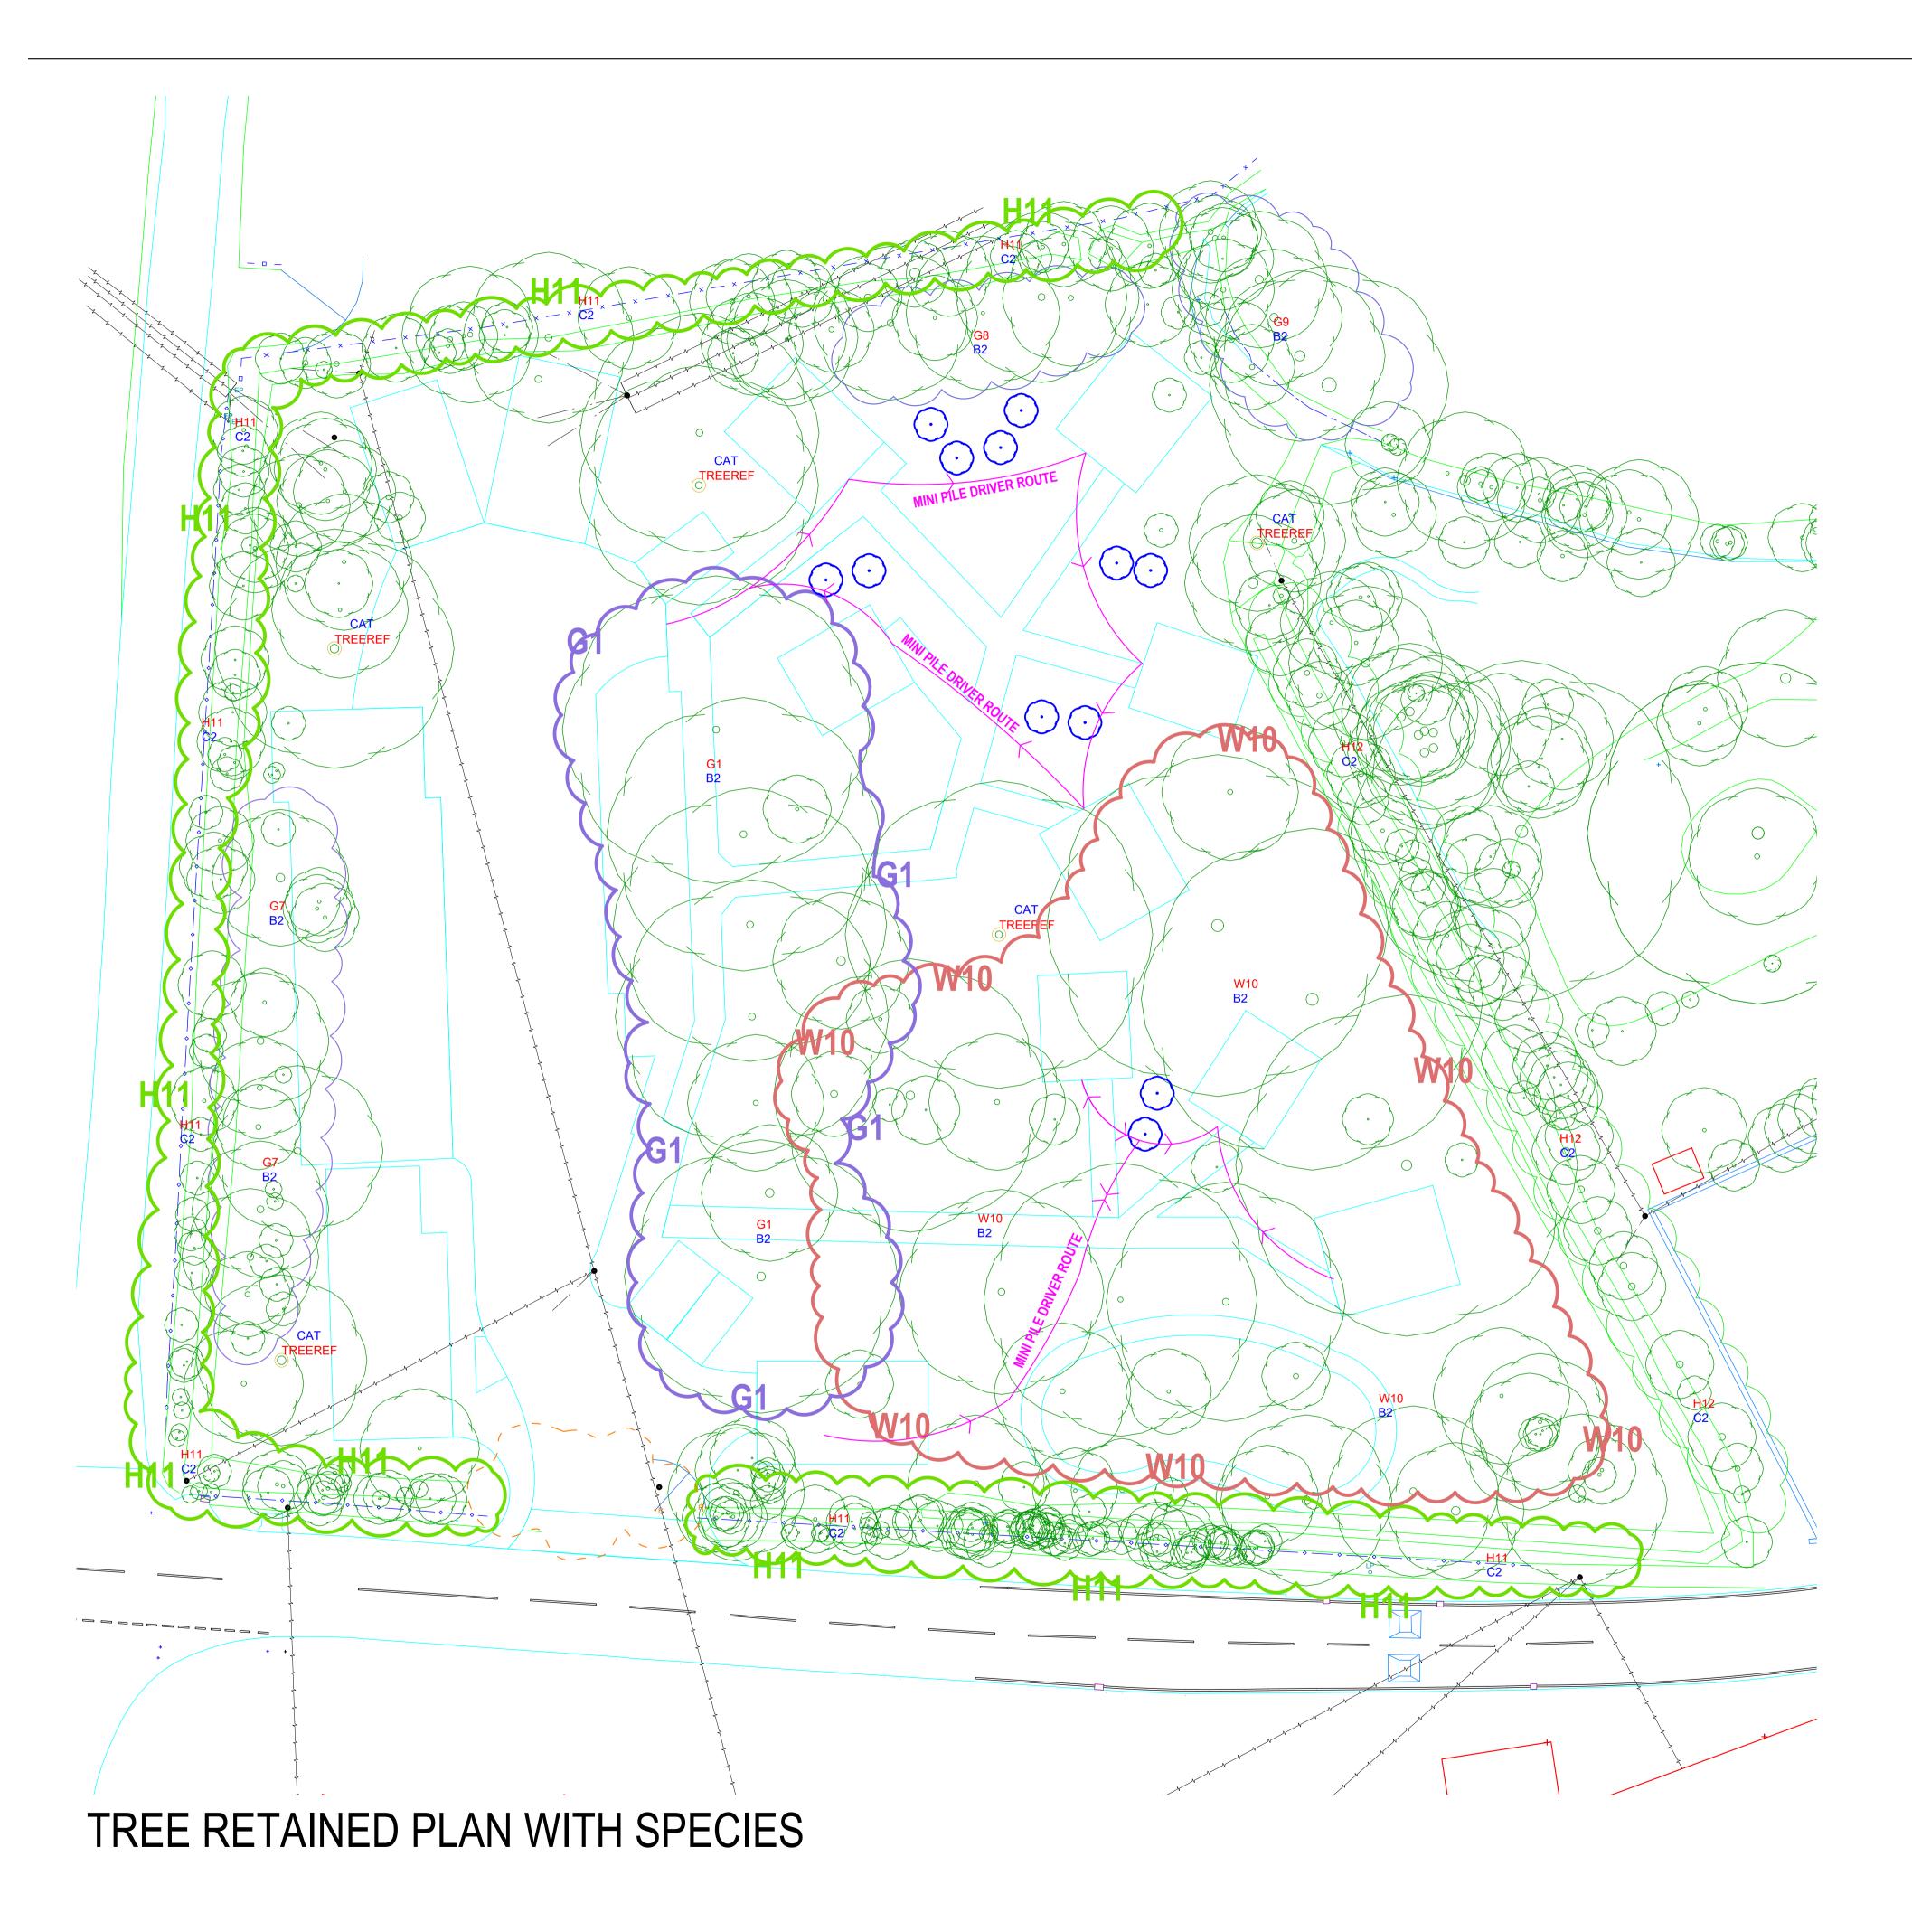
Tree No.	Species	H'gt.	Stem Dia.		ranch pread	H'gt of C.C.	1st Branch @	Age Class	PC	Structural Condition	Preliminary Management Recommendations	ERC	Cat Grade	RPA Sq.m's	RPA Circle Radii m's
G1	Predominantly Limes	14	750	N E S W	7 avg.	4		М	F	Linear group. Frequently multi stemmed presumably from historic coppicing. Have been recently crown lifted. Reasonable vitality. Minor dead wood and old branch stumps all typical of species.	No action at present. Monitor	20	B2	254.50	9
T2	Ash	15	750	N E S W	6.5 avg	6		м	F	Reasonable vitality. Minor dead wood and old branch stumps all typical of species. Hymenoscyphus fraxineus - Ash Die Back Disease present within local environment - life expectancy must be considered as limited.	No action at present. Monitor	10	C2	254.50	9
T3	Cherry	10	650	N E S W	6.5 avg.	3		м	F	Reasonable vitality. Minor dead wood and old branch stumps all typical of species. Smaller specimens in close proximity - all suppressed.	No action at present. Monitor	10+	C2	191.16	7.8

T4	Black Pine	16	550	N E S W	5avg.	5		м	Б	Reasonable vitality. Minor dead wood and old branch stumps all typical of species. Part of linear group but stands as specimen.	No action at present. Monitor	20	B2	13 <mark>6</mark> .87	6.
Т5	Pine	14	500	N E S W	5 avg.	4.5		м	F	Reasonable vitality. Minor dead wood and old branch stumps all typical of species. Part of linear group but more dominant specimen. See G7.	See G7.	20	B2	113.11	6
T6	Lawson	14	625	N E S W	4.5 avg.	3.5		М	F	Non native specimens. Some screening value and possible ecological value due to evergreen habit. Over head lines in close proximity.	May require pruning to affords acceptable clearances to o/h lines.	10	C2	176.74	7.
G7	Pines	13	500	N E S W	4 avg.	4.5		М	F	Linear group to western boundary. Drainage ditch - unmanaged in close proximity and some tree failures possibly due to waterlogged soils. Manageable.	If possible improve condition of drainage ditch to reduce waterlogging of soils and assist in retaining stability of trees present. Monitor.	20	B2	113.11	6

G8	Oak	10	350	N E S W	5 avg.	3		м	F	Random linear group to northern boundary. Generally decurrent forms but reasonable vitality. Useful boundary feature / screen.	No action at present. Monitor	20	B2	55.42	4.
G9	Sycamore	12	400	N E S W	6.5 avg.	4		М	F	Situated on top of banking. Multi stemmed habit all indicative of historic coppicing. Reasonable vitality. Ownership unclear. Interesting stone Ha Ha type wall below.	No action at present. Monitor	20	B2	72.39	4
W10	Mixed species.	16	500	N E S W	5 avg.	4		EM/M	F	Random species selection including Eucalyptus, Cedar and Evergreen Oak. Presumably planted simply for amenity to property. Tight spacings and species selection has resulted in some poor establishment but has been recently managed / opened up and increase light availability may encourage further development.	No action at present. Monitor	20+	B2	113.11	6
111	Mixed species.	10	300	N E S W	3.5 avg.	3		м	F	Hedgerow to northern, western and southern boundary. Random species selection with some non native coniferous material. Has been historically managed in past with some sections possibly having been layered. Ummanaged in recent times but readily reclaimable with items present that can be left as "standards" within hedge line for amenity.	Manage to achieve required site objectives. Can be flail cut to required height to maximise screening and density or layed (preferably) o maximise both screening and security. Retain any desirable "standards" at reasonable spacings for visual amenity and traditional effect.	20	C2	40.72	3

H12	Predominantly Sycamore.	11	400	N E S W	4 avg.	.4		м	F	Coppice type material to top of banking to far side of drainage ditch. Reasonable vitality. Minor dead wood and old branch stumps all typical of species. Can be managed in whichever way is required to maintain screening to boundary.	No action at present. Monitor	20	C2	72.39	4
