VISUAL STRUCTURAL INSPECTION

**BARNS ADJACENT TO
MOWBRAY FARM
FRIZINGTON
CUMBRIA**

RC CIVILS

Reference - WDS/05/9202/REP01

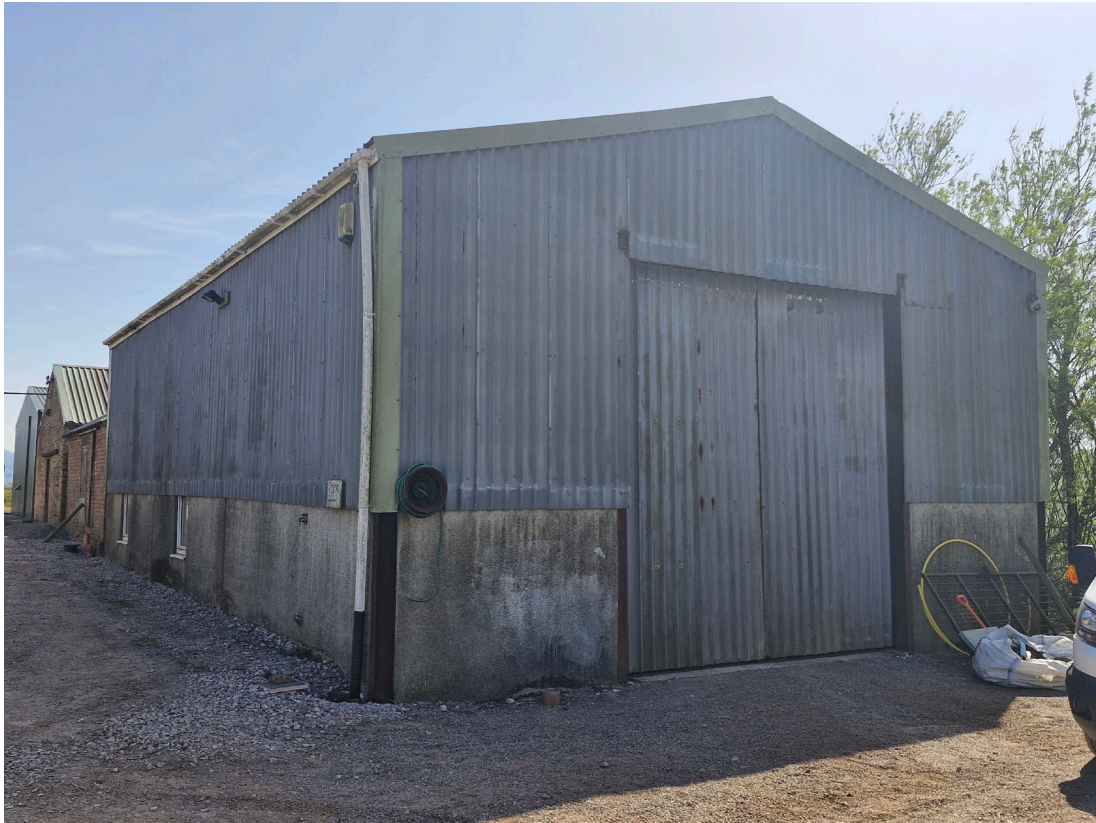
- 2.1** Barn 1 and 5 steel frames have some surface rust throughout however this has not compromised the structural integrity of the buildings. The frames appear structurally suitable and do not show any signs of distress or excessive deflection that would affect its conversion. The proposed conversion works will be sympathetic to the existing structure and will not apply any additional loading to the existing frames.

PHOTO 01 VIEW ON BARN 1 FRONT ELEVATION

- 3.1** Barn 1 and 5 are structurally adequate in their current form and it is proposed to convert the buildings sympathetically to the existing structures. We propose a new masonry and timber framed structure is built internally around the frame to allow the frame to be retained whilst relieving loading off the steel frame and thus not compromising the existing barn structure. The steel frame will need cleaned down and painted with a rust inhibiting paint.

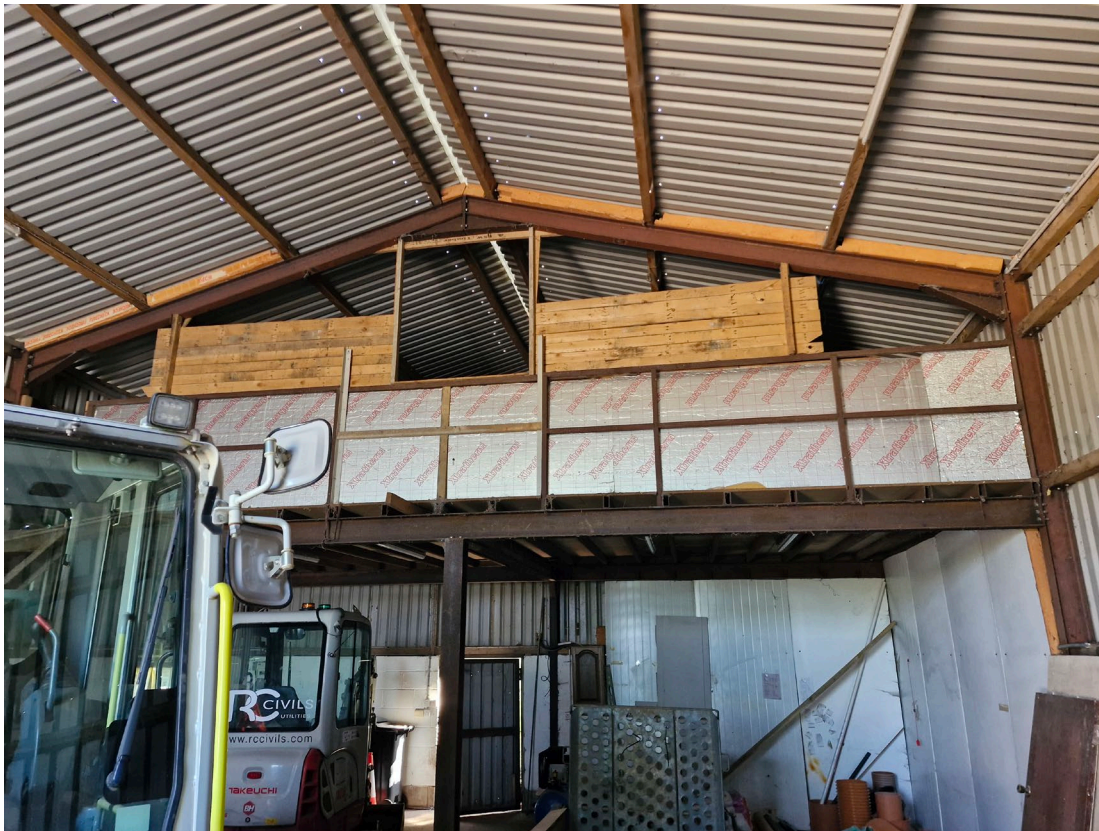
PHOTO 02 INTERNAL VIEW BARN 1

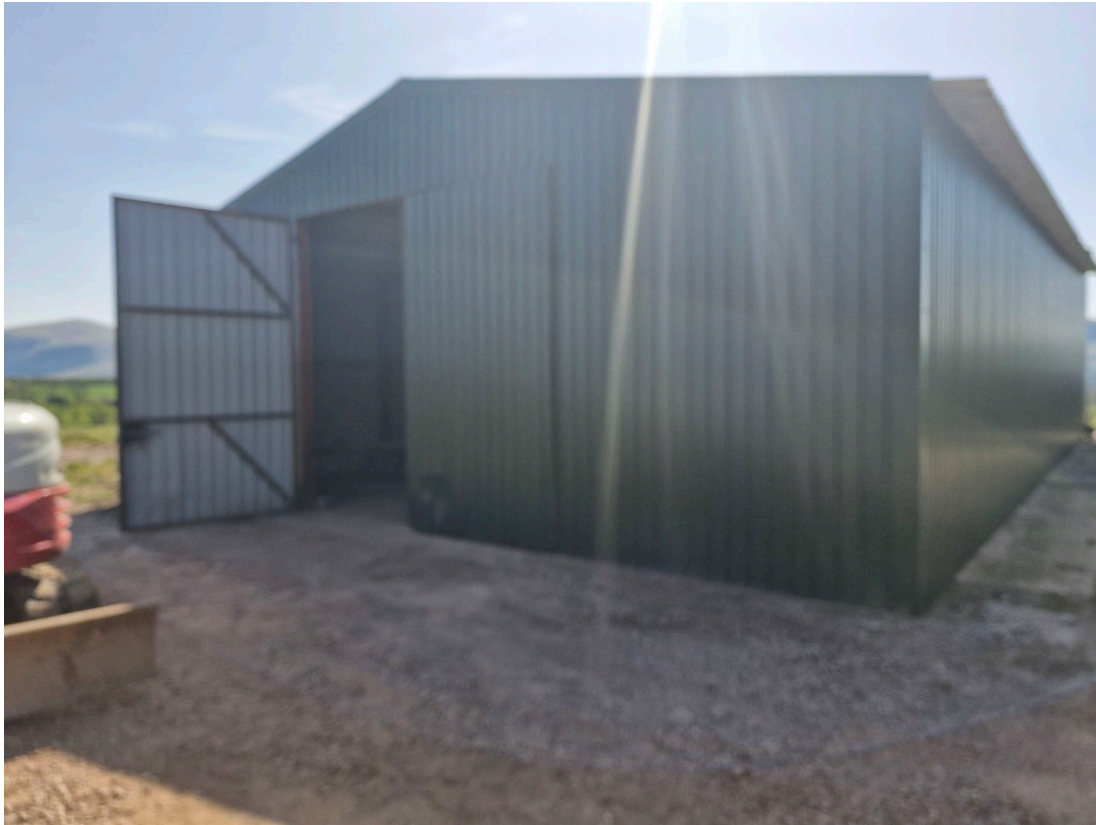
PHOTO 03 BARN 5 FRONT ELEVATION

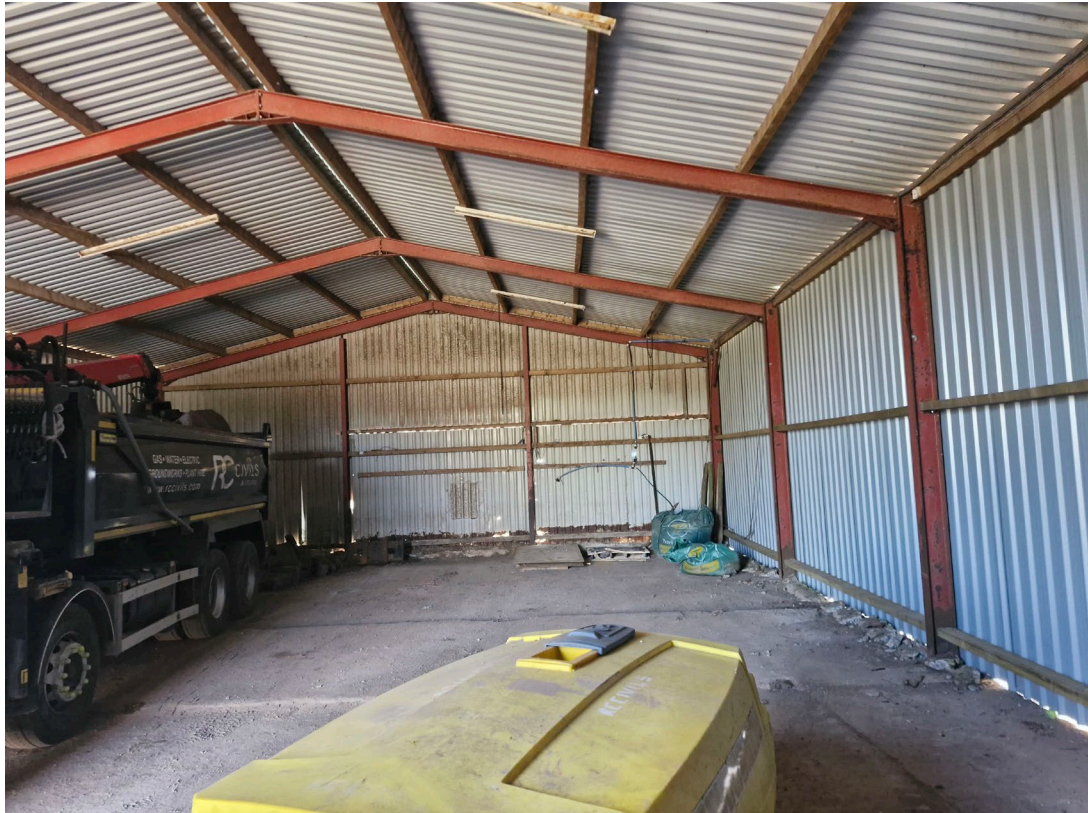
PHOTO 04 BARN 5 INTERNAL VIEW

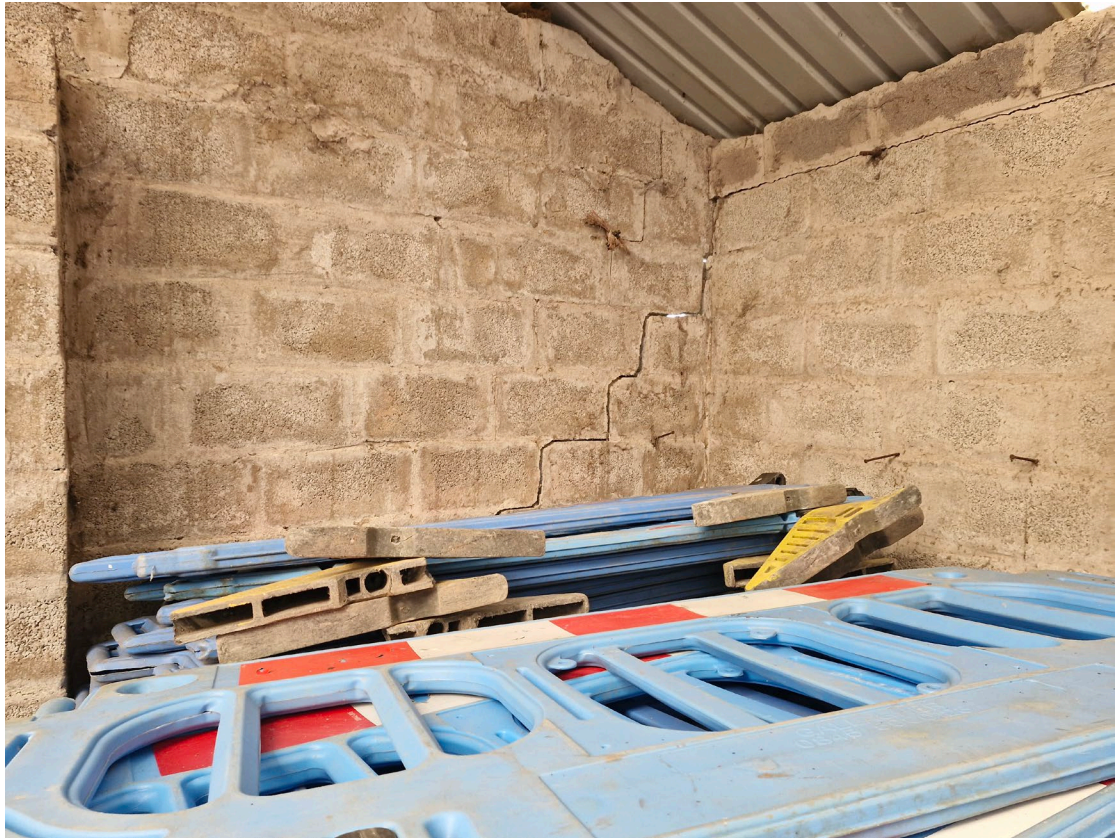
- 2.2** Barn 4 rear wall is cracked (see photograph 09 attached). The cracking is consistent with structural movement of the foundations. It appears that the building has been built on raised ground, the ground may have settled towards the rear extent. The steel roof trusses are excessively rusted and the purlins are structurally inadequate when considering a insulated boarded roof structure; the roof will need replaced as part of any conversion scheme.

PHOTO 09 CRACKING TO REAR WALL BARN 4

- 3.2** Barn 4 needs the rear wall underpinned and the cracking to the rear gable masonry wall tied. Depending on the foundation extent it may be more cost effective to rebuild the rear wall off a new foundation. The roof structure will need replaced as part of any conversion scheme. With the works noted completed the building will be suitable to be retained as part of a conversion scheme.

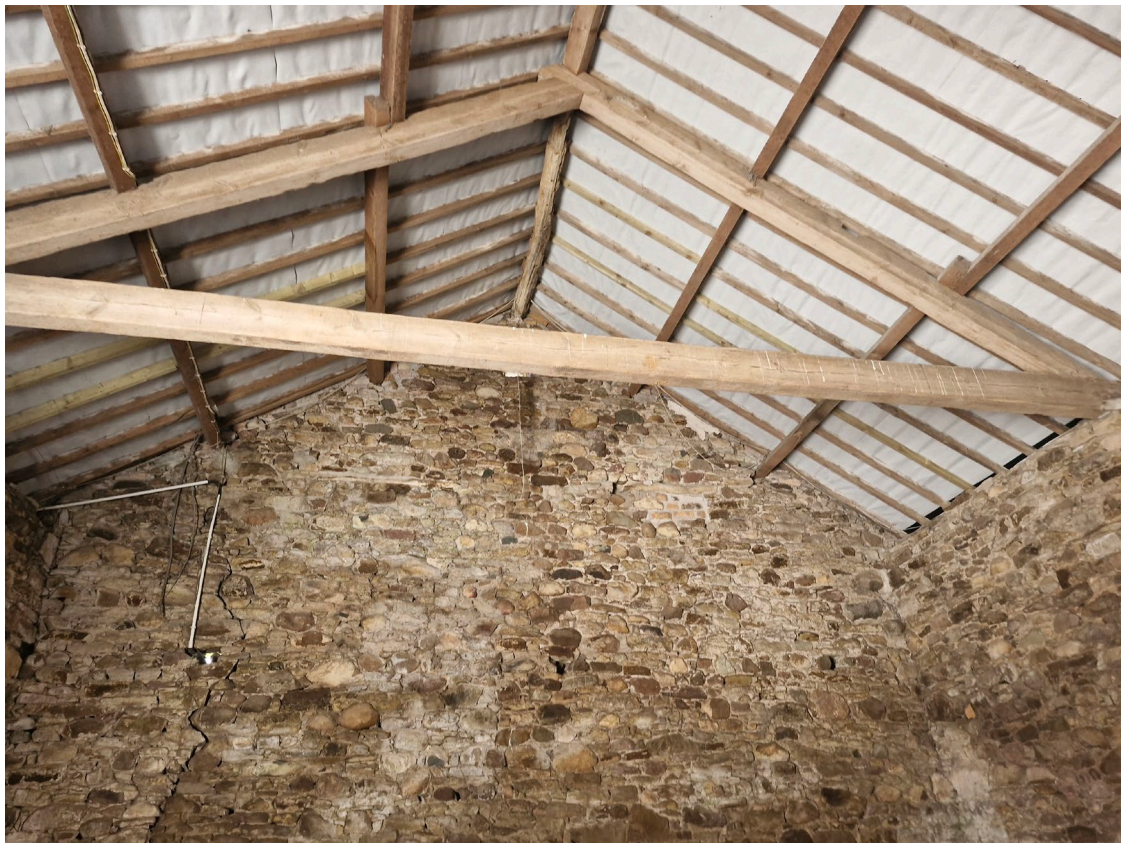
- 2.3** Barn 6 is generally in poor condition due to a lack of maintenance. The walls have numerous cracks and there a numerous rotten/woodworm infested inset timber lintels. The walls to the single storey extent are out of plumb especially to the front and left hand flank walls. There is evidence of separation cracking to the two storey extent gable wall although this appears due to historic movement. The roof structure to the single storey extent is in a poor condition and needs removed; the roof to the two storey extent is in a better condition and could be retained with some strengthening works. See photographs 10-11 attached.

PHOTO 10 BARN 6 INTENRAL VIEW TWO STOREY EXTENT

- The roof structures, if to be retained, will need inspected by a timber specialist to check for infestation and rot and treated accordingly. It is likely that only the main trusses will be structurally suitable to be retained as the rafters and purlins are not in accordance with current standards. Depending on the findings of the timber specialist the purlins may be strengthened, this will need checked by a structural Engineer as part of the building design phase

- The masonry corners to the rear two storey extent need retied as part of any conversion scheme. There are numerous areas of loose masonry which will need rebuilt/pointed. In addition, there are numerous masonry cracks which will need re-tied as part of the general building refurbishment works. The bowed walls may need some rebuild however we see this as less than 20 percent of the overall building wall extent.

- The timber lintels and inserts throughout the building will need replaced with precast concrete or steel sections to suit spans and loadings.
- We recommend that a trial hole is excavated at each corner of the barns to expose the base level of the wall such that the ground floor slab and insulation detail can be specified to ensure that undermining of the wall does not occur during construction.

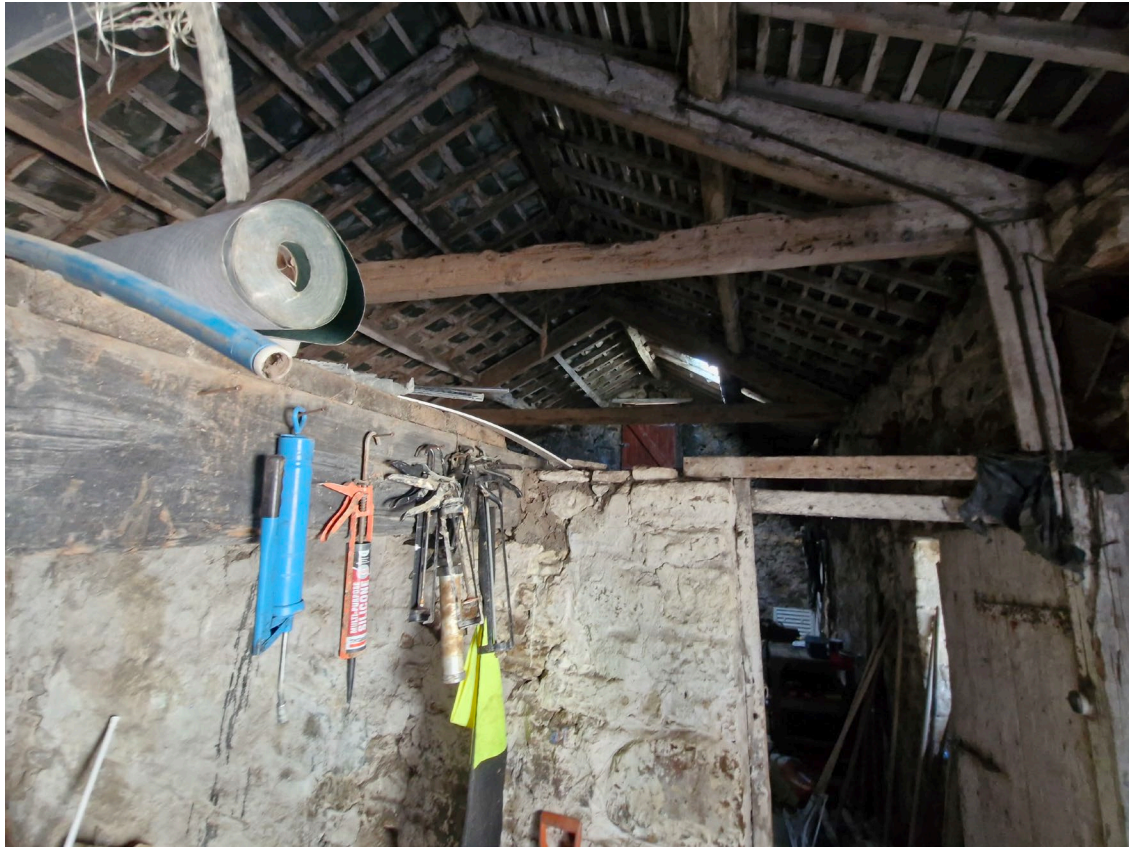
PHOTO 11 BARN 6 SINGLE STOREY ROOF STRUCTURE
