**WHINBARROW DESIGN  
SERVICES LIMITED**  
CIVIL & STRUCTURAL  
ENGINEERS

**VISUAL STRUCTURAL INSPECTION  
OF THE  
ATTACHED BARN  
WOODEND MILL  
WOODEND  
CLEATOR  
CUMBRIA**

**MR & MRS TOOMEY**

**Reference - WDS/05/9259/REP01**

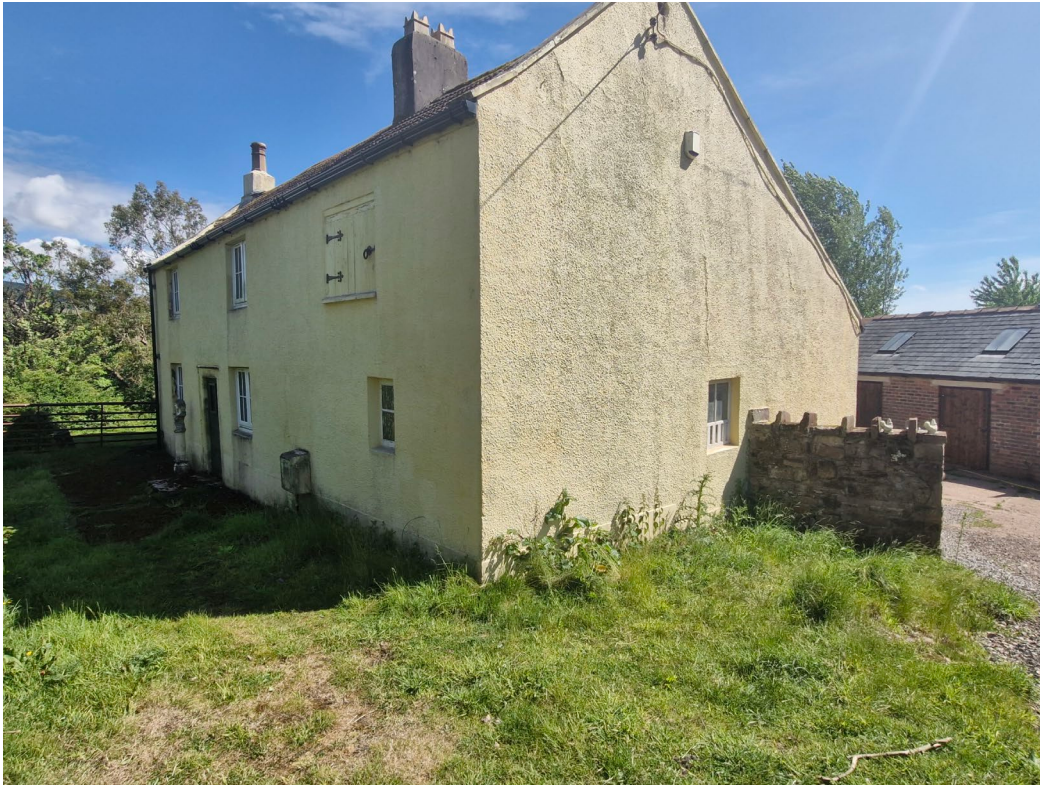
PHOTO 01 VIEW ON BARN BUILDING REAR & GABLE

- 2.1** The barn generally is in an adequate structural condition. The walls are slightly out of plumb, the gable has an outward bulge but this is not significant. There are a number of cracks apparent in the walls however these are longstanding and not due to any active movement. See photographs 01-03 attached.

- 3.1** The main barn walls generally are in need of refurbishment, this may require some local rebuilding works where the masonry is found to be loose, especially after removal of the existing render. The provision of a new first floor should offer enhanced lateral restraint to the building.
- 3.2** The timber lintels and inserts throughout the building will need replaced with precast concrete or steel sections to suit spans and loadings.
- 3.3** The roof structure, if to be retained, will need inspected by a timber specialist to check for infestation and rot and treated accordingly. It is likely that the rafters and purlins are not in accordance with current standards and we

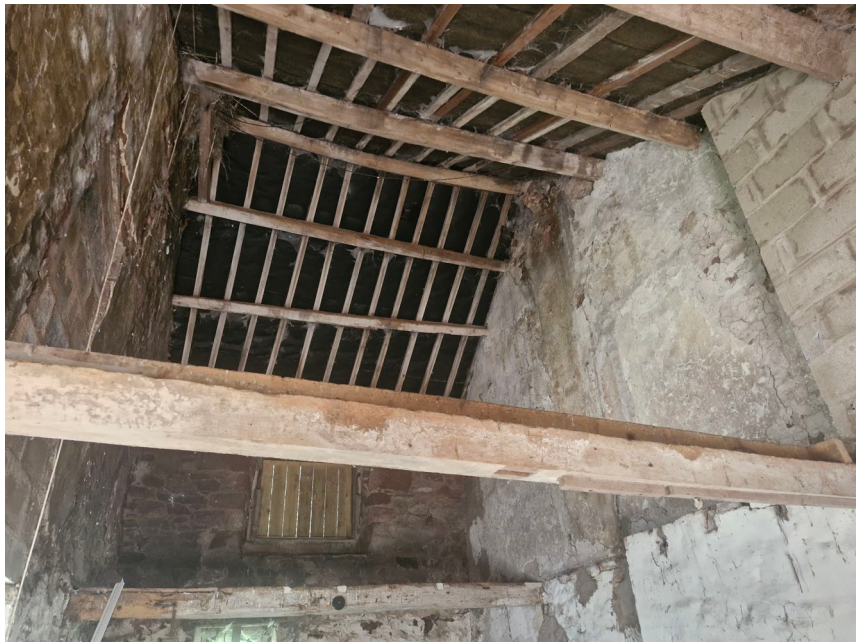
PHOTO 04 TYPICAL VIEW ON ROOF STRUCTURE AND FLOOR BEAM

- 2.2** The roof structure, if to be retained, will need inspected by a timber specialist to check for infestation/rot. The purlins are undersized to modern design standards and will need replaced or strengthened as part of the conversion works.. We understand that the first floor structure will be reinstated as part of the conversion works and hence no further comment will be made concerning the timber floor beams still in place, these will need removed. See photograph 04 attached.

therefore recommended that the barn is provided with a new roof structure throughout.
