**VISUAL STRUCTURAL INSPECTION  
OF THE  
BARN BUILDING  
ADJACENT TO  
ARLECDON FARM  
ARLECDON  
CUMBRIA**

**Reference - WDS/05/9333/REP01**

**Date - 22/07/2025**

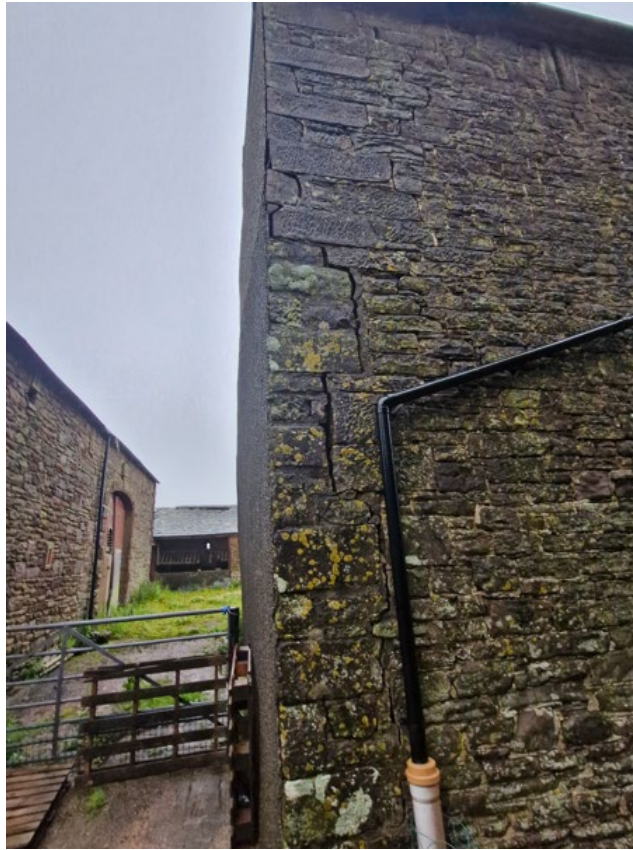
- 2.1 Generally the walls appear to be in an adequate structural condition. Externally the masonry is weathered and in need of pointing. There are some minor cracks apparent however these are due to historic movement. There are also a number of timber inserts and lintels which have been affected by infestation and rot and in need of replacement. The left hand gable wall has been subject to structural movement with a significant outward bow apparent.

Furthermore there is separation cracking at the front left hand corner caused by the movement to the gable. It appears that some remedial works have been carried out to the gable over the years including partial rebuilding in block however the gable is still excessively out of plumb. The gable is in need of demolition/rebuilding. See photograph 01 attached.

PHOTO 01 SIDE VIEW ON GABLE AND CRACKING

- 3.1 The left hand gable to the barn needs rebuilt from ground to roof line off a new foundation and fully built into the return front and rear walls. Elsewhere the walls are in an acceptable condition with no significant structural remedial works necessary. The provision of a refurbished roof structure and first floor will greatly enhance the lateral rigidity of the barn. As a minimum the walls need re-pointed and all timber inserts and lintels replaced with precast concrete elements. Any cracked masonry should be re-tied by inserting 750mm long Spanlite lintels into the wall across the crack location at 450mm

vertical centres. Alternatively where the stone masonry is to remain exposed Helifix Ltd's masonry crack stitching system can be adopted.

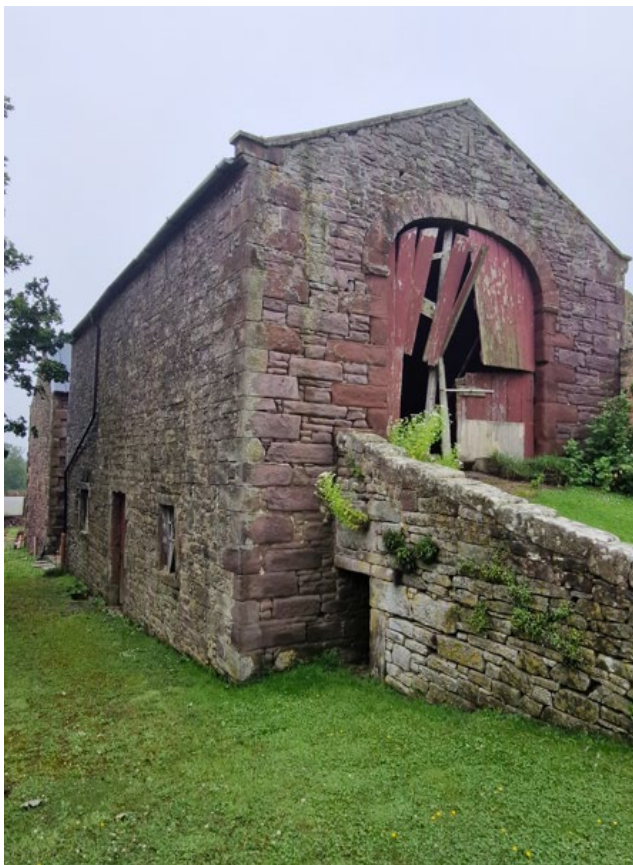
- 2.2 The retaining wall to the approach ramp leading to the entrance on the right hand gable is bowing outwards and has locally failed. See photograph 02 attached.

PHOTO 02 VIEW ON ACCESS RAMP RETAINING WALL

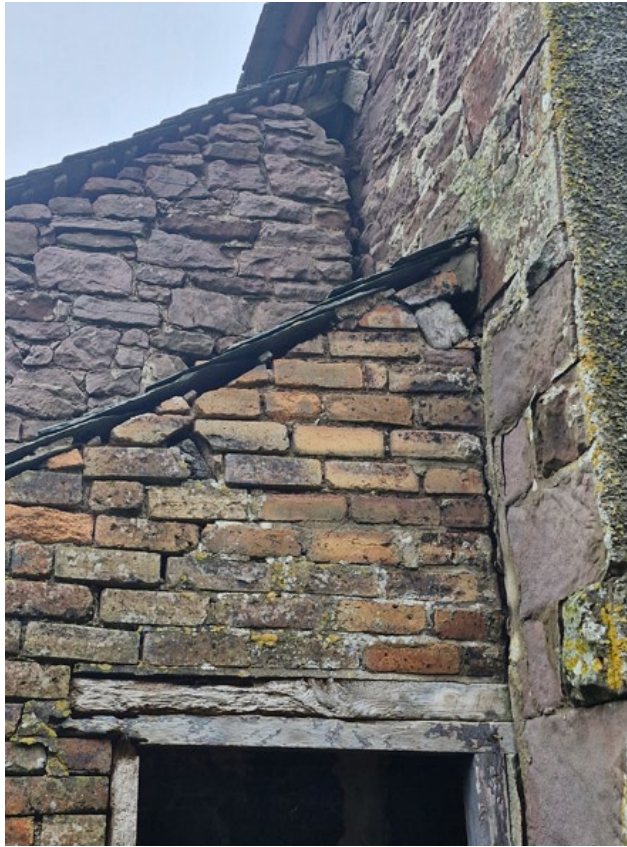
- 2.3 As noted the rear lean-to is to be demolished. These have rotated away from the main barn with significant separation cracking apparent between the extension and main barn walls. See photograph 03 attached.

PHOTO 03 REAR LEAN TO SEPARATION CACKS

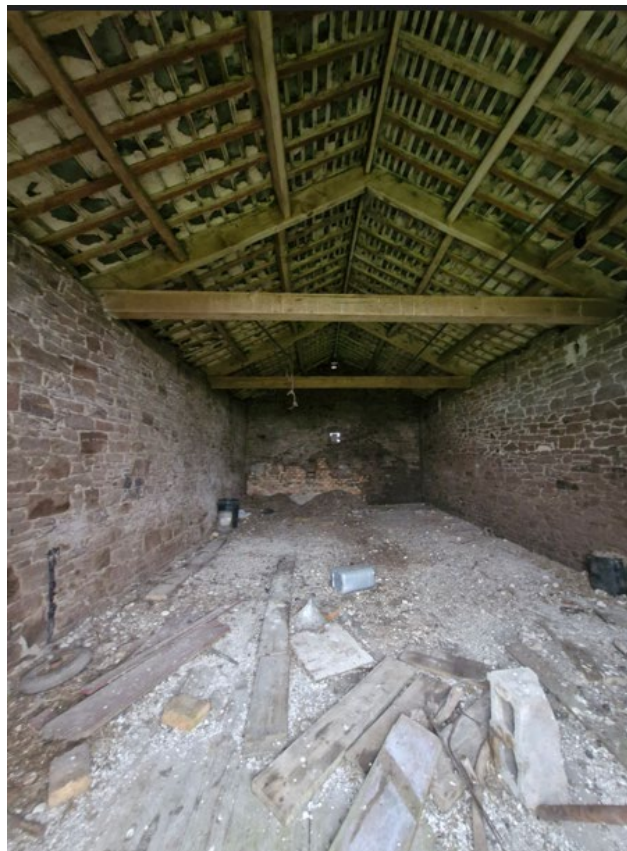
- 2.4 The roof structure is to be retained as part of the barn conversion. The roof appears adequate however the various timber elements to be retained will need inspected by a timber specialist to check for infestation and rot. Similarly a structural assessment of the elements will need made to current structural design standards where they will carry additional loading, this may dictate strengthening works. See photograph 04 attached.

PHOTO 04 VIEW ON ROOF STRUCTURE

- 3.2** The roof structure, if to be retained, will need inspected by a timber specialist to check for infestation and rot and treated accordingly. It is likely that the purlins will need strengthened as will the rafters to accommodate the additional loading associated with a new insulated roof build up.
- 3.3** If the access ramp off the right hand gable is to be retained then the bulged masonry flank wall will need locally rebuilt.
- 3.4** We recommend that a trial hole is excavated at each corner of the barn to expose the base level of the wall such that the ground floor slab and insulation detail can be specified to ensure that undermining of the wall does not occur during construction.
