**VISUAL STRUCTURAL INSPECTION
OF THE
BARN BUILDING
ATTACHED TO
ARLECDON FARM
ARLECDON
CUMBRIA**

Reference - WDS/05/9333/REP02

Date - 22/07/2025

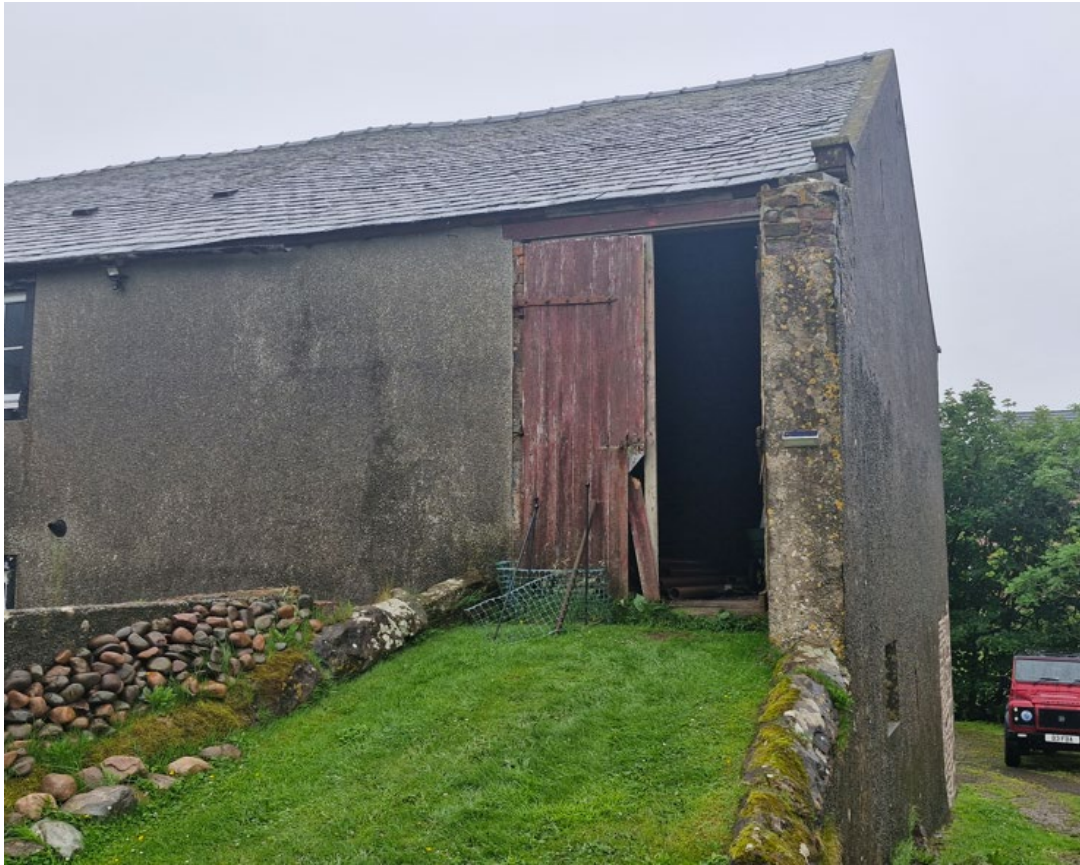
PHOTO 01 REAR ELEVATION AND RAMP

- 2.1 Generally the walls appear to be in an adequate structural condition. Externally the masonry has been rendered, the render is at the end of its life expectancy. There are some minor cracks apparent however these are due to historic movement. There are also a number of timber inserts and lintels which have been affected by infestation and rot and in need of replacement. The walls are slightly out of plumb but within acceptable limits. See photograph 01 attached.

- 2.2** The retaining wall to the approach ramp leading to the rear entrance is out of plumb. See photograph 01 attached.
- 2.3** The roof structure is to be retained as part of the barn conversion. The roof appears adequate however the various timber elements to be retained will need inspected by a timber specialist to check for infestation and rot. Similarly, a structural assessment of the elements will need made to current structural design standards where they will carry additional loading, this may dictate strengthening works. See photograph 02 attached.

- 3.1** The building walls are in an acceptable condition with no significant structural remedial works necessary. The provision of a refurbished roof structure and first floor will greatly enhance the lateral rigidity of the barn. As a minimum the walls need re-pointed/re-rendered and all timber inserts and lintels replaced with precast concrete elements. Any cracked masonry should be re-tied by inserting 750mm long Spanlite lintels into the wall across the crack location at 450mm vertical centres. Alternatively where the stone masonry is to remain exposed Helifix Ltd's masonry crack stitching system can be adopted.

- 3.3** If the access ramp off the rear elevation is to be retained then the side walls may need strengthened or rebuilt.
