**WHINBARROW DESIGN  
SERVICES LIMITED**  
CIVIL & STRUCTURAL  
ENGINEERS

**VISUAL STRUCTURAL INSPECTION  
OF THE  
BARN  
SNECKYEAT FARM  
WHITEHAVEN  
CUMBRIA**

**Reference - WDS/05/9222/REP01**

**Date - 07/05/2025**

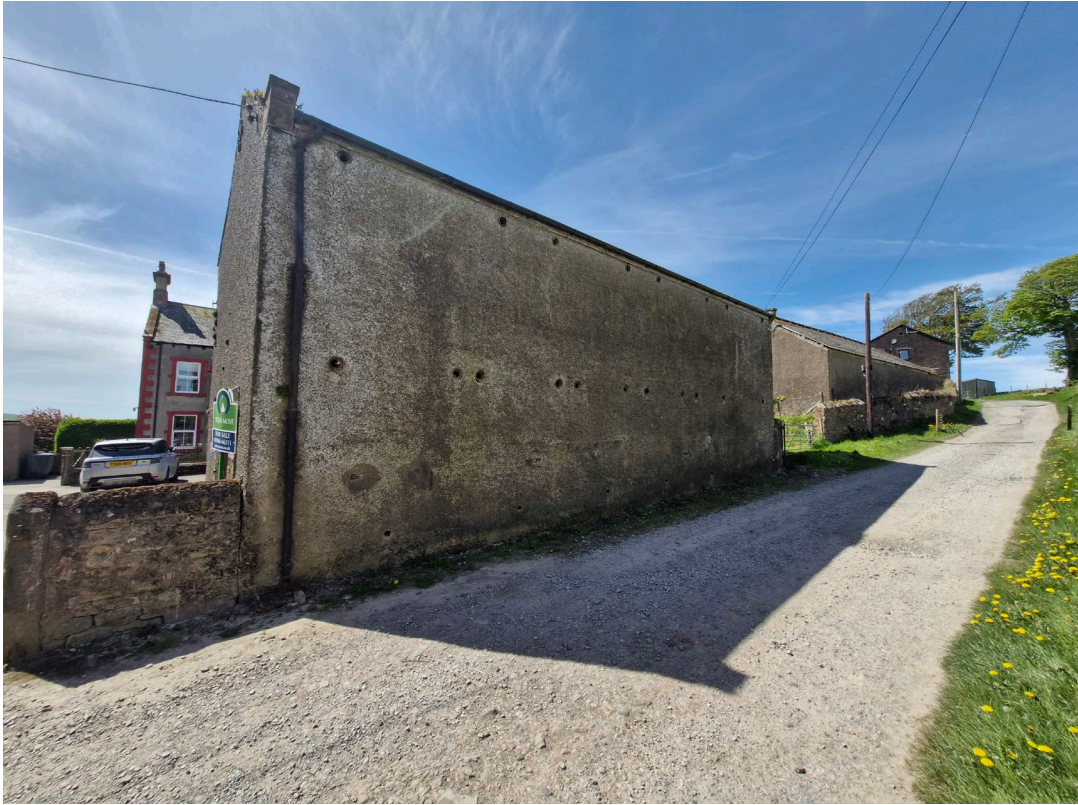
- 2.1** The barn generally is in an adequate structural condition. The walls are slightly out of plumb but within acceptable limits. Some cracking is apparent in the render finish however this appears historic. A number of the timber lintels have deteriorated and need replaced. The rear lean to extension is in a poor condition, this is a more modern construction but needs removed as part of any conversion scheme

PHOTO BARN FROM THE LANE

- 3.1** The main barn walls are generally structurally adequate but will need refurbished as part of any conversion scheme. This as a minimum should include re-rendering the external elevations and applying a scratch coat to the internal elevations to bond the masonry. Any cracks should be tied prior to re-rendering/plastering the walls. The provision of a new first floor should offer enhanced lateral restraint to the building. The lean to needs removed and should be replaced as part of the conversion scheme.

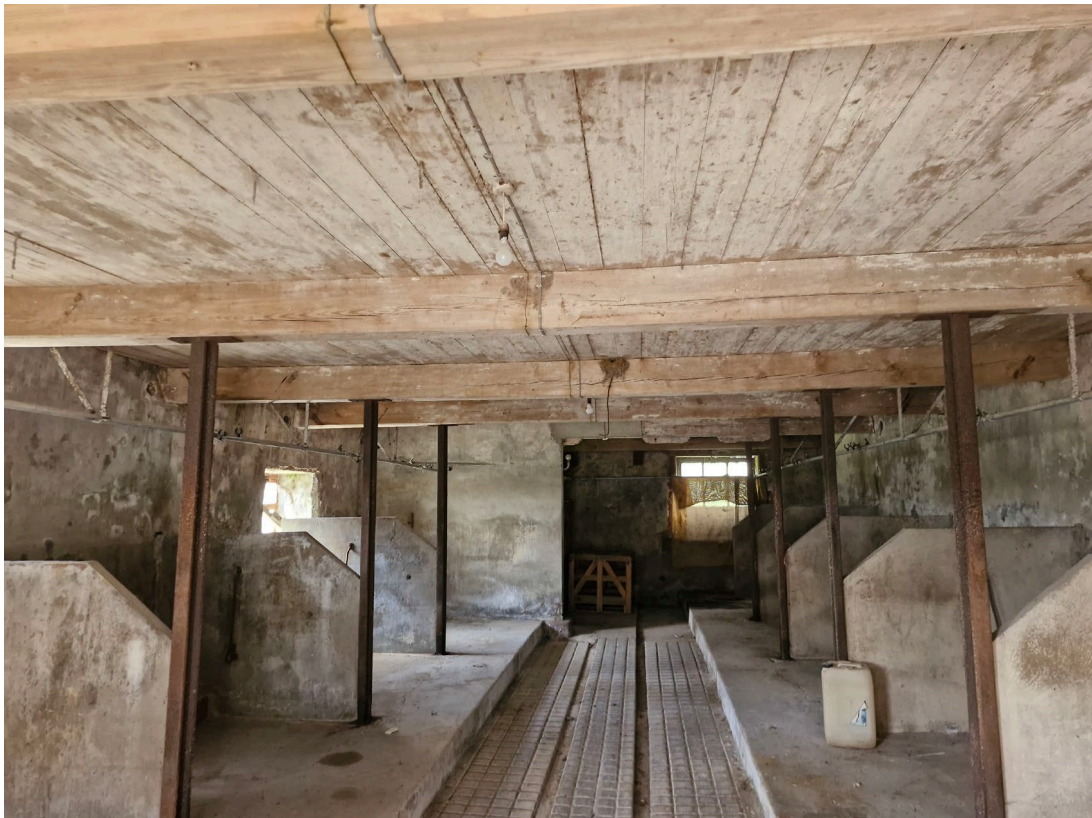
- 2.2** The roof structure, if to be retained, will need inspected by a timber specialist to check for infestation/rot. The purlins are undersized to modern design standards and will need replaced or strengthened as part of the conversion works. We understand that the first floor structure will be totally renewed as part of the conversion works and hence no further comment will be made in this report regarding its condition.

PHOTO 02 FIRST FLOOR STRUCTURE

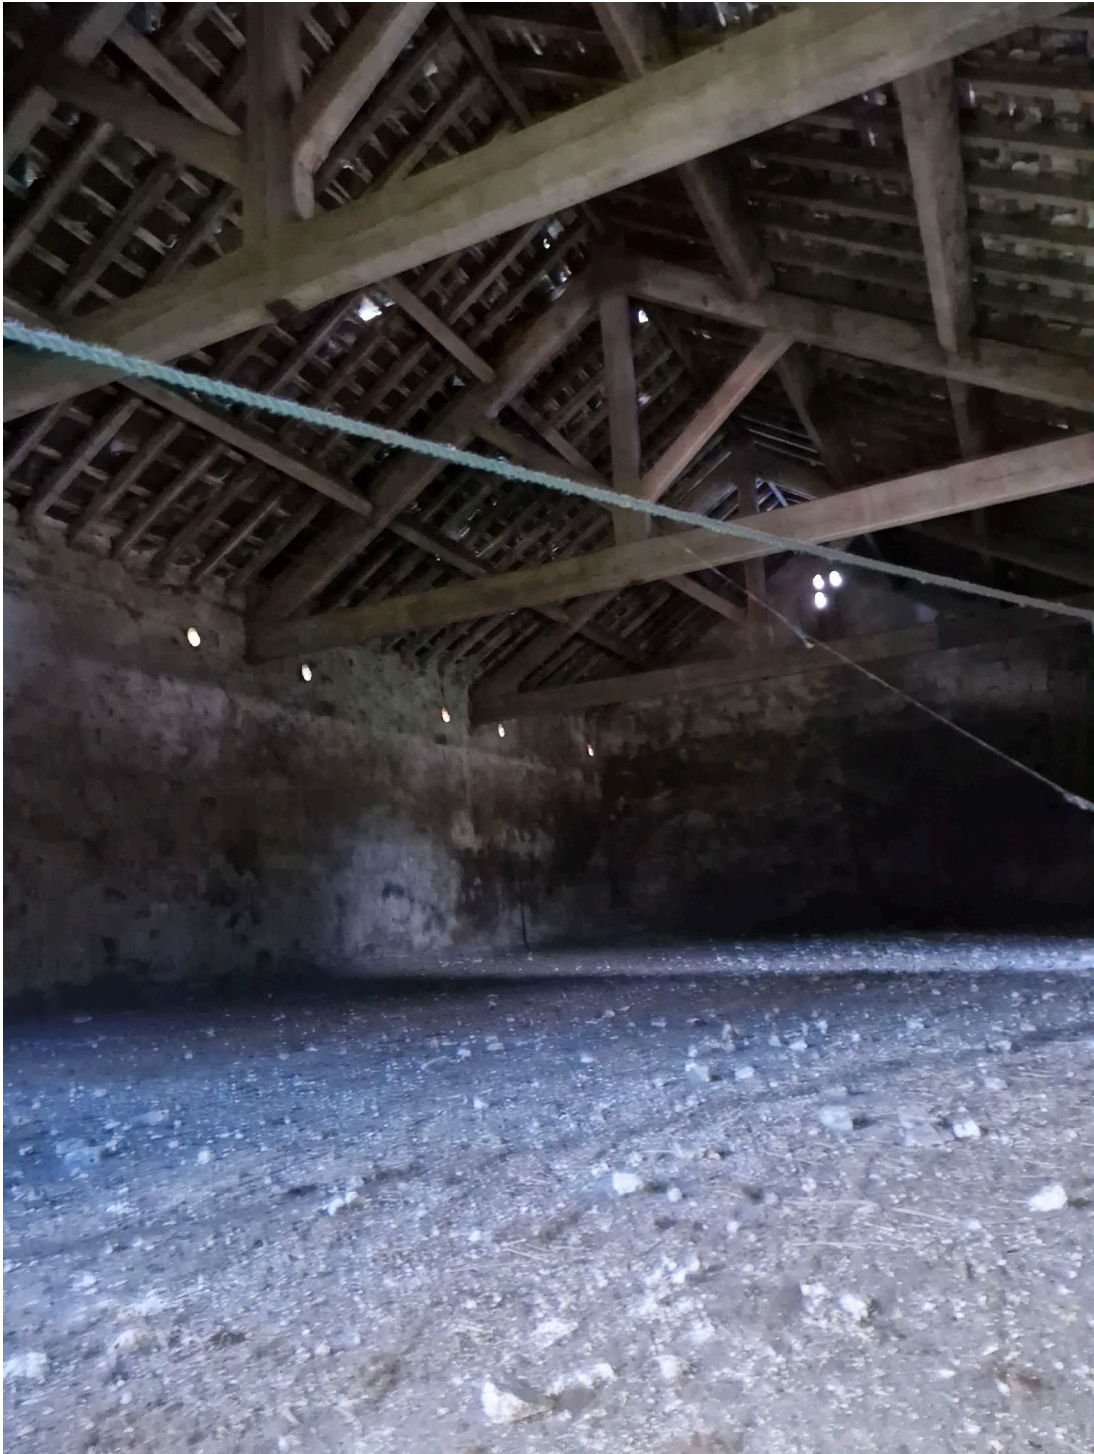
PHOTO 03 VIEW ON ROOF STRUCTURE

- 3.2** The timber lintels and inserts throughout the building will need replaced with precast concrete or steel sections to suit spans and loadings.
- 3.3** The roof structure, if to be retained, will need inspected by a timber specialist to check for infestation and rot and treated accordingly. The purlins will need strengthened as will the rafters to accommodate the additional loading associated with a new insulated roof build up.
