**VISUAL STRUCTURAL INSPECTION**

**OUTBUILDINGS  
GREENMOORSIDE FARM  
BECKERMET  
CUMBRIA**

**AVISON YOUNG**

**Reference - WDS/05/9858/REP01**

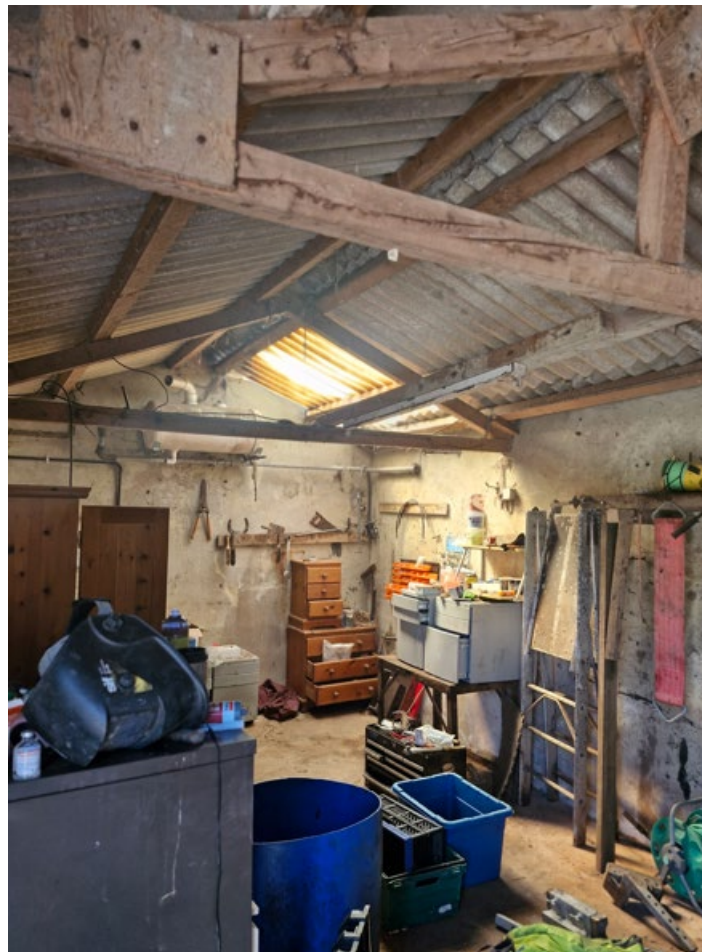
- 2.1** The random stone masonry building (outlined in blue on Fig 1) is in an adequate condition. The walls are slightly out of plumb and in need of repointing with historic cracking apparent to all elevations. The timber rafter, purlins and truss roof structure has been affected by woodworm and has suffered from creep leading to a deflection on the roof finish. See photographs 01 and 02 attached. The lean to roof off the front of the building is at risk of collapse and needs replaced, see photograph 03 attached.
- 2.2** The masonry buildings off the left hand gable of the building noted above are derelict, the roof has partially collapsed and the walls have suffered excessive movement. See photographs 04 and 05 attached.

PHOTO 02 VIEW INSIDE BLUE LINED BUILDING

**3.1** The front masonry building (outlined in blue on Figure 1) is in an adequate structural condition. The roof structure needs some strengthening works and some of the timbers will need replaced where loss of section is excessive. The roof trusses and purlins where sat into the walls need strapped down the walls using 1500mm long Bat straps. The walls need pointed and the cracks sealed to ensure the walls remain structurally adequate. The lean-to canopy roof to the front elevation needs replaced.

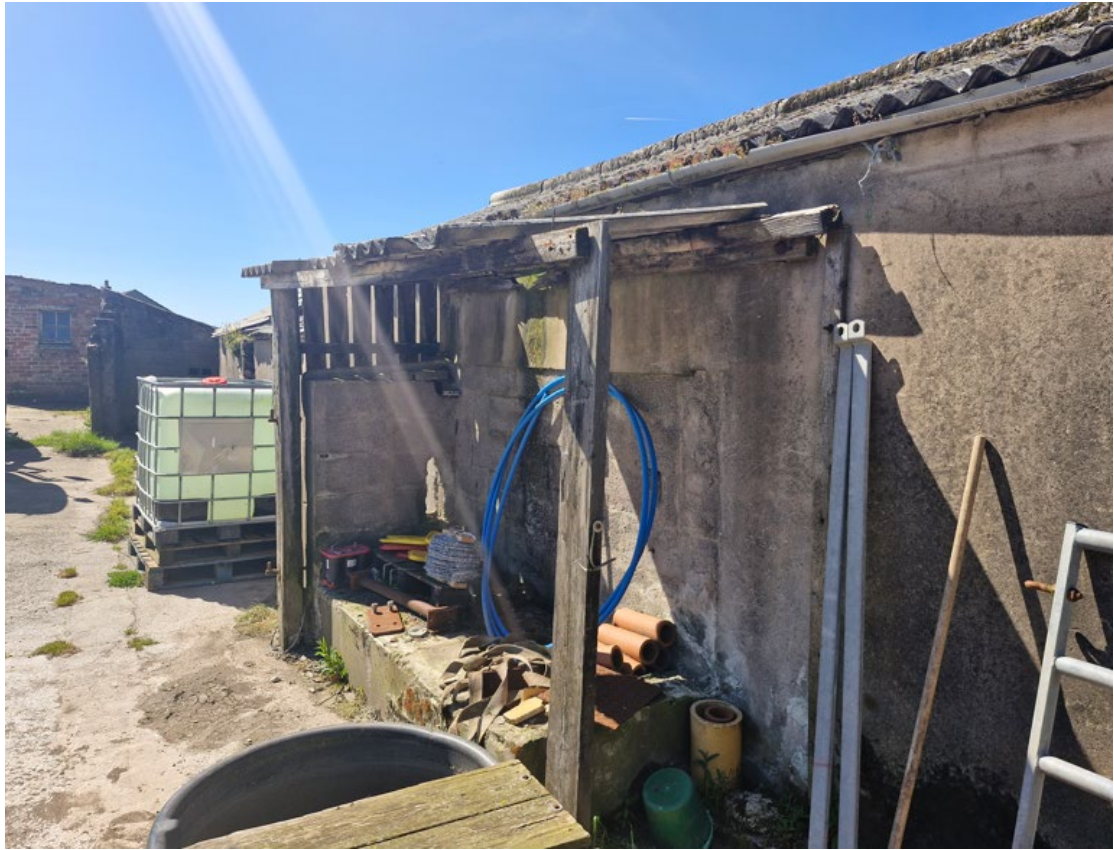
PHOTO 03 LEAN-TO CANOPY FRONT BUILDING

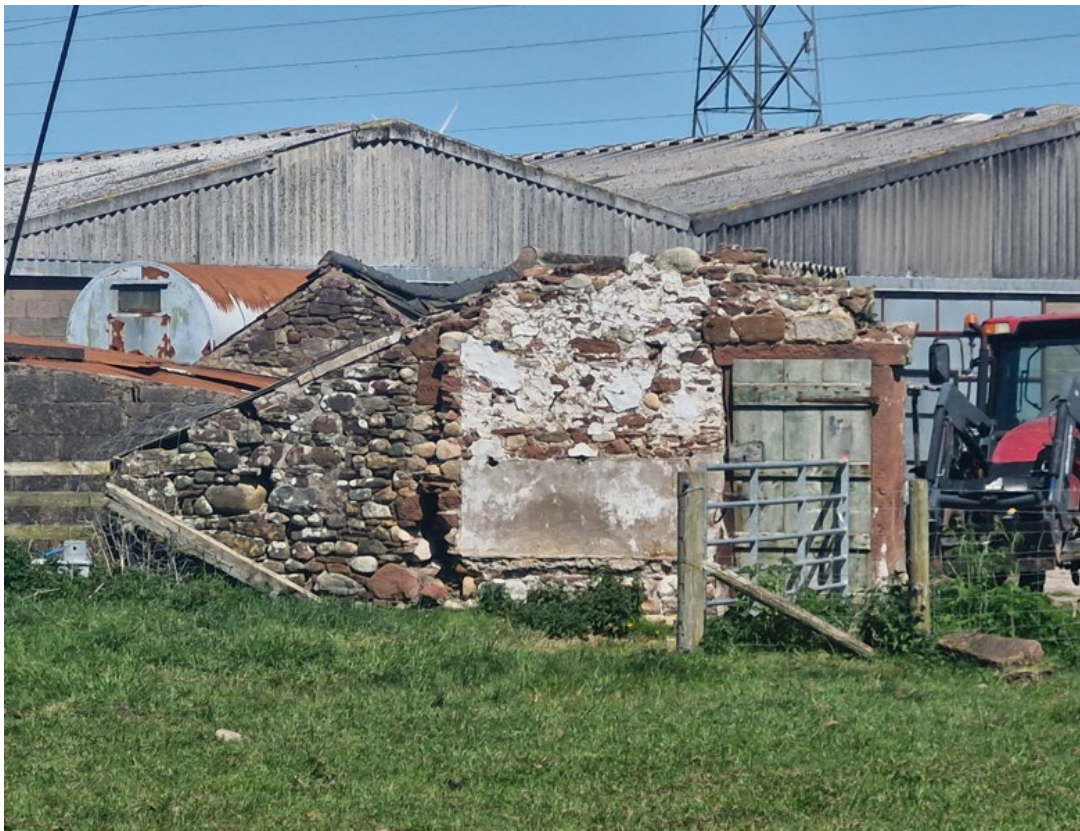
PHOTO 04 VIEW LEFT HAND MASONRY BUILDINGS

**3.2** All other buildings noted are beyond repair due to a lack of maintenance over many years combined with inadequate construction. Partial collapse has occurred to a number of the roofs and the rear timber portals are at risk of collapse during high wind or heavy snow conditions. We recommend that these buildings are demolished as soon as possible and should be cordoned off until removal has taken plac.. The removal of these buildings will not have an adverse effect on the building noted in 3.1 above.

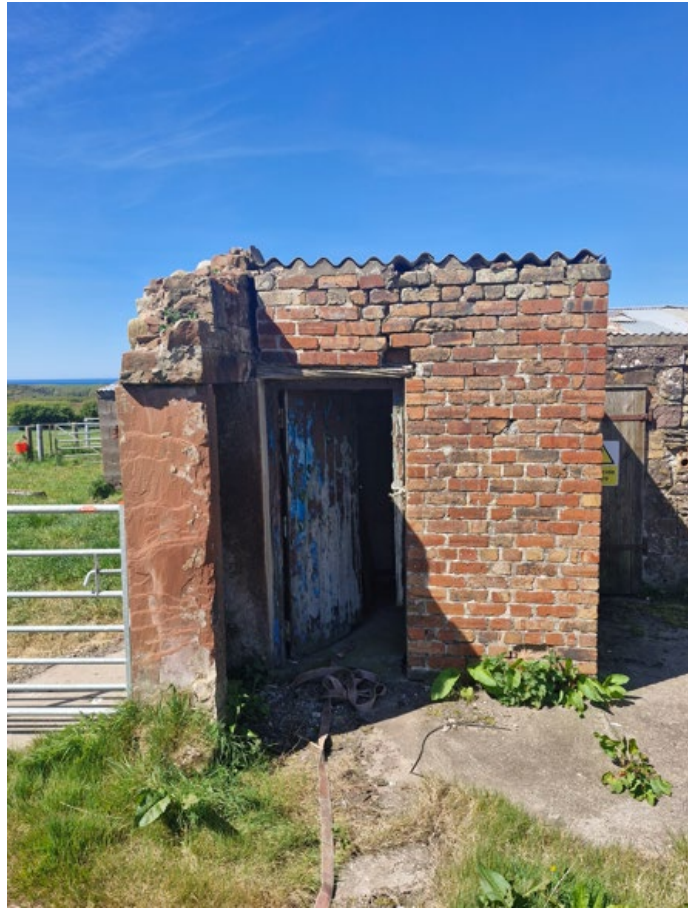
PHOTO 05 FRONT LEFT BRICK MASONRY BUILDING

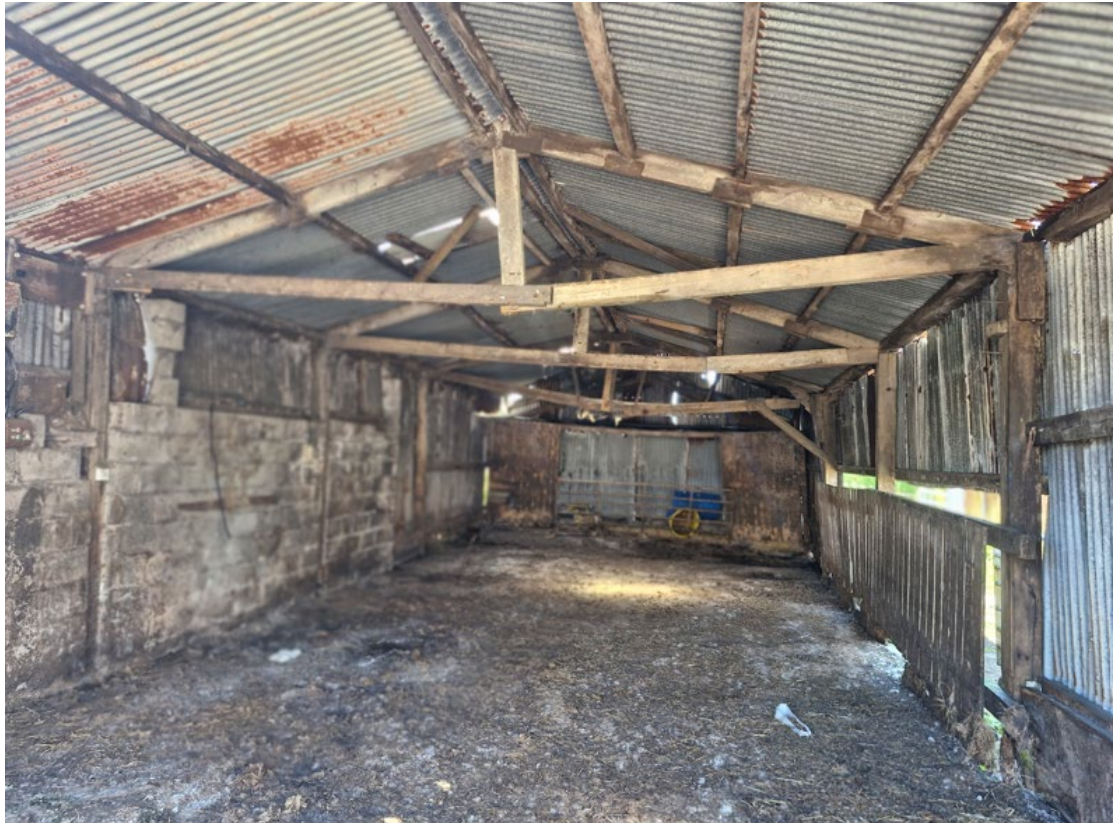
**2.3** The timber framed portal buildings to the rear of the site are structurally inadequate. These have not been erected to any design criteria, but merely just 'put up'. The buildings have both suffered sway due to wind loading, the roof truss and column connections have failed in a number of locations and the cladding is loose. See photographs 06-08 attached. The buildings are disused. They are at risk of collapse in high wind or heavy snow conditions.

PHOTO 07 TIMBER PORTAL SHED TYPICAL INTERNALLY

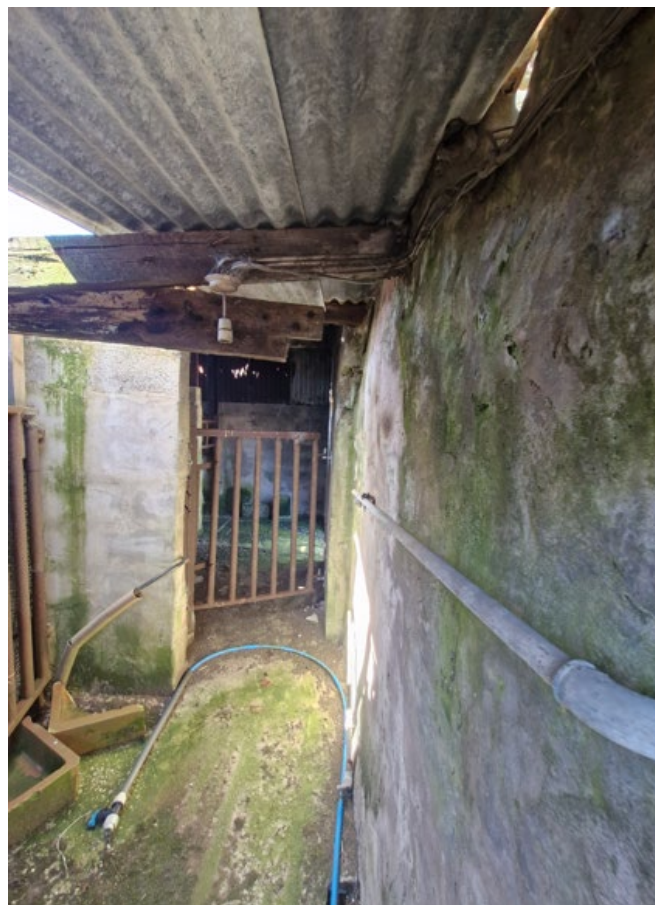
**2.4** The buildings between the front stone structures and rear portal frames are in a very poor condition. The structures erected were probably built by the farmer in a sequential order as more buildings were necessary. They comprise timber canopies which have rotted and partially collapsed. A lightweight steel framed container has been repurposed, but the steel has been excessively affected by rust and is at risk of collapse. See photographs 09-11 attached

PHOTO 10 LINK BUILDING TYPICAL
