Project Name: 2021_01_26 Westakes Edge

Inspection Standard: MSCC5 Sewers & Drainage GB (SRM5 Scoring)

CCTV Drain Survey - West Strand Whitehaven

Investigate existing surface and combined drains around the Wellington car park on West Strand for a proposed activity centre.

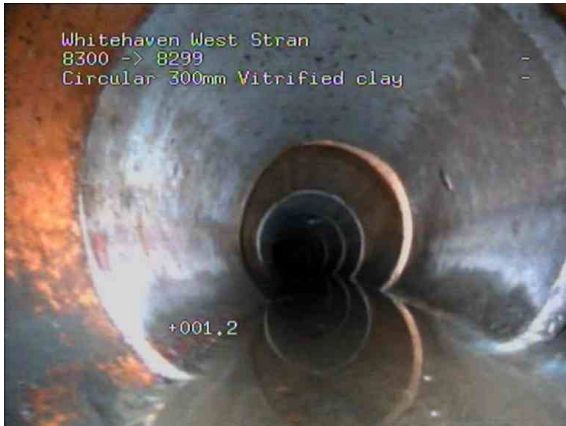
8300X_3c2c67f0-8708-4fc2-80d0-f0ac6a738835_20210127_0
85230_436.jpg, 00:00:30, 1.20 m
Open joint, medium, start

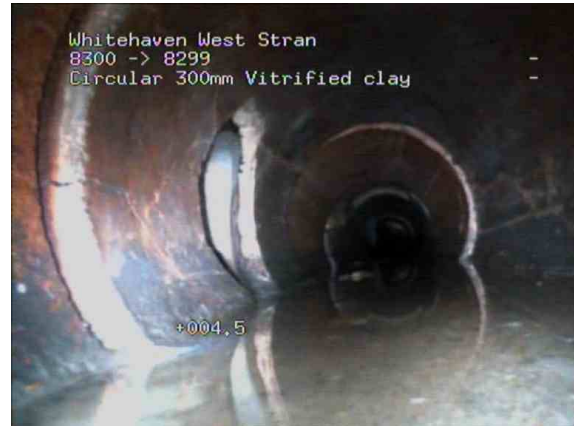
8300X_b3112f4e-bf19-41eb-9e4f-7ef07e9f85ff_20210127_085
419_027.jpg, 00:01:33, 3.40 m
Open joint, medium, finish

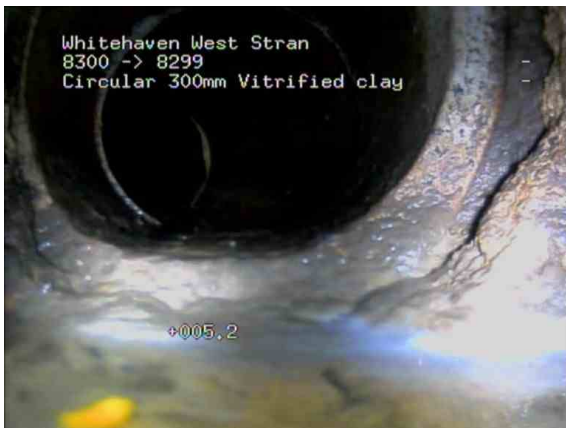
8300X_9122fc2a-8fcb-4f3d-87fb-abdfed0b38db_20210127_08
5659_944.jpg, 00:02:15, 5.20 m
Connection defective at 9 o'clock, diameter: 100mm, defunct

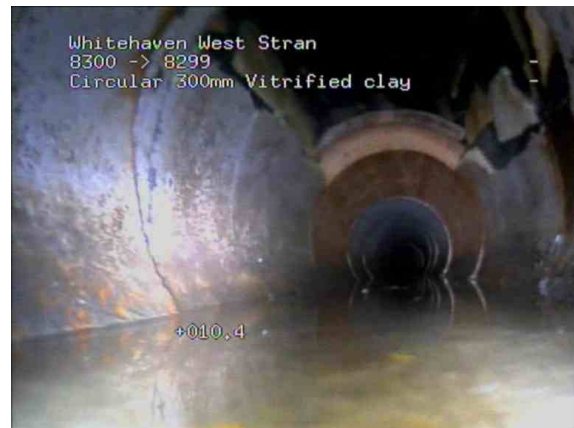
8300X_f105f827-fbda-4d9e-92ed-00a32f8fc4f0_20210127_09
0258_468.jpg, 00:03:26, 10.40 m
Broken pipe from 11 o'clock to 1 o'clock, Old access point -

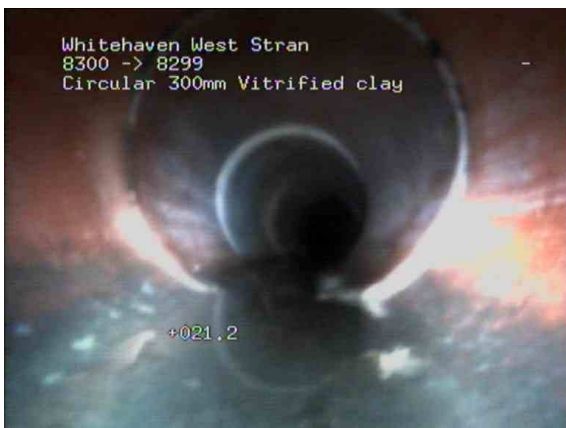
8300X_32a619e3-77b9-40d4-b051-c5e59971465d_20210127
_090741_536.jpg, 00:05:59, 21.20 m
Crack, longitudinal at 10 o'clock, cracked along length

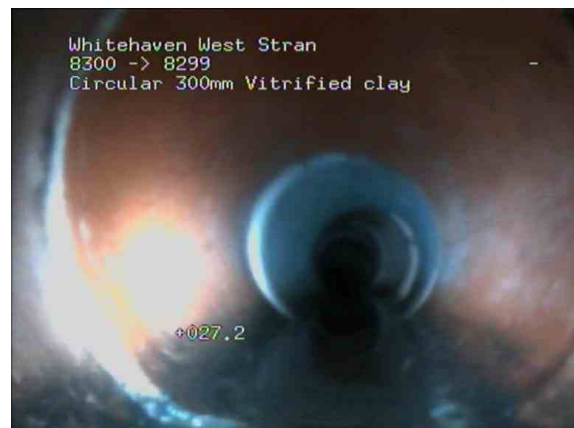
8300X_7e689ab5-758e-4139-a4b1-d54a4769d5c1_20210127
_091117_727.jpg, 00:07:11, 27.20 m
Open joint, medium, start

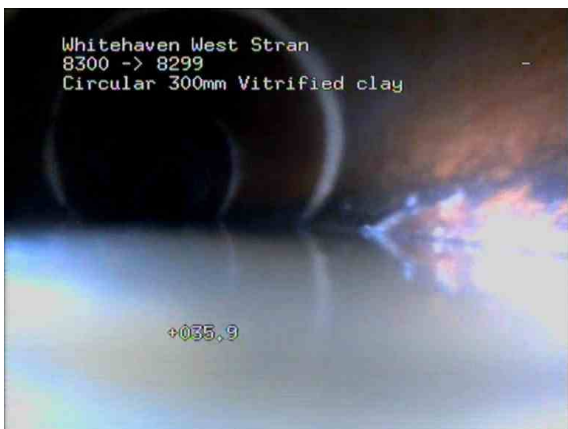
8300X_48e006d8-774a-473d-af09-569ac07c0270_20210127_091344_834.jpg, 00:08:53, 35.00 m
Turbid water level, 15% of the vertical dimension

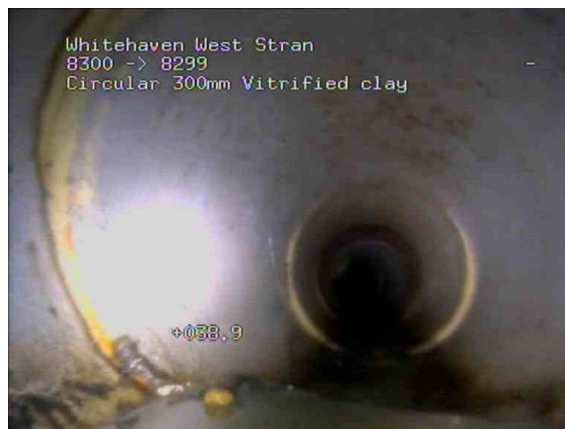
8300X_027885fd-0194-4e7f-bac6-b044ea709bdc_20210127_091553_409.jpg, 00:09:29, 39.00 m
Open joint, medium, finish

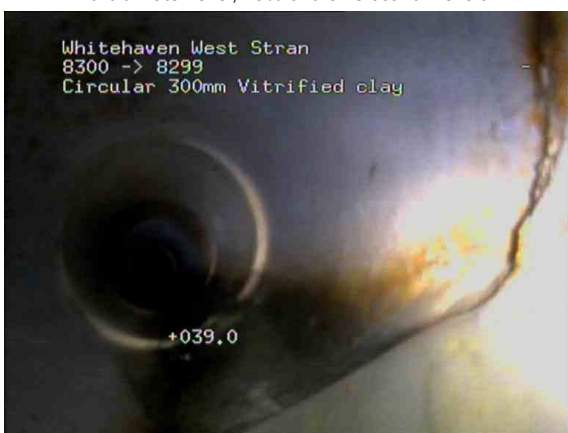
8300X_ae598982-02d1-4213-b522-96764395a7cc_20210127_091719_289.jpg, 00:09:48, 39.00 m
Survey abandoned, Drop in drain

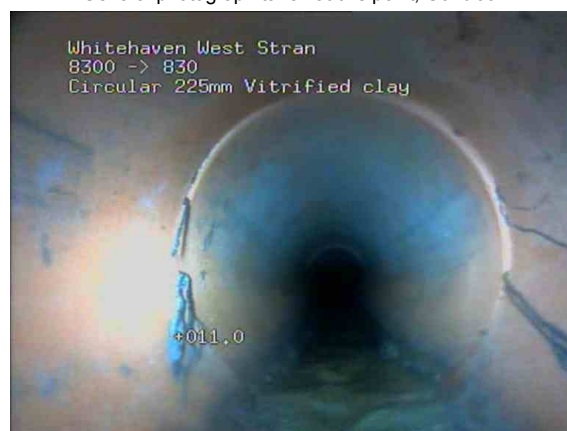
8301X_15416dba-28ab-4a75-a224-647719843da8_20210127_
114723_554.jpg, 00:02:17, 11.00 m

Roots, fine at joint

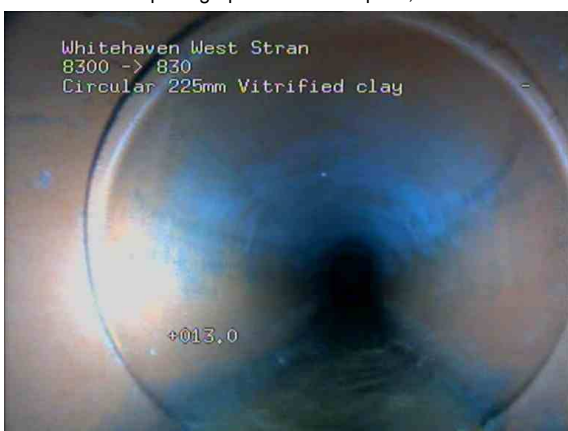
8301X_f55ef21b-fddd-4dbe-b114-ff3381fb8722_20210127_11
4838_133.jpg, 00:02:36, 13.00 m

Open joint, medium

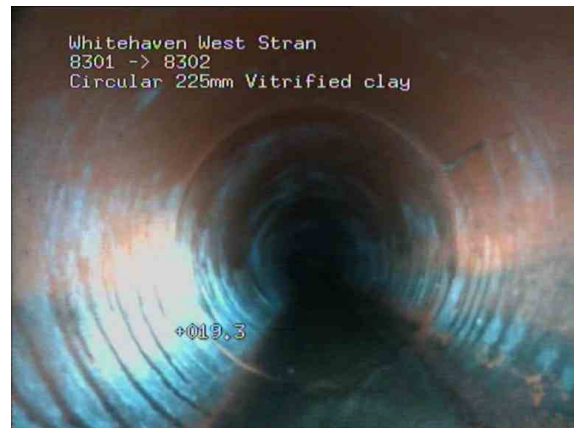
8302X_2a8fea1b-cda0-4112-aef6-51178ebace45_20210127_1
115735_137.jpg, 00:03:28, 19.30 m

Crack, longitudinal at 2 o'clock

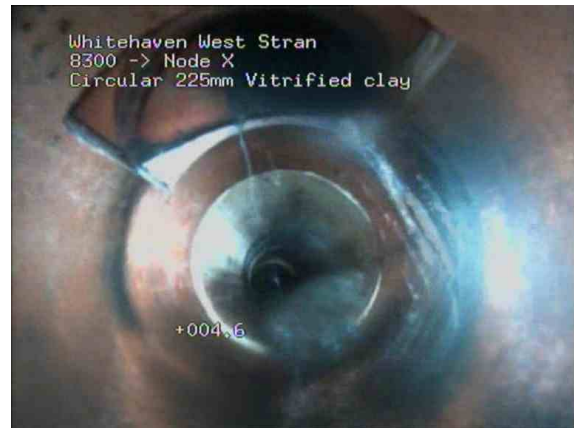
Node
XX_2a6516cd-1af3-4454-b80c-31b1bfcd21a8_20210127_131
916_517.jpg, 00:01:14, 4.60 m

No.	m+	Code	Observation
1	0.00	IC	Start node type, inspection chamber, reference number: 8300
2	4.60	CXZ	Connection defective, other at 12 o'clock, diameter: 150mm, Defective
3	5.30	DES	Settled deposits, fine, 25% cross-sectional area loss, start
4	9.40	CN	Connection other than junction at 3 o'clock, diameter: 150mm
5	17.40	DES	Settled deposits, fine, 25% cross-sectional area loss, finish
6	17.40	SA	Survey abandoned, Blockage

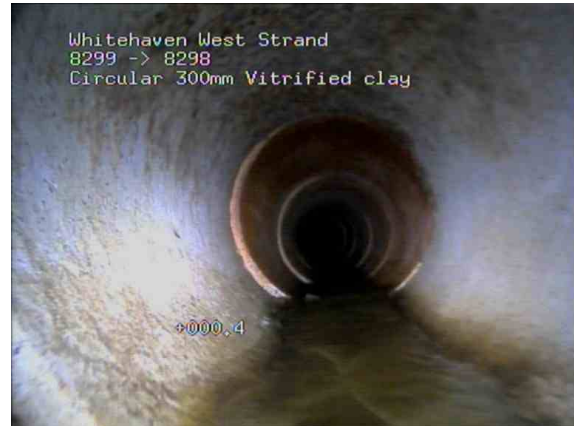
8299X_fb57aca2-85e8-43c8-902c-79d34894295b_20210127_135207_363.jpg, 00:00:45, 0.40 m

Joint displaced, medium, start

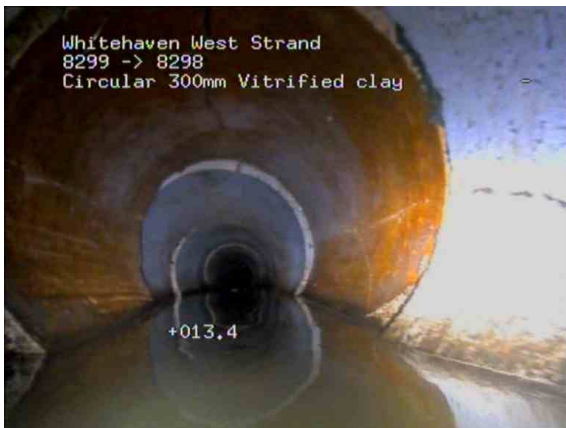
8299X_dcc401ee-cc89-4e4b-b1ab-f3672884c418_20210127_134114_720.jpg, 00:02:48, 13.40 m

Turbid water level, 10% of the vertical dimension

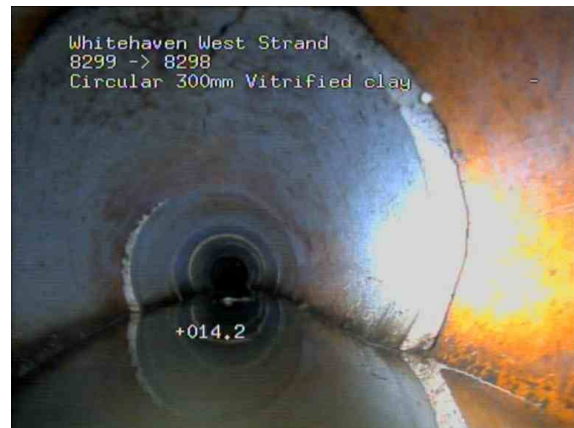
8299X_6ac32ab3-3f60-49c2-b8c1-3336fed06969_20210127_134159_796.jpg, 00:02:54, 14.20 m

Crack, longitudinal at 12 o'clock

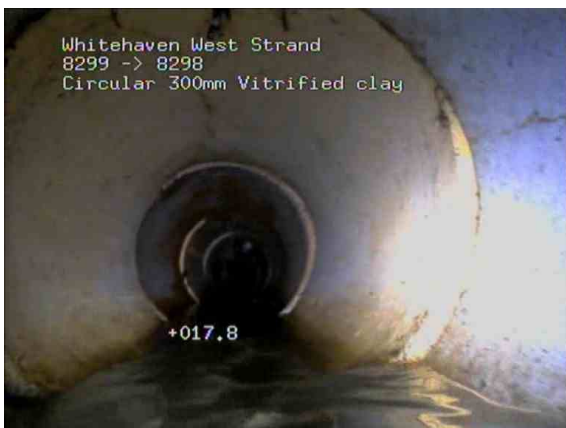
8299X_f08c3c8e-7431-4c64-ac4e-aa5525c6b757_20210127_134327_070.jpg, 00:03:29, 17.90 m

Crack, longitudinal at 12 o'clock

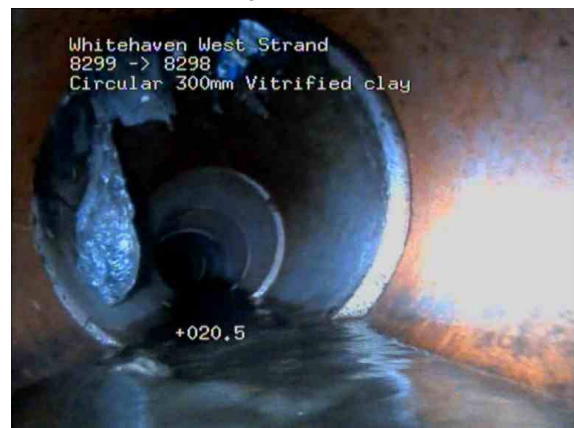
8299X_928b07dd-5373-4e01-a7ad-f3c668069da5_20210127_134459_300.jpg, 00:03:53, 20.50 m

Other obstacles at joint from 10 o'clock to 12 o'clock, 10%

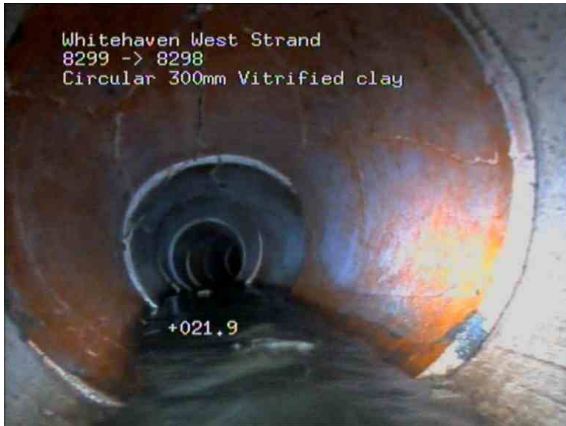
8299X_c0c2e085-19d3-4d35-9365-69e53ab72fa0_20210127_134558_593.jpg, 00:04:07, 21.90 m
Cracks, multiple from 8 o'clock to 3 o'clock

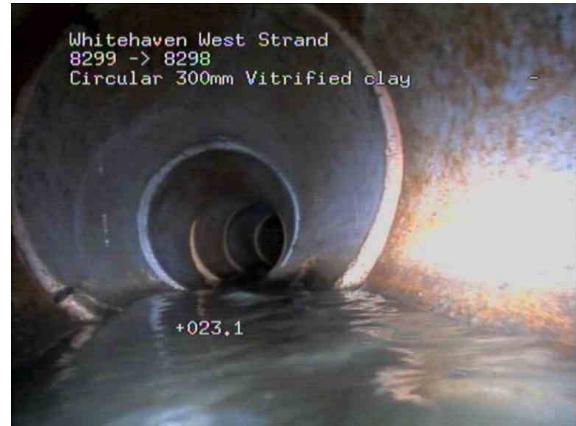
8299X_83244a2d-91ac-4d1f-8f90-816056fd9270_20210127_134650_463.jpg, 00:04:18, 23.10 m
Crack, longitudinal at joint at 7 o'clock

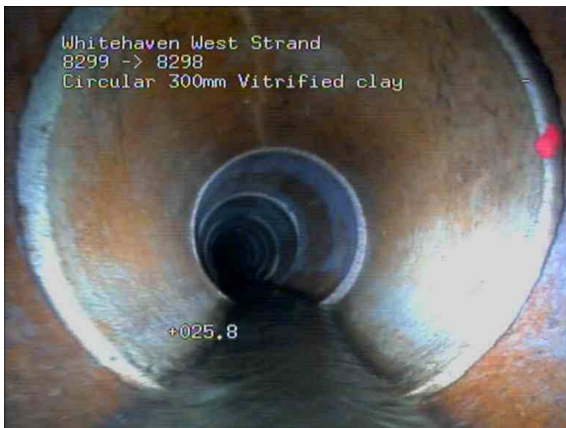
8299X_c4c59bfa-c898-4e95-ad7a-4c7b2ab741fb_20210127_134752_746.jpg, 00:04:45, 25.00 m
Crack, longitudinal at 12 o'clock

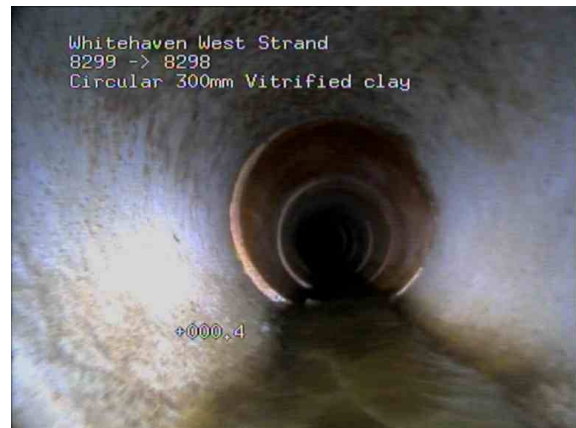
8299X_c65224e6-83d1-4db8-af87-a4a6a3af1c21_20210127_133833_441.jpg, 00:00:45, 38.80 m
Joint displaced, medium, finish

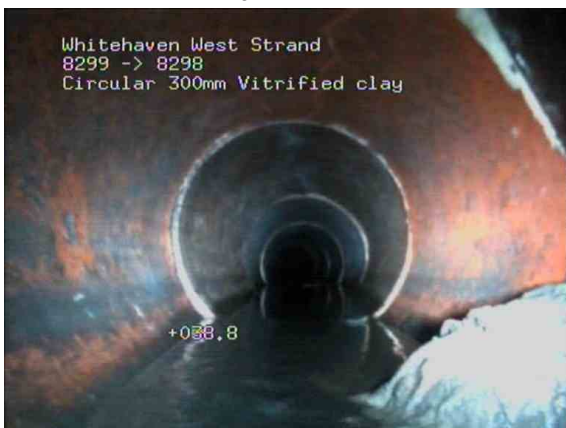
8299X_b6d85f02-8f59-4d60-9979-0fab5b24b70a_20210127_135420_484.jpg, 00:07:00, 39.00 m
Connection defective at 2 o'clock, diameter: 100mm,

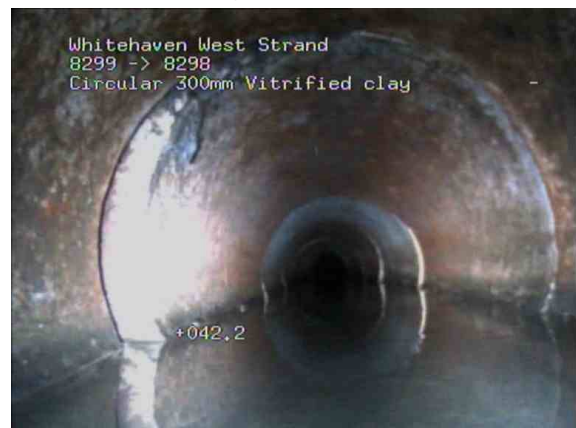
8299X_9b51a8fc-0a0b-4498-b374-753f6b89415c_20210127_135551_203.jpg, 00:07:53, 42.20 m
Turbid water level, 20% of the vertical dimension
