Woodhouse - Low Road, Whitehaven

Coal Mining Risk Assessment

Astime Properties Ltd

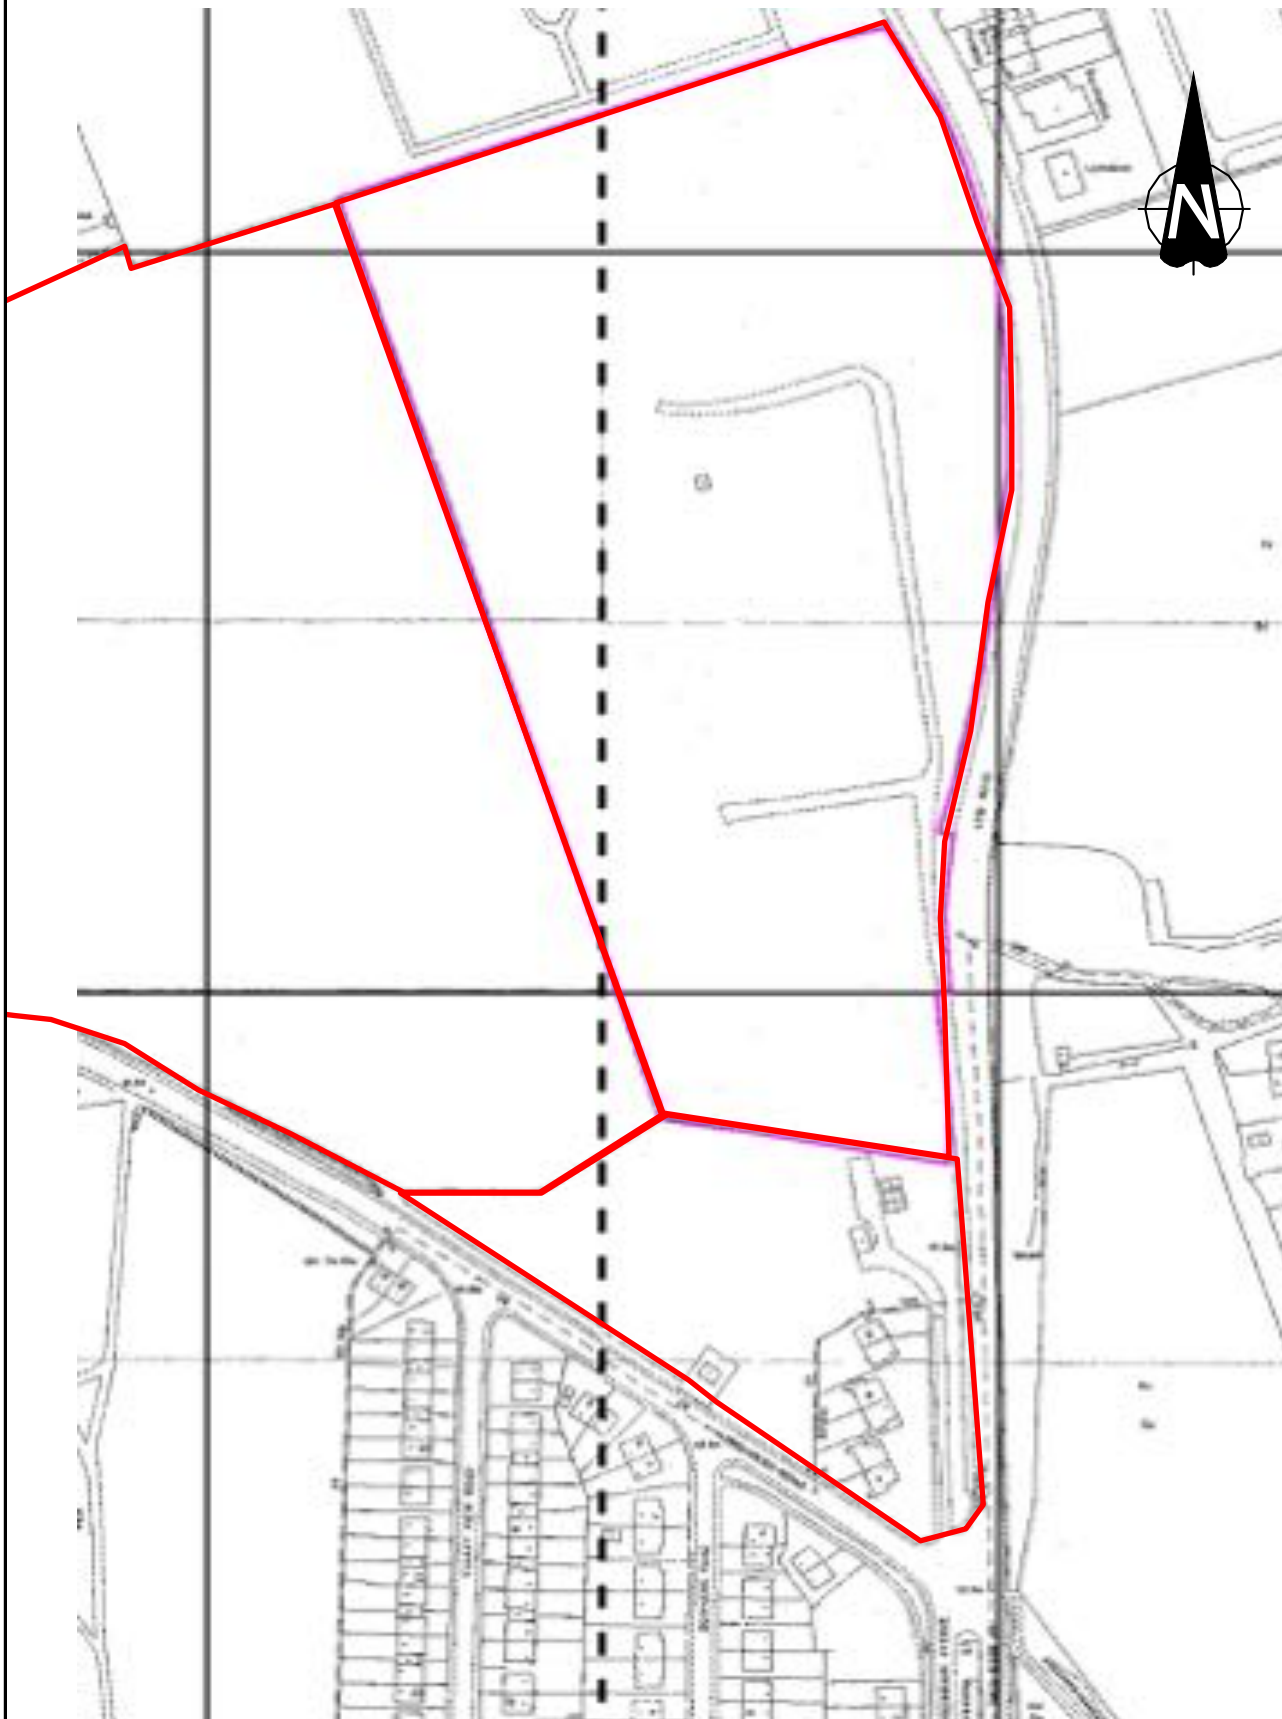
- 4.1.2 The Main coal seam crops out along Low Road and dips westwards beneath the site at an angle of approximately 18°. (In terms of access for miners this makes for a very steep gradient of 1 in 3). The Bannock coal seam crops out further up the hillside through the centre of the site. The strata are heavily faulted with the faults mainly aligned north-west to south-east, but in addition, a conjugate north-east to south-west trending fault line is shown to cross the central part of the site. This fault brings younger strata to crop out on its northern side, with the Slaty and Black Metal coal seams shown to crop out along the central northern half of the site, and an unnamed coal seam is shown to crop out further west. The map identifies, in ascending order, the following coal seams cropping out at or near the site; Yard, Main, Bannock, Slaty, Black Metal and unnamed. The Main coal seam is also referred to as the Main Band coal seam. The reports that the Main and Bannock coal seams are up to 4.0 m and 2.5 m thick respectively. An extract of the geological map is shown in Figure 6.

- 4.1.3 The map identifies two mine shafts in the southern part of the site. Their locations match those given in the Coal Authority reports.
- 4.1.4 The British Geological Survey's (BGS) website has been checked for archived borehole logs, and this has identified four boreholes drilled on the western side of the site by Newdale Construction Ltd in 1980 to locate mineworkings. However, there is some uncertainty about the actual borehole locations. The website defines the locations with a six figure grid reference, but this is only accurate to 100 m. The location on the borehole logs is identified as 'Meadows View', which is the former Workhouse on the eastern side of the site (the Low Road site). Nevertheless, it is significant to note that voids were identified in one borehole and water flush was lost in two other

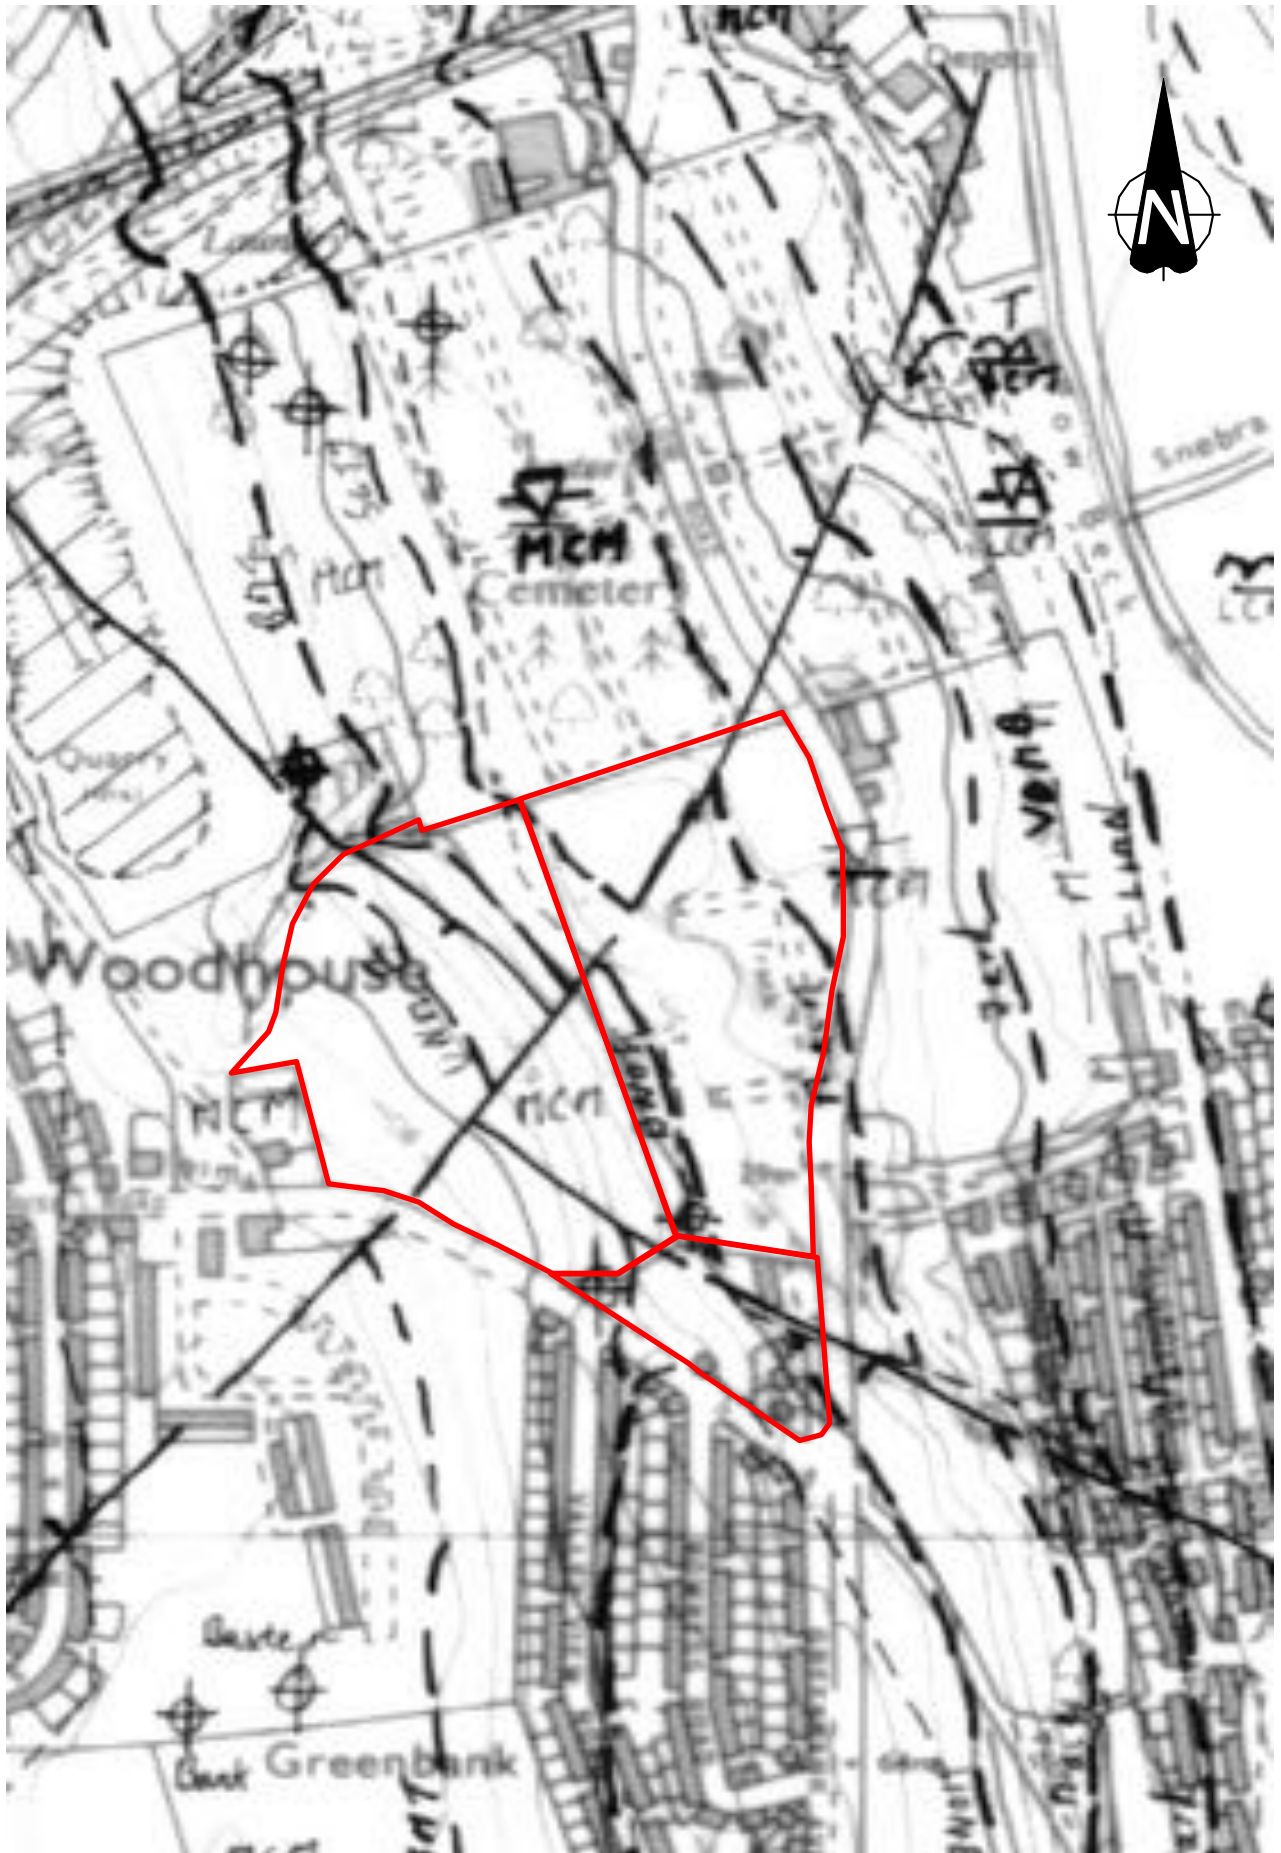
- 4.2.3 The plan shows the Main coal seam to have been worked throughout most of the site using the pillar and stall coal extraction method. The extent of the workings is shown on Figure 7. Only a small part of the Low Road site was unworked, and this corresponds quite closely to the lower lying area of ground in the north east corner of the Low Road site. Two shafts are shown on the plan and these may correspond to the shafts shown on the geological map and the Coal Authority reports.

- 4.2.5 The abandonment plan indicates that the pillars of coal left in place to support the roof are quite large, and are typically 10 m square. Any exploratory drilling should therefore avoid drilling on a regular grid pattern so as to avoid only intersecting pillars and concluding that no voids are present.

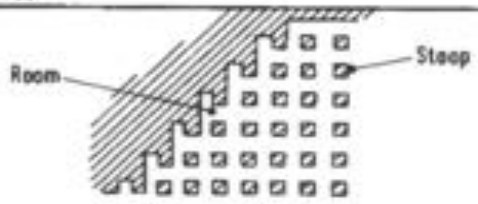
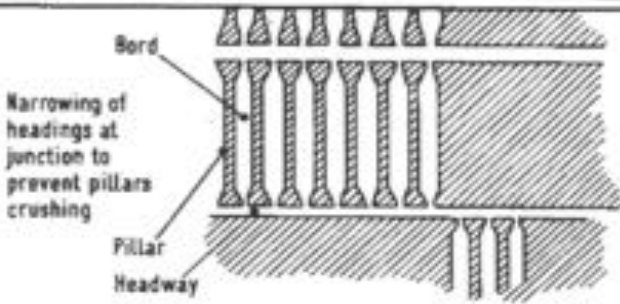
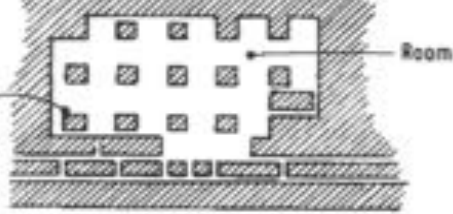
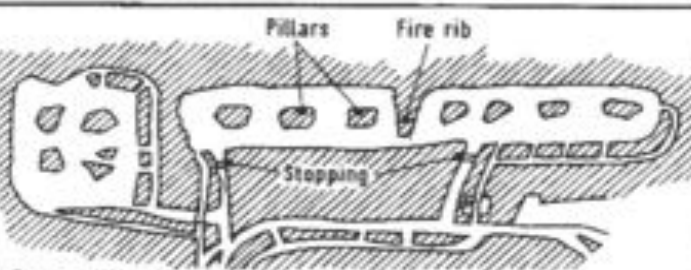
Extract from Healy and Head (1984) showing variations on the theme of pillar and stall workings

- 4.2.4. Pillar and stall working is a term used to describe an extraction technique where pillars of coal were left in place to support the roof. The technique is described as follows by Healy and Head (1984) and illustrated on Figure 8:

- ‘The pillar and stall method of extraction was an early mining technique which itself replaced bell pit workings. Access to the workings was either through shafts or adits with associated roadways. Unworked pillars were left to support the overburden. This enabled larger quantities of mineral to be extracted through single or pairs of shafts. Initially the pillars were haphazard in size and arrangement, and the rooms were generally quite small. However, more systematic methods developed and intersecting roadways driven in the seams formed pillars of a more uniform size’. After the initial phase of mining it was quite common to partially or totally ‘rob’ the pillars as a retreating operation to extract more coal.

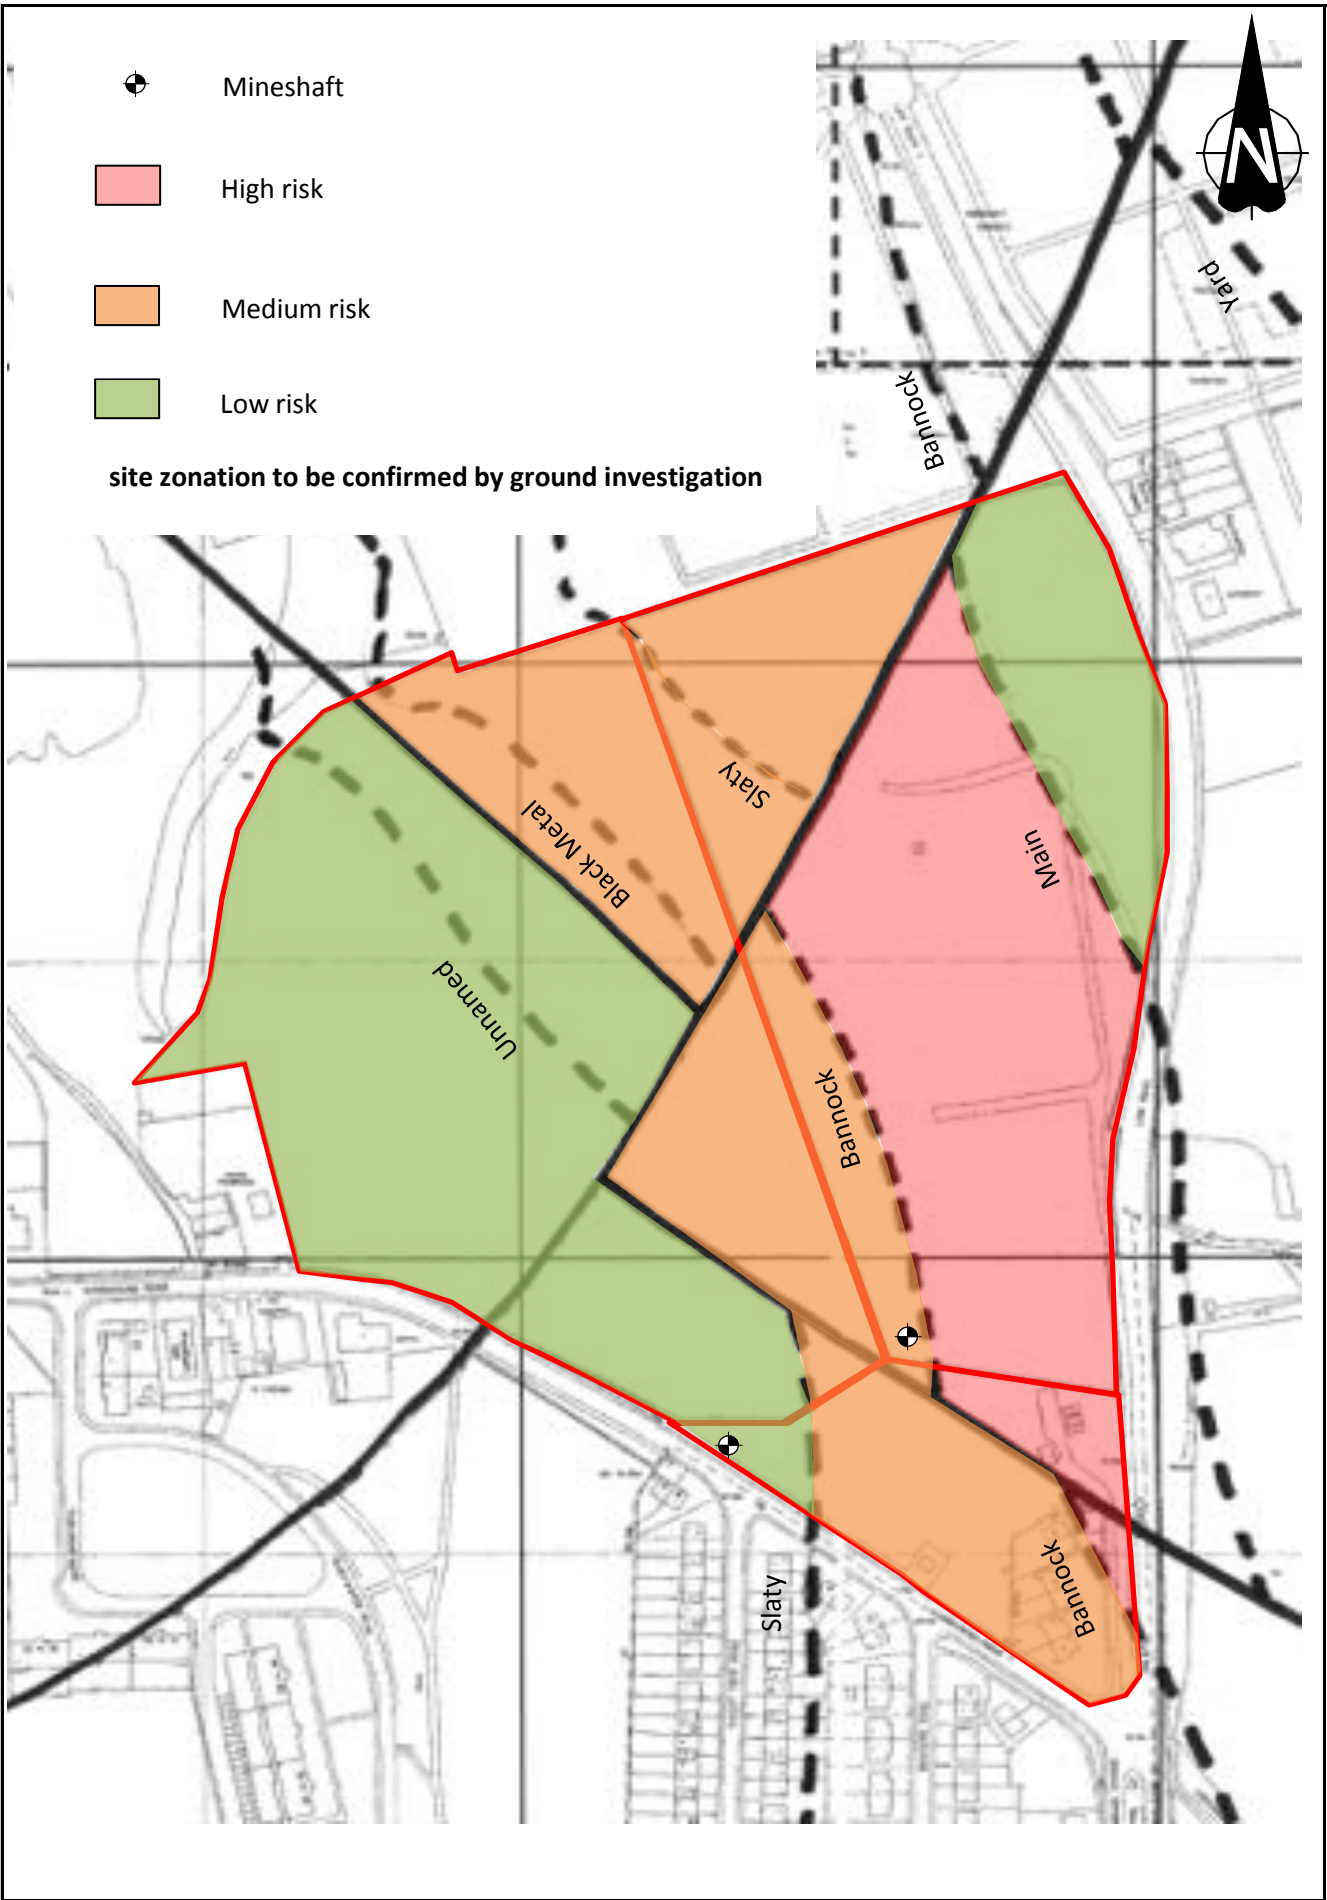
- 6.1 The risk assessment has identified three main hazards affecting the development site, viz: subsidence, mineshaft collapse and mine gas.
- 6.2 In relation to subsidence, the site has been divided into three zones. The highest risk areas are underlain at shallow depth by the Main coal seam, and these areas should be considered for ground stabilisation. The medium risk areas are underlain by the Bannock coal seam where it is unclear if mineworkings are present. It is recommended therefore that investigations be undertaken to determine ground stabilisation requirements. The lowest risk area is in the north-east corner of the site which lies below the Main coal seam. It is unlikely to be undermined at shallow depth and it is therefore unlikely that treatment would be required for this area. The western quarter of the site may also prove to be a low risk area where no treatment is required. The site zonation is illustrated in Figure 9.

- 6.3 The site zonation is based largely on current geological mapping. This appears to show that a fault drops the elevation of the Main coal seam out of the zone of influence across the north-western half of the site. However, the mine abandonment plan shows continuous workings in the Main coal seam with no indication of the fault shown on the geological map. Therefore, owing to the uncertainty in delineating these zones, ground investigations may be required to check the validity of the site zonation. It should be noted that grid patterns of exploration should be avoided to prevent inadvertent matching of the borehole layout with the pillar and stall coal extraction layout.

- 6.4 The two mineshafts present a development hazard. One option is to establish an exclusion zone around the mineshafts and leave the area undeveloped. Alternatively, in order to maximise the developable area, the mineshafts can be positively identified and capped. This will require clearance of the vegetation to improve access, a local geophysical survey to identify suitable targets for investigation, and exploratory excavation to identify the shafts. The mineshafts should then be backfilled and capped in accordance with current guidance (eg CIRIA 32 and its recent replacement CIRIA RP940).

- 6.5 All developments should incorporate a gas proof membrane.
