Cleator Moor Conservation Area Appraisal

2021

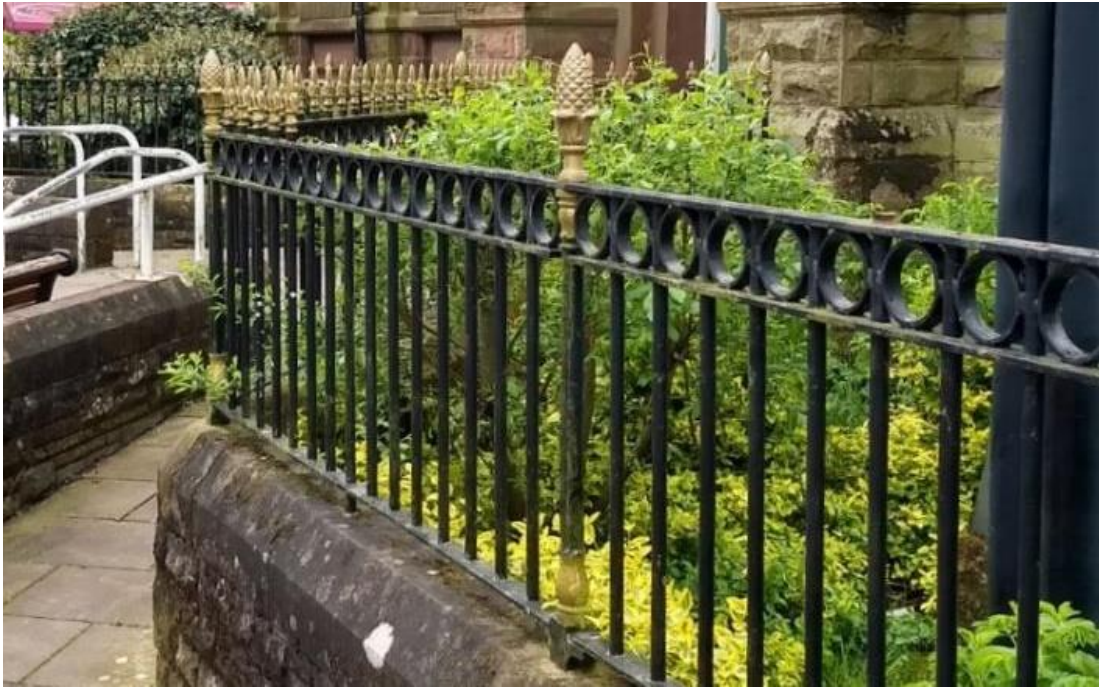
The impression of Market Square has been eroded by the large quantity of railings that were fitted during a public realm scheme in the early 1990s. They are not objectionable by themselves, and are indeed of good quality in isolation, but collectively they overpower the space, making it appear cluttered and partitioned.

Figure 11 Iron railings, dating from the early 1990s

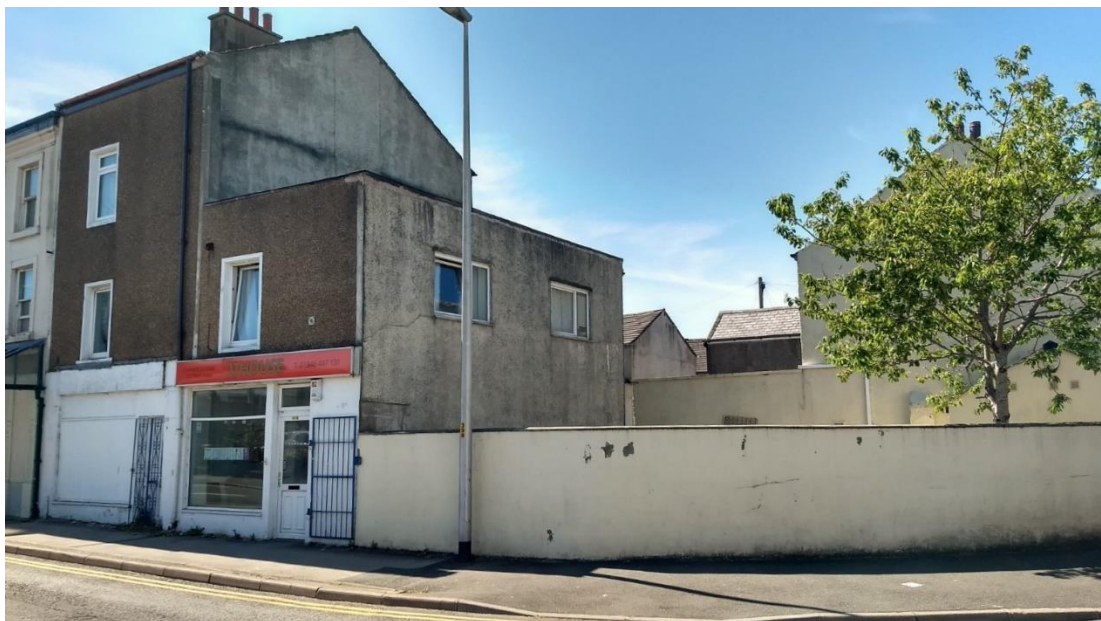
On the corner of Jacktrees Road and High Street there used to stand a substantial three storey building with shop fronts around its base, however, following fire in 1921 this was mostly demolished, leaving a gap site that does little to define the junction.

Figure 13 The vacant corner plot of Jacktrees Road and High Street. This robs an important junction (between High Street and the Market Square) of a lot of stature.

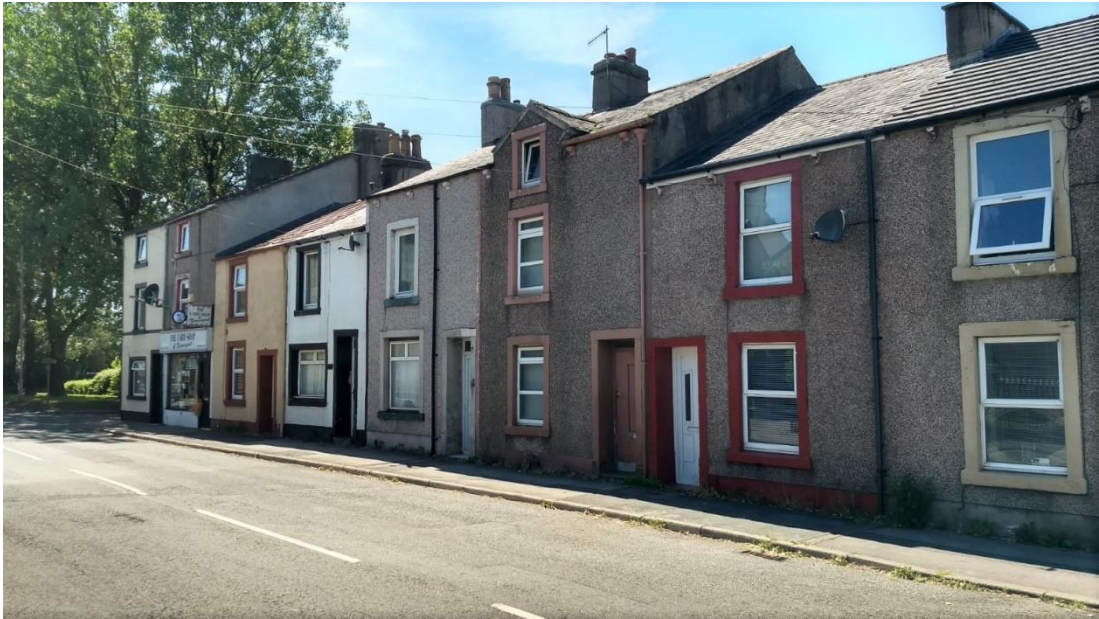
Figure 15 Numbers 16-23 Jacktrees Road. Plastic windows and doors, pebbledash, satellite dishes and roof tiles are very much in evidence, but the row has much potential.

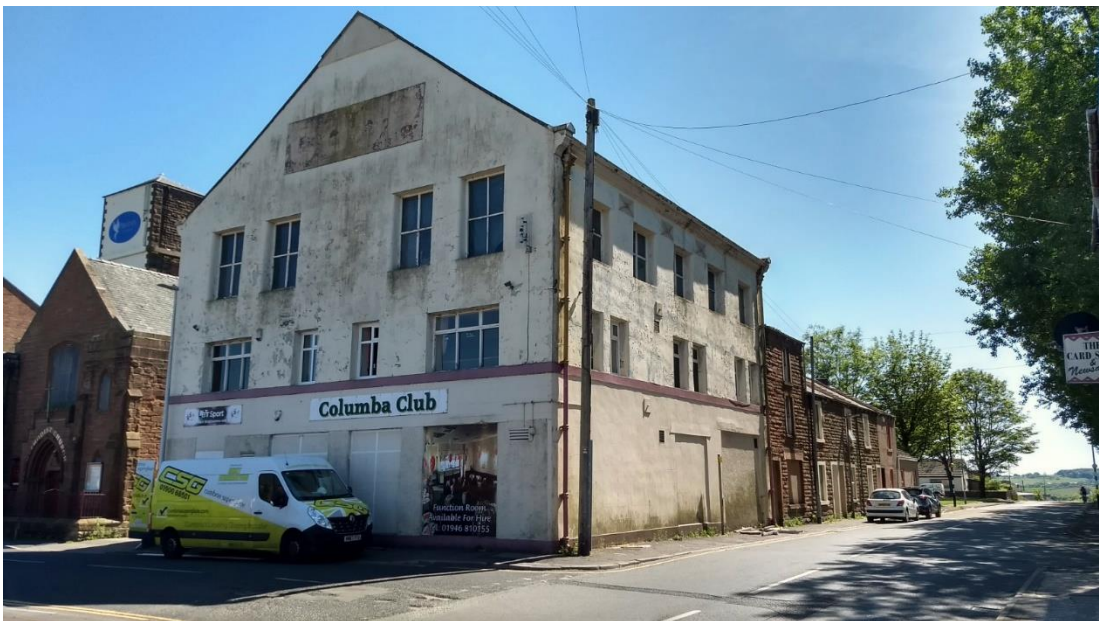
Figure 16 Columba Club. Aside from the need for external redecoration, this building suffers from an inactive ground floor, which could be altered to make more of this corner.

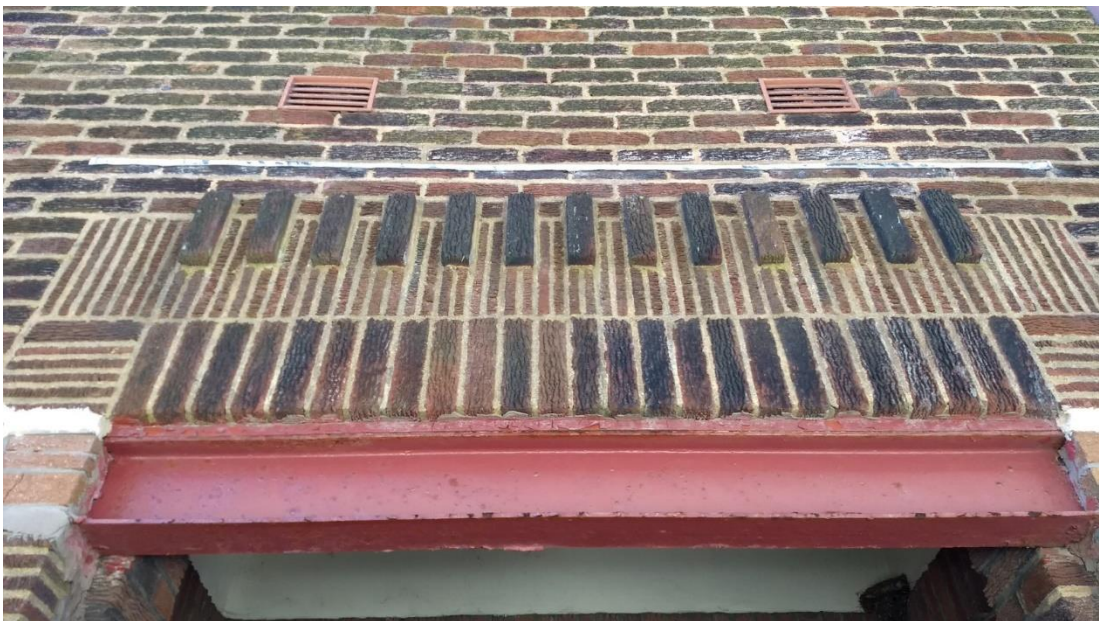
The Methodist church is gothically styled in red sandstone. Adjoining it to the rear is a Sunday school in the international style. This is an unusual but not unwelcome addition to the conservation area and presents a handsome façade to Earl Street composed of a mixture of pink, brown and umber bricks. This building dates to during or shortly after World War Two, although the pink brick sections of the façade appear later and are poor. Its two main doorways are beautifully executed in bricks of various sizes and colours with butterscotch coloured pointing, but both have been disfigured by the inept insertion of steel joists, presumably to support the lintels.

Figure 18 Sunday school doorway on Earl Street. This excellent brickwork would greatly benefit from the replacement of the RSJs with something more subtle, and greater care in future repairs with the pointing.

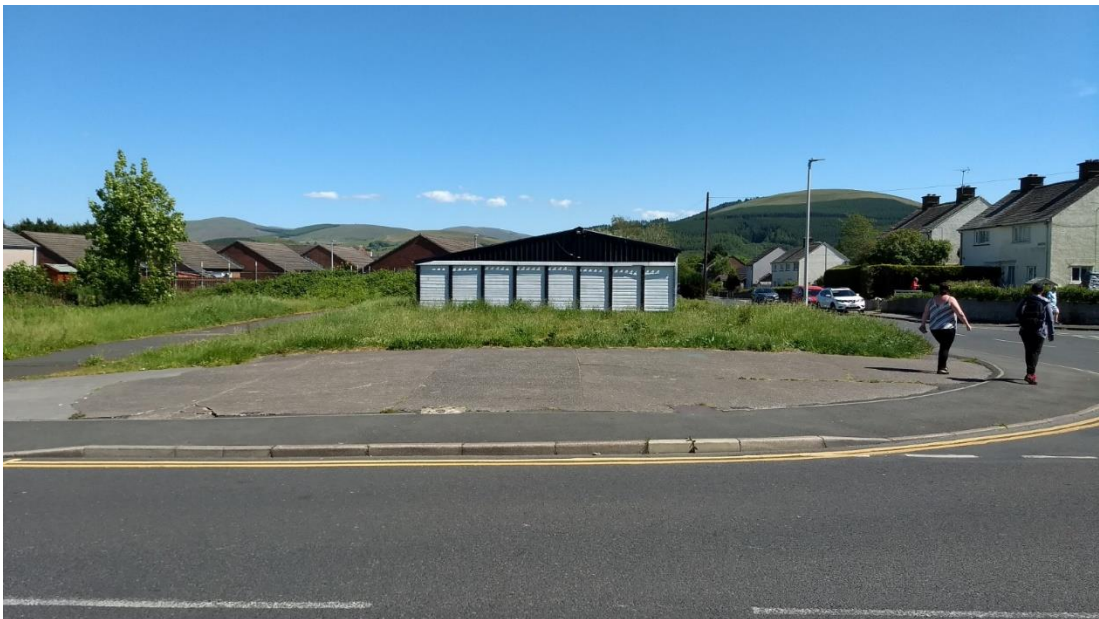
Figure 21 Site of the former picture theatre. Although the square is missing a piece here, it does allow a lovely view of the mountains. The concrete, garages and weeds, however, do not allow the view to be fully enjoyed.

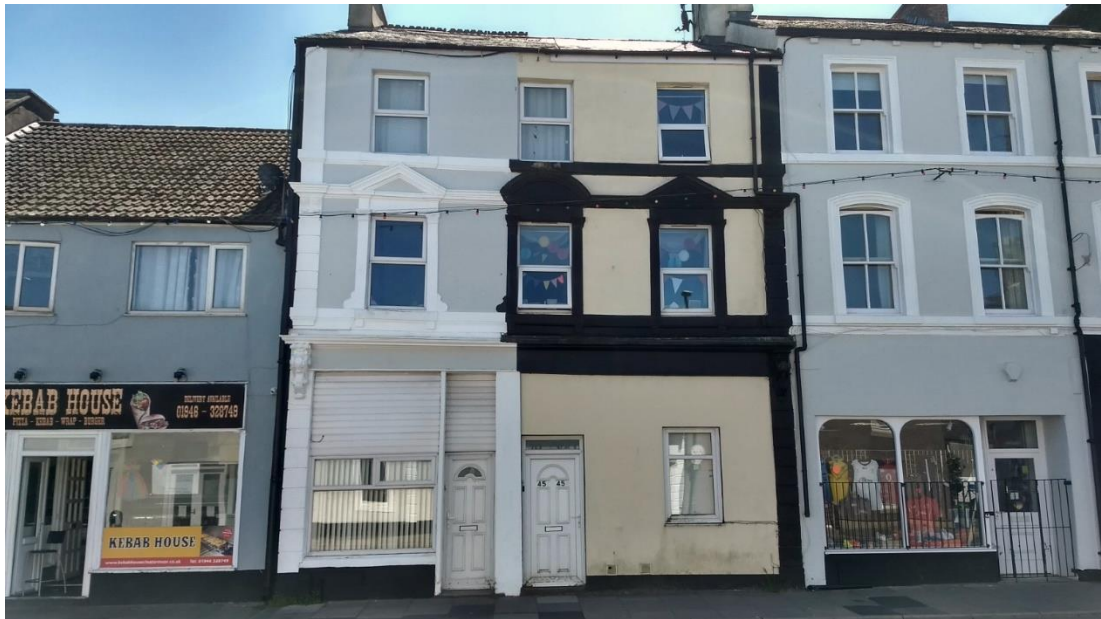
Figure 24 Numbers 43, 44, 45 and 46 High Street

Note the ground floor treatments of 43, 44 and 45. Fortunately, at first and second floor height, ornate console brackets, string courses and window pediments survive. The paint scheme of Number 45 has had the effect of both hiding its ornamentation and failing to match with 44. Note that the roof of 45 has also lost its ridge tiles and no longer matches 44. There is a distinct contrast between the windows of 43-45, and those at 46. There exists much potential to improve these buildings using Copeland's guidance on shopfronts.

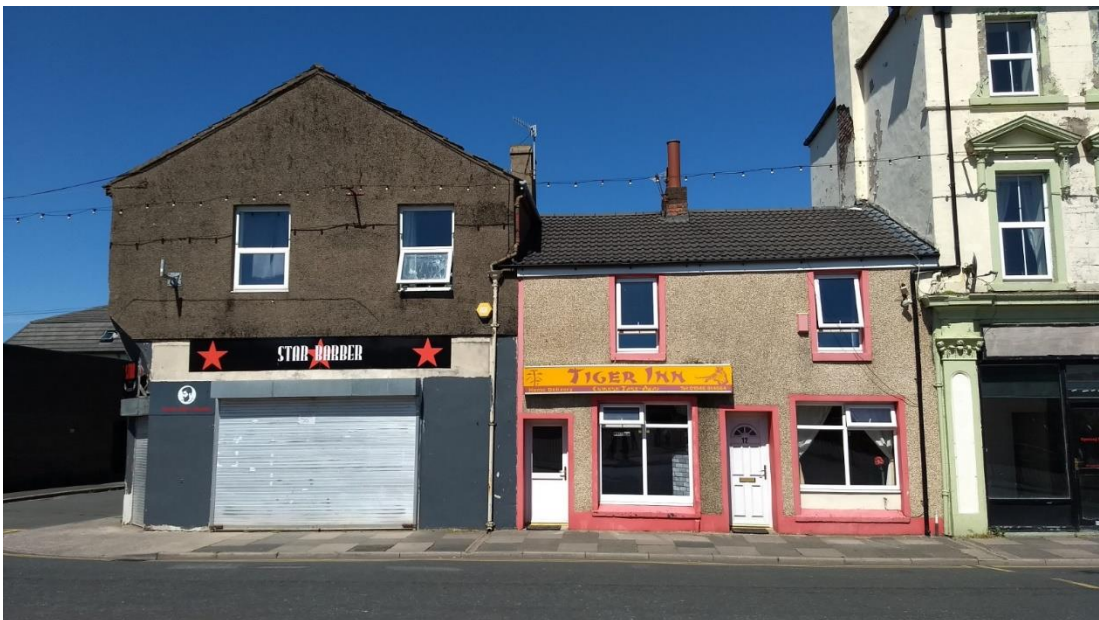
Between 13-20 High Street and Aldby Street stand 10, 11 and 12 High Street. These are low, two storey buildings that have lost much of their historic detailing. Number 10, which stands on the corner, retains its chamfered corner containing the door but has lost its attractive pierced bargeboards and spiked ridge tiles. All three of these properties once featured rounded corners on the ground floor windows, and the upper floor ones too at Number 10, but these have all been lost and replaced with standard rectangular openings.

Figure 26 Number 10, 11 and 12 Market Place. Almost no facets of their original beauty have survived

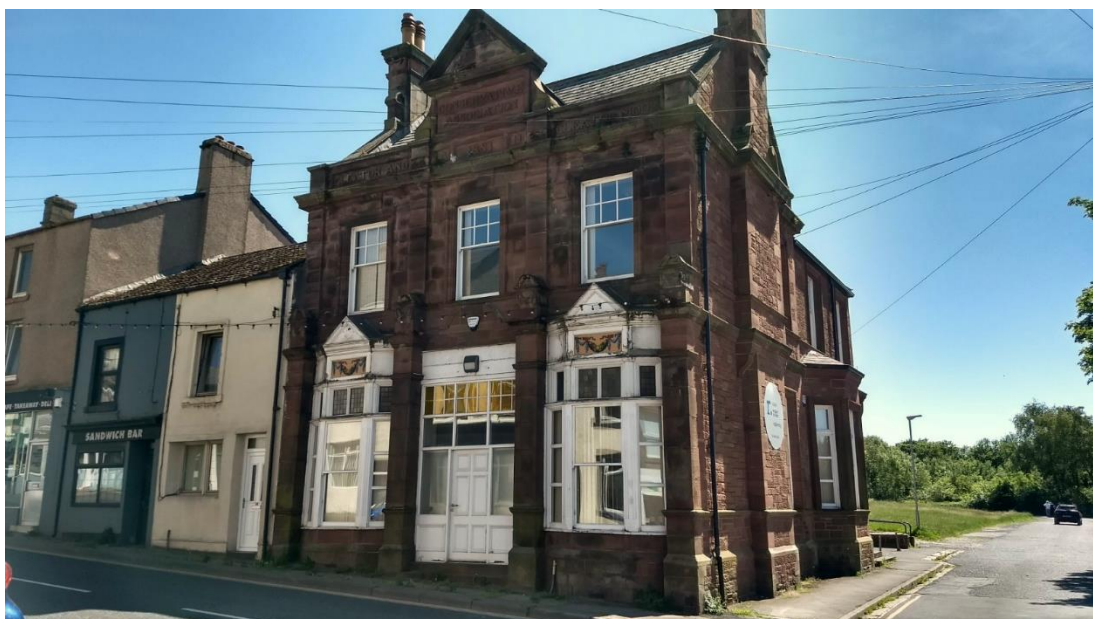
Figure 31 The former conservative club of 1883. Note the ornamentation to the windows and the lettered frieze and pediment at the top. Timberwork such as this is vulnerable and requires regular inspection.

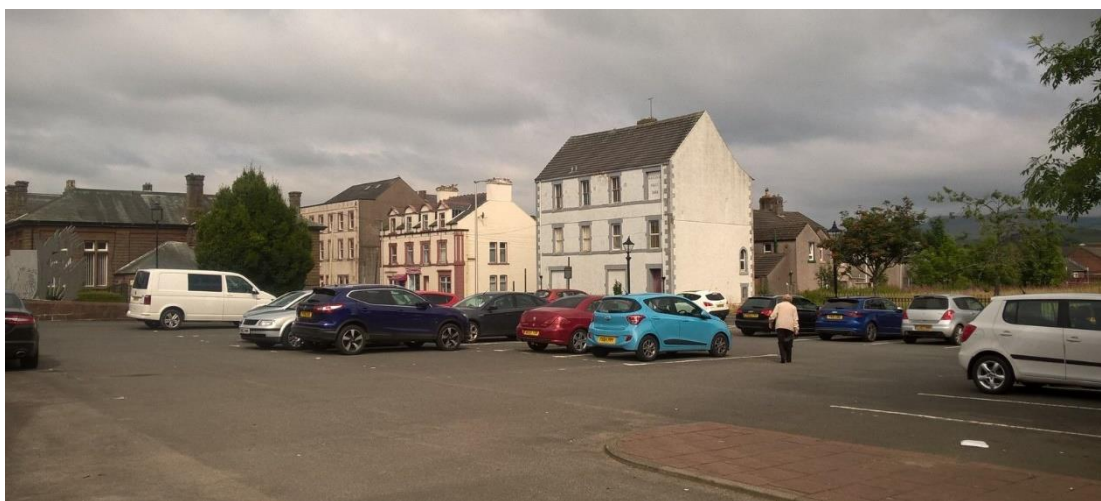
Figure 36 Surface car parking to the rear of Market Square creates seas of grey, ill-defined tarmac

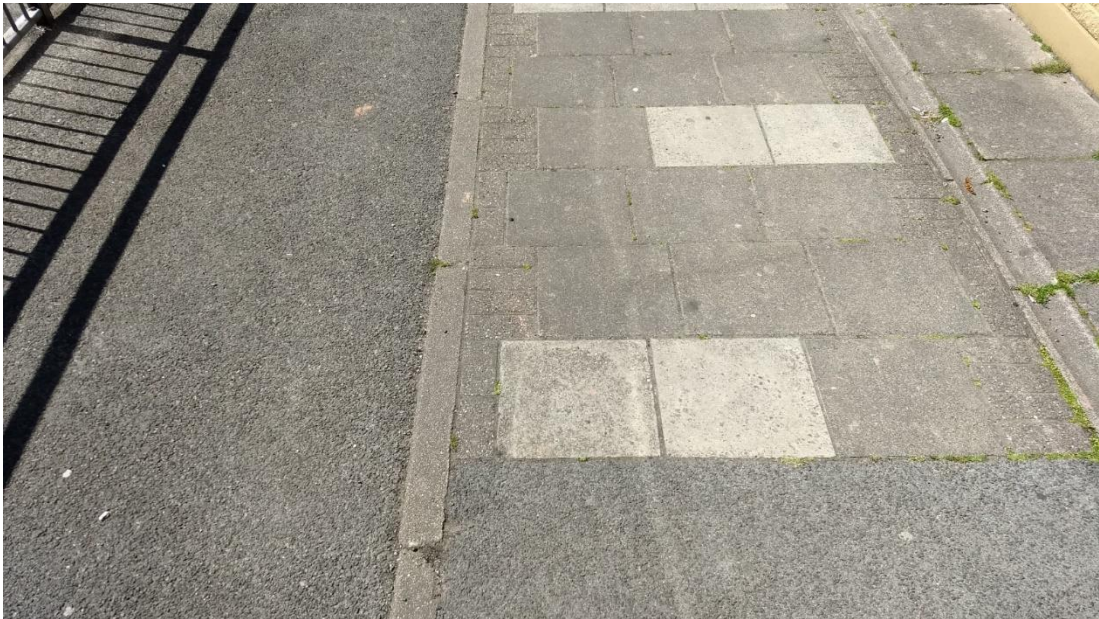
Figure 37 Concrete and tarmac surfaces abound

The surfacing of pavements and the road itself is otherwise tarmac in poor condition, with some pavements on High Street being a slightly more attractive grey cement paving slab.

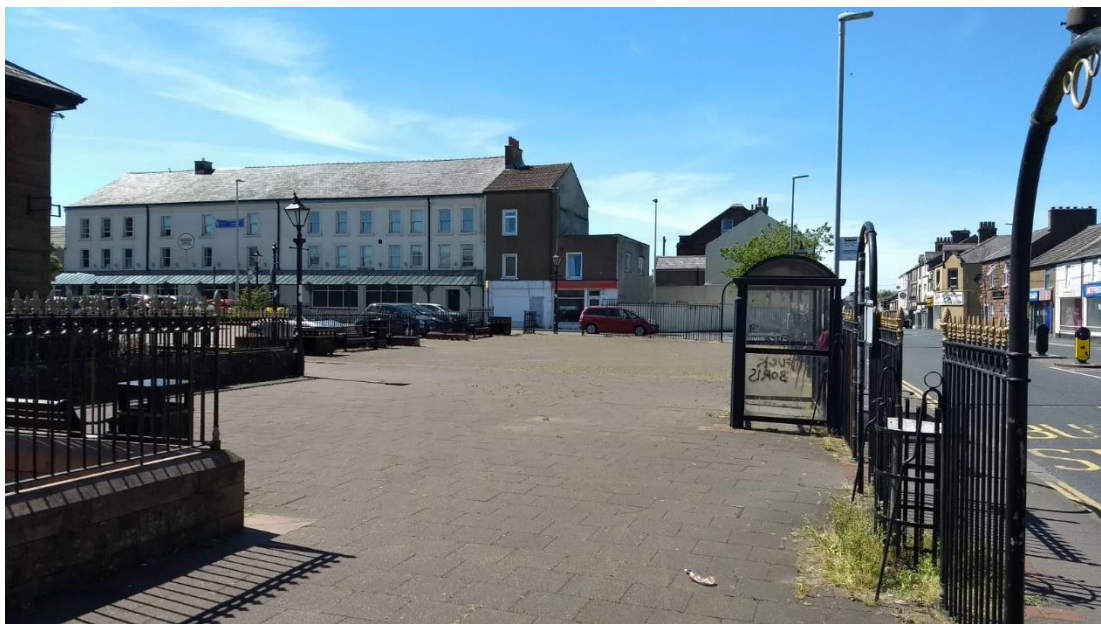
Figure 39 Edges in Market Square are characterised by slightly haphazard and untidy collections of fencing, bollards etc. These are not optimal.

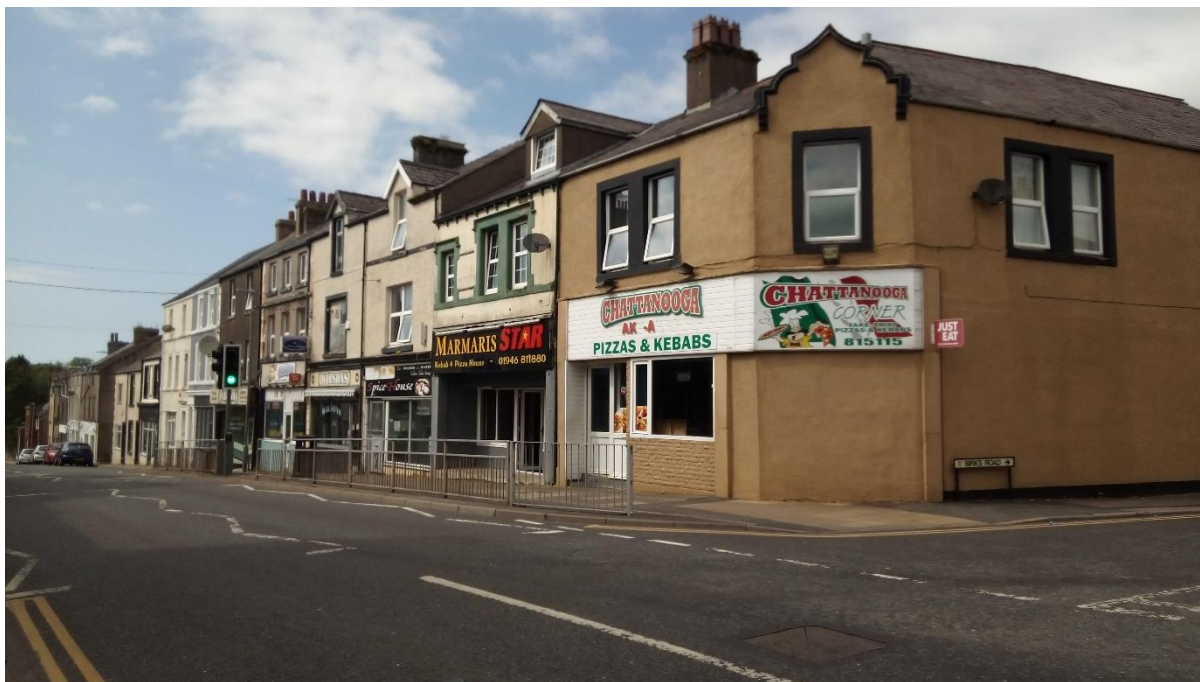
Figure 42 High Street looking to the west, showing unsympathetic fenestration, loss of shop fronts and unattractive signs. Note also the nearest building, which has lost its corner doorway at some point, upsetting the emphasis of its façade. The streetscape is particularly uninspiring, comprising tarmac, concrete and steel, none of it deployed with any thought for attractiveness.

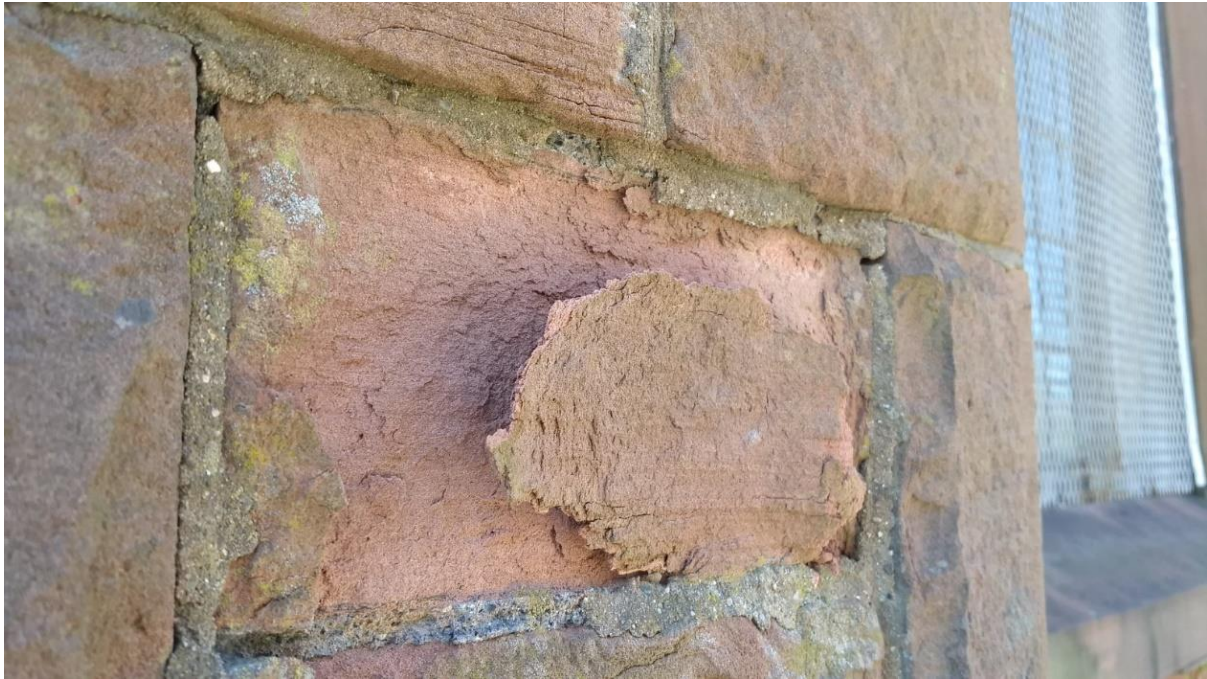
Figure 43 The side elevation of the Methodist Church bears particular witness to the damage that can be caused by hard cement pointing. Much of the stone has delaminated and powdered as a result.

Solid walls constructed from soft, porous materials such as sandstone require soft, porous materials to repoint, render and plaster them. The Council can give advice on the use of lime, which is the recommended material.
