HERITAGE IMPACT ASSESSMENT

BARN AT BARWICKSTEAD,

BECKERMET - 22 February 2022

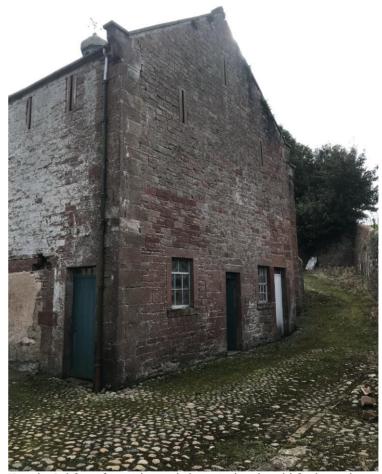
North Gable elevation with retained cobbled paving, upper floor new windows designed to reflect detailing of the lower ground floor windows

To create suitable internal daylight it is proposed to insert four new windows within the sandstone gable of the building. To upper floor windows are enlargements of the original ventilation slots, these remain and repeat across the main façade.

Below these two further windows are introduced, given the regularised nature of the barn, these apertures mirror the upper windows in scale and proportion. In acknowledgement of the detailing below these have sandstone heads and cills to match. It is acknowledged that this alteration does see a variation to the original building and indeed on a visible elevation. The scale and proportion of the windows does align with the original building intent and with windows recessed into the walling the shadowing provides the appropriate setting for these windows.

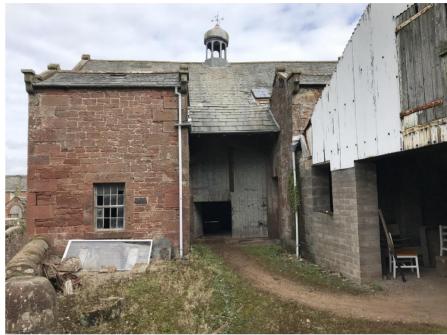
Decay and rot to the current gin house structure has been identified and repairs to the original timber structure is beyond repair. The proposal seeks approval for reducing the depth of the gin house by a single bay and therefore sees the removal of the modern steel frame and block work structure to the front bay. Alongside this the corrugated metal façade will be removed and replaced with a more sympathetic timber elevational treatment.

View looking East, modern gin house wall to be moved back to allow view of existing symmetrical turreted sandstone rear outriggers

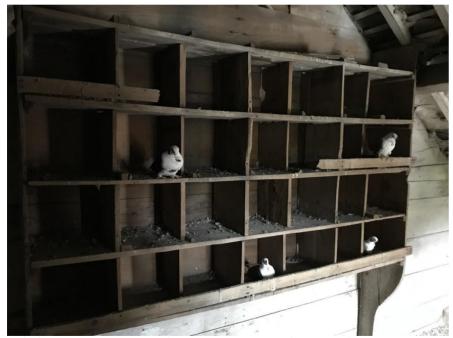
The upper ground floor is a double height space with high level pigeon loft to the southern gable, which is accessed by a winding timber staircase which is in part collapsed due to woodworm infection.

Original photo 2019 prior to access stair becoming unsafe

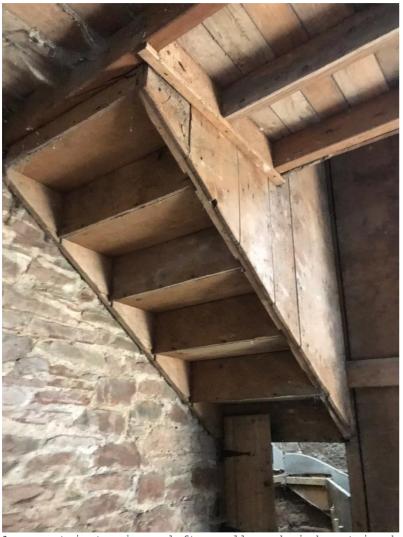
Access stair to pigeon loft - collapsed winder stair shown preventing access to loft level

To the south gable the current pigeon loft will be repaired / re-instated when safe access is gained, to allow this a full replacement winder stair is required to be re-constructed. This will remain as designed floating within the loft area of the barn and siting on the bottom chord of the king post truss.

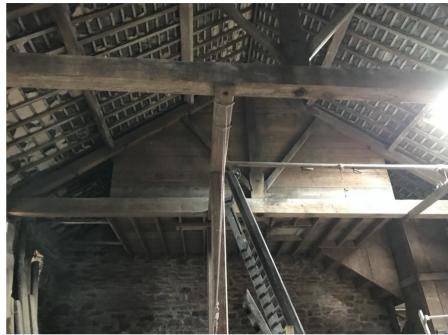
Double height barn with kingpost truss and pigeon loft bearing on truss chord

- 3. Roof Truss the existing king post trusses will be retained within the building and exposed as a feature all timbers will be retained and treated for woodworm following a high level inspection. It is the intention to retain similarly the purlins forming between the trusses (in contradiction to the SE report), this was required due to the additional loadings placed upon the structure as a result of the thermal upgrade, however as the barn is now a Listed Building the thermal upgrade can be limited to within tolerance of the current roof structure.

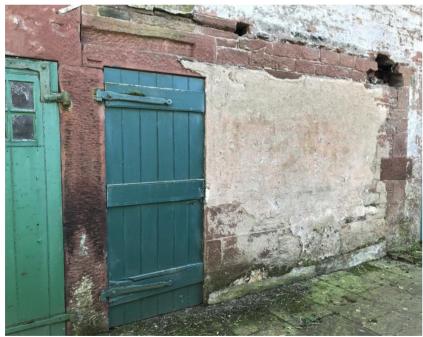
Limewash to existing wall in area of previous structure. Stonework to be patched into existing wall and sourced from sandstone on site

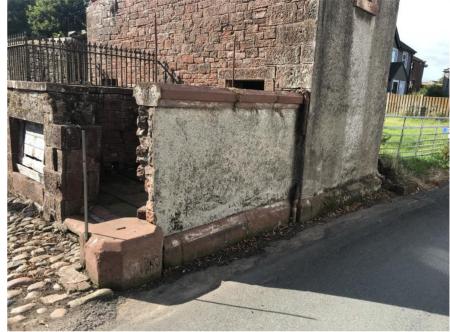
Former gate stoop to North corner of site - matching gate stoop to South corner of gate now lost as part of earlier entrance widening

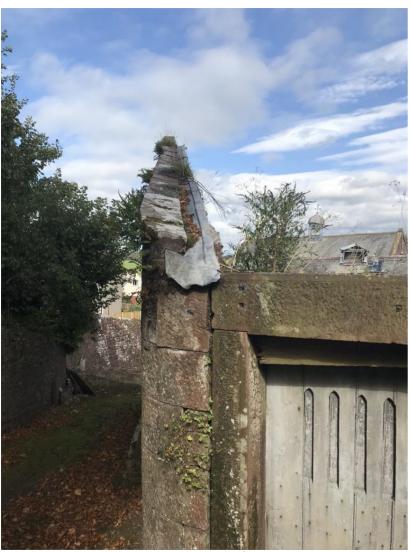
Remaining elements of the stable / boiler house with parapet and leadwork in tact, roof has been collapsed for over twenty years. Works will stabilise the wall and allow long term retention of the built form.
