**PLANNING COMMENTS FOR
12 CATHERINE STREET,
WHITEHAVEN,
CA28 7PA**

**PROJECT NO.
MGC/PD/44656-Ms003**

Date: 8th February 2021

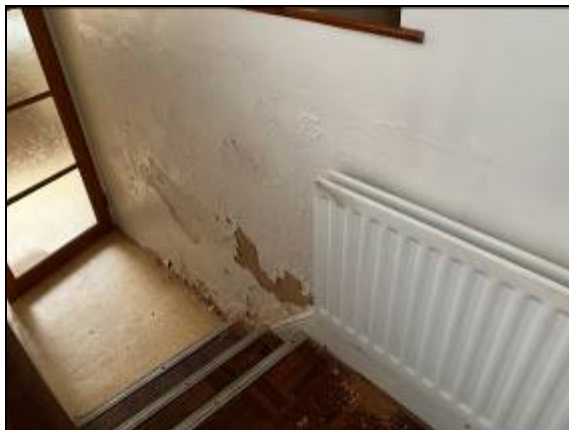
The existing rear extension is of poor quality and lacks any character and detailing to enhance the existing building. The existing extension has been built and results in a step down into the kitchen resulting in an area that is divorced from the main level. There are two places for egress reducing usable space within the dining room, hallway and kitchen.

Fig.1 - Steps in hallway

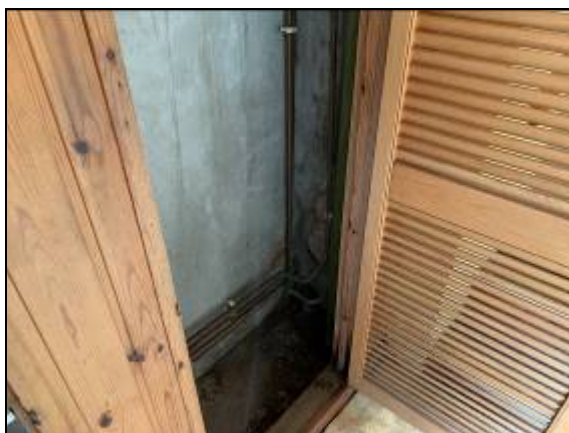
The layout is impractical for modern living due to excessive circulation areas/space for compact living, dining and kitchen areas. There are a lot of areas indicating dampness to the walls which will need attention to be rectified.

Fig.2 - Cupboard in kitchen shows inadequate insulation to wall and plumbing/heating pipes

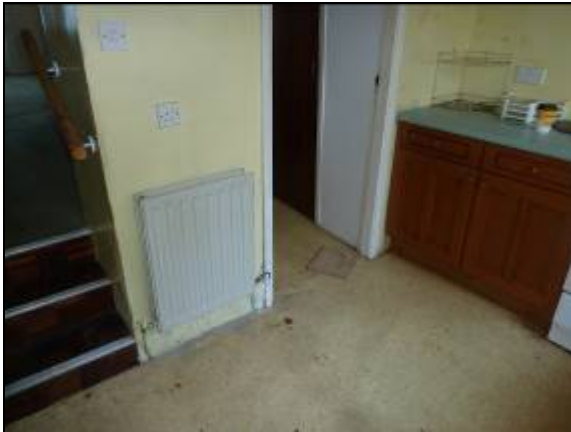
Fig.3 – Steps into lounge and hallway steps

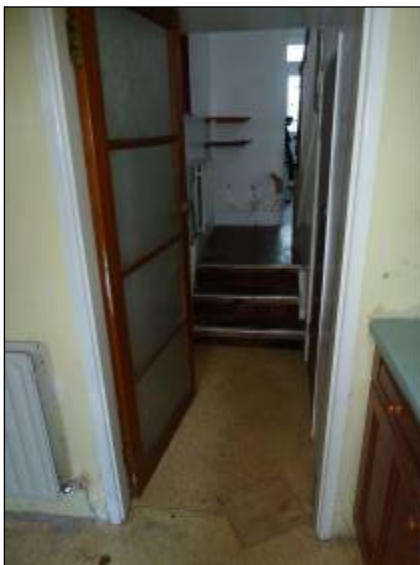
Fig.4 – Steps in hallway

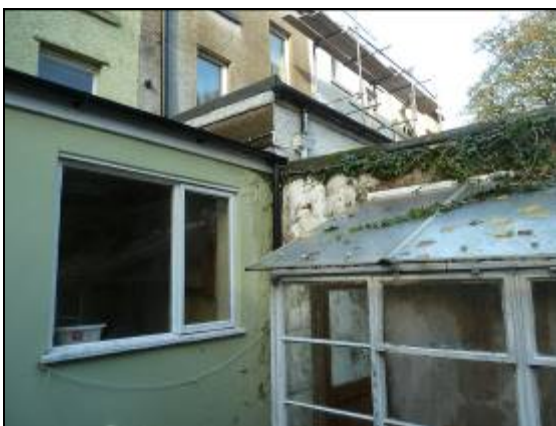
Fig.5 – Lower level of extension

The felt flat roof, cavity walls to the party walls and external elevation will need to be removed. The cavity walls will be rebuilt with additional insulation to the cavity to meet current Building Regulations. Any voids remaining to the ground floor will be ducted to external air, increasing air flow and preventing no air flow throughout. The raised kitchen floor will be a solid concrete floor which will have floor insulation and electric under floor heating. The external walls will be rendered with a sand/cement render with a smooth finish. The surface will be painted with a breathable external paint with a suitable colour advised by the Conservation Officer.

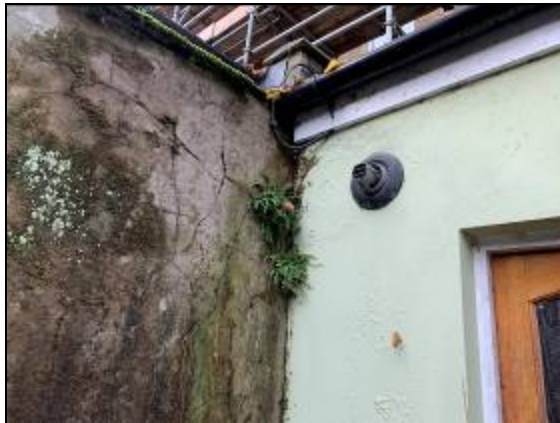
Fig.6 – Junction at party walls

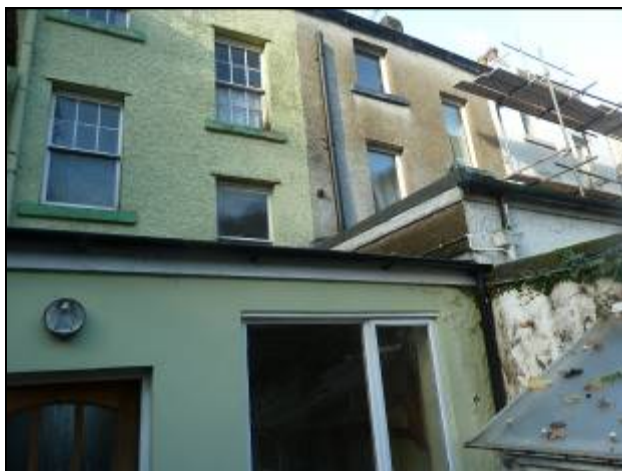
Fig.7 – Parapet detail to finish above adjacent flat roof.

A parapet wall will be formed to match existing extensions and will be weathered using lead flashing and soakers all around.

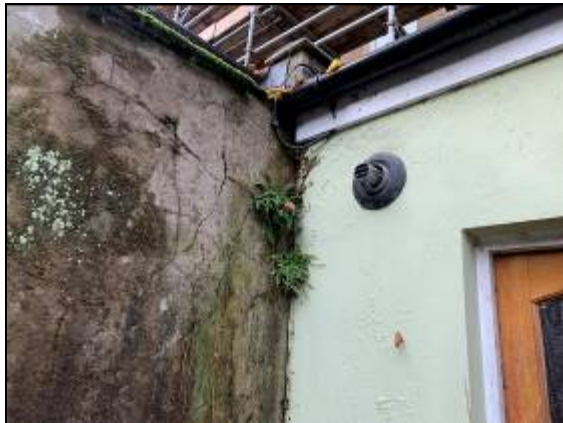
Fig.8 – New parapet detail to front of rebuilt extension to form better detail and weather proofing

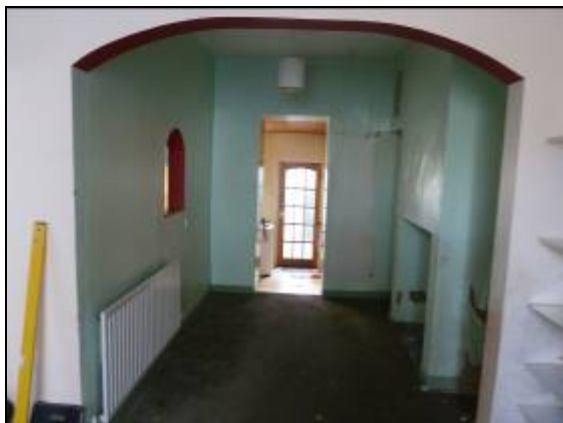
Fig.9 – Existing opening in dividing wall and opening down into the kitchen

To allow a more functional layout and use of the total ground floor an additional 1600mm of wall needs to be removed to allow a steel beams to be positioned to support the structure above.

Part of the wall will need removal and adjustment at the top. Alteration to the ground floor staircase and landing is required to open up the ground floor accommodation.

The existing construction of the wall would still remain as is shown, so keeping the historical construction. But the beam above the door and opening would be replaced with new steelwork.

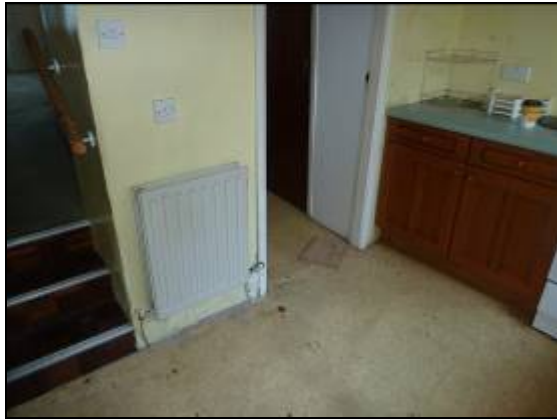
Fig.10 – Existing openings in dividing wall and opening up into the dining and hallway

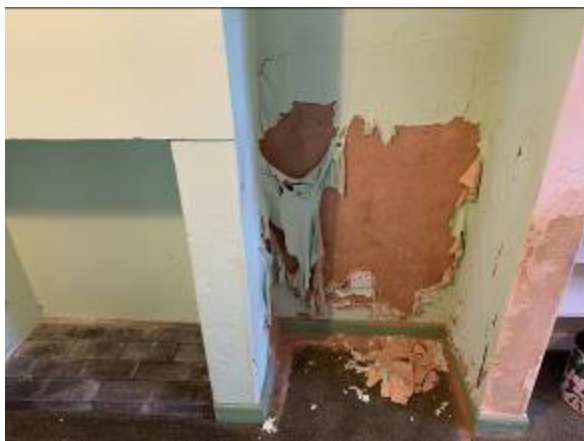
Fig.11 – Existing chimney breast in the dining area

Removing the chimney breast at the ground floor will allow the dampness to be attended to by allowing the walls to be adequately treated, dried and painted. The loose laid blocks that are sat on the floor will be removed and the brickwork will be removed up to a height to allow supporting steel angles to support the remaining chimney breast area.

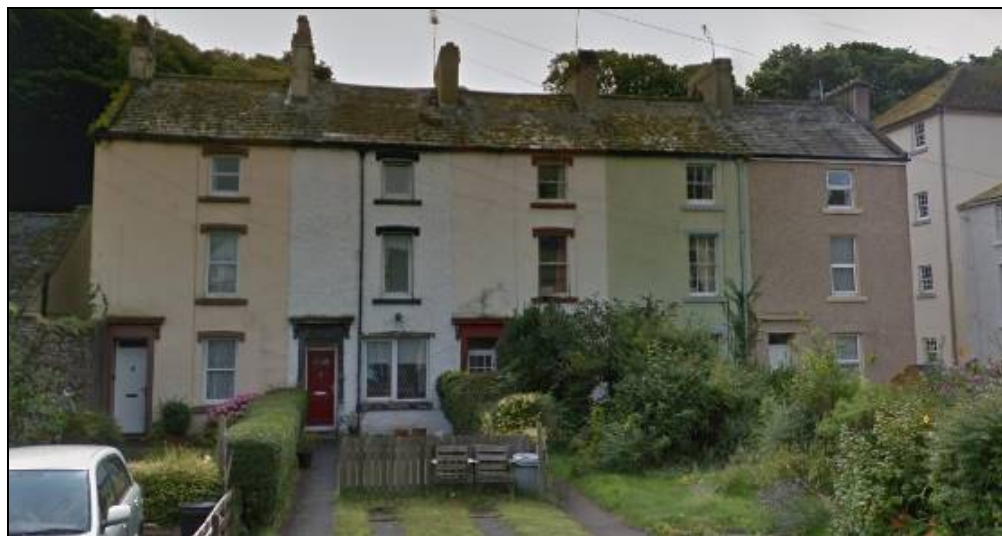
Fig.11 – Existing window styles to the block of houses showing the different styles and configurations

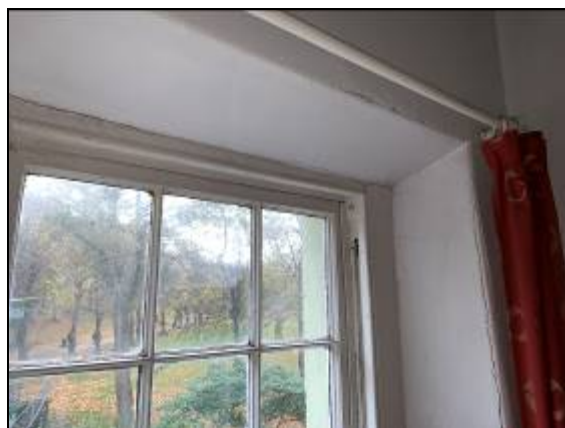
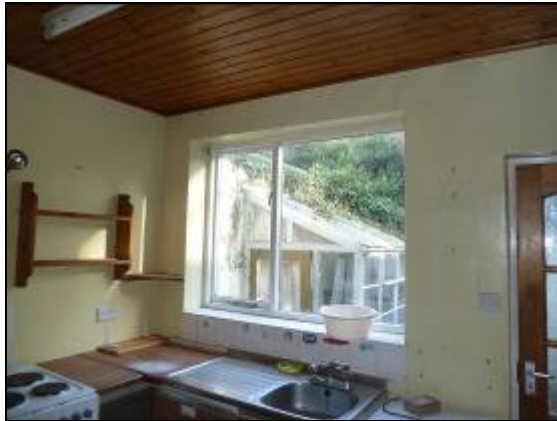
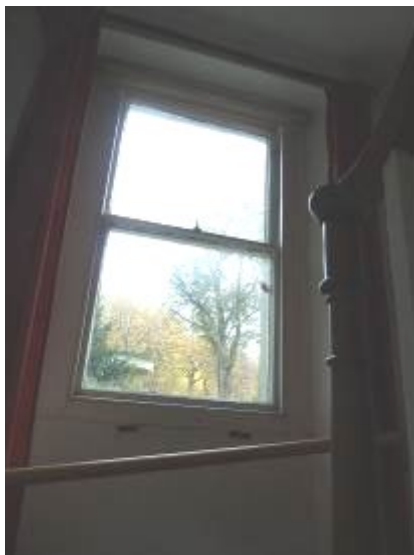
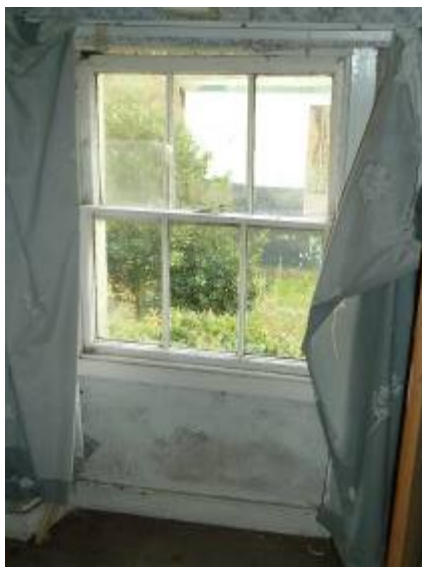
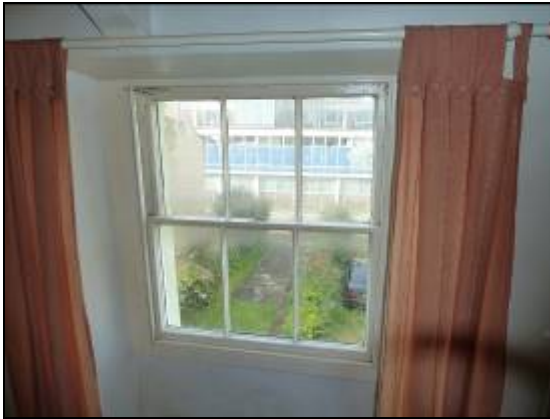
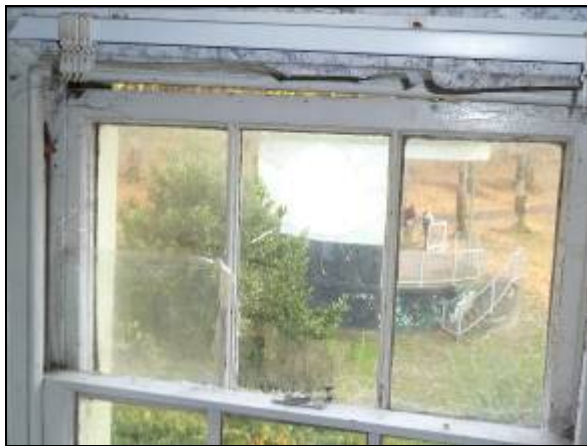
The existing windows are all timber sliding sash type apart from the window to the rear extension. All the windows are single glazed, do not have trickle vents (for background ventilation) have poor energy performance and have not been maintained for many years which has led to rotting timber, snapped chords and rusted pulley wheels.

To increase the thermal efficiency, living environment and maintenance of the property it is proposed to replace the windows with uPVC sash windows that will be configured to match the ones being replaced. Replacement uPVC windows will be detailed as shown in figure 23 in a traditional sliding sash layout and detail.

The existing windows will be replaced and the reveals made good to allow the fitting of replacement uPVC double glazed windows. The new windows will be fitted in the same elevational plane as to retain the aesthetic of the block. The windows are thermally efficient, have thin profiles and have a "A"- rated energy efficiency. This will provide adequate escape, energy performance and the ability for cleaning. It is our view the new windows will greatly enhance the current property. See figure 23.

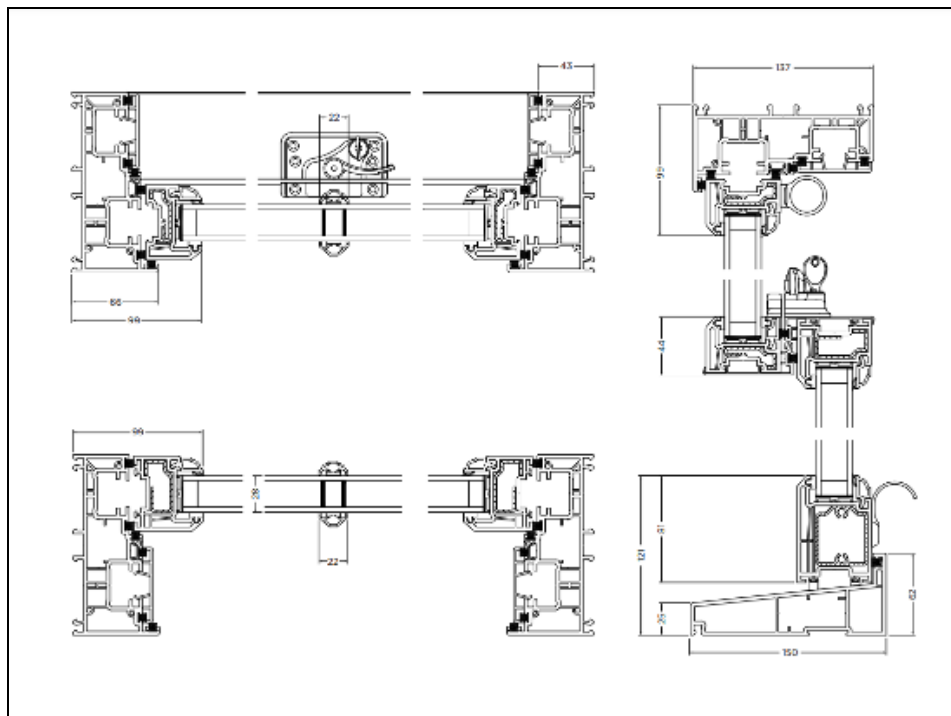
Fig.23 – New uPVC sash window details, showing the profile sections and narrow glazing bar
