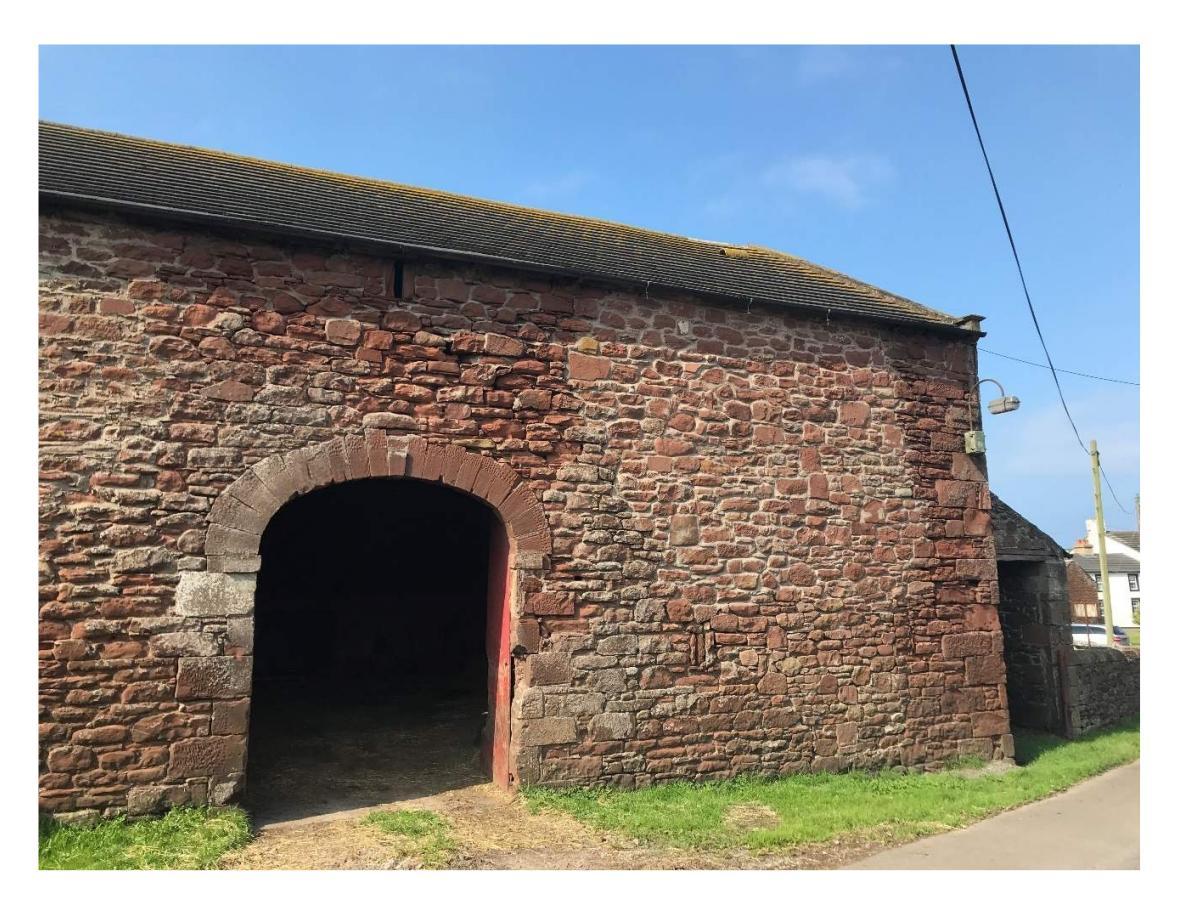
Figure 3.15 – Area of rebuild

The rebuilt section of the wall appeared sound at the time of survey but still displayed some undulations. We would recommend this is monitored over the next year. The arch had dropped and the area of stone above it would appear to benefit from being taken down and rebuilt, with the arch reset at this point. This area is particularly susceptible to movement due to how flat arch is. We were unable to closely inspect the roof but it appeared relatively sound upon inspection from the ground floor.

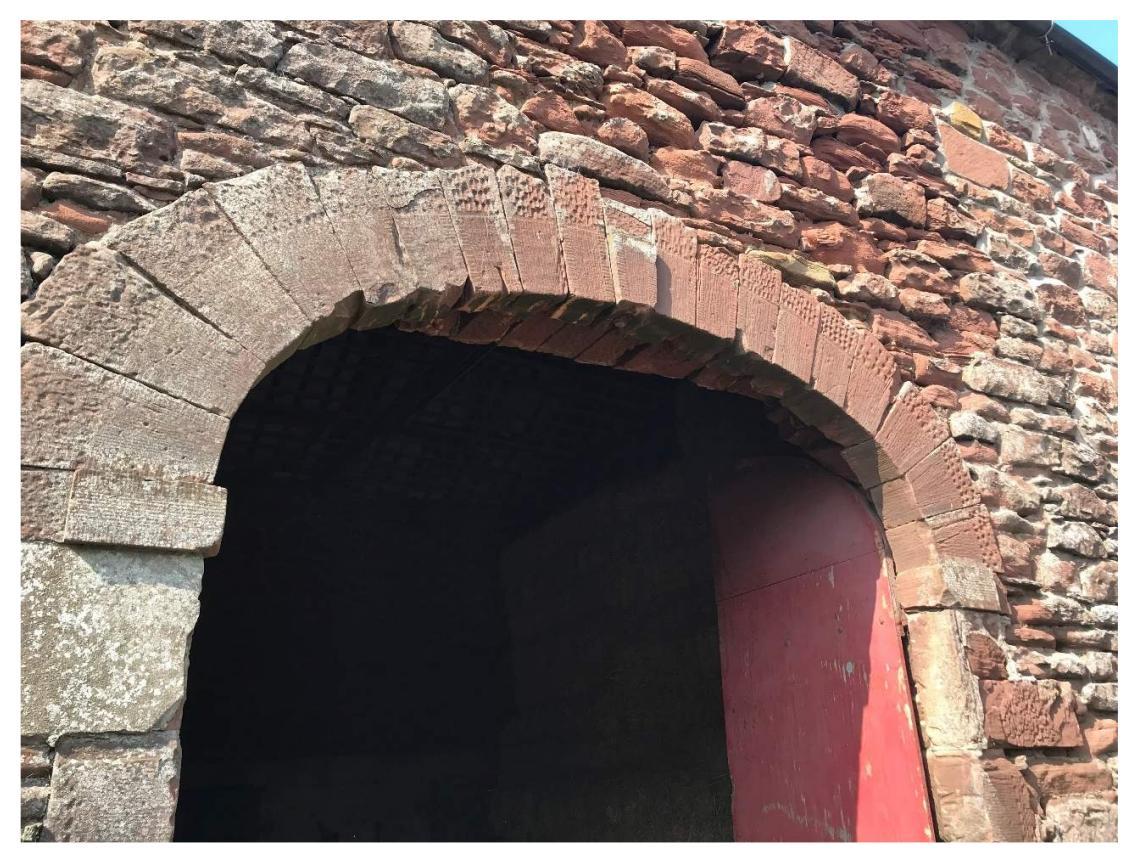
Figure 3.16 – Dropped arch stone

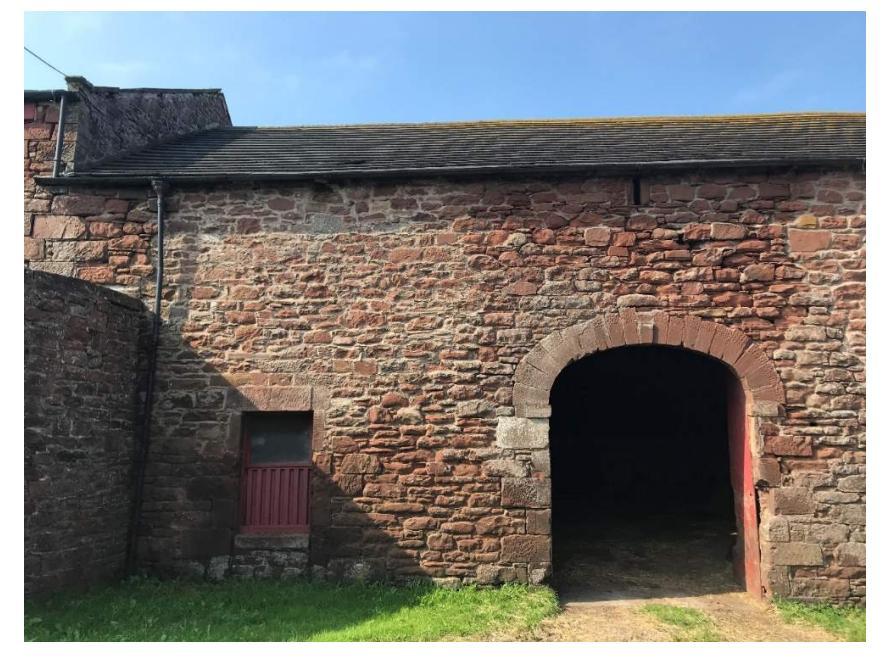
There was a slight undulation in the rebuilt section of wall, along with a slight inwards lean at eaves on the left hand side of the wall. The cast iron downpipe discharges onto the ground adjacent to the retaining wall. The roof appeared to be relatively straight and had been reroofed and the finish replaced with concrete tiles.

Figure 3.17 – Downspout and apparent rebuilt section where inwards lean noted

Several downspouts were noted to discharge directly onto the ground, which can lead to saturation of the ground around the foundations and washing away of the substrate, promoting settlement. We would recommend that any downspouts are directed into drains away from the base of the buildings.

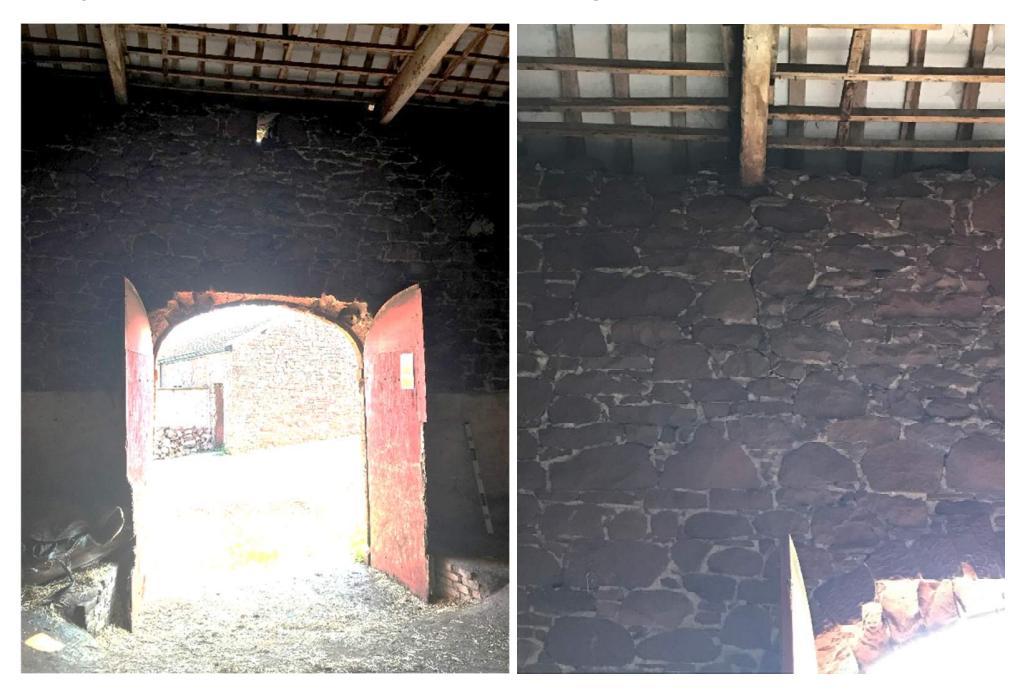
Internally, there was a concrete ground floor and a similar timber truss and purlin roof structure to Barn One. There were battens spanning between the trusses, with the area adjacent to the first floor door being used as storage. There was some cracking under the roof truss bearing over the door, some loose mortar joints and some embedded timber. The front wall and internal crosswall do not appear to be keyed in. It was difficult to view the junction with the rear wall due to wiring.

Figure 3.18 – Cut arch stones and cracking under truss bearing

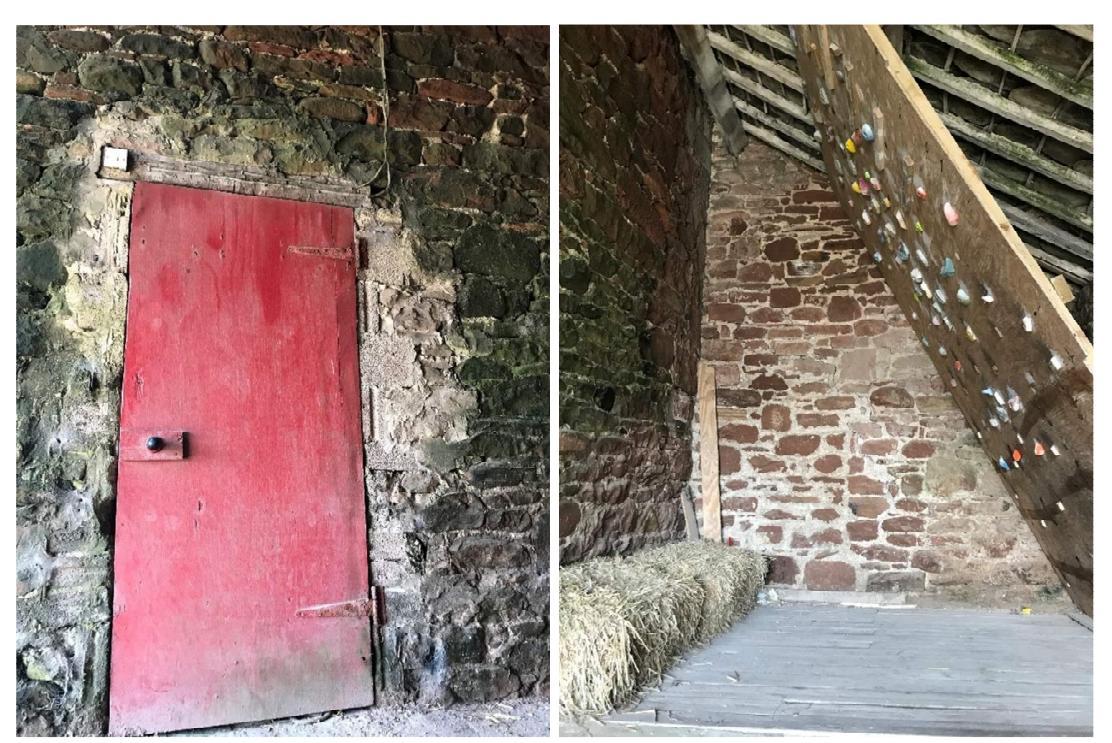
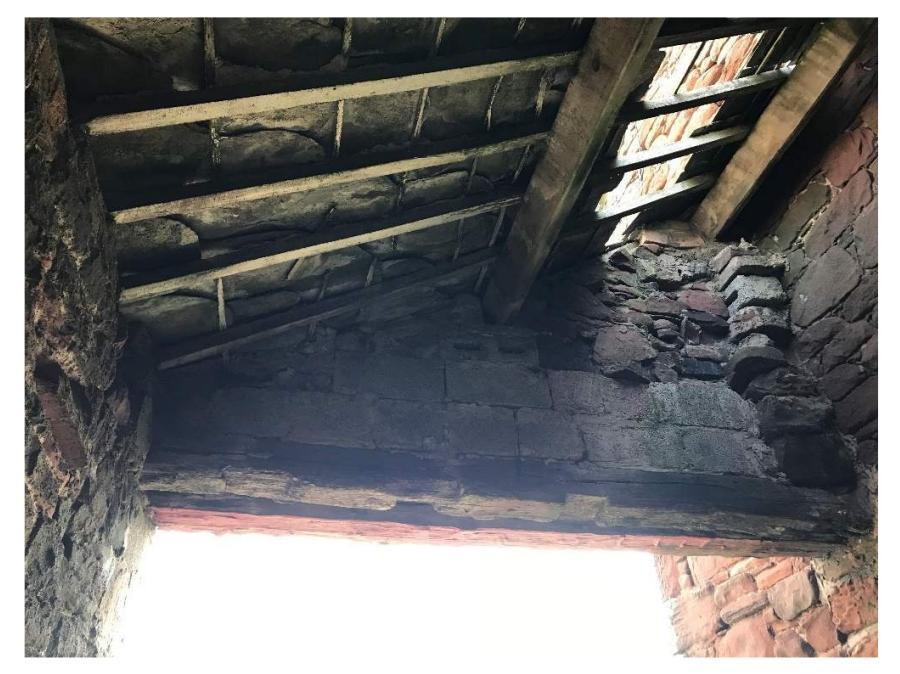
There was an another lean to extension to the north west gable of Barn Two. The walls were of stone construction, with timber rafters and purlins and a slate roof. It was open to the road side with a door through the Barn Two gable wall. There were numerous open joints with some cement patching and the rear wall did not appear to be keyed into the barn wall. There was a raised platform along the gable and rear, on blockwork, part concrete and part timber. The internal lintel over the door showed signs of infestation and had a reduced section size. There was also some blockwork and cement patching around the doors. The patching noted to the rear wall appeared to have re-cracked (diagonally away from the gable peak). There were also slates missing to the roof over the entrance.

Figure 3.19 – Blockwork patching around doors and cracking to rear wall

As at the opposite gable, we would recommend the roof of the lean to extension is removed and replaced and all loose stone at the eaves removed and reset. Whilst not showing signs of significant distress, we would recommend that the timber and steel lean to is demolished over the longer term.

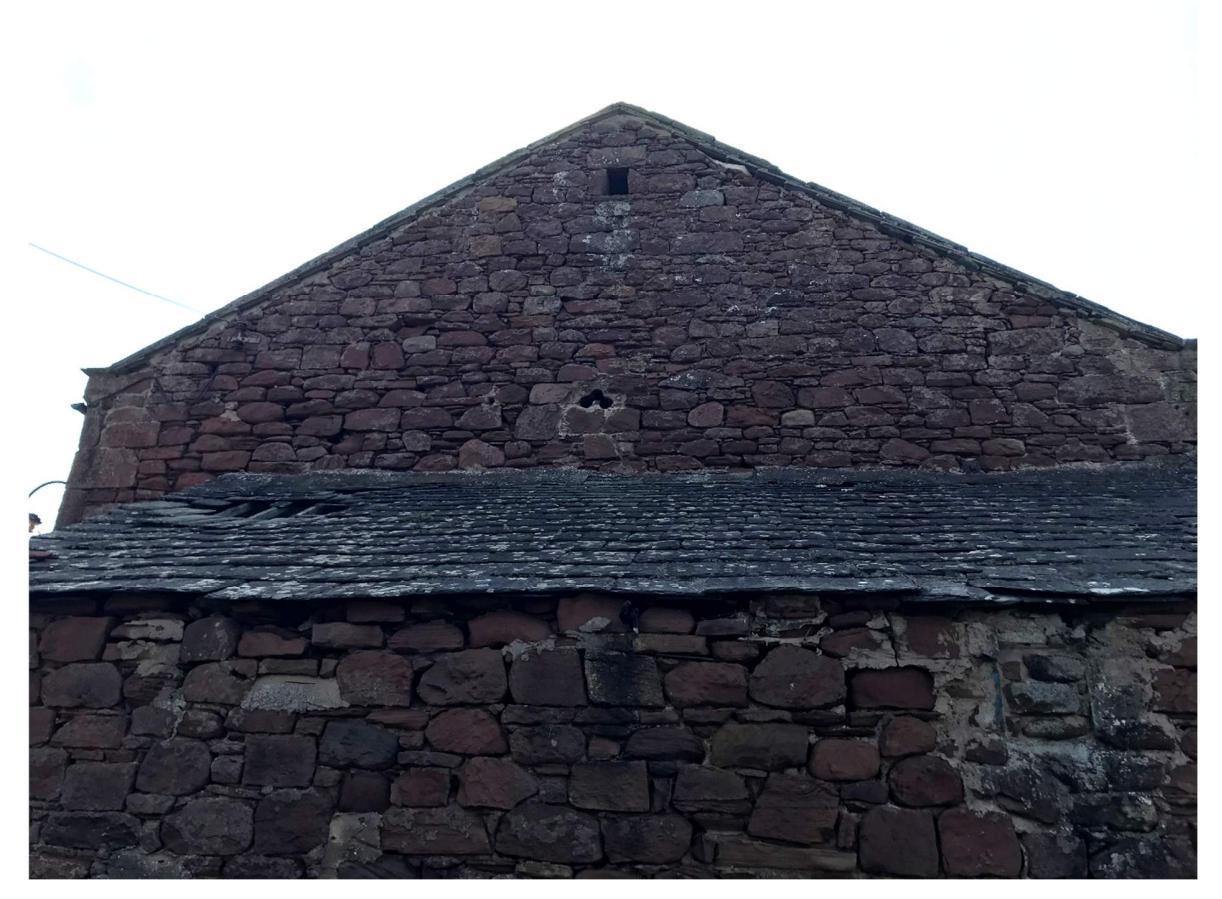
Externally, there was undulations in the roof (sagging purlins), loose and missing stones at eaves and missing guttering. There was some cement patching and some loose and missing mortar (as elsewhere). There were also areas of heavily weathered stonework.

Figure 3.20 – Lean to extension and Barn Two gable

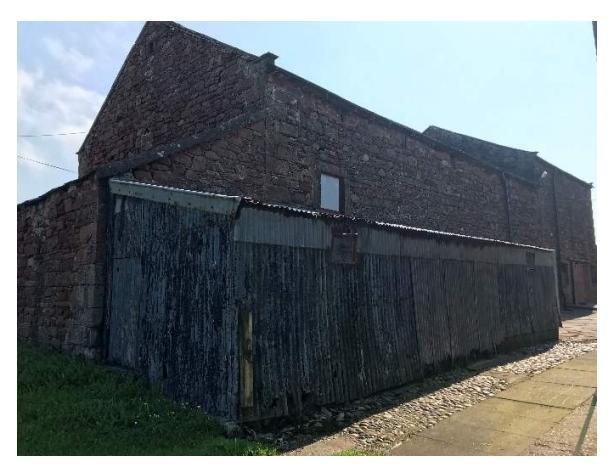
There were dry mortar joints to the Barn Two gable above the lean to roof. Missing cement at the verge was noted and a bolt and plate was observed on the right hand side just above the lower roof. Again, there was some cement patching, particularly around the eaves and the lower opening (potentially moved at some point from lower down). The timber and corrugated sheeted building to the side showed signs of decay and corrosion.

Figure 3.21 – Timber building adj Barn Two

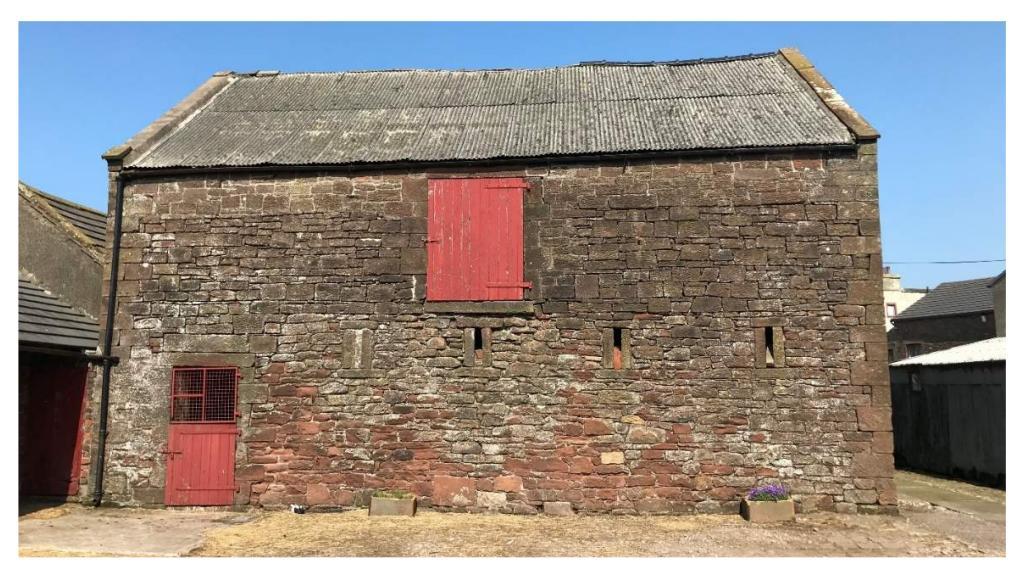
Barn Three was located at the north western end of the yard, adjoining The Cottage and Barn Four. The structure consisted of red sandstone walls, corrugated sheeting roof and timber first floor. Undulations were noted in the roof slopes and ridge, presumably sagging between roof trusses. There were dry mortar joints throughout the external walls.

Figure 3.22 – Barn Three yard side wall

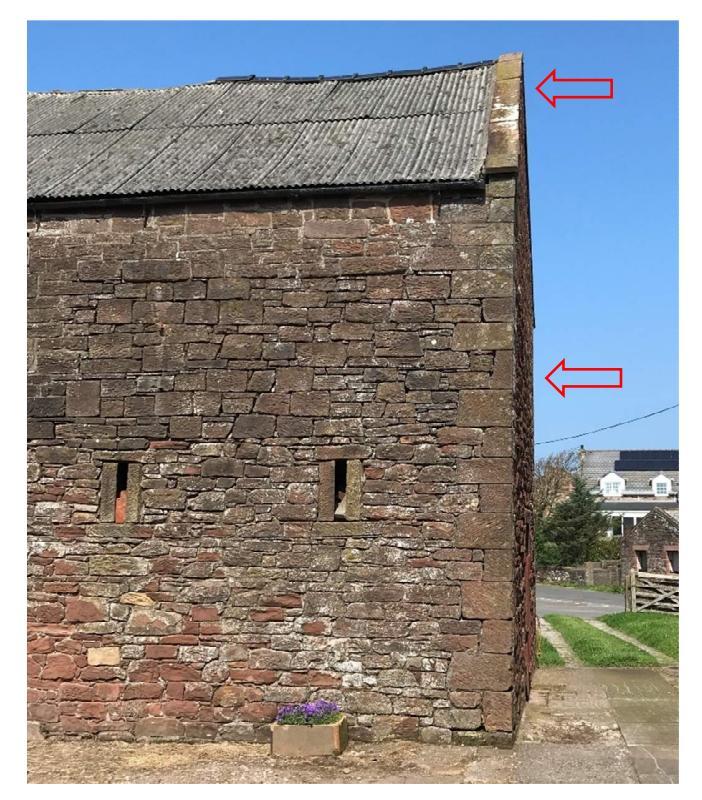
An outwards bulge was noted in the gable wall, worsening towards the gable peak, where the ridge then leans inwards (i.e the opposite direction to the bulge). There were also loose coping stones at the verge.

Figure 3.25 – Bulge in first floor wall and lean at ridge

Barn Three appeared to suffer from very similar issues to Barns One and Two, with some movement in the gable, likely due to lack of bracing in the roof. It is difficult to say from one site visit whether this movement is ongoing, so we would recommend that it is monitored over the next year.

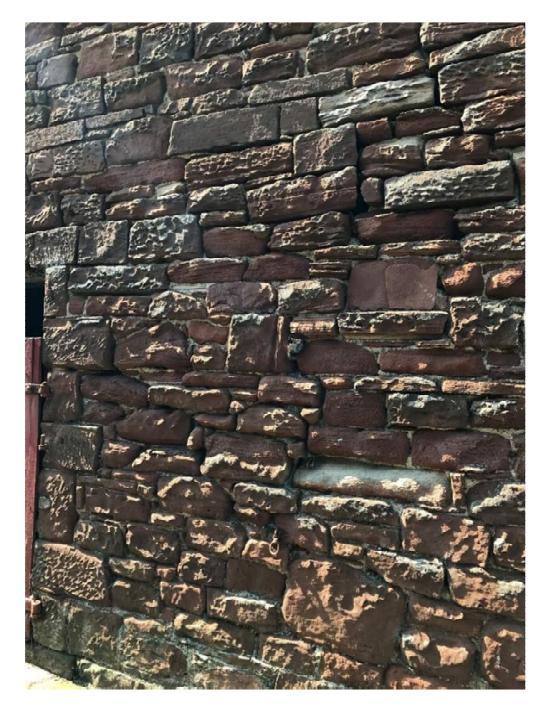
Heavily weathered stone was observed on the gable wall along with recessed mortar joints.

Figure 3.26 – Heavily weathered stone to gable wall

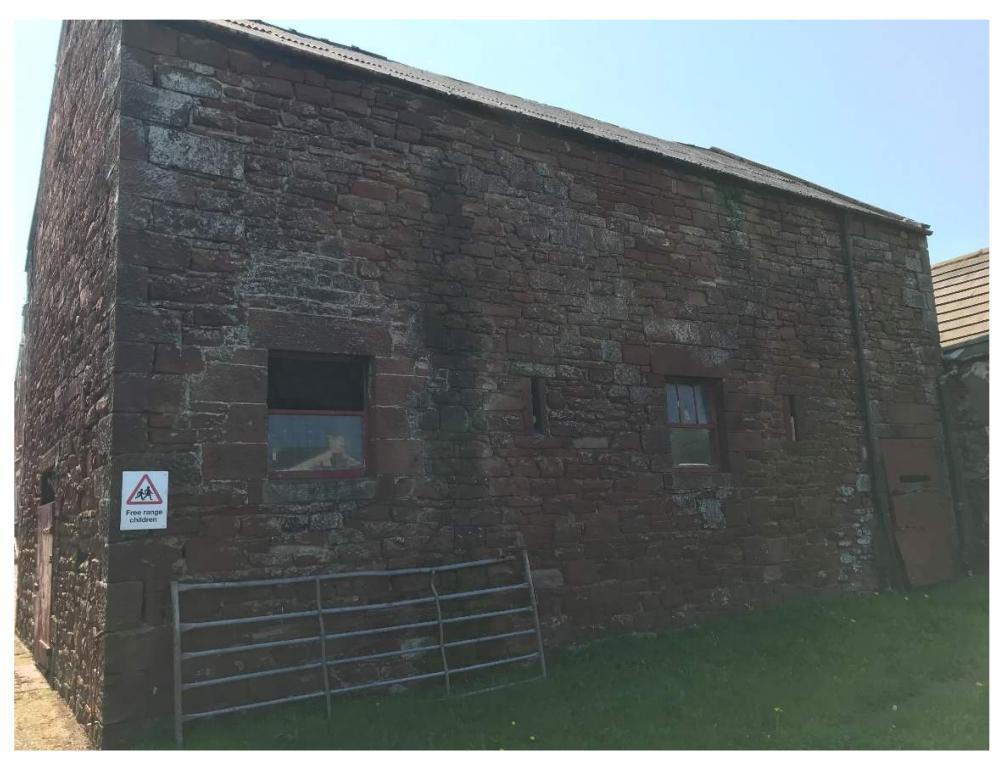
There was staining where the gutter had appeared to have cracked on the northern wall. An apparent dip in the bed joints was also noted in this area. Some loose brick infill was observed between Barn Three and The Cottage. The downspout adjacent also discharged directly onto the ground.

Figure 3.27 – Staining to northern wall

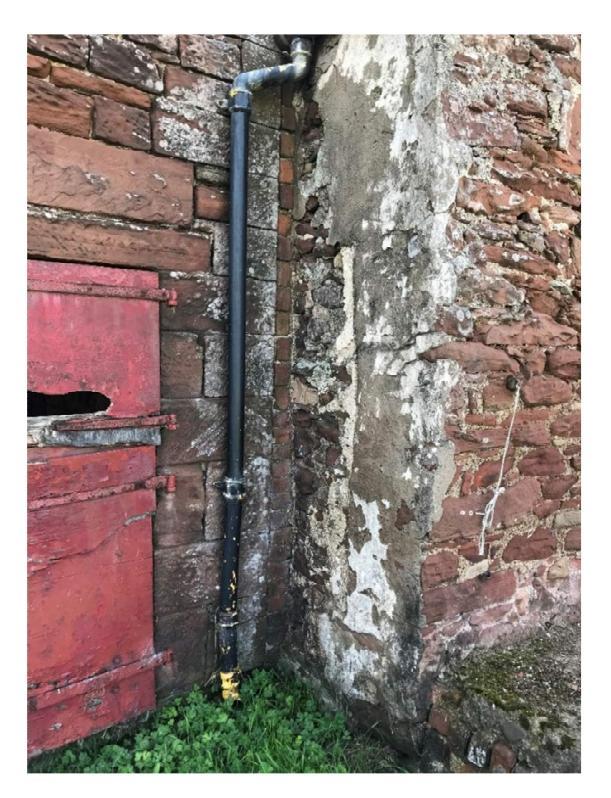
Figure 3.28 – Brick infill adjacent to the cottage

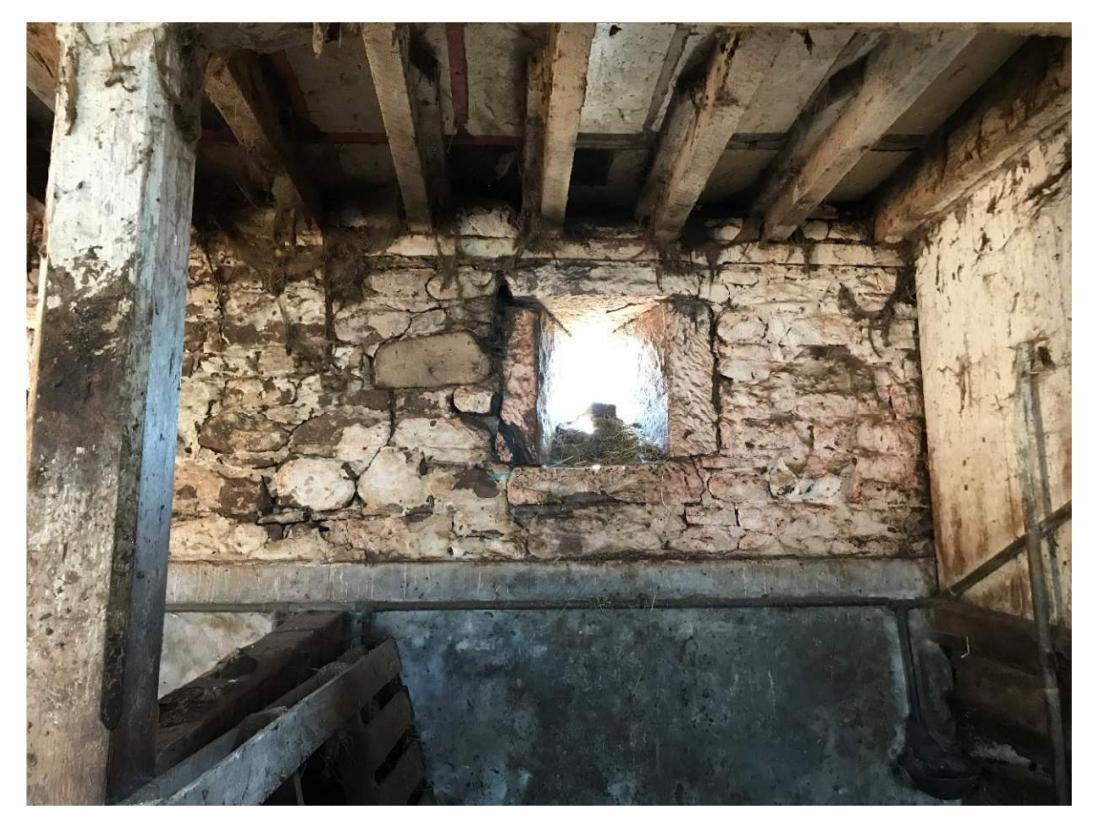
Internally, there was a timber beam and joist floor, propped on the stall posts, with a concrete ground floor. The timberwork appeared sound but there was some cracking in the wall around the yard side windows.

Figure 3.29 – Cracking around yard side windows

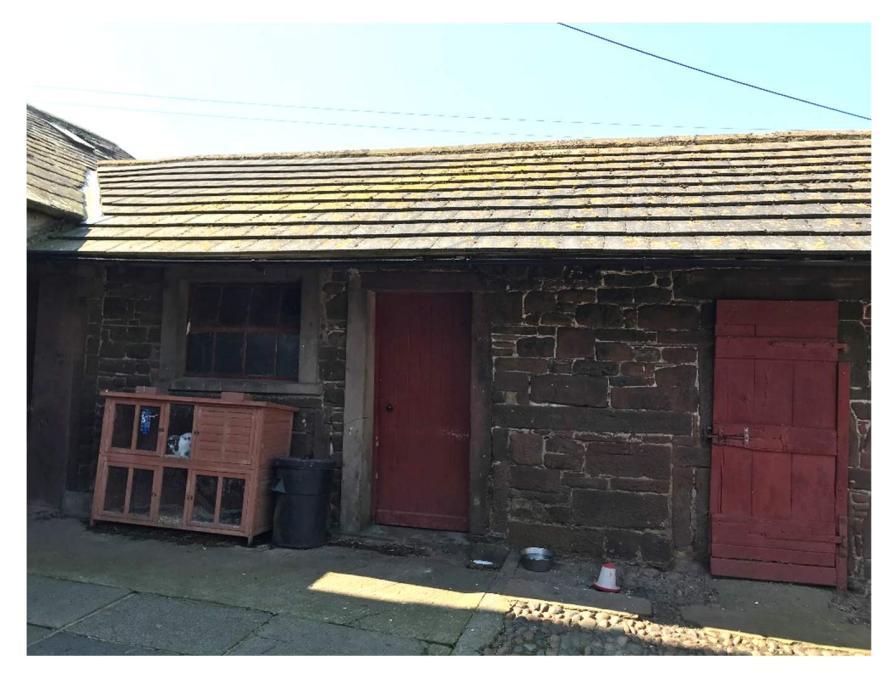
Figure 3.30 – Horizontal crack through door stonework

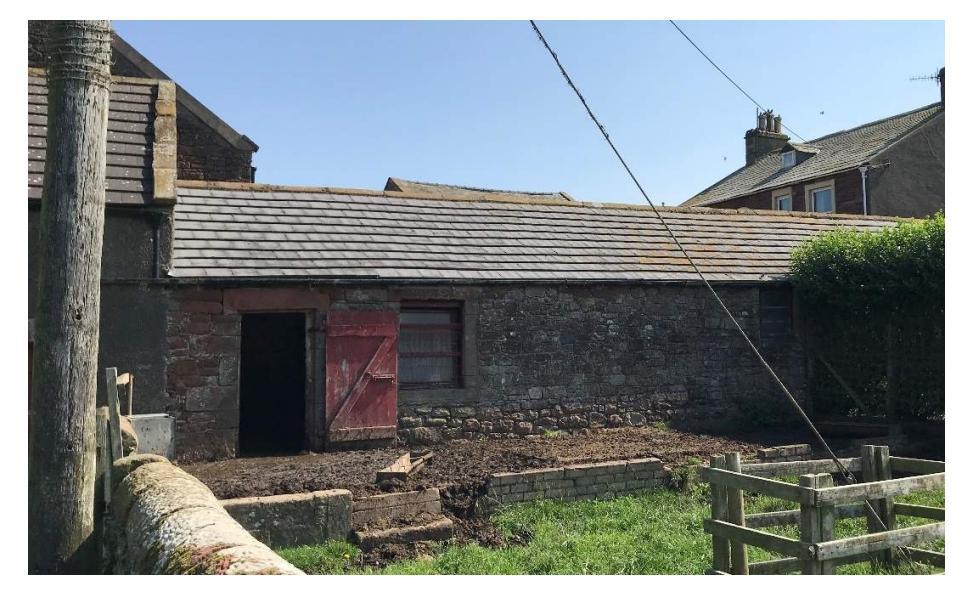
Figure 3.32 – Dip in roof adj to cottage

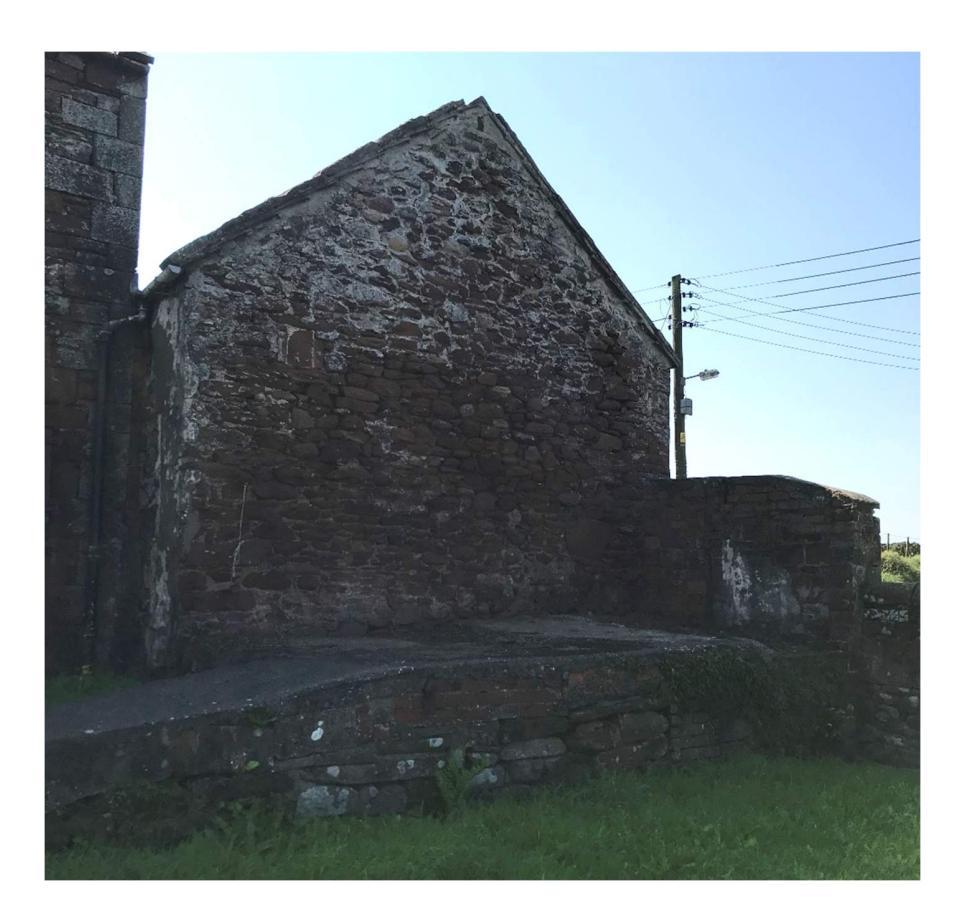
Loose stone and dry mortar joints were observed on the gable wall, with cement patching to the gable corner, gable peak and verge.

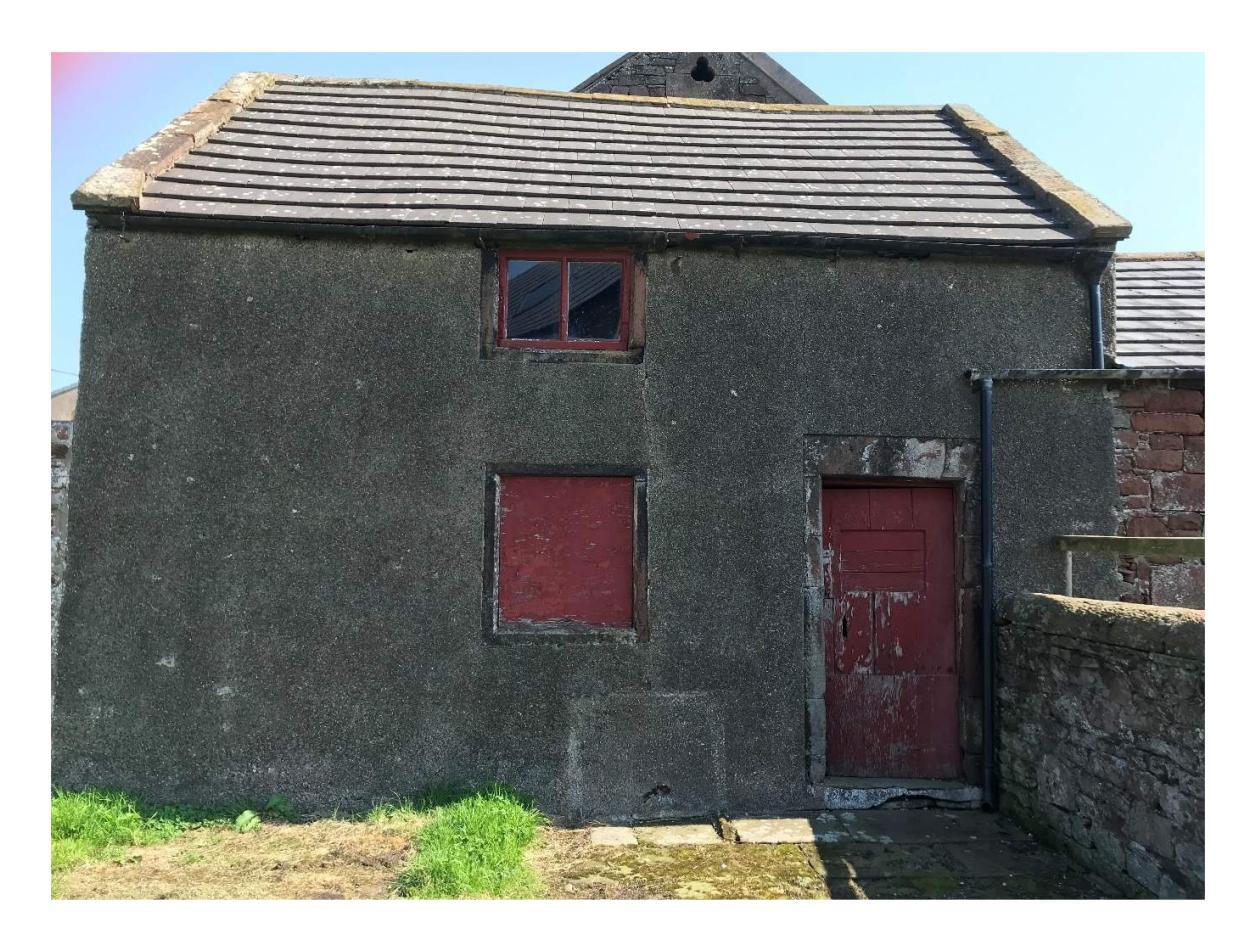
Figure 3.34 – Cracking in front wall of cottage

The roof was finished in cement tiles, with stone copings at the verges. There was a crack through the centre of the front wall with significant undulations around the windows and door. The wall dished inwards around the window and then bulged outward adjacent, between the window and the door. The difference between outwards bulge and inwards dish was measured at approximately 70mm. The downspout servicing Barn Four and the cottage discharged onto the ground adjacent to the door.

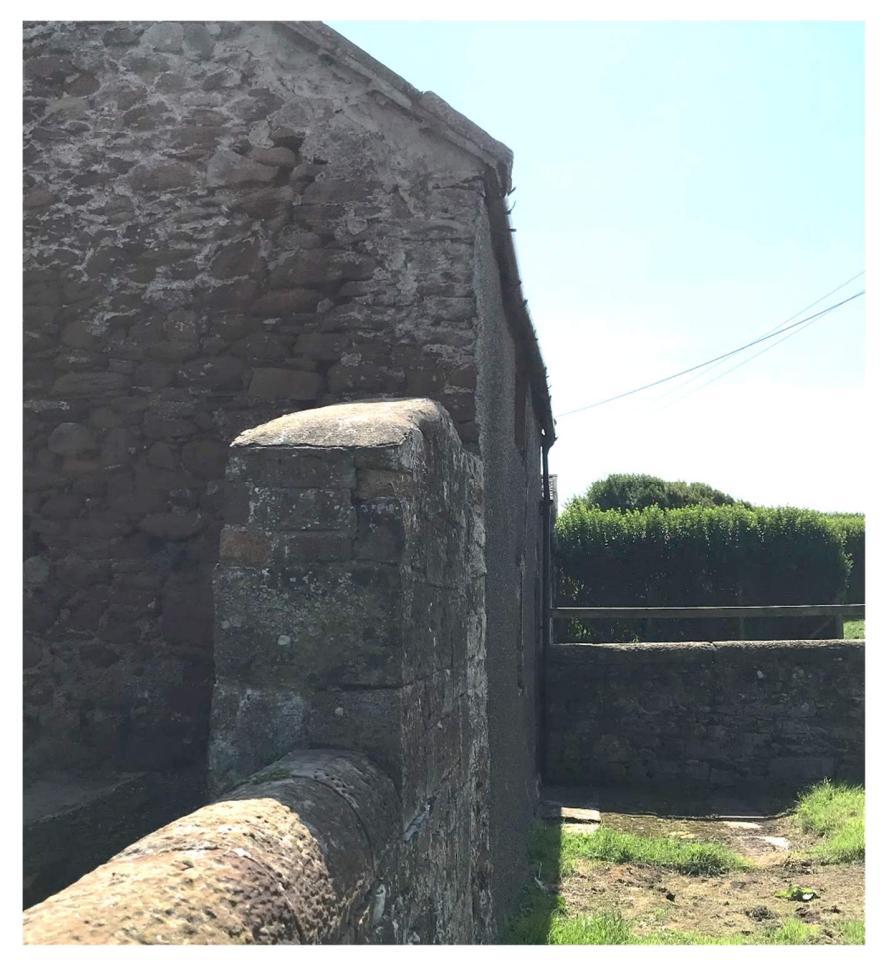
Figure 3.35 – Undulations to front wall of cottage

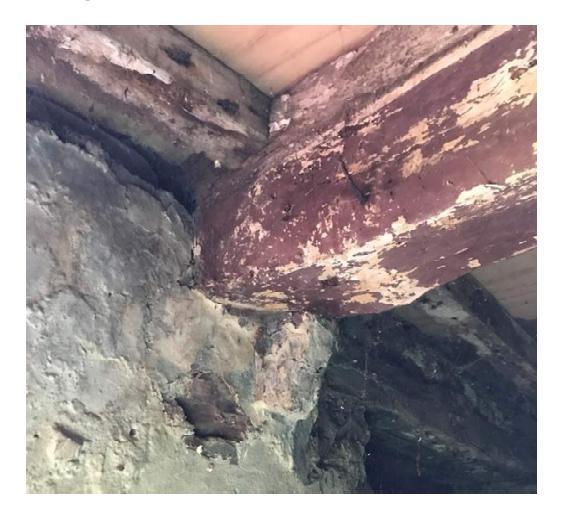
Internally, there was a stone flag ground floor and timber first floor supported on timber beams spanning front to back. All timberwork showed signs of rot and infestation. An alcove in the internal crosswall with Barn Four has a timber plank lintel that had deflected significantly. There was significant cracking adjacent to the front door and the fireplace lintel had snapped in the centre and dropped at the left hand side. There was also significant deflection in the timber beams over the fireplace. We also observed a pull on the first floor beam bearing on the front wall.

Figure 3.36 – Front beam bearing

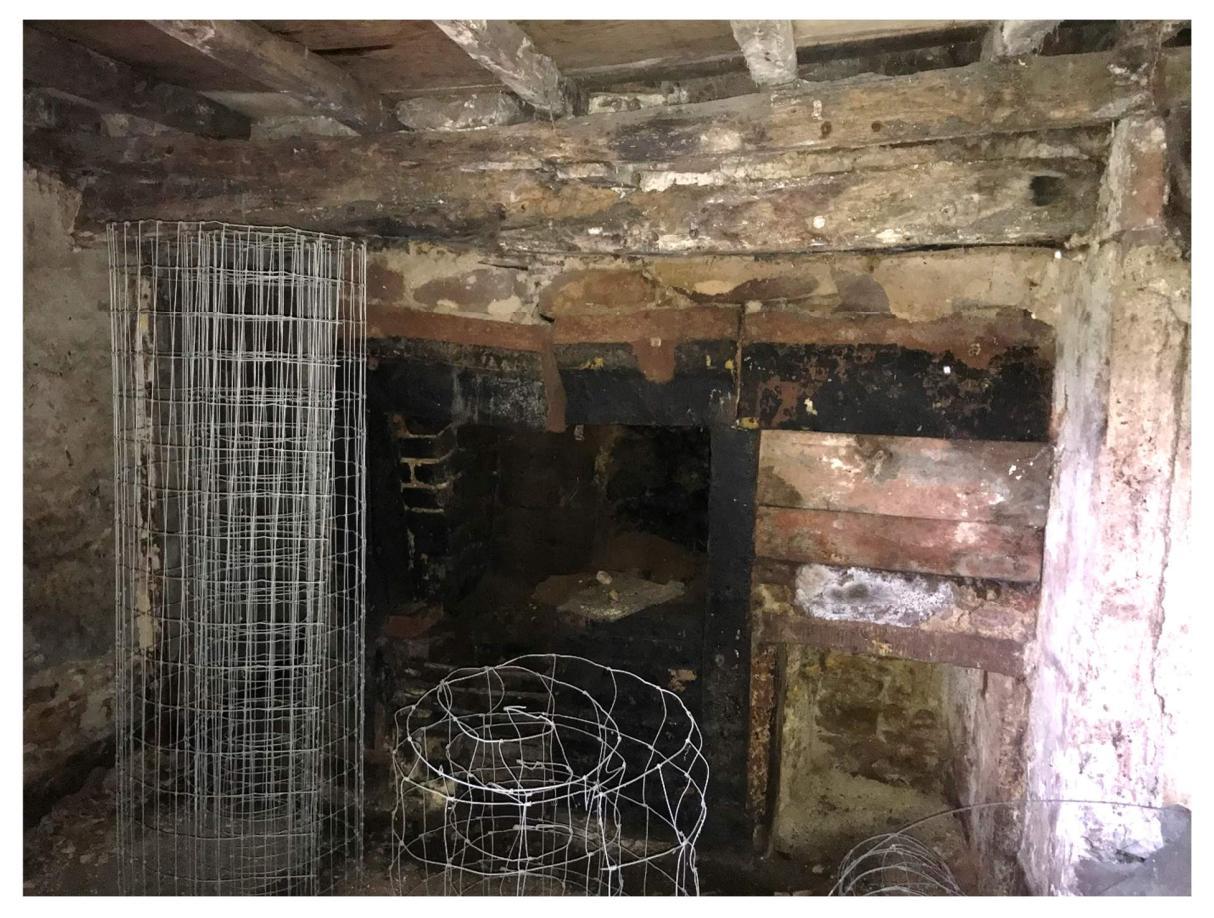
Figure 3.37 – Split fireplace lintel

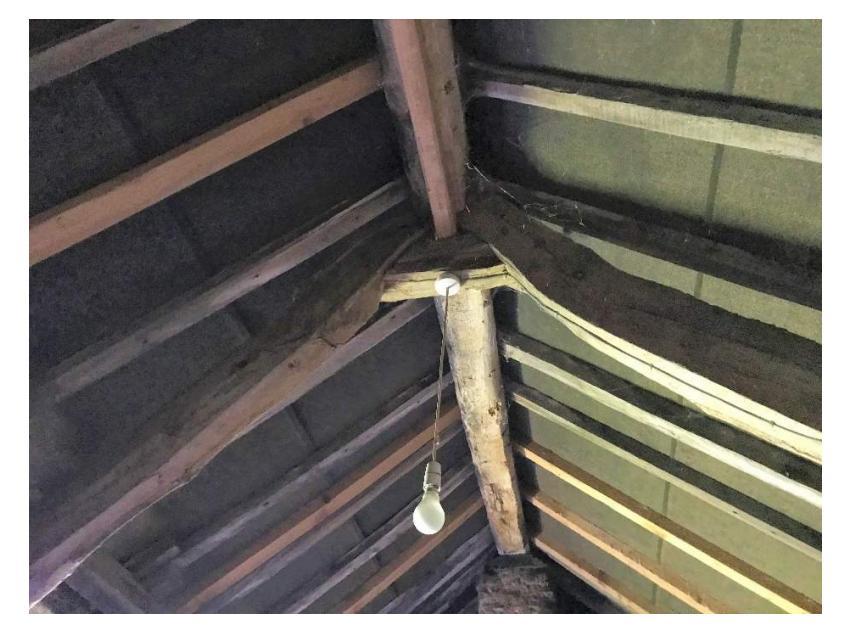
The stone staircase in the eastern corner led up to the first floor, through a timber door and partition. The door stuck when trying to open and close. The roof was supported by a truss which had a collar arrangement at the ridge – it was unclear whether this was original but did appear to be a similar age to the other timber. An additional timber had been installed beneath the ridge between the truss and the Barn Four gable.

Figure 3.38 – Roof truss apex

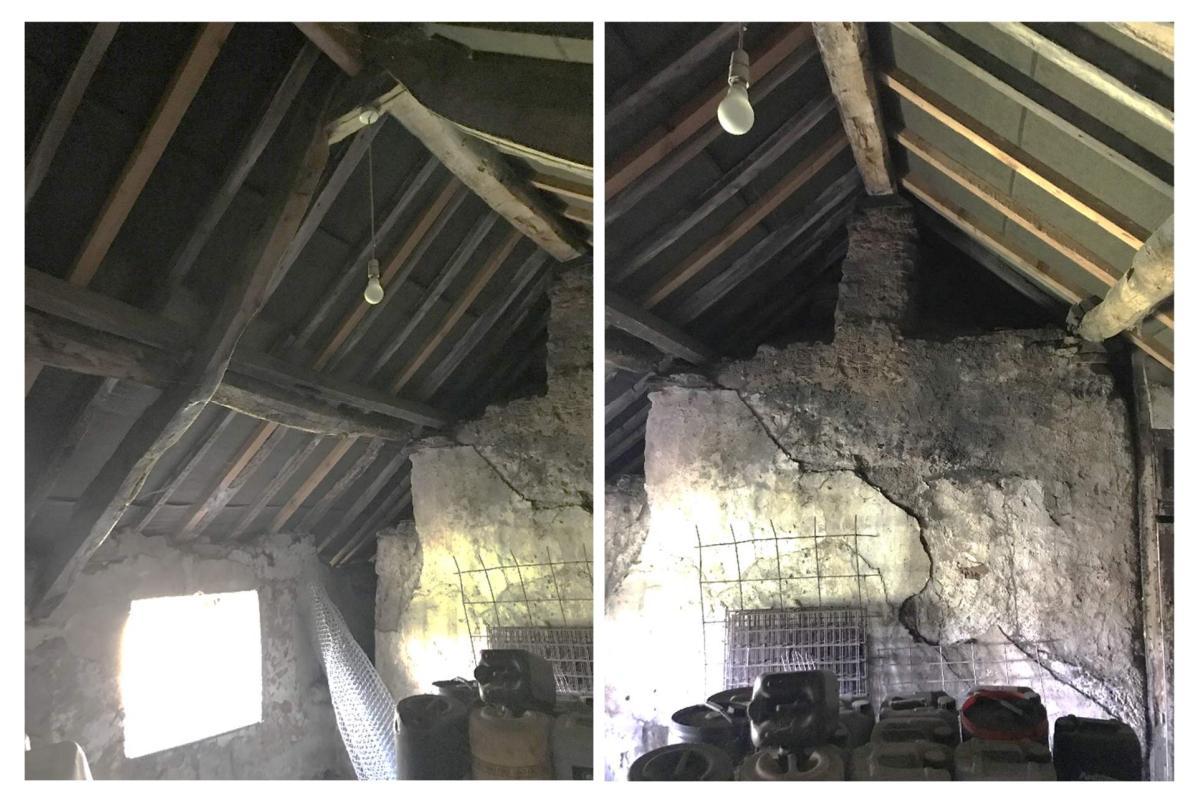
Figure 3.39 – Roof structure

A twist in the truss rafter was observed at the bearings when viewed from directly underneath the apex. There was also a drop in the purlins, particularly over the stair partition. Loose stonework was observed at eaves level and the stonework pier supporting the ridge was noted to be leaning to the rear (although there was little, if any cracking so it could have been constructed this way). We were unable to inspect the chimney breast and gable wall on the first floor due to the unstable nature of the floor.

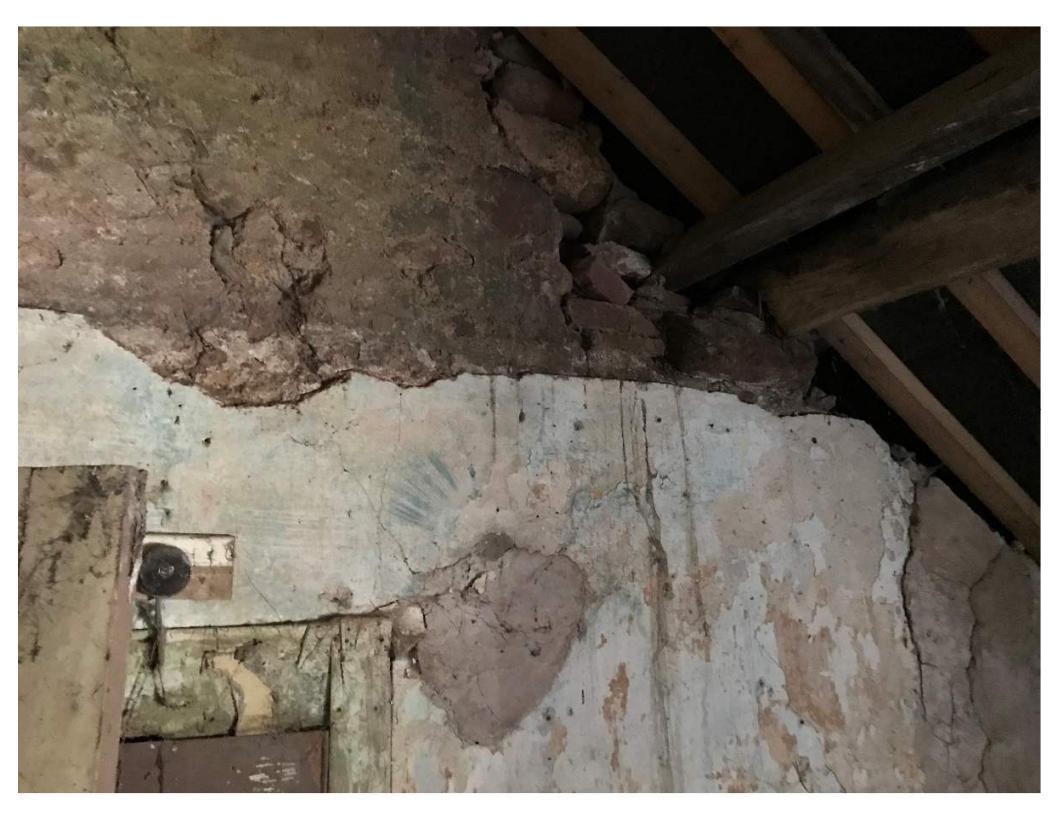
Figure 3.41 – Gable wall cracking at purlin bearing

A series of cracks were noted on the gable wall adjacent to the stair, with several areas of loose stonework, particularly around purlin bearings. The roof appeared to have been reroofed, with new loose rafters and felt. The cement tiles externally were the same as elsewhere.
