## Ecology Team Consultation Response

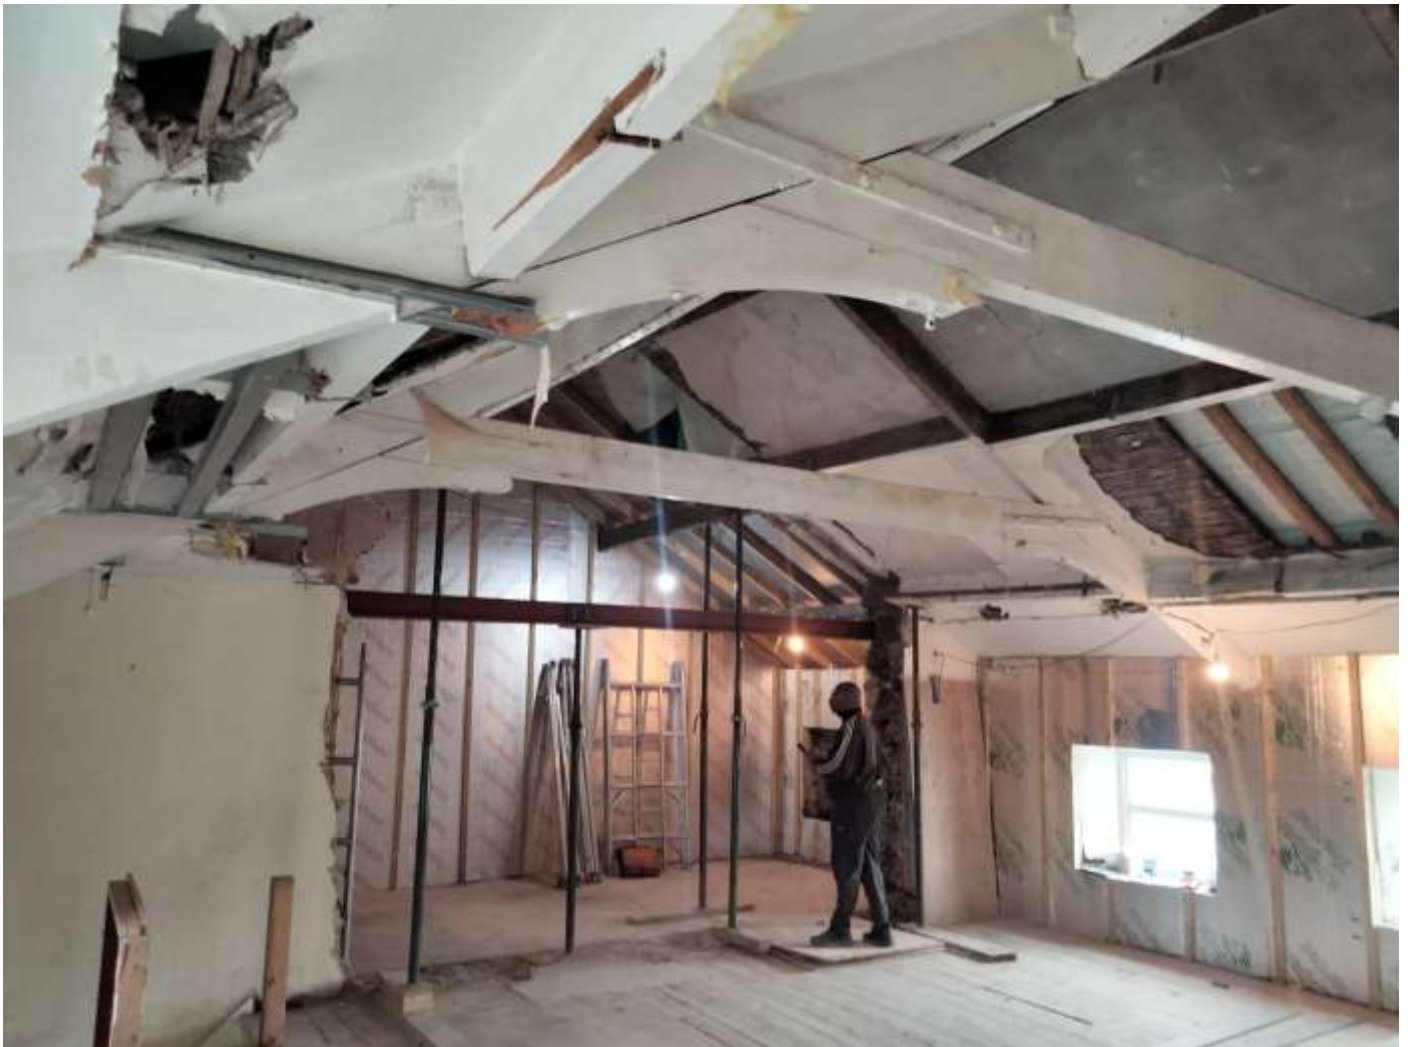
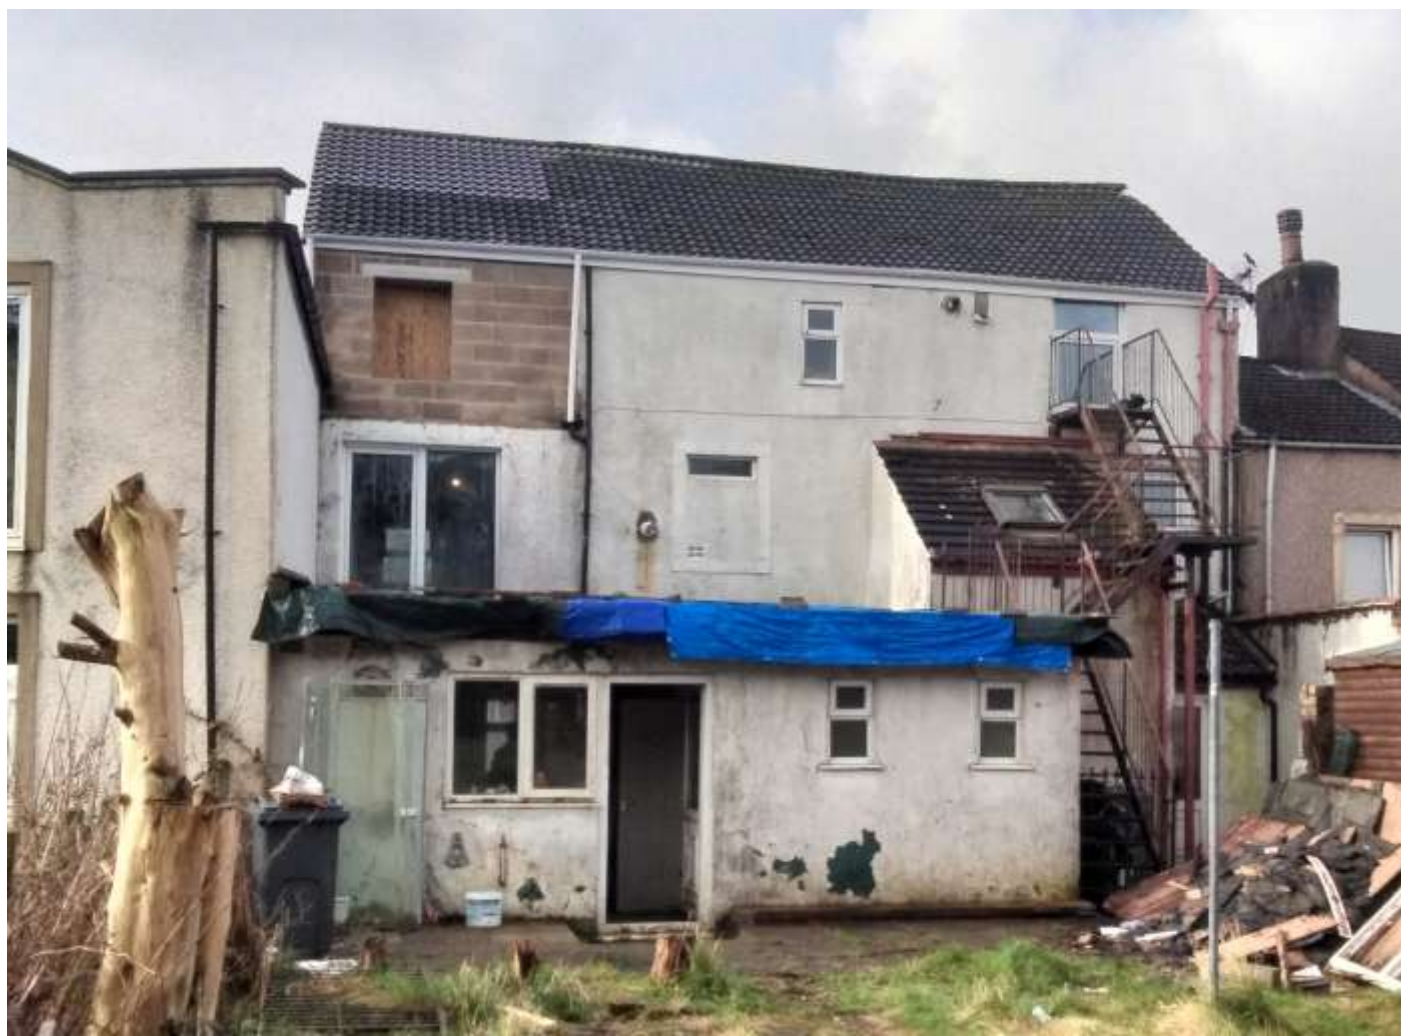
There is no loft void to the existing building, the roof space being open internally to the existing second floor.

Furthermore, the roof finish to the existing building is in a good state of repair, with close fitting tiles. There is no opportunity for bat roosting within the Tile-Felt void.

Finally, during the ongoing site works no evidence of bat roosting has been observed.
