Arboricultural Impact Assessment

Underwood
The Hill
Millom
LA18 5EZ

April 2024

Job no.	LTC237
Site	Underwood, The Hill, Millom, LA18 5EZ
Client	Mr and Mrs Slack
Agent	HM Architecture (NW) LLP
Arboriculturist	Jennie Keighley PhD MSc MArborA
Local authority	Cumberland Council
Date	24 April 2024
Issue	Final issue for planning

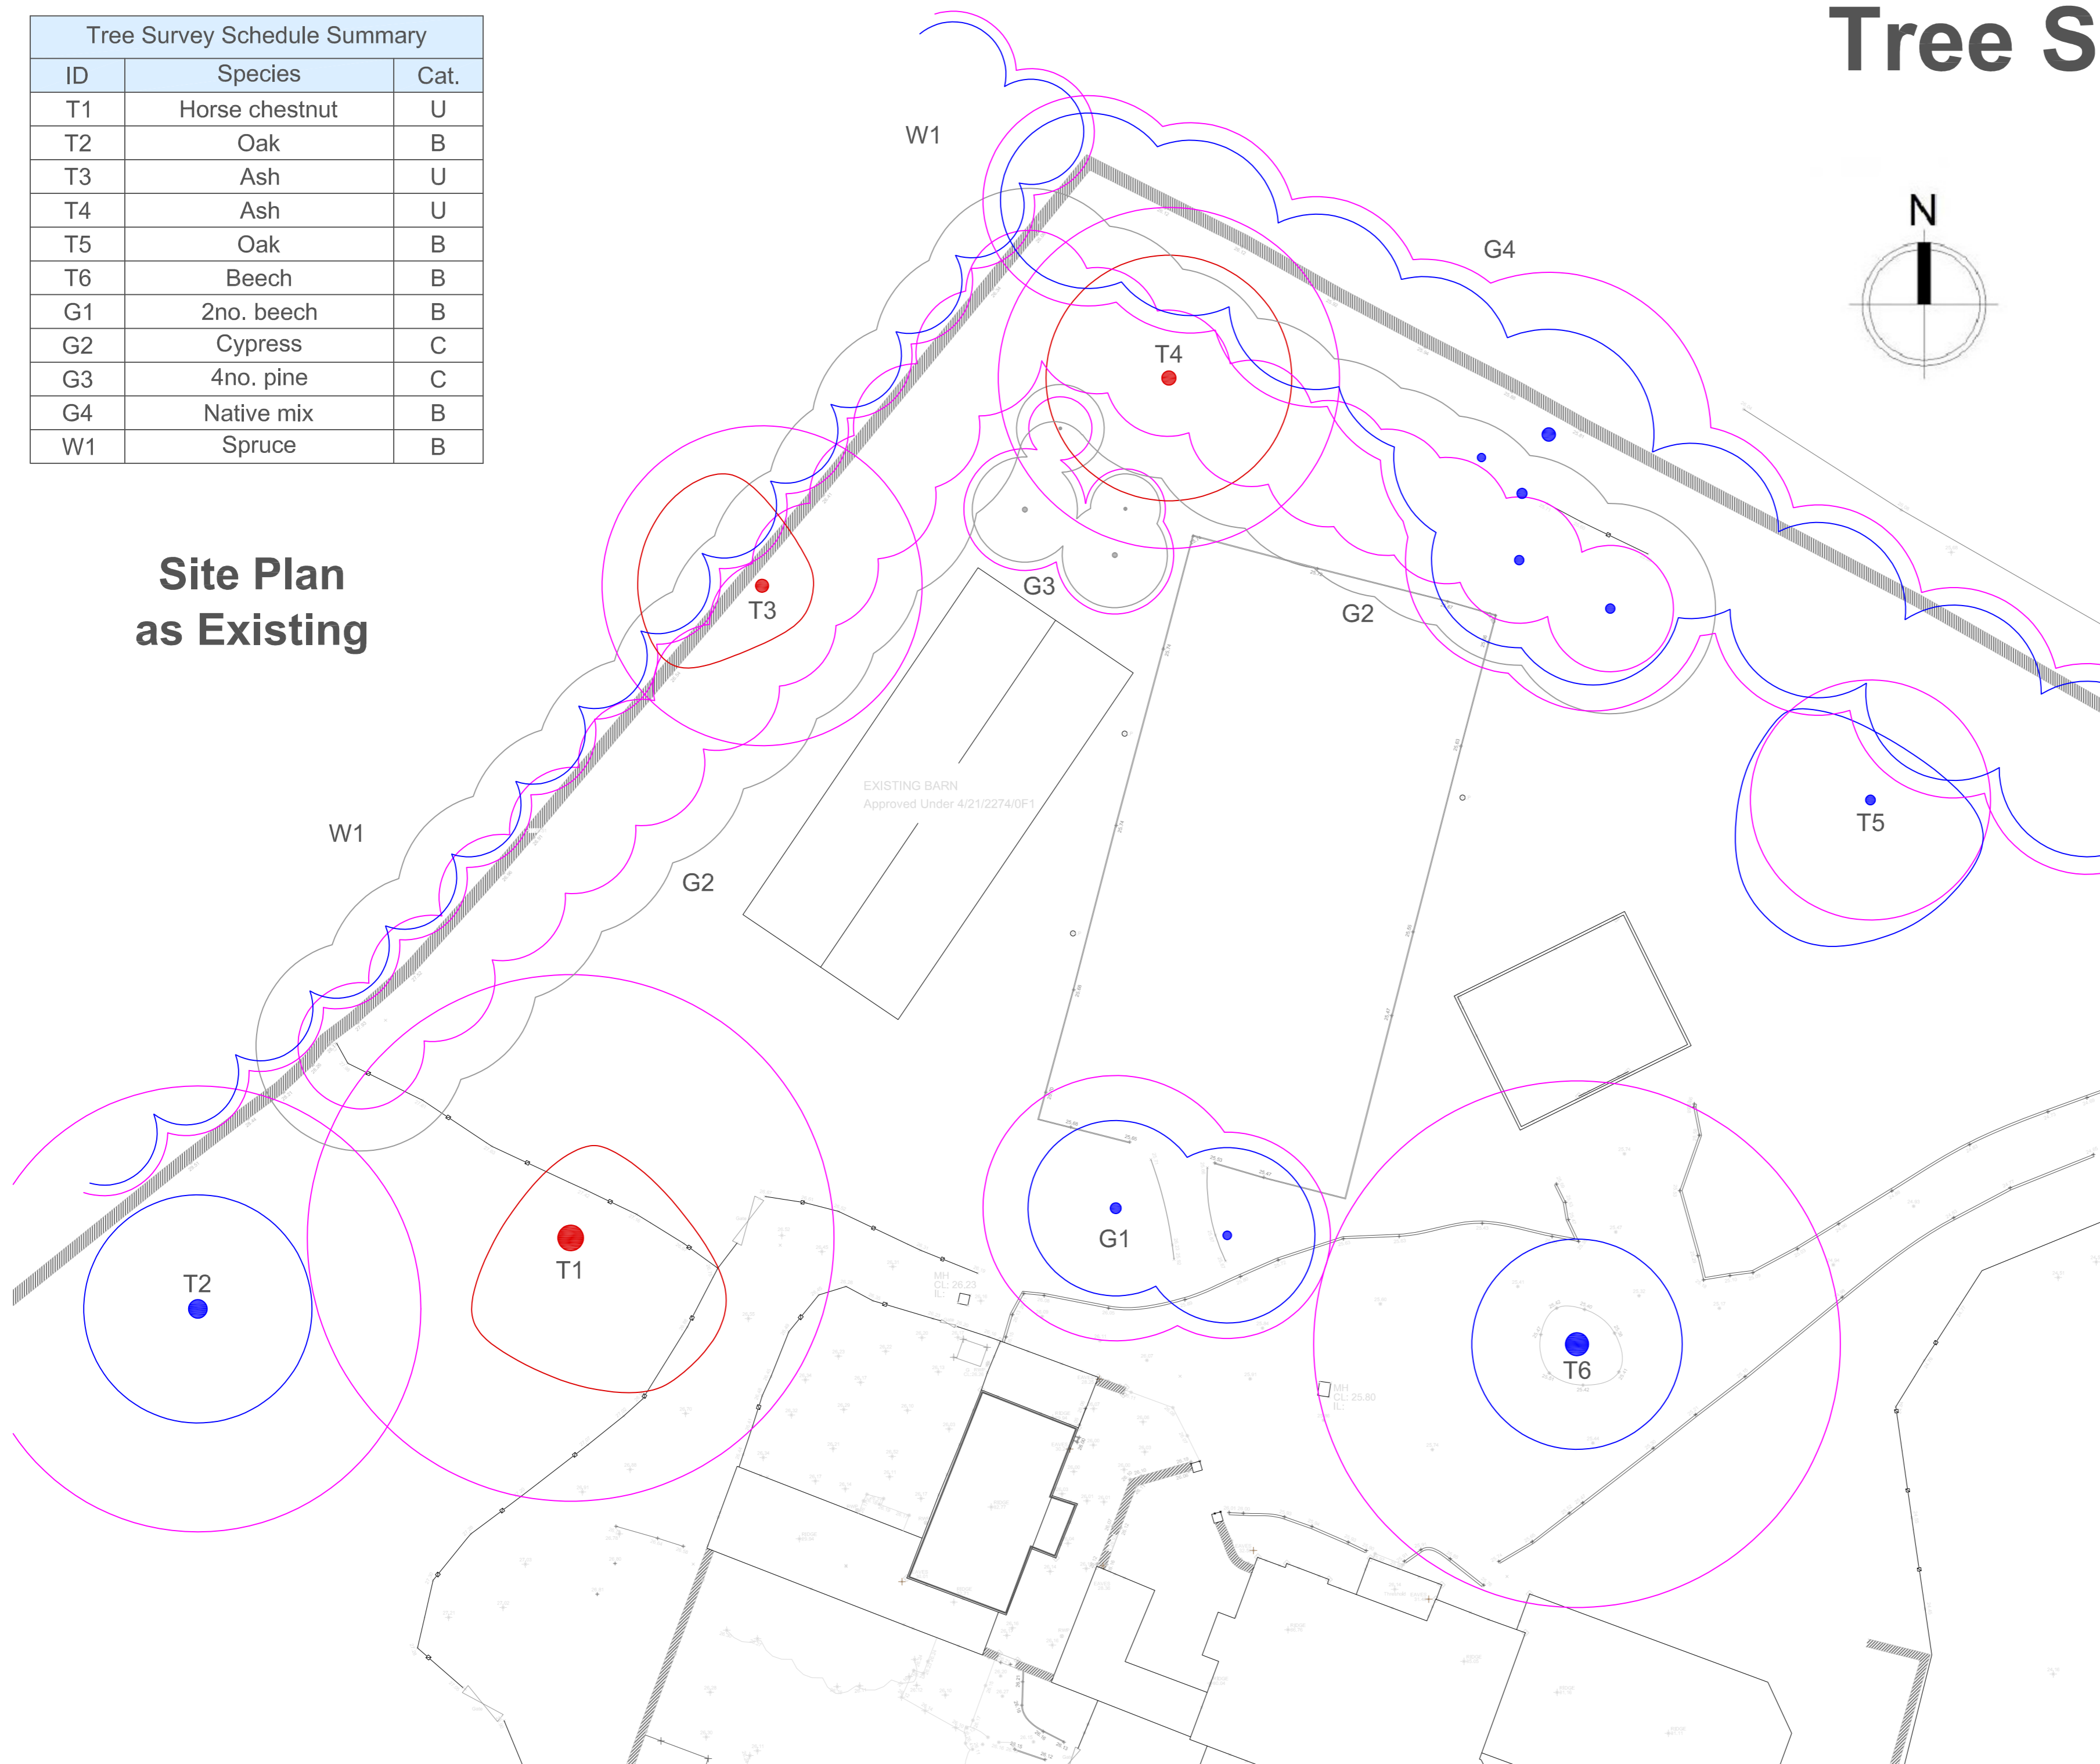
Drawing: LTC237-TSP

Tree Survey Schedule Summary		
ID	Species	Cat.
T1	Horse chestnut	U
T2	Oak	B
T3	Ash	U
T4	Ash	U
T5	Oak	B
T6	Beech	B
G1	2no. beech	B
G2	Cypress	C
G3	4no. pine	C
G4	Native mix	B
W1	Spruce	B

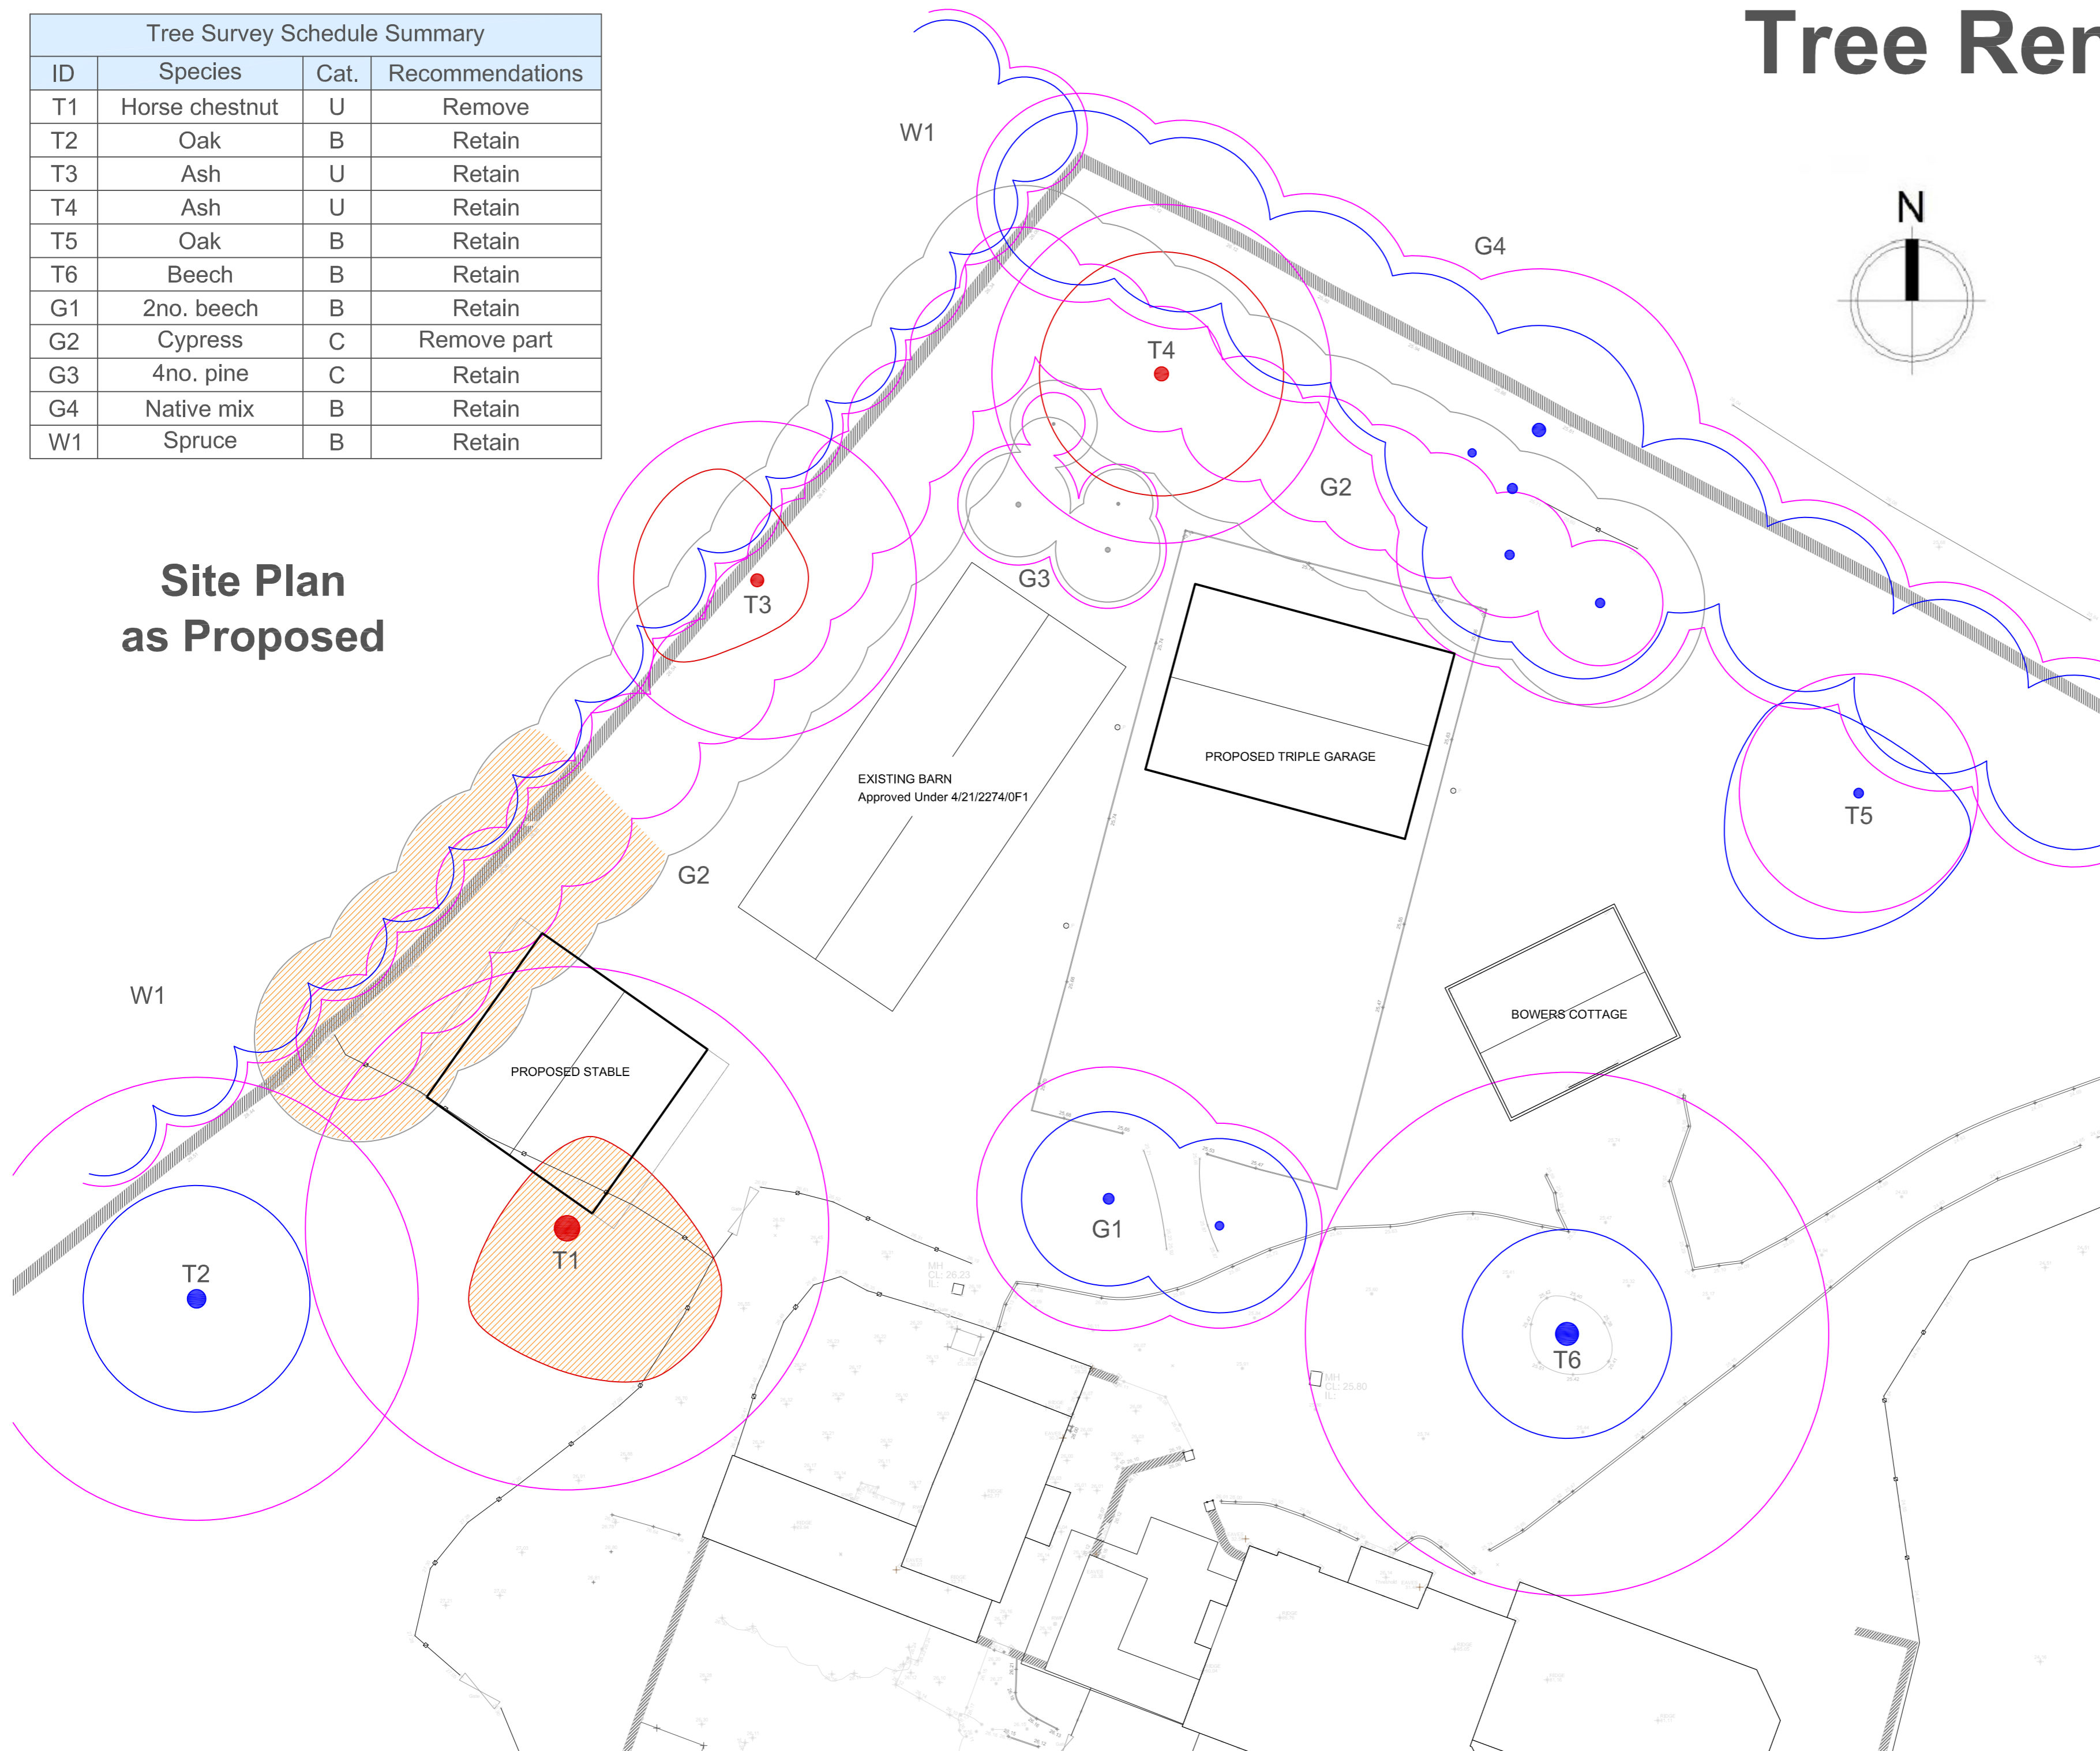
Drawing: LTC237-TRP

- 4.3 As shown on the appended tree removal plan and in Table 1, below, construction of the development will require the removal of one U-category tree and part of a C-category group. It is noted that U-category horse chestnut T1 is recommended for removal regardless of the development proposals, as it is at risk of full stem or rootplate failure due to an established honey fungus infection and an associated loss of structural integrity.

ID no.	Species	BS5837 cat.	Recommendation
T1	Horse chestnut	U	Remove due to safety concerns regardless of development proposals
G2	Leyland cypress	C	Remove southern end of group, as shown on the tree removal plan, in order to accommodate proposed stable
Total tree removals			1no. U-category tree Part of 1no. C-category group

Tree Survey Schedule Summary			
ID	Species	Cat.	Recommendations
T1	Horse chestnut	U	Remove
T2	Oak	B	Retain
T3	Ash	U	Retain
T4	Ash	U	Retain
T5	Oak	B	Retain
T6	Beech	B	Retain
G1	2no. beech	B	Retain
G2	Cypress	C	Remove part
G3	4no. pine	C	Retain
G4	Native mix	B	Retain
W1	Spruce	B	Retain

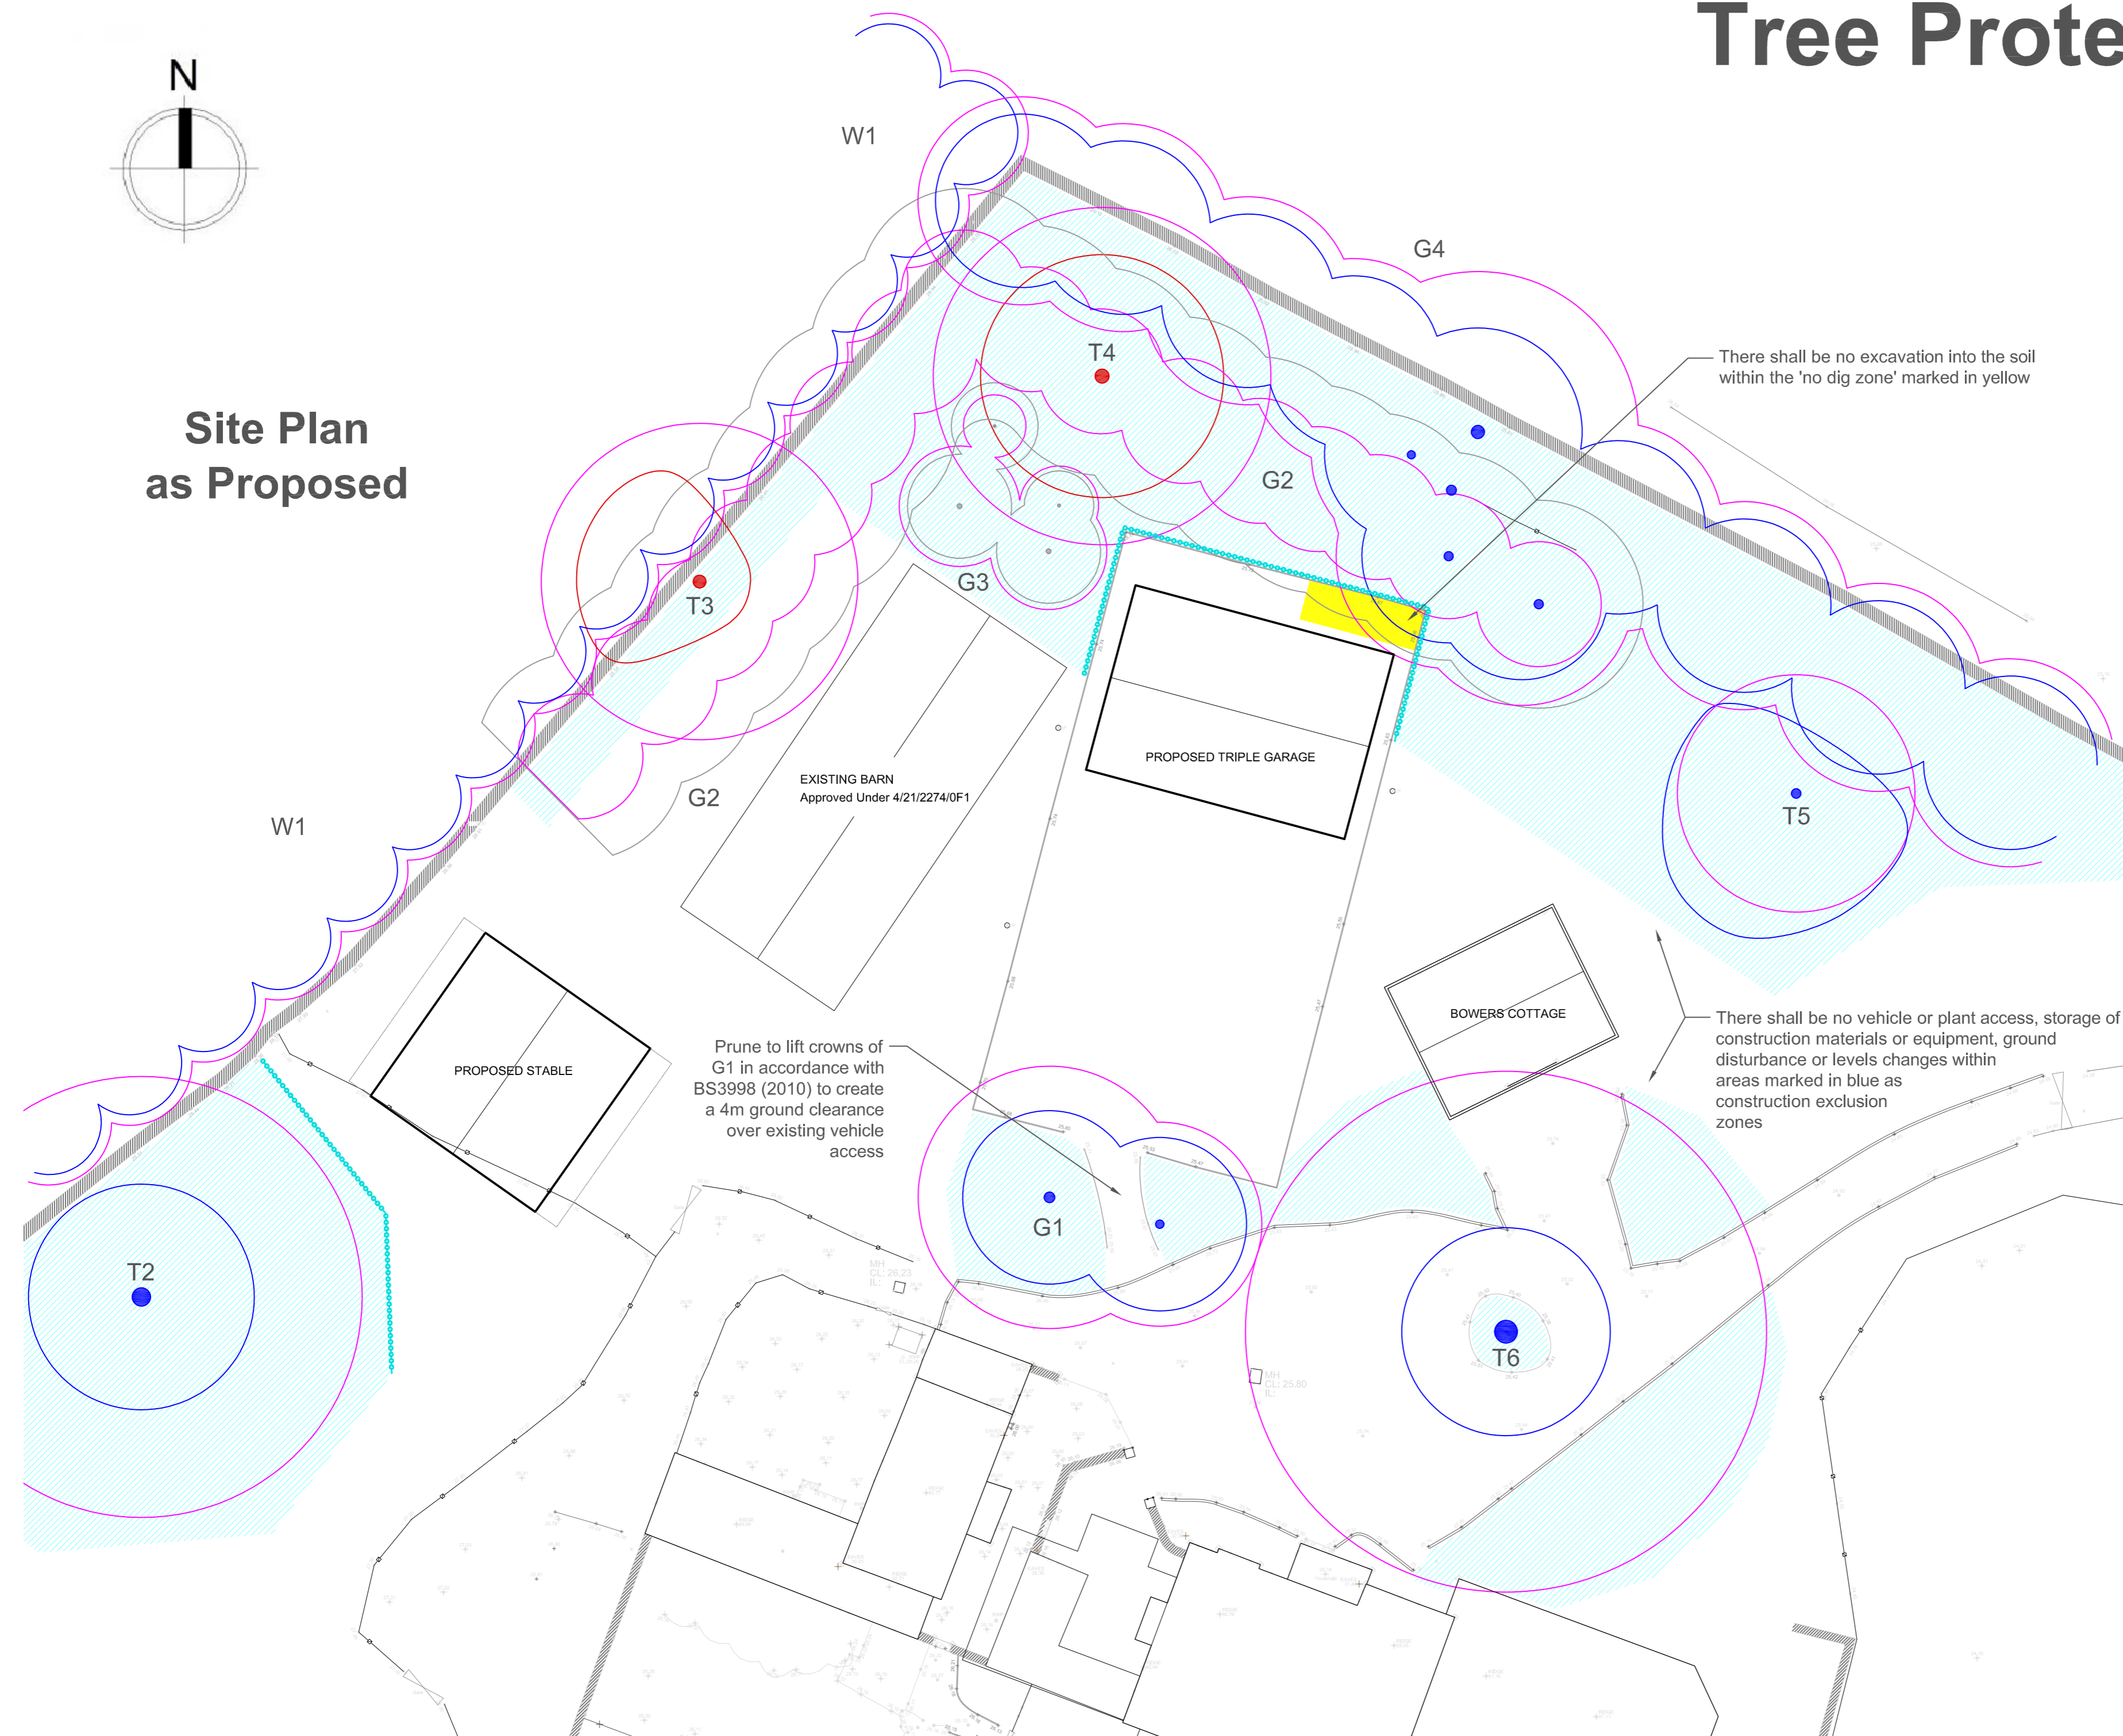
Drawing: LTC237-TPP

Operation	BS5837 Guidance
Erection of garage	<ul style="list-style-type: none"> • The proposed garage sits close to the RPA of a large pine tree within group G4 • Whilst it is noted that there is an existing hard surface in place in the area in which the garage will be sited, there must be no excavation into the soil within the 'no dig area' marked in yellow on the tree protection plan, at the rear right of the new garage, in case there are any significant tree roots growing under the existing surface • The edge of the existing hard-surfaced area must be fenced-off where adjacent to trees to form a construction exclusion zone, as indicated on the tree protection plan

- 5.2 For the development in question, the default BS5837 (2012) tree protection fencing specification, as shown on the appended illustration, is expected to be suitable. An alternative fencing specification can be agreed with the LPA Tree Officer prior to commencement, if required. The fencing is to be laid-out as indicated on the appended tree protection plan prior to any works on site, including site preparation and deliveries, and shall remain in place until the development is complete and all associated materials have been removed from site. Once erected, the tree protection fencing shall be labelled at regular intervals with all-weather notices stating 'TREE PROTECTION AREA - KEEP OUT!'.
