## Cumbria Barn Owl inspection - 5th June 2026

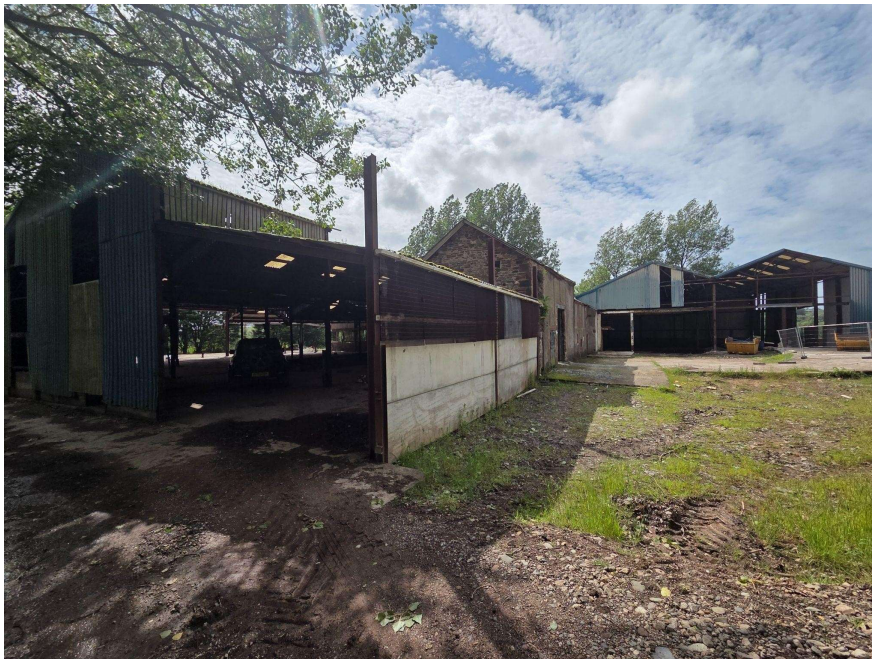
*Image: Overview of survey barns (Left to right: Barn 1, Stone Build, Barn 2)*

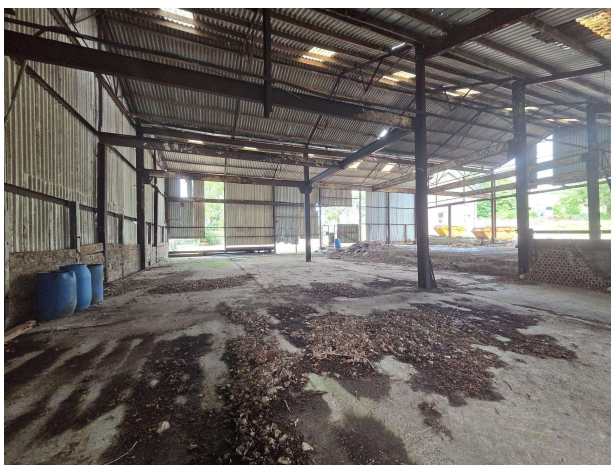
*Photo above: Internal view of barns 1 and 2 on site. Both of the barns did not have sides nor did they have any cavities for inspecting.*

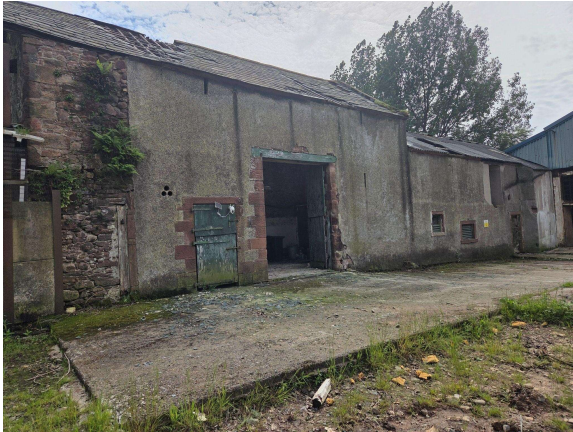
*Photo above: External view of stone barn that is not due to be removed from the site. Building has two stories with the upper story being unstable for access.*

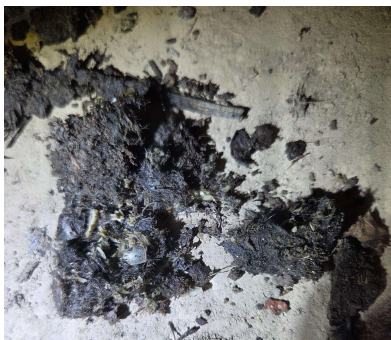
#### *Barn 1:*

Inspection of the first barn was fairly straightforward with an open view of the barn. The barn was previously used for cattle housing. Roof space of the barn was open with little space for any roosting species to be able to settle.

No location suitable for nesting in the barn was found. Only piece of Barn Owl activity found within Barn 1 were two pellets located at the bottom left corner next to the previous barn doors (since removed).

Pellet was dry with evidence of rat and mouse bones within, likely that a bird had sheltered within the barn on occasion.

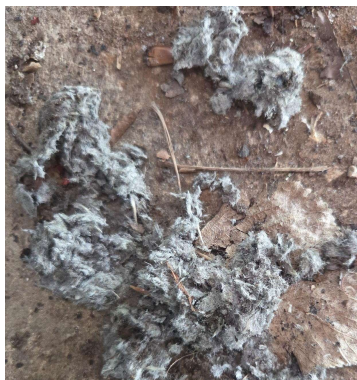
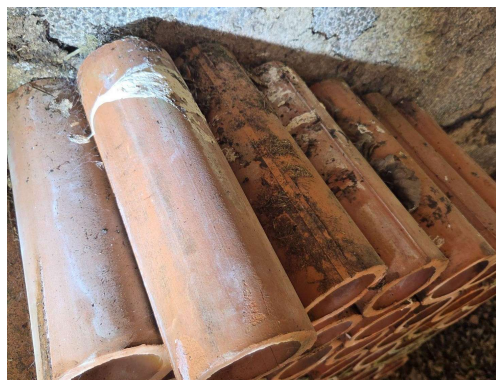
#### *Barn 2:*

Similar to barn 1, the second metal barn was previously used for cattle with no pens or rafters remaining. Evidence found within this barn consisted of a dried pellet with evidence of rat and mouse again, older than the aforementioned pellet.

Some chalking marks were located on some pipes near the pellet likely the owl had roosted on an evening - not recent activity.

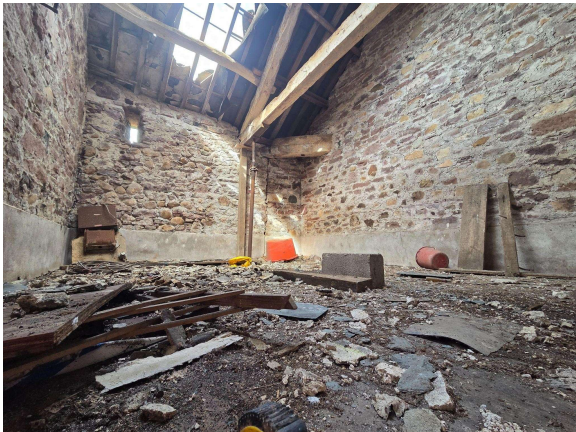
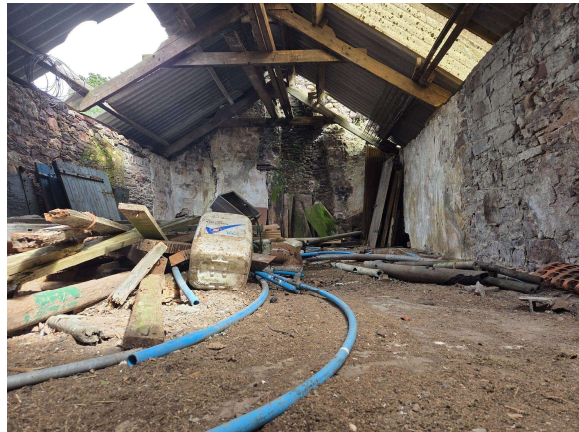
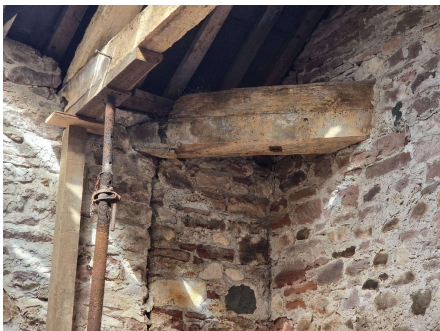
*Stone Building:*

The downstairs has a cattle crush, and storage room, the upper level on both section was noted to be unstable for us to physically enter and inspect.

Both loft spaces have a roof which has fallen through in places.

Evidence of Stock Doves breeding in these areas were found, including a bird on a nest. Other evidence includes droppings and feathers across the flooring.

On the upper flooring of the first section of the roof had a beam which had droppings below which could be from a Barn Owl roosting, but no pellets or extensive chalking was found so possibly just an occasional roosting space.

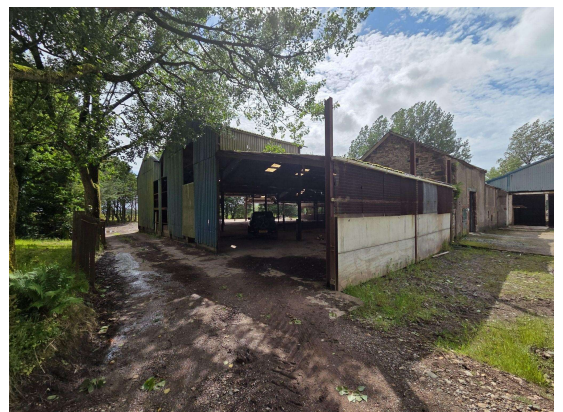
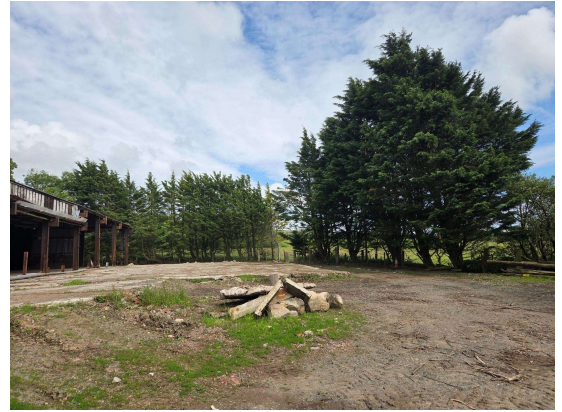
*Tree Inspections;*

Requested by client, tree marking and inspecting was carried out in the vicinity of the barns. There were little suitable breeding trees for Barn Owls, but the pines were possible for Tawny Owl - neither owls or any evidence of breeding was noted.

Trees were a mixture of fir trees, conifers, sycamore and some smaller shrub species, none of these had any cavities suitable for nesting owls and no evidence of breeding was found.
