Our Ref. No.: DS21BAT041 Date: 18th January 2022 Your Ref. No.: N/A

## Preliminary Site Inspection for Bats - Hensingham House, Hensingham, Whitehaven, CA28 8QB

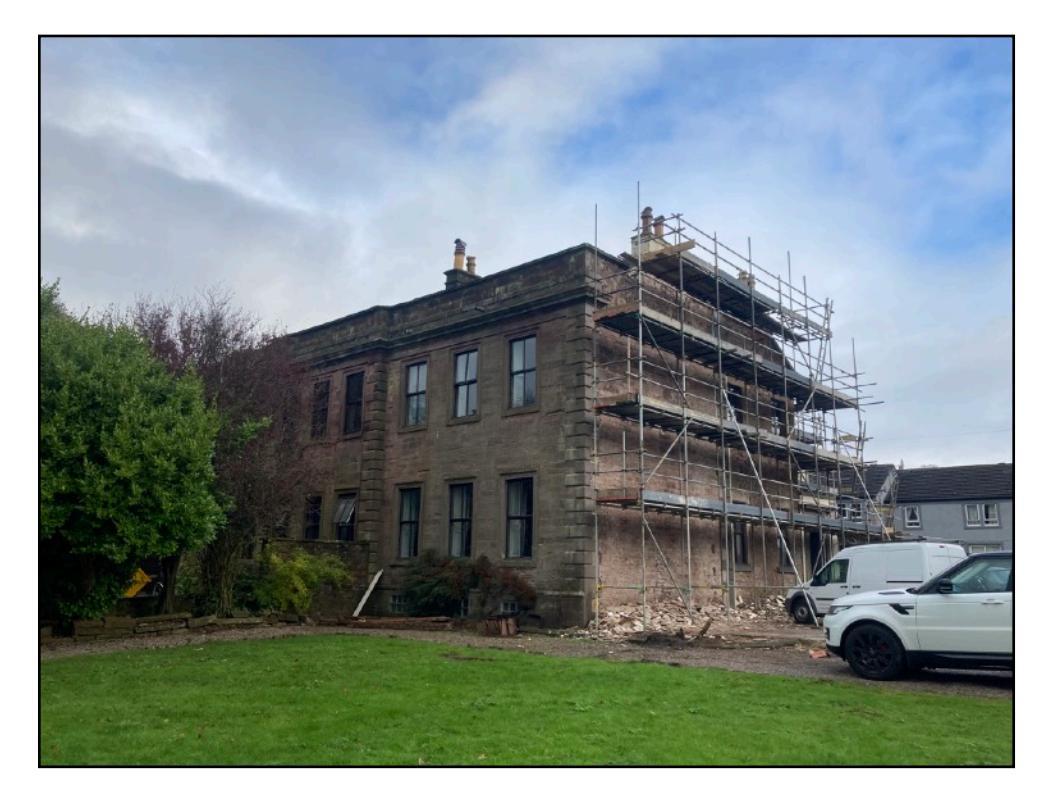
The parapet walls and coping stones create a barrier to the roof verges and wall tops which typically would offer access into crevices / roof spaces for bats. At the south elevation there were a few gaps along the stone wall top and below the coping stones, however these were draughty and appeared to have been created with the recent render removal.

**Figure 5:** Showing the south and west elevations. The external walls had no gaps for bats, and the parapet walls along the main elevations make the roof verges inaccessible; with no wall top gaps present. Scaffolding enabled access to external roof and thorough inspection for potential bat access.

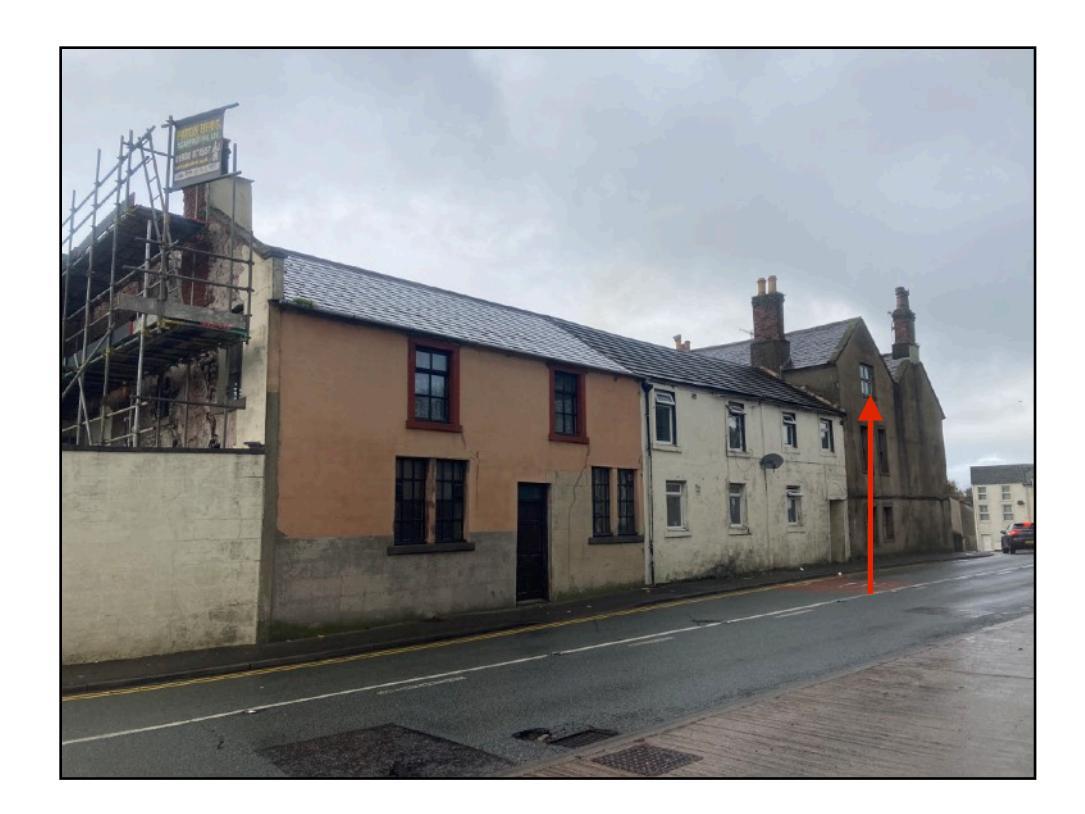
**Figure 6:** The eastern elevation / annexe section and northern section - 1st gable as indicated. No gaps along the eastern roofline and wall tops gaps are generally unsuitable along the street lit roadside.

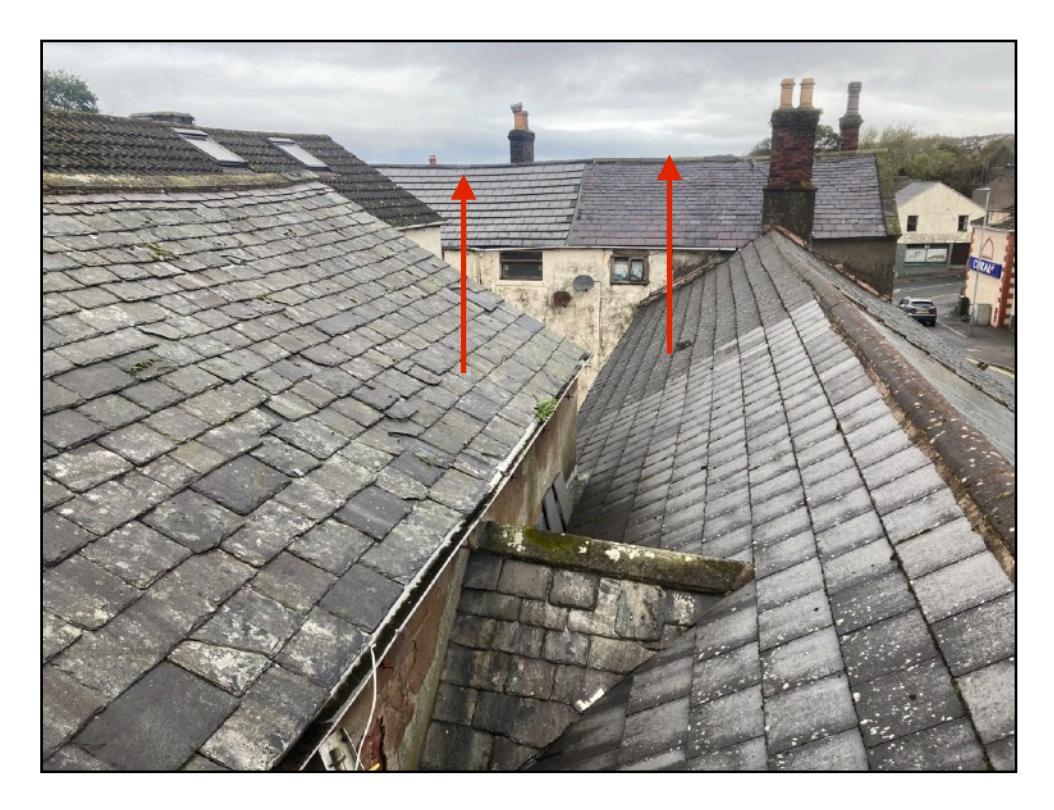
**Figure 7:** The eastern roof section (annexe) was clad in synthetic slates that offer no gaps for bats, adjacent roofs were also tightly clad, the northern roofline may offer very low potential for single bats as there appear a couple of small gaps along the ridge-line (indicated).

- Overall, the main roof sections offer negligible potential for bats, due to the lack of access / gaps beneath cladding and the valleys and parapet wall; making access to any potential small gaps very difficult / unlikely.
- The roof sections to the north and east (annexe) are generally tightly clad, the lack of gaps and street lights to the east offer negligible potential for crevice dwelling bats and the smaller voids here are not suited to void dwelling species.
- There may be small gaps along the northern ridge line which may offer very low opportunity for individual bats only.

There is a small risk that individual bats could opportunistically occupy gaps whilst works are underway and there is very low potential for single bats, beneath ridges along the northern roof section. As this roof has had recent work then roofing works to this area are not anticipated, but care should be taken if works here are required. Gaps along the ridge should be maintained (at least 20mm).

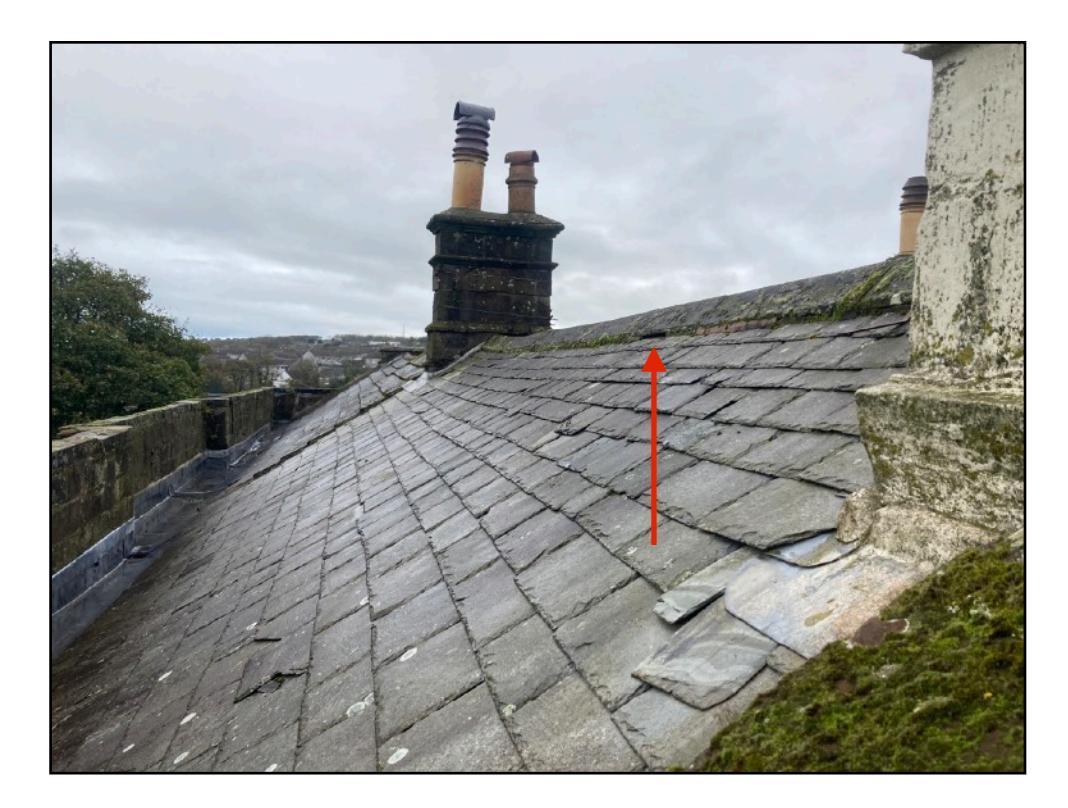
At the west facing roof pitch (southern section) there is one gap beneath the ridge, which as it is facing the habitat at the west (not a valley roof) could theoretically offer opportunity for bats to access. This roof space was accessed and thoroughly inspected and there was no evidence of bat occupation at any time. The roof interior was lined with lime mortar at the eastern facing pitch and had sarking at the western pitch. The adjacent loft space (to the centre of the main building) was also accessed and inspected, with no evidence of bats present. This loft interior was lined with lime parging at the western pitch and felt on the eastern side. The roof light on the western pitch allowed light into the void making it unsuitable for void dwelling bats.

**Figure 8:** The western roof pitch surrounded by the parapet wall, no gaps along the wall tops / gables. There is a single gap (as shown) under the ridge tiles that may offer access, the parapet wall makes the roof / drop zone less suited to bats. Roof void was throughly inspected and no evidence of recent / historic use by bats was present.

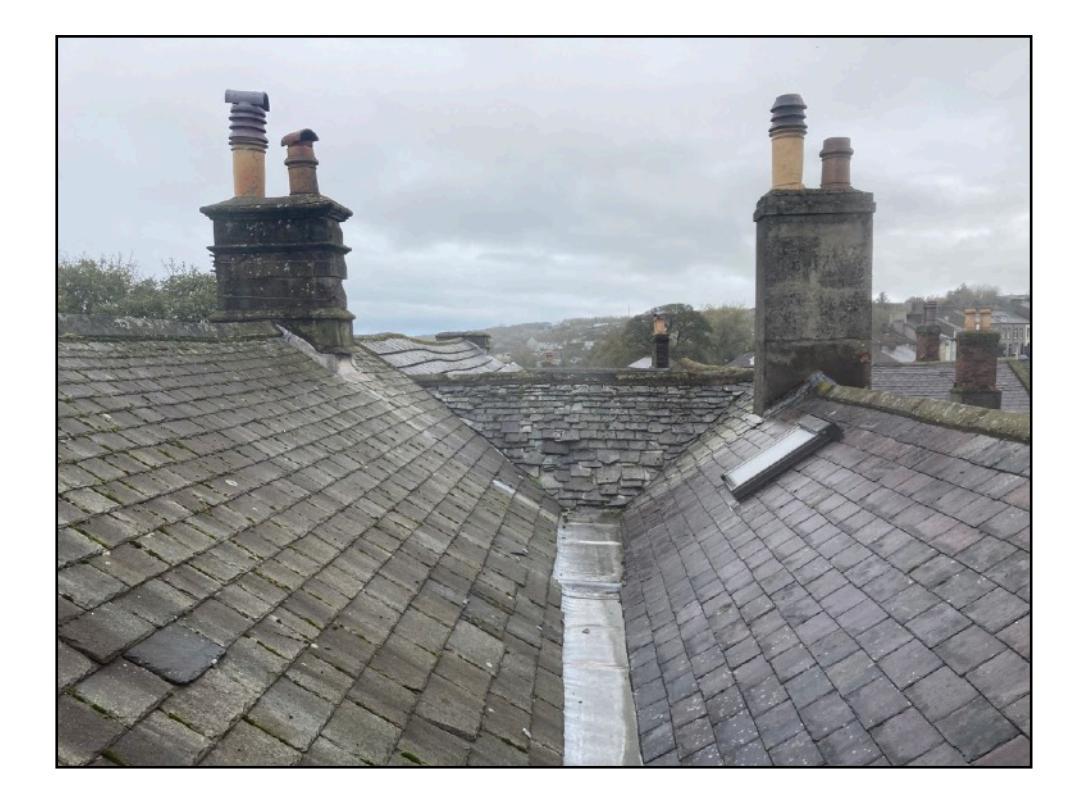
The valley roofs to the main part of Hensingham House were also thoroughly inspected from scaffold height, slates were tightly laid and ridges well cemented with no suitable gaps present, lead flashing around chimneys may offer very small gaps.

**Figure 9:** The central roof section, valley roofs are not highly accessible for bats, they create a cluttered 'drop zone' and the slate cladding is very tight with no visible gaps. These roof voids were accessed and throughly inspected.

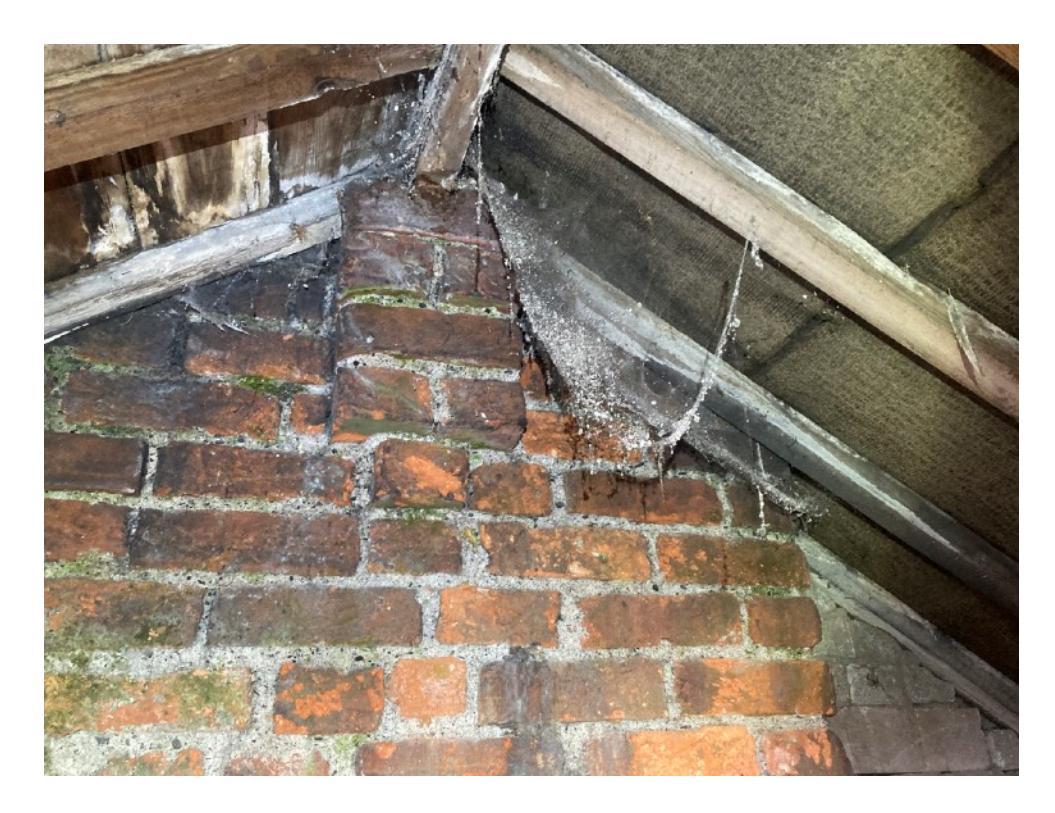
Figure 10: Roof interior (See Figure 8) apex was cobwebby with no evidence of bats and very little opportunity for access.

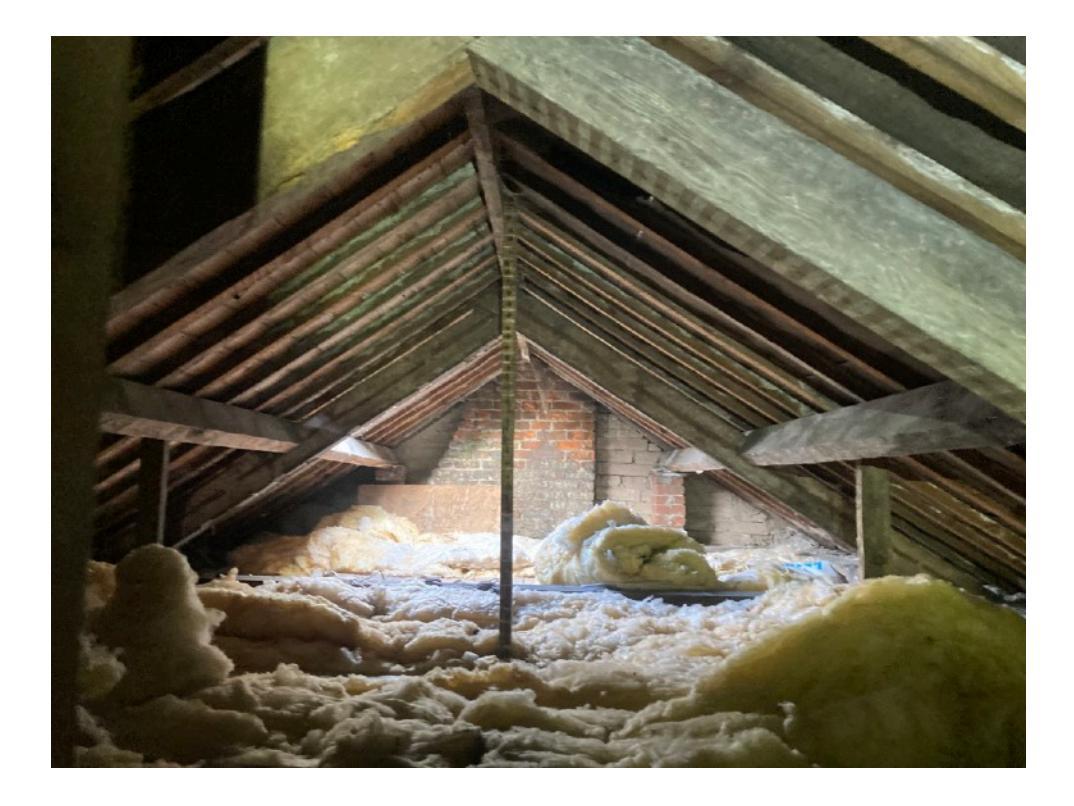
Figure 11: Roof interior (See Figure 9), light spill into void and tight cladding gives nil potential for bats.

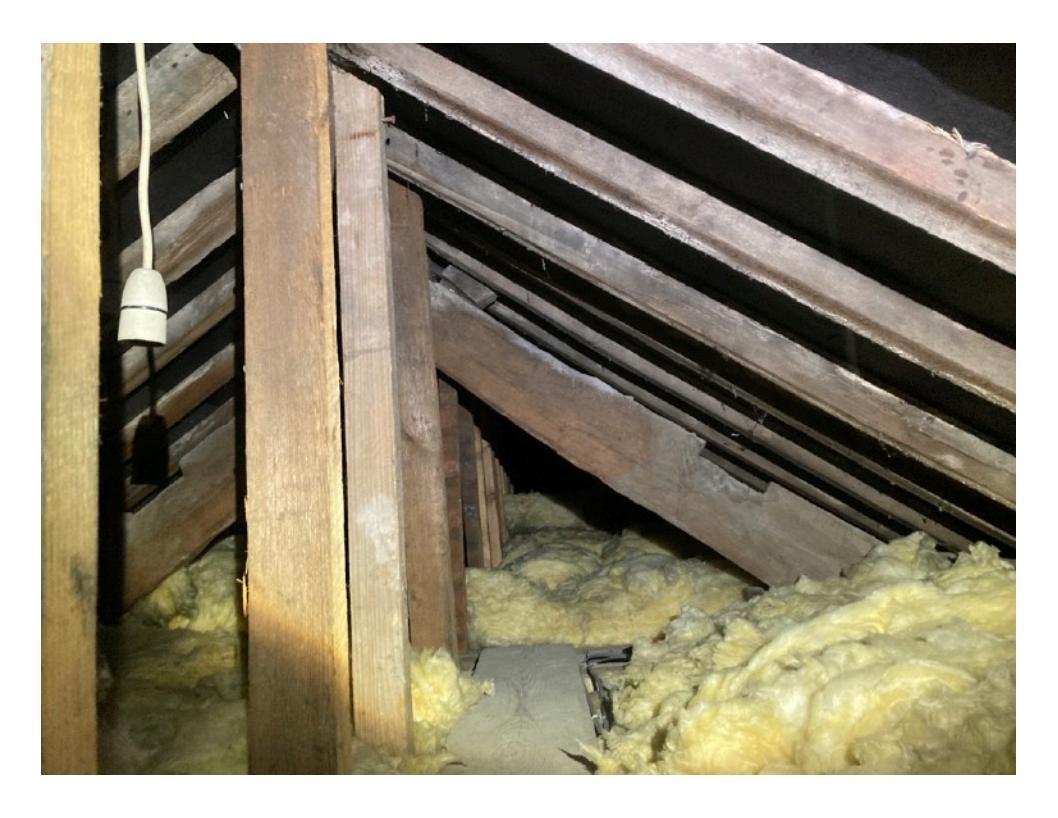
**Figure 12:** Roof interior to eastern section (See Figure 6), no gaps in cladding and roof spaces were inspected with no evidence and no potential for bats to access, wall tops along the eastern elevation are unlikely to be used due to street lighting / unsuitable habitat at this aspect.
