FLOOD RISK AND DRAINAGE ASSESSMENT

Cleator Mill, Proposed Residential Development, Flood Risk Assessment.

RO/FRA/RES/19002.1

Asset Condition survey: River Ehen (right bank) Flood Defence at Cleator Mills

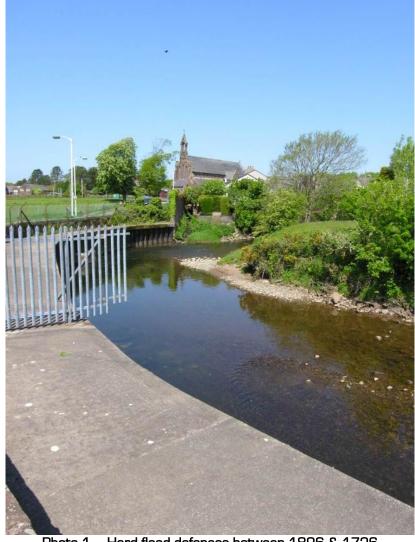
Photo 1 - Hard flood defences between 1896 & 1726

There are flood defences affording the site protection from the risk of flooding, as identified in Appendix D. The hard flood defences are substantial and appear to be in operational condition which is supported by the Environment Agencies grade 3 'fair', on the Environment Agencies asset condition criteria. The soft defences and the riverbank do not appear to be adequately maintained to the required standard to ensure effective operation; the Environment Agency have graded these 4 'poor'. It is understood that further work has been undertaken on the flood defences, but this needs to be assessed as to suitability and graded accordingly. It is recommended that a full site walkover and grading of the defences be undertaken, subject to planning being granted.

A previous report assessing the condition of the embankment was commissioned by Hampton Investment Properties Ltd and undertaken by Dr John Chatterton, this is included in Appendix E. RWO Associates Ltd have undertaken a site walkover and note that the defences do not appear to have varied in condition since the survey in 2008.

It is recommended that at the locations identified within Dr John Chatterton's survey remedial works be undertaken either by the developer or by agreement with the Environment Agency involving a commuted sum. No development should be undertaken until the flood defences are improved and formally surveyed.

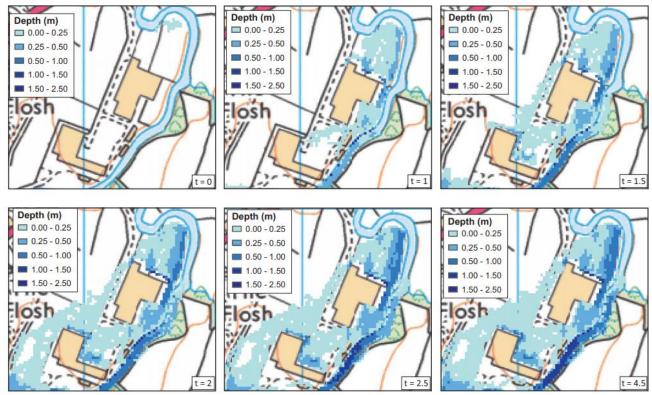
Figure 5 – Extract from Envireau Water of Breach 1

A breach in the gabion baskets north of the site has been considered for the 1:100 year plus climate change return period. The approximate location of the breach event is indictated in Figure 4. During the breach, flood waters reach the site at the 1.5 hour mark, with the existing Kangol factory being flooded first and then flows head to the west reaching the proposed residential development site.

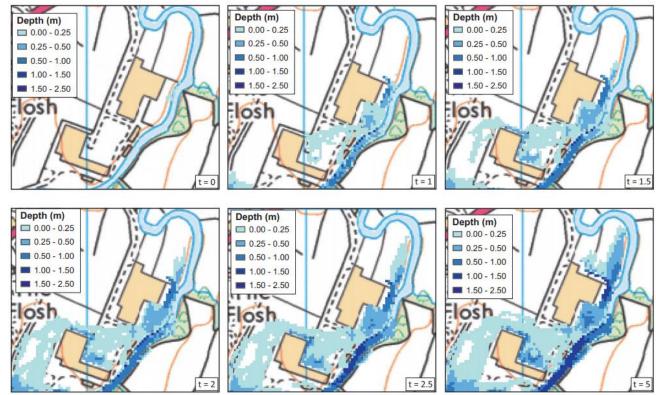
Figure 6 – Extract from Envireau Water of Breach 2

A breach in the earth embankment to the east of the site has been considered for the 1:100 year plus climate change return period. The approximate location of the breach event is indictated in Figure 4. During this breach event the only building impacted upon is the Kangol Factory which does not form part of this application. As such the risk of the site flooding from a breach at this location is deemed low.

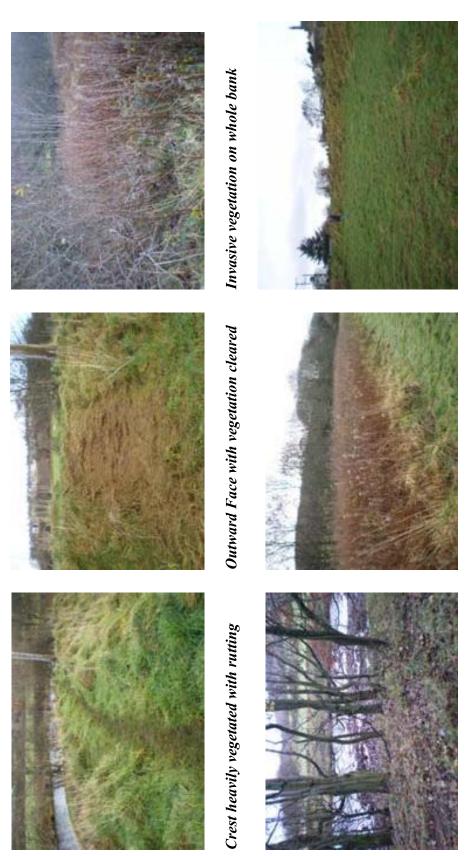
2. 01104EHEN0401R24 (Raised earth embankment)

The defence fails to meet target 3 as currently set and wholescale vegetation clearance is required along the whole length of defence, with selective vegetation management in co-operation with EA's Fisheries, Recreation and Biodiversity team on the berm and channel side. The rock revetment at the toe of the channel side is helping to prevent undercutting of the berm and strategic repair might be appropriate.

Research by HR Wallingford on behalf of EA indicates that a narrow earth/turf flood embankment like this in grade 4 condition would have a 70 per cent chance of failure if water levels (flood) reached 0.25 metres above crest level and about a 30 percent chance of failure should flood water should reach crest level (see diagram below). Remedial work on vegetation management and reprofiling the embankment without improving its standard of protection would reduce this fragility significantly. A Grade 2 or even 3 embankment is unlikely to fail at all until flood levels achieved are at least 0.2metres above the crest level.

Mature Trees on Inward face

Invasive vegetation on outward face

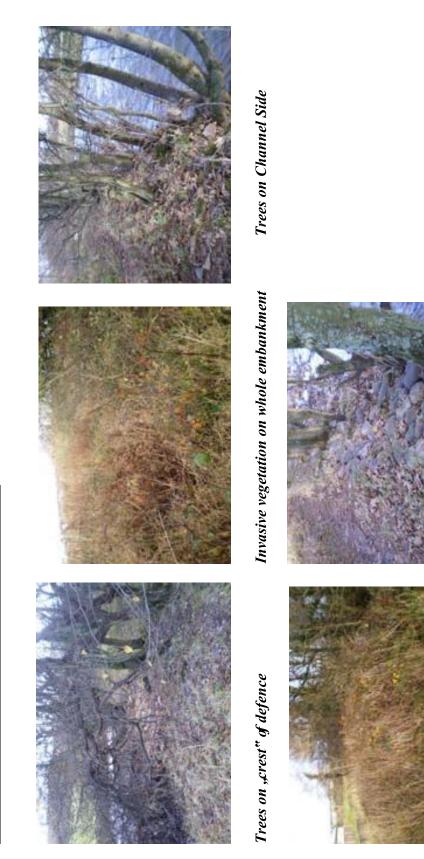
3. 01104EHEN0401R04 (Raised earth embankment)

EA have changed the asset type for this defence section from *Fluvial raised defence* (embankment) to *maintained channel*, though evidence suggests it is a natural channel adjacent to 'high ground'. NFCDD identifies the standard of protection as 1 in 25 years. However the EA ISIS model results, when compared with ground levels from an earlier level survey, indicate a standard of protection much higher than this. The defence length is adjacent to the Kangol factory and the accurate level of this High Ground is crucial within the context of this flood risk assessment.

"Embankment at rear of Kangol

Stone revetment on channel side

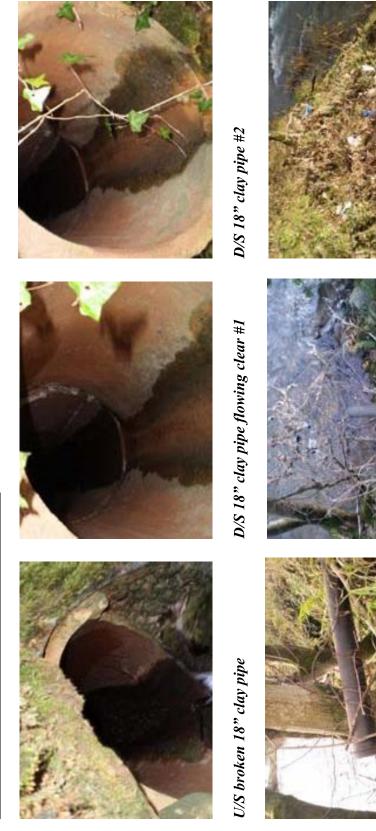
4. 01104EHEN0401R02/R03 (Natural Channel)

6" iron pipe #1

6" iron pipe #2

• Following construction of the development the clay pipes or their replacements should be fitted with flaps to prevent ingress of flood water.
