Heritage, Design and Access Statement

Traditional Barn Conversion to form dwelling, Barwickstead, Beckernet

June 2020 **Rev C 21/09/2021**

PHOTOGRAPHS OF CONDITION OF GINNERY – Sept 2021

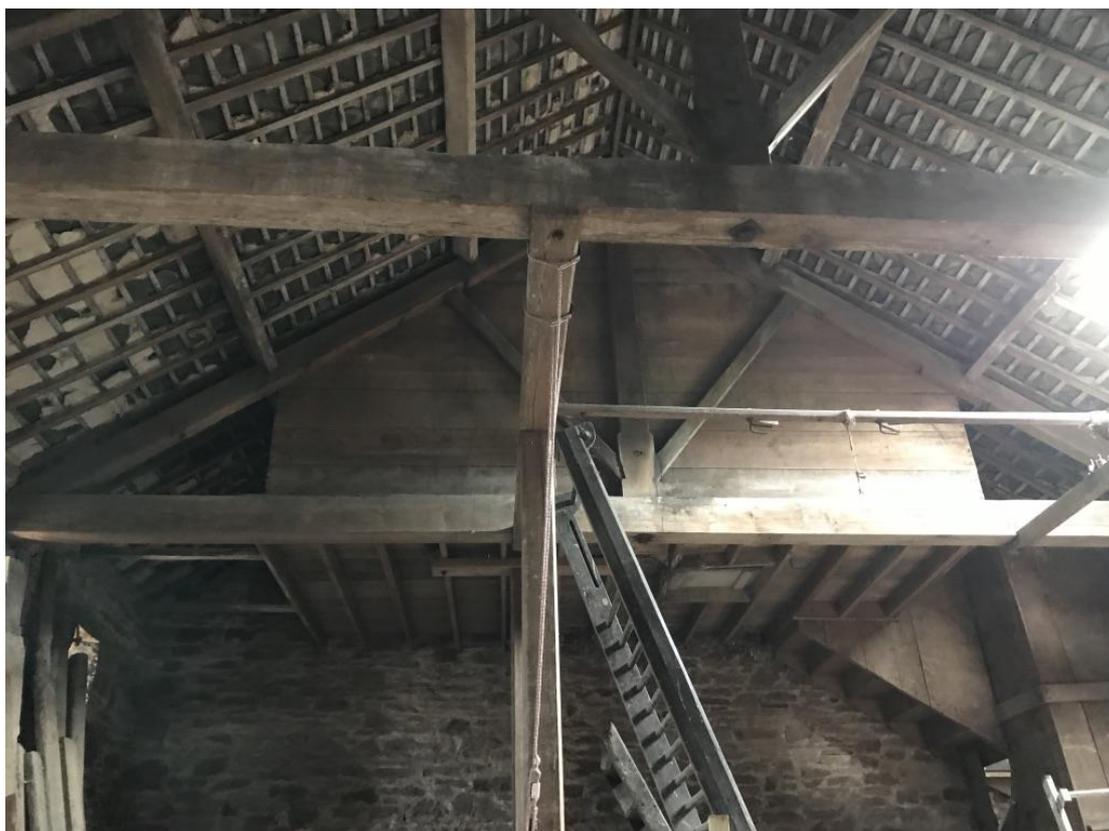
The existing upper pigeon loft which has suffered rot and is now unsafe, this will be dismantled and a new mezzanine floor created in this location. The general internal aspect of voluminous / double height

Existing loft are within the trusses forming pigeon loft

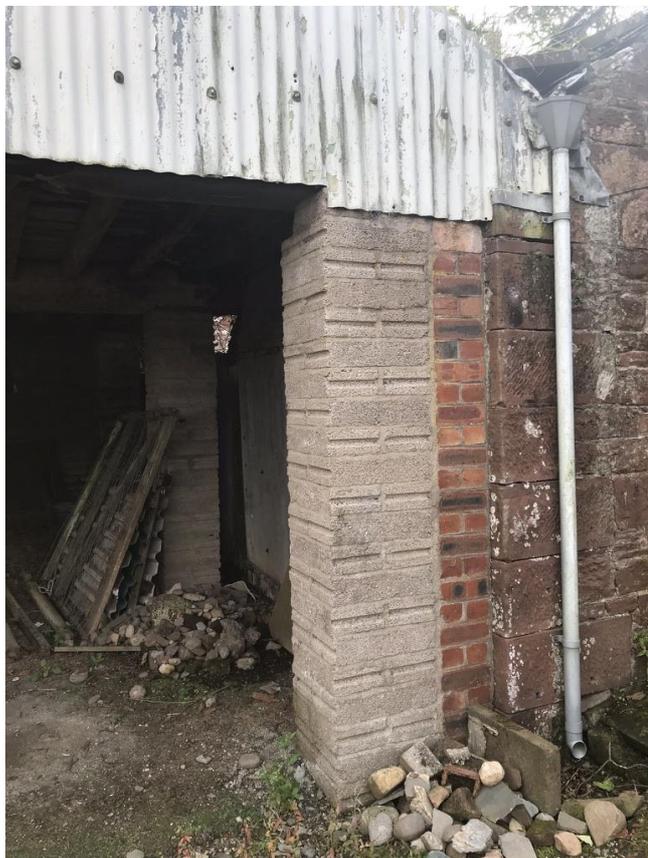
6. The front beam was replaced due to decay in the 1970's a culmination of rot to the ends due to being buried in the walls and having a front face exposed to the elements, this similarly is now supported on new blockwork columns.

Right hand column of ginnery supported on new masonry columns

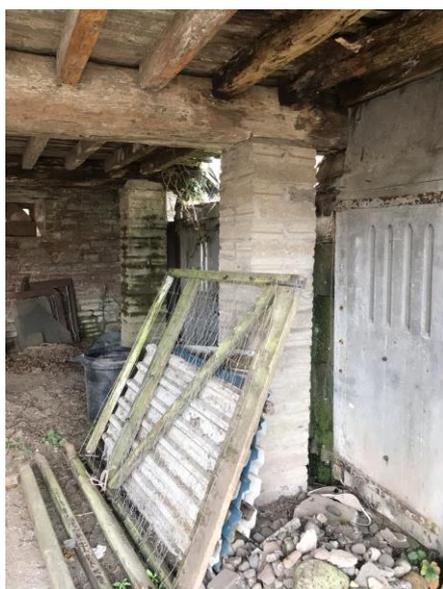
5. The central two floor beams are approximately 8m in span and sized at 300 x 350mm approximate in section, these forms part of the roof truss design with vertical steel rods providing a mechanical connection to the lower truss chord. These two floor beams have evidence of significant decay to their ends and new concrete block columns were installed around 1970's to provide a solid bearing for the ends which due to being buried in a masonry wall had decayed significantly. Wet rot has spread further now and the decay extends 1.8m along the beams towards the centre of the ginnery.

Modern internal block piers supporting decayed end of the timber

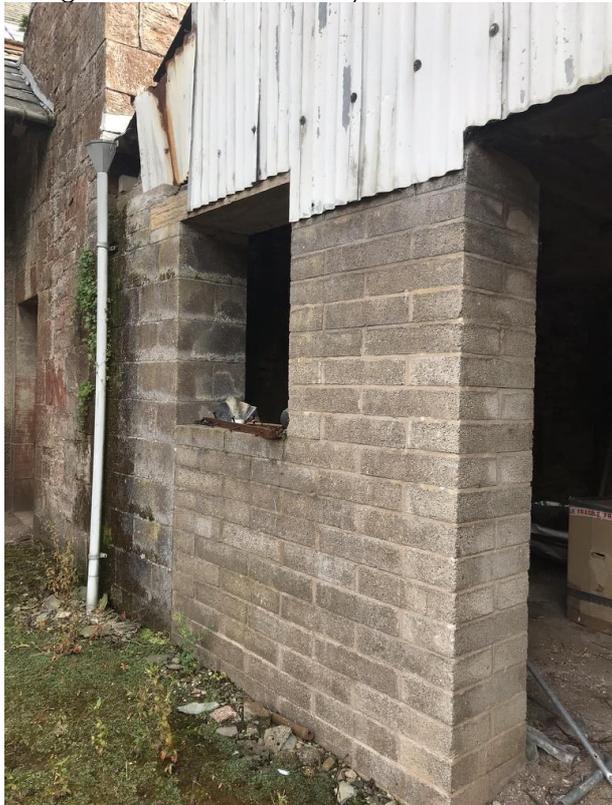
Left hand side opening shortened in width circa 2m to support bearing of new steel beam

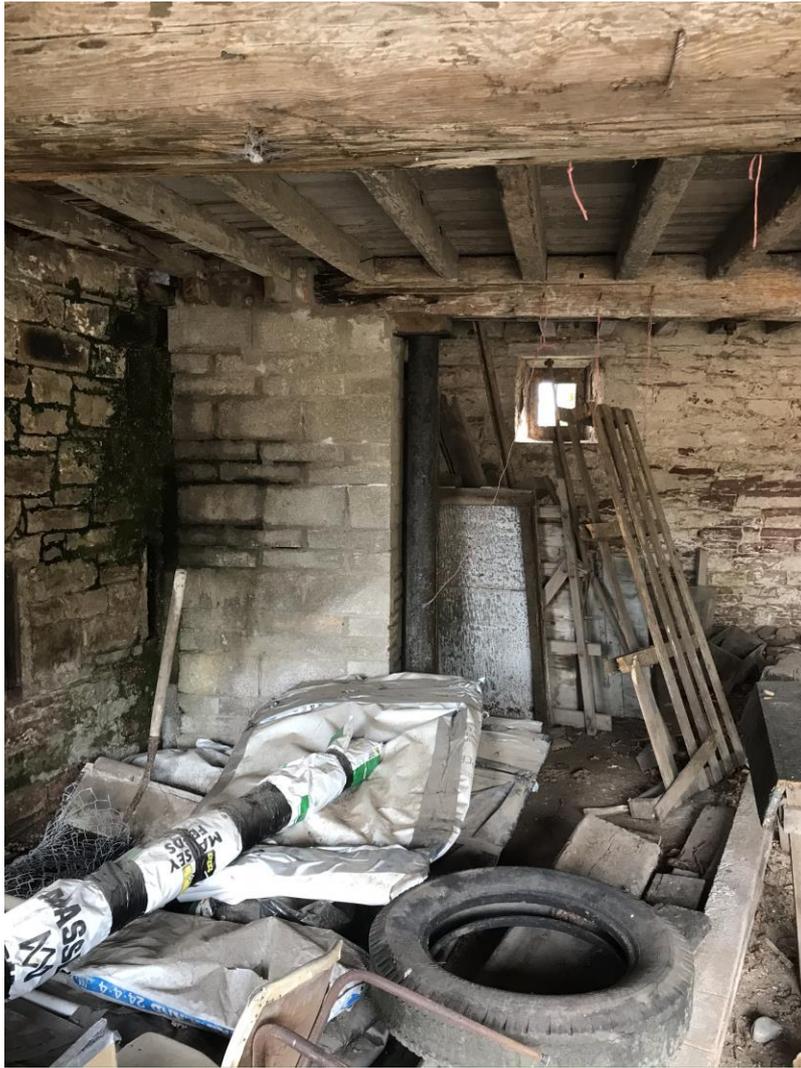
Rear left hand masonry column, timber beam decayed and rotted at valley junction

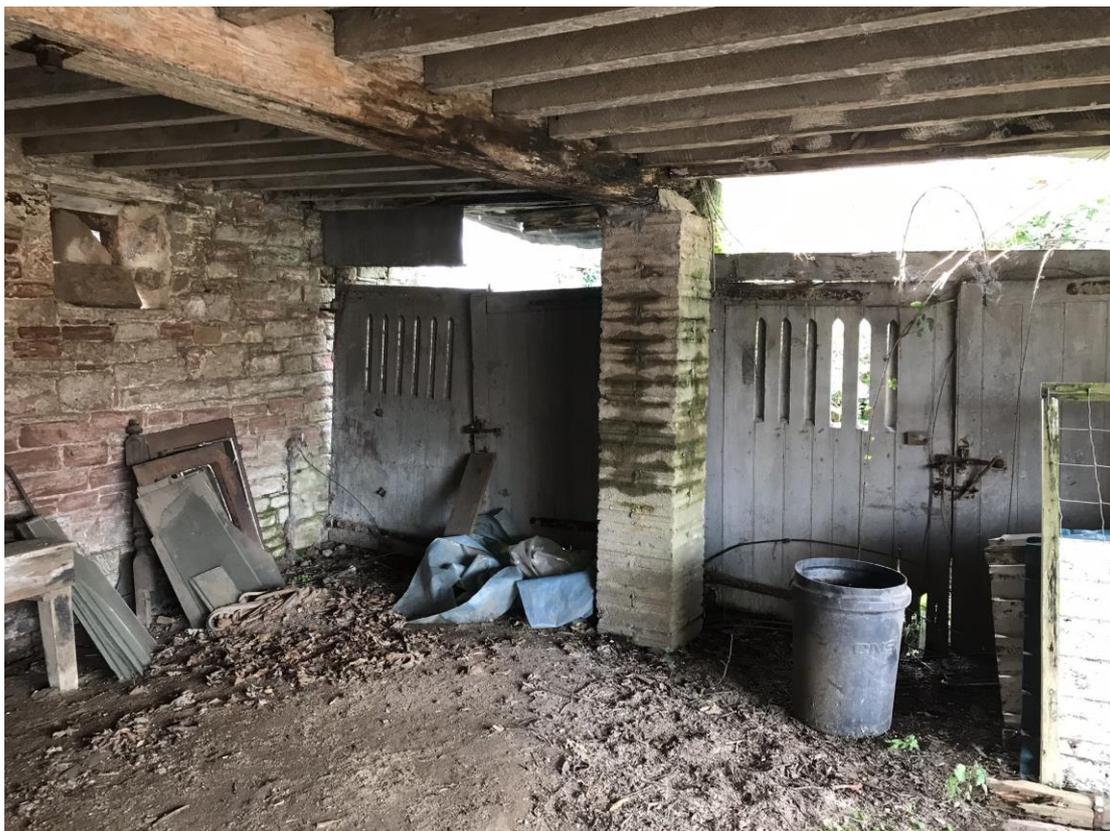
Slender piers too small to provide adequate support to the barn floor

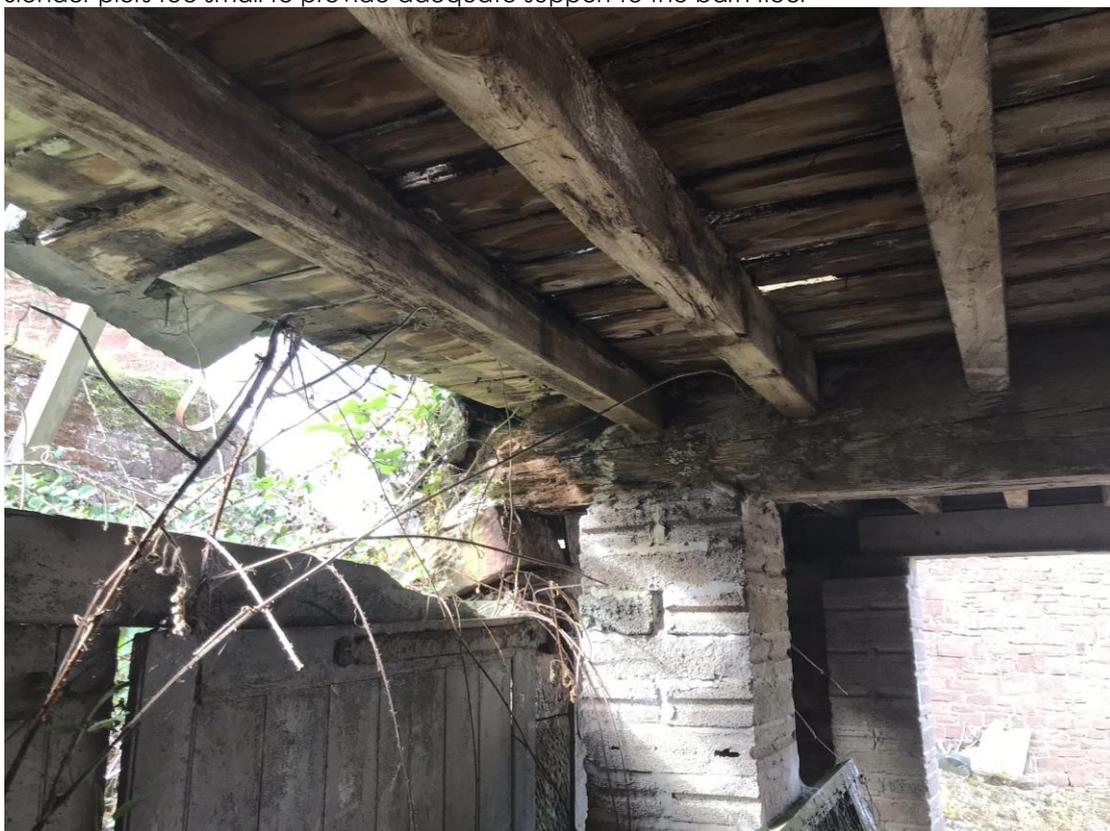
Floor overhanging at first floor level, with lower course of slates showing as valley and ead work has disappeared / rotted away.

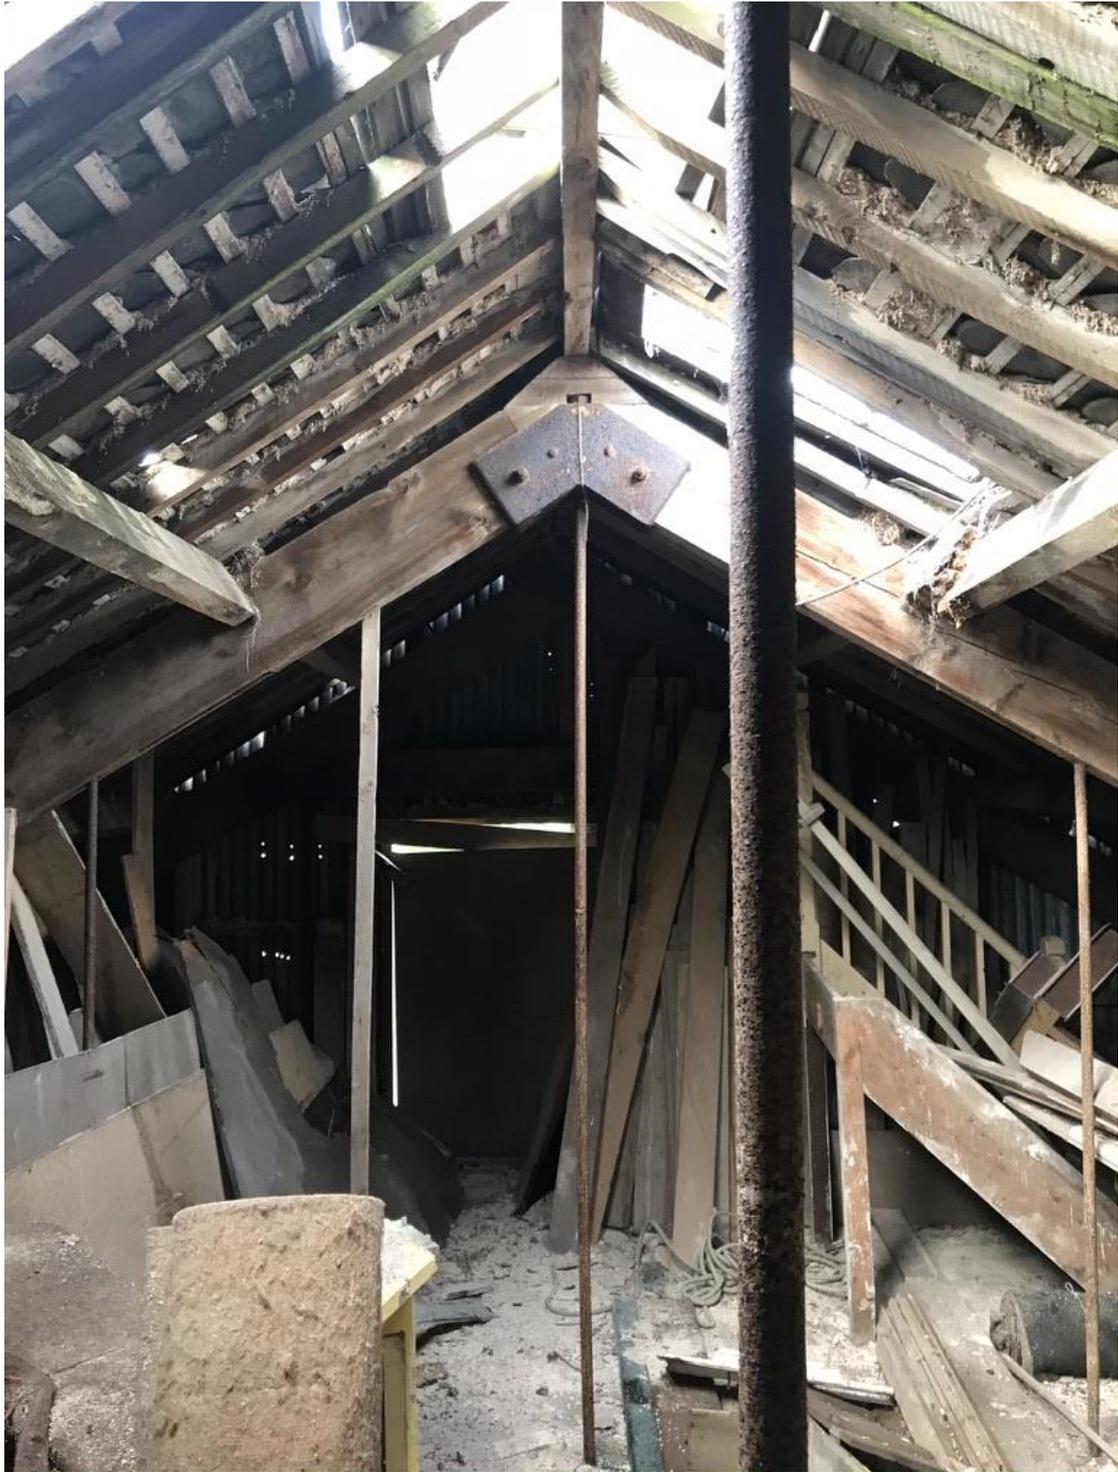
Steel bars and support frame up the truss

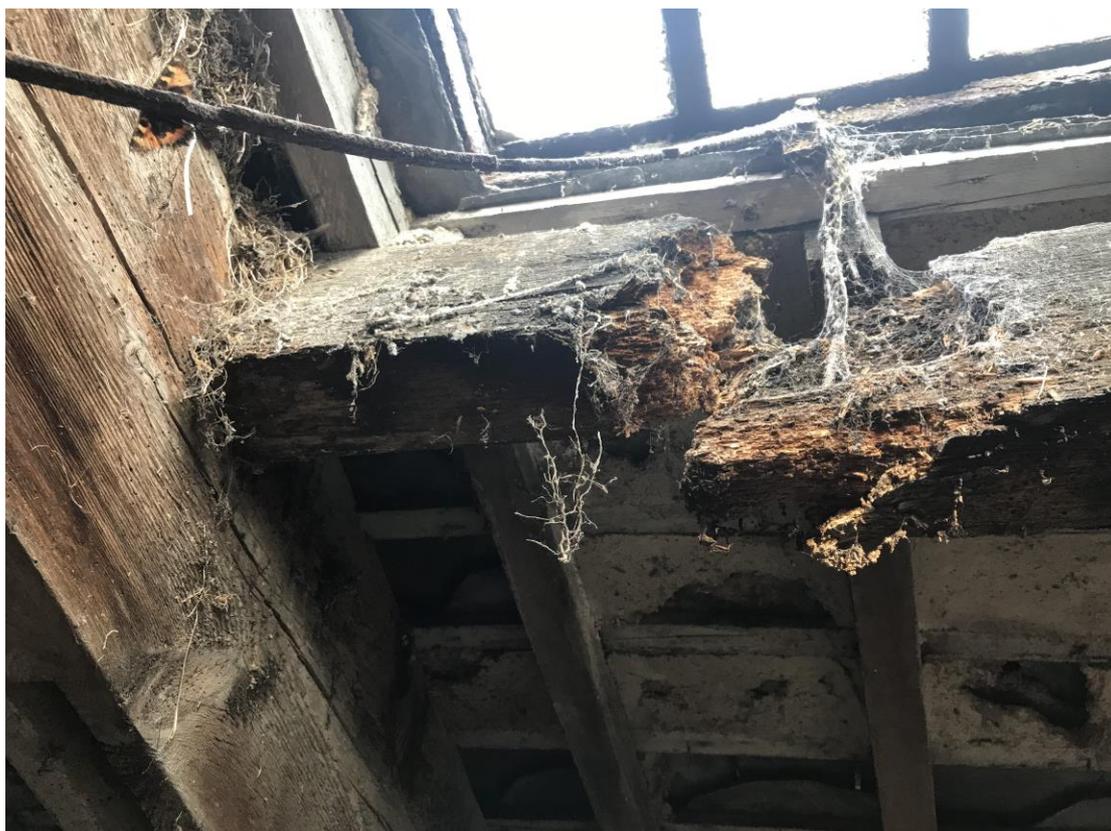
8. The ventilation stack is construction of timber with part leaded roof and this has now decayed and rotated as rot has set in. Within the roof slope two cast iron rooflights have significant decay and the water ingress surrounding this has now badly affected the floor deck, purlins and roof timbers around the central core of the building.

Water damage from rooflight has decayed timber purlins and leaked onto floor below

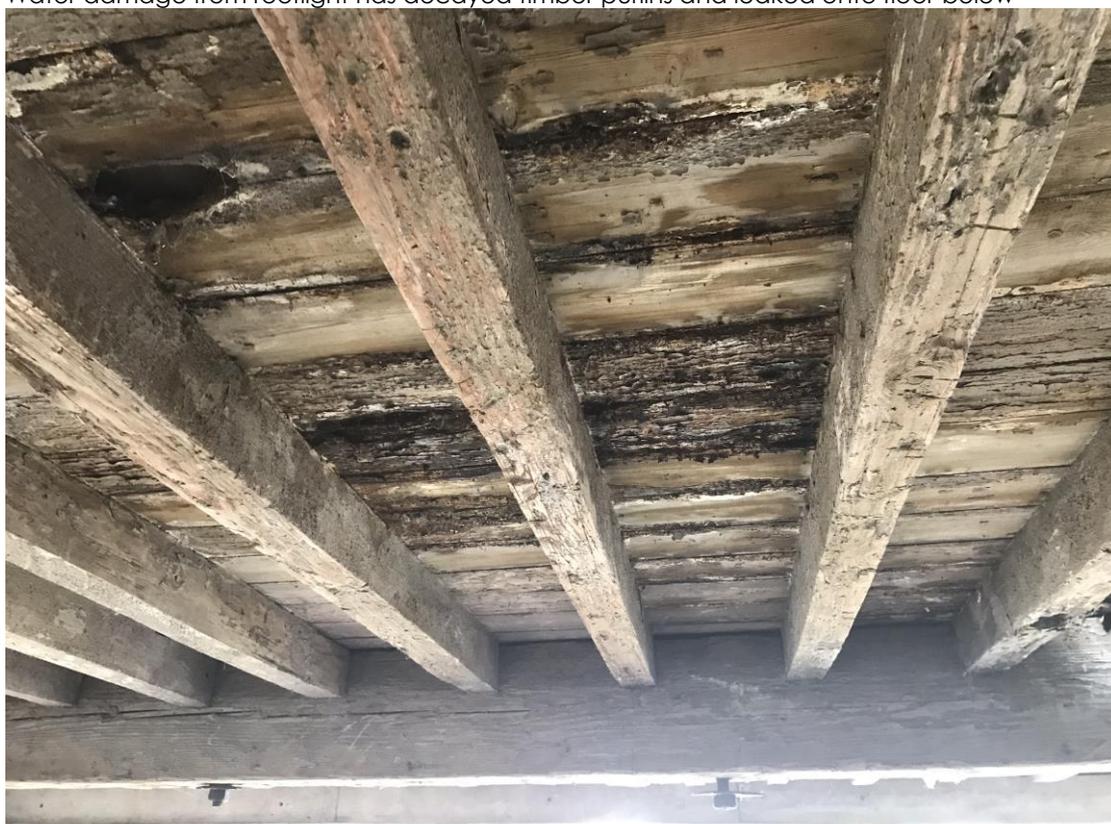
Water damage to floor boards – now soft with wet rot

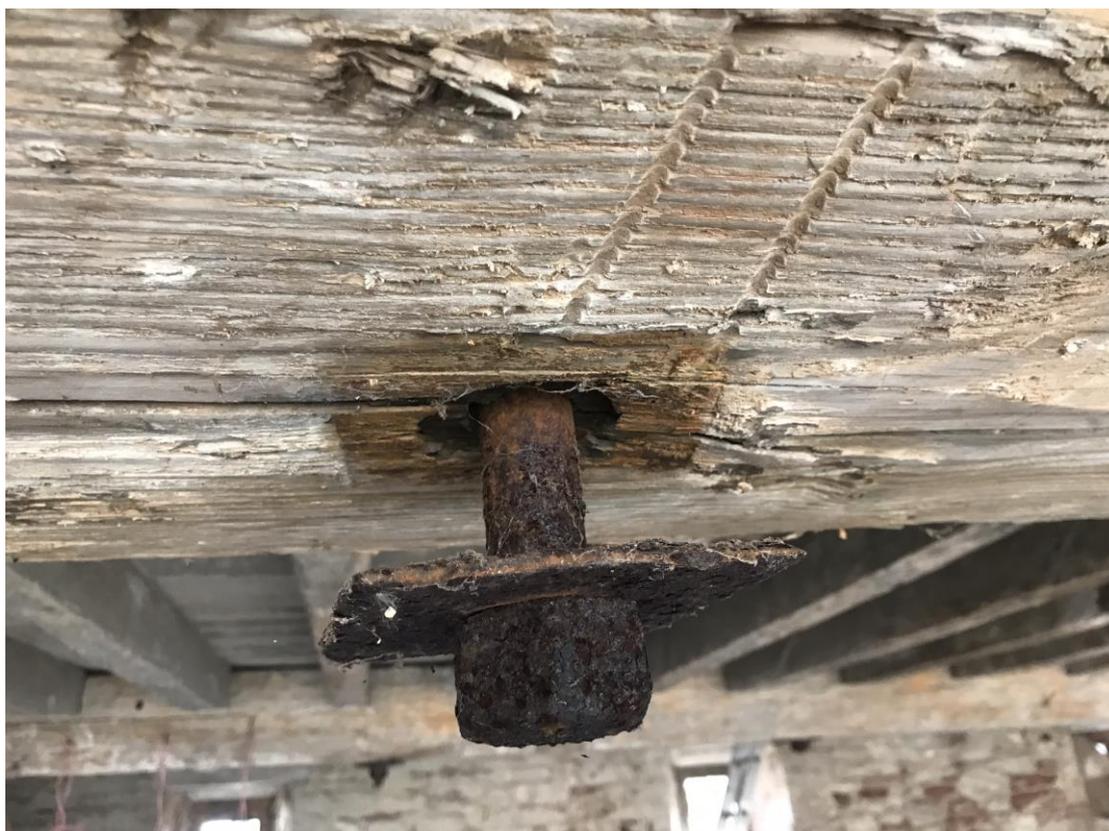
9. Of particular note here is the steel tensioning rod passing through the trusses in three locations forming a structural frame. These bolts and plates no longer provide a function and have separated from the lower truss chord by 75mm indicating significant rotation of the main truss, this could be due to age, weight of the roof or decay in the roof timbers.

Steel bars forming roof truss have separated from lower chord as whole truss has rotated as decay has set in, separation 35mm

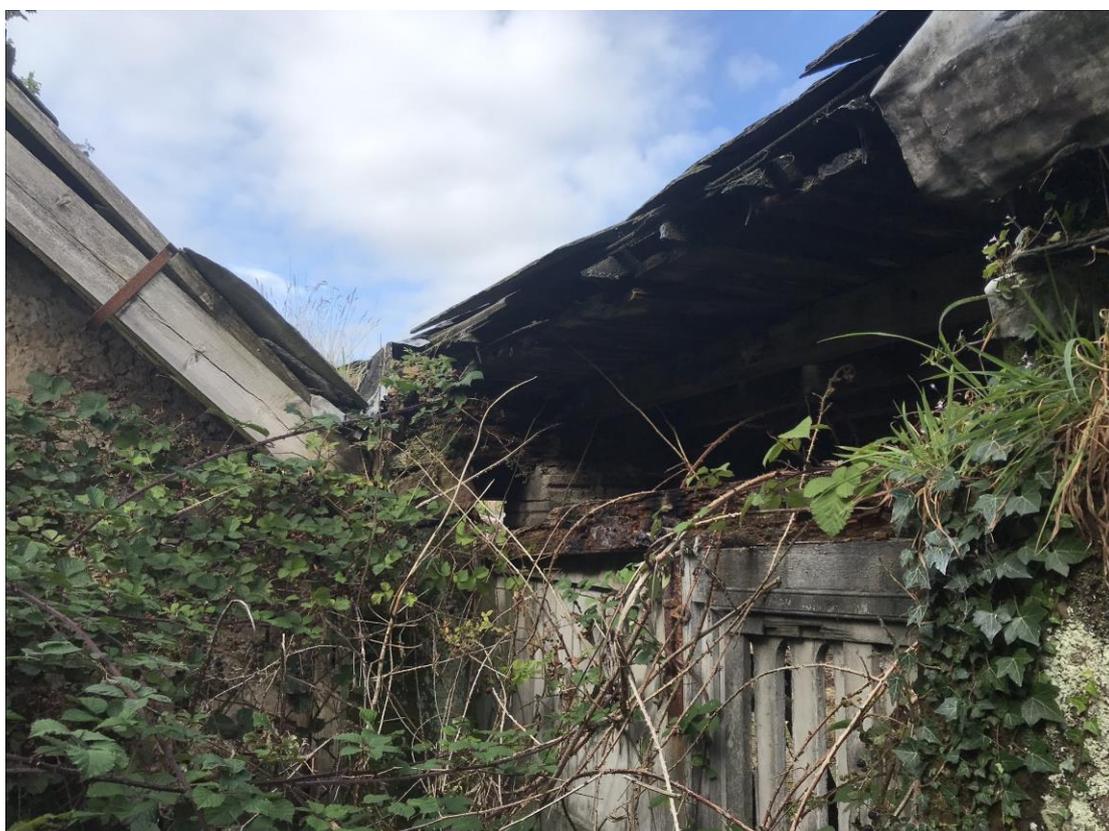
Location of former valley gutter between higher range of the ginnery all timbers have decayed offering no support.

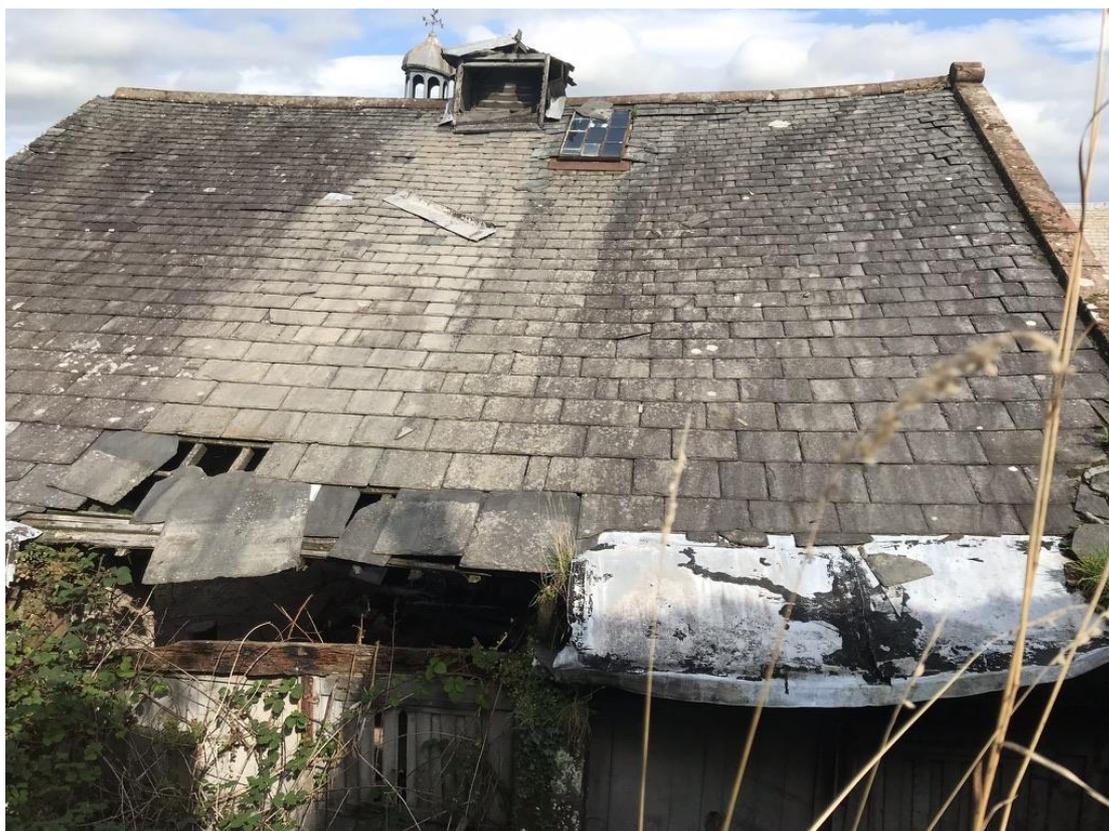
10. Viewing the roof externally a change in profile is evident with the ridge near the parapet wall remaining constant and the ridge timbers dropping away from this again confirming rotation of this element. Further decay will lead to this being more pronounced and with purlins being built into the rear wall, failure of the roof does create a real risk of the wall in part collapsing.

Part of lead valley in situ, rotation of truss evidences with ridge dropping sway from rear wall, ventilation cowl shown in poor condition.

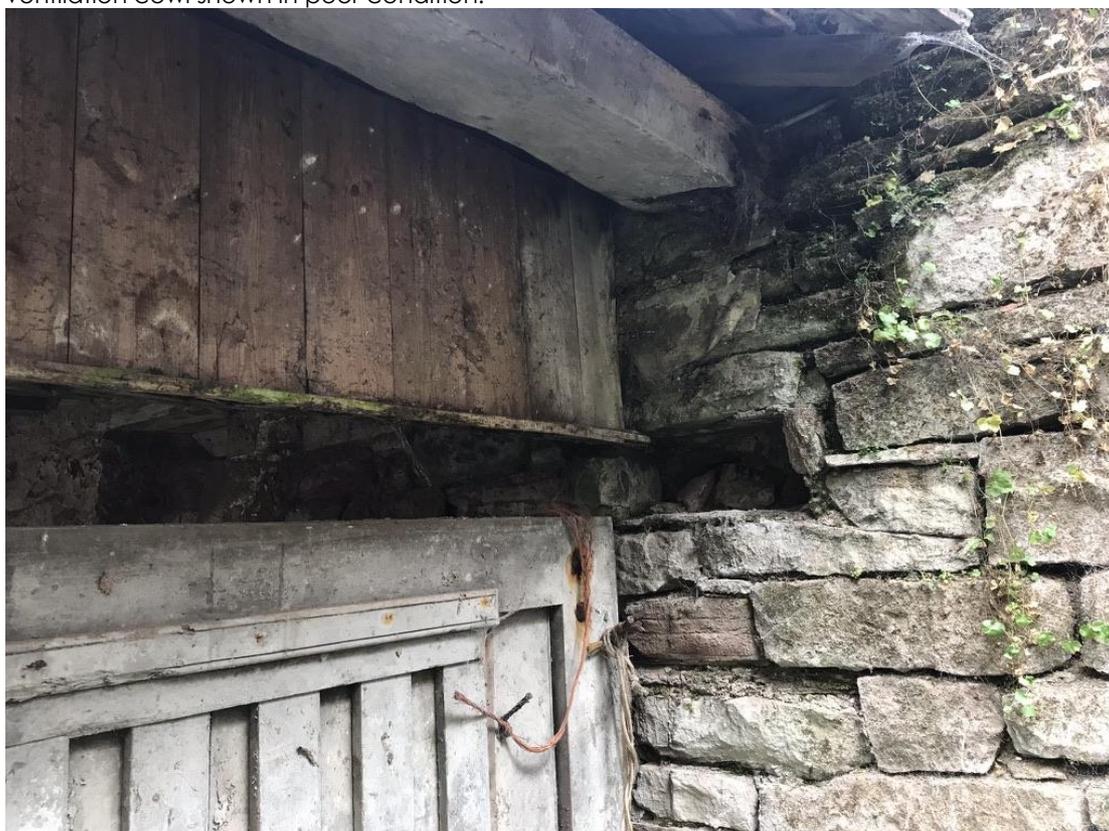
Pockets in stonework identifying locations of timber lintels long since rotted away, exposed rafter feet on roof shown above.
