Heritage, Design and Access Statement *SUPPLEMENTARY INFORMATION*

Change of Use of Offices to C3 Residential Serviced Apartments, The
Old Customs House, West Strand, Whitehaven – 22 May 2022

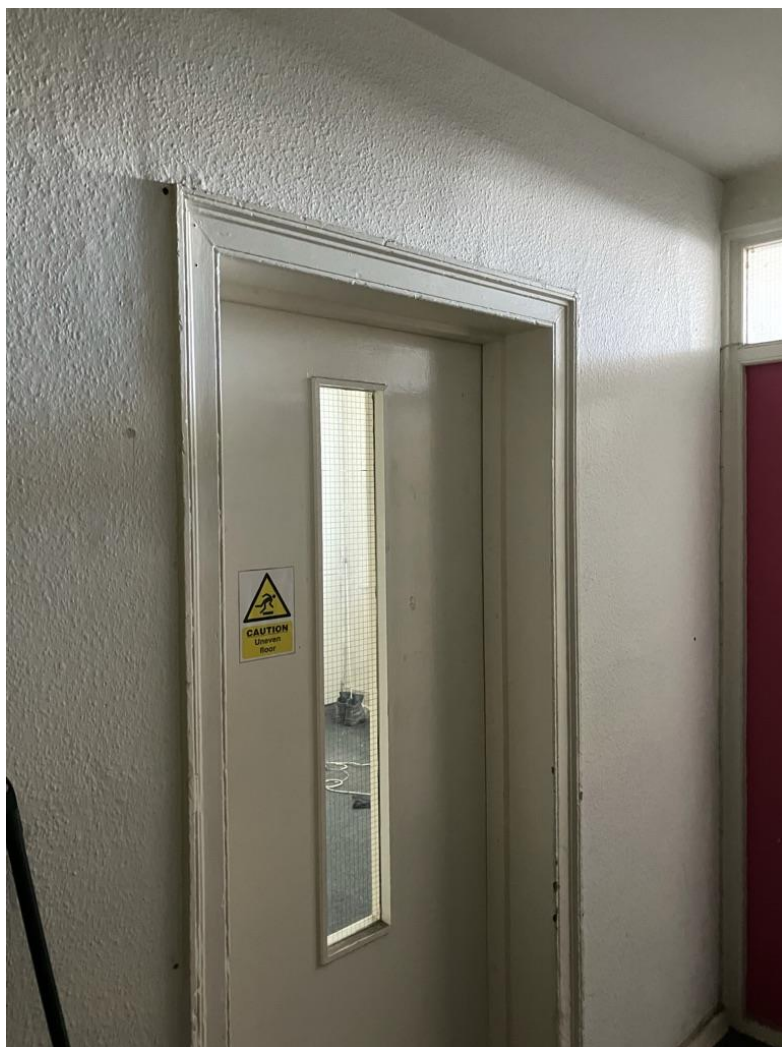
View of internal doorway into the front of Apartment 2

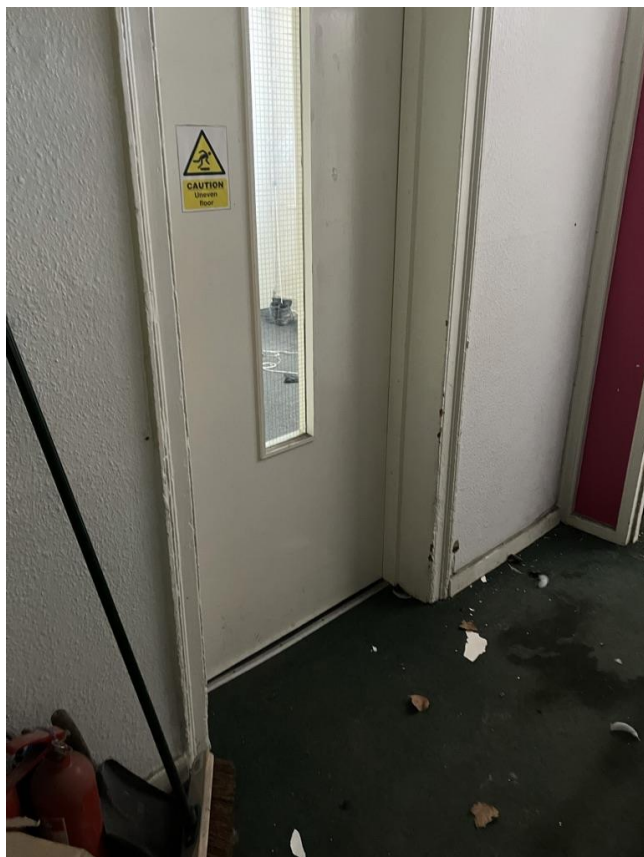
Apartment 2 – Existing door into front room. This is a historic door opening, the door linings and architrave indicate this. The skirtings and doors and both modern and offer no loss of heritage from the building.

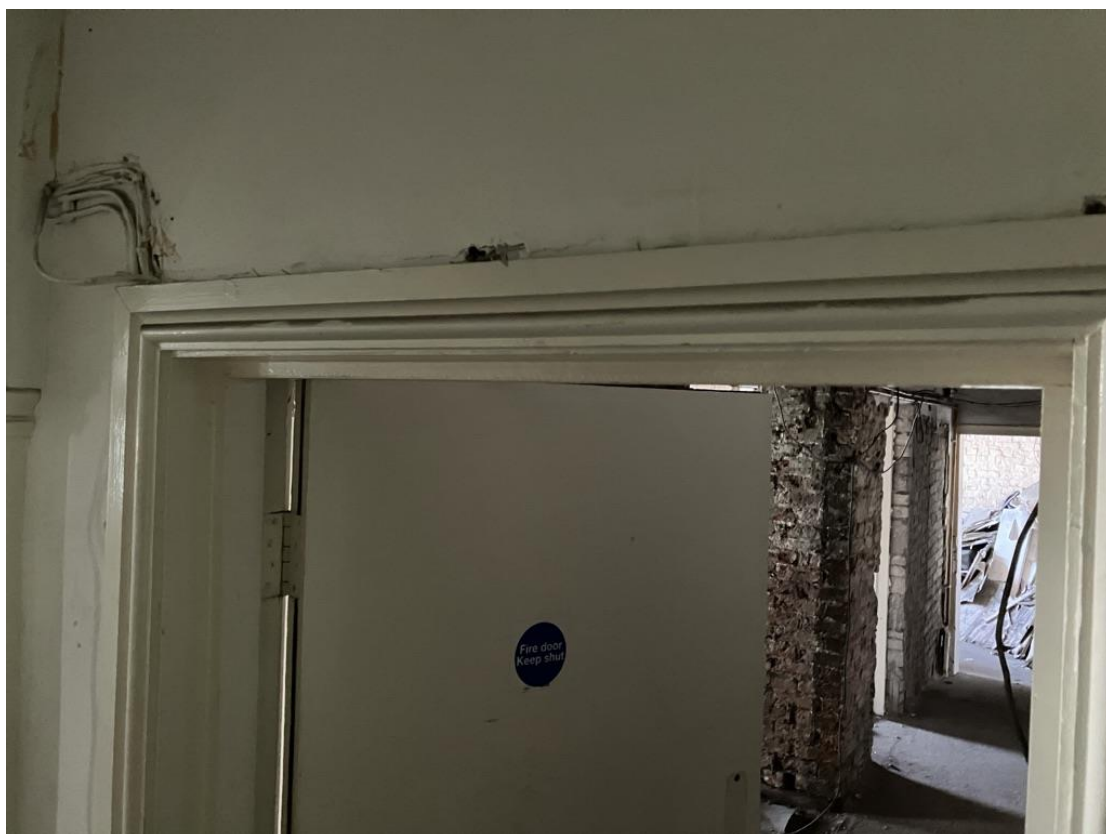
Photo of rear doorway into Apartment 2 from main hallway.

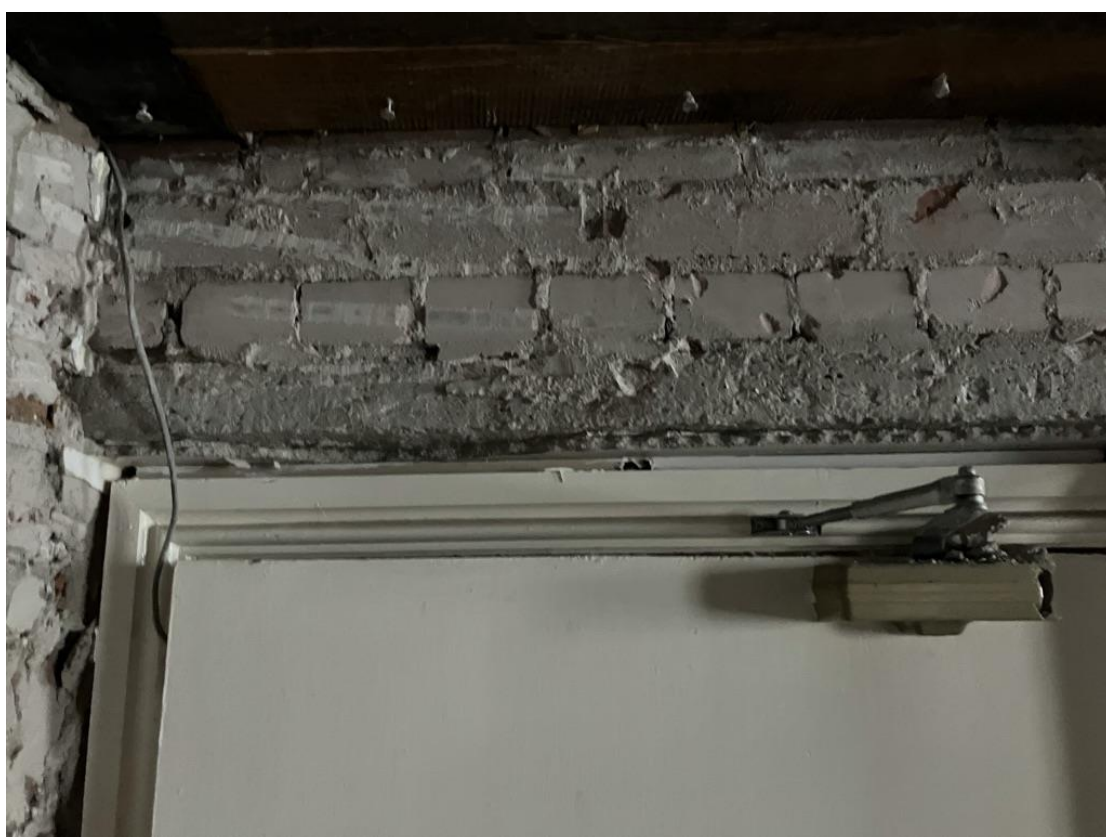
Internal view of rear doorway into Apartment 2

This is the retained door way into Apartment 2, it confirms this as modern doorway with torus softwood architraves, ply faced fire door and concrete lintol with modern brick infill panel over door

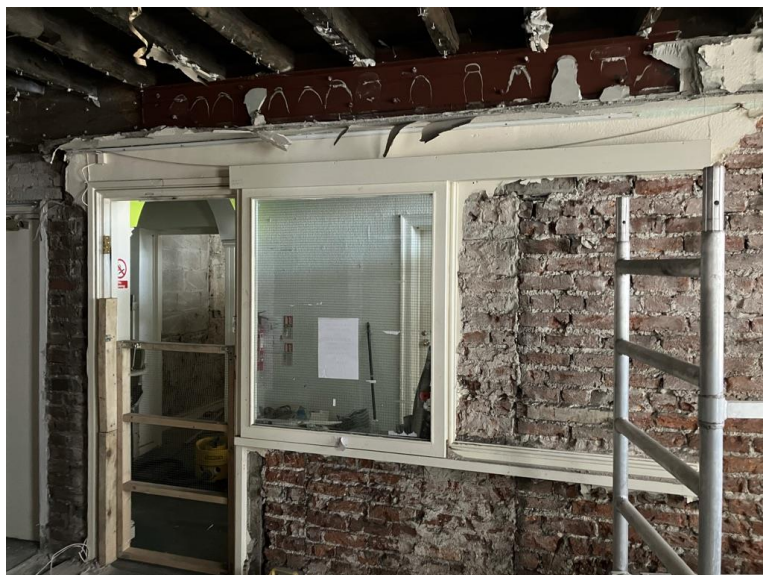
Existing modern door screen to Apartment 1 to be removed – evidence of steel beam over – split in brickwork suggest some re-modelling – wall not clearly shown on original plans. Apartment 1 Flat Entrance doorway to left of photo is to be retained with new Fire door installed as this doorway opens on to a protected stairwell.

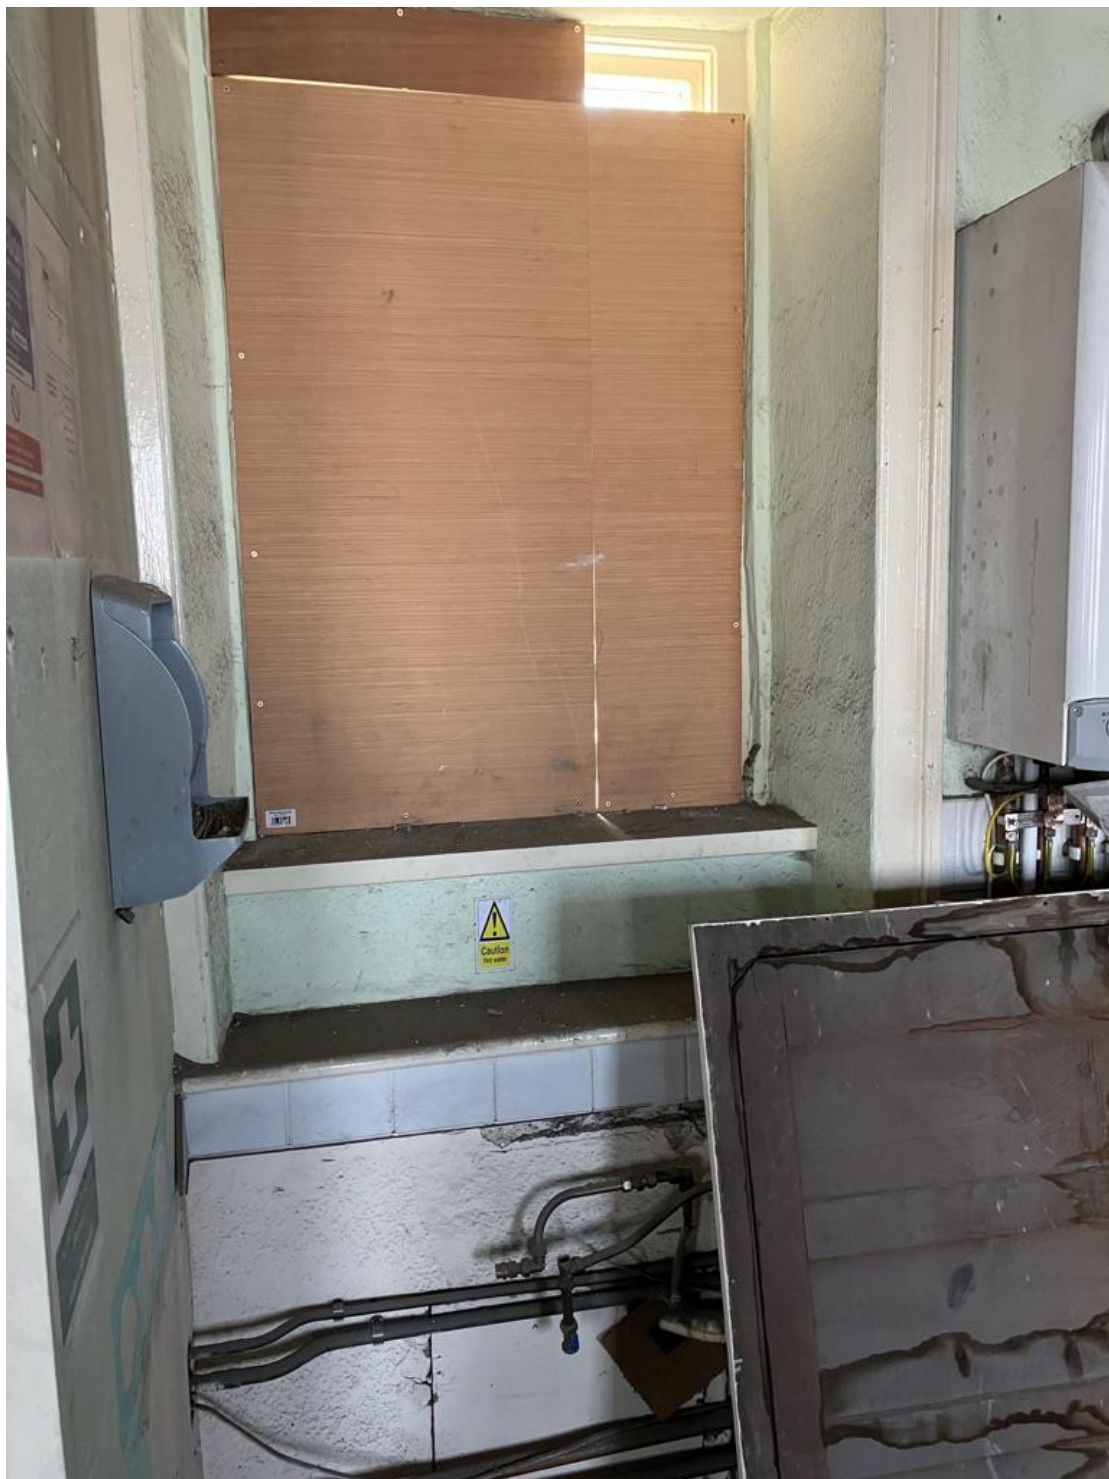
Internal view of window indicating a modern raised cill to allow kitchen to be installed. Wooden timber beads to plasterwork remain and architrave to window reveal

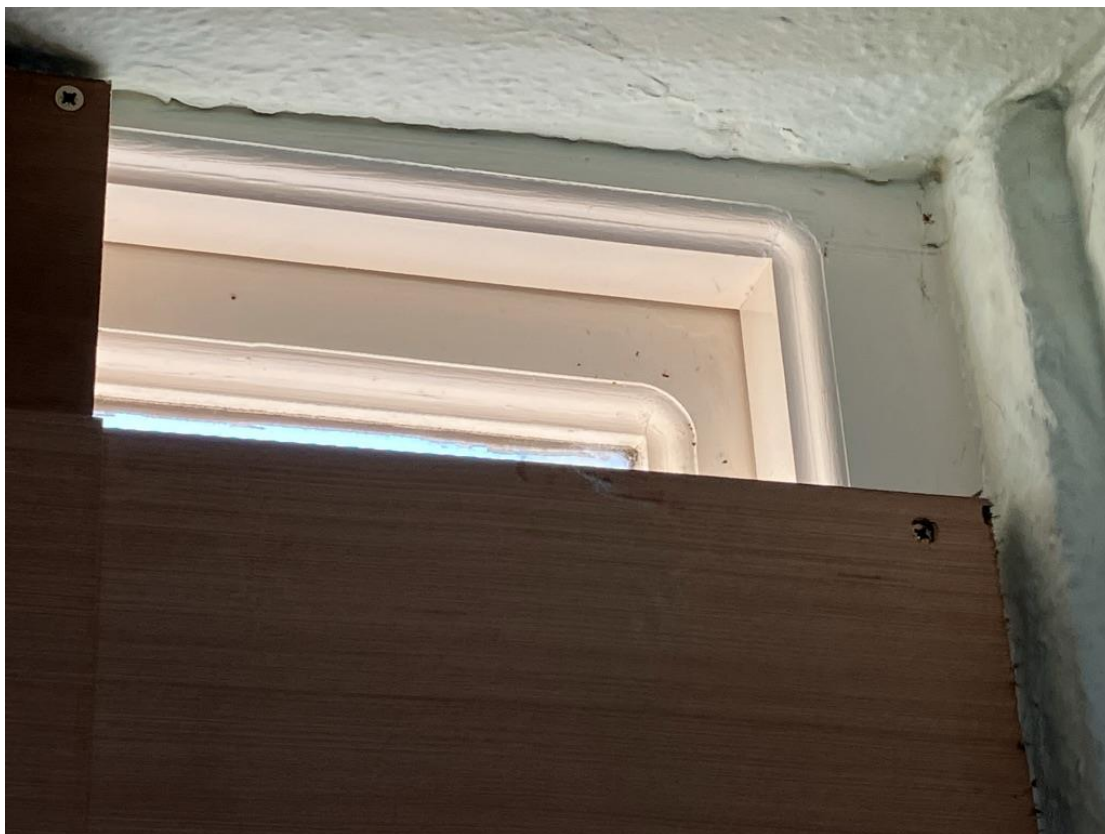
Close up photo of rear window - Internal view confirms this is a modern factory made window with routed curved edges confirming this. Window is temporary boarded due to vandalism

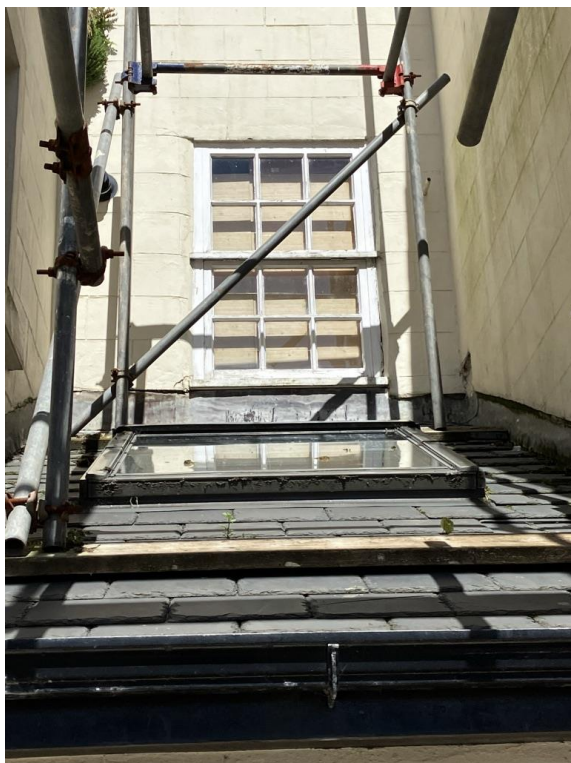
Modern timber window replacement – softwood mock sash window with lower hung casement window, lean to slate roof below

The existing timber window is not historic, the proposed works provide an external improvement to the building seeing the removal of a modern rooflight insertion and this is replaced with a traditional sliding sash window.

The proposed works do see the removal of this historic window opening however this is replaced with a new sash window in a newly aligned outer leaf. In addition the works see the removal of the modern velux rooflight.

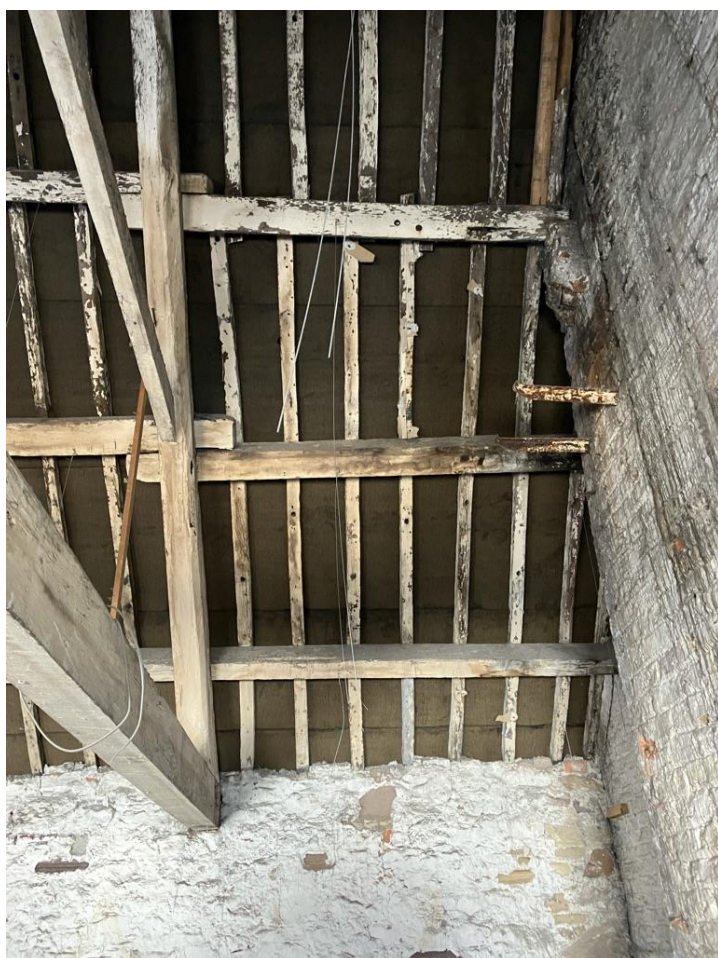
Location of attic stairs to right hand gable of existing roof structure.

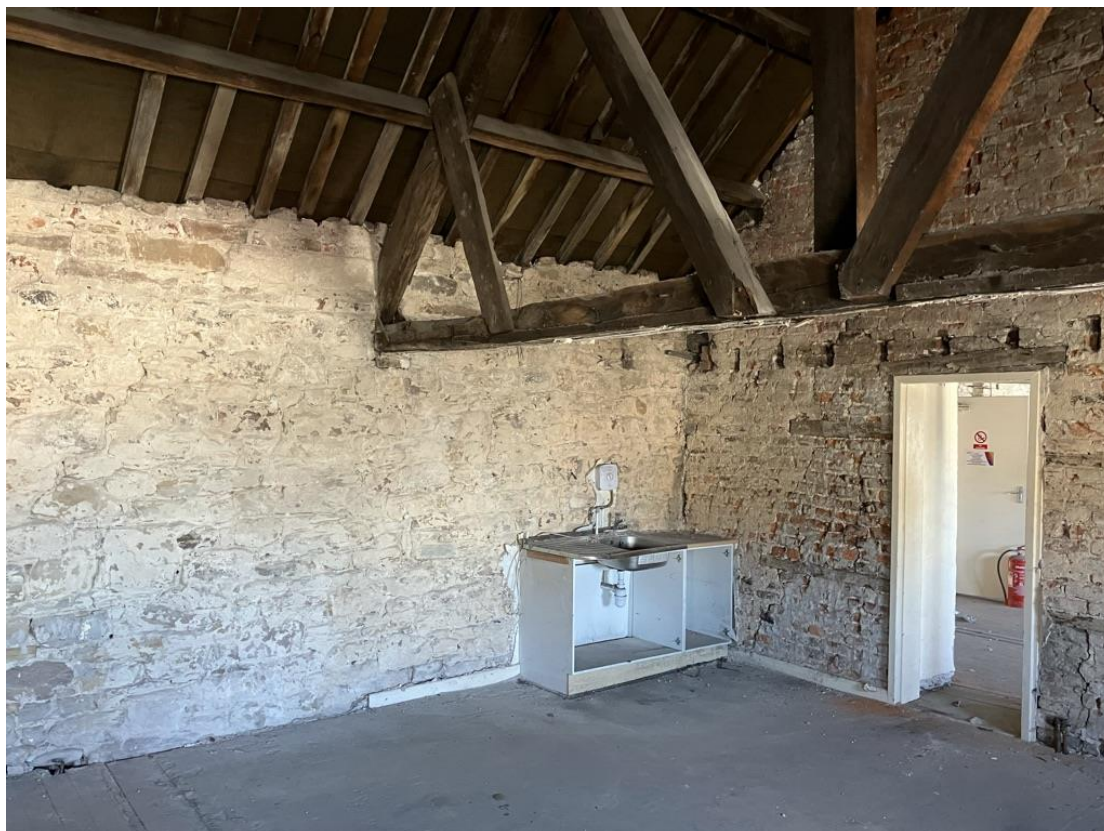
Location of attic stairs to left hand section of second floor – stairs fitted between truss and former 'party wall'

The photographs demonstrate that the works in creation of the attic floors do not impede on the existing roofing structure or layout. The trusses have previously been strengthened and altered over time. The works generally on this floor level allow the exposure of the existing roof structures to be read and are no longer obscured behind modern suspended ceilings.

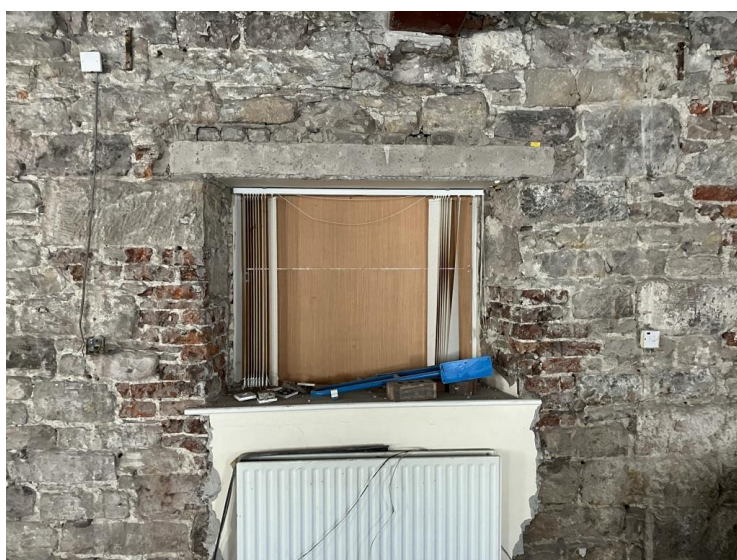
Existing modern window insertion at first floor to rear of building

The building have been altered or adapted over time and the proposal to insert an additional window in the second floor above this newer opening allows for the development of the building with time. The size and proportions of the windows are correct for this building and the enhancement of the rear elevation with the removal of the steel staircase offsets this variation in the building.

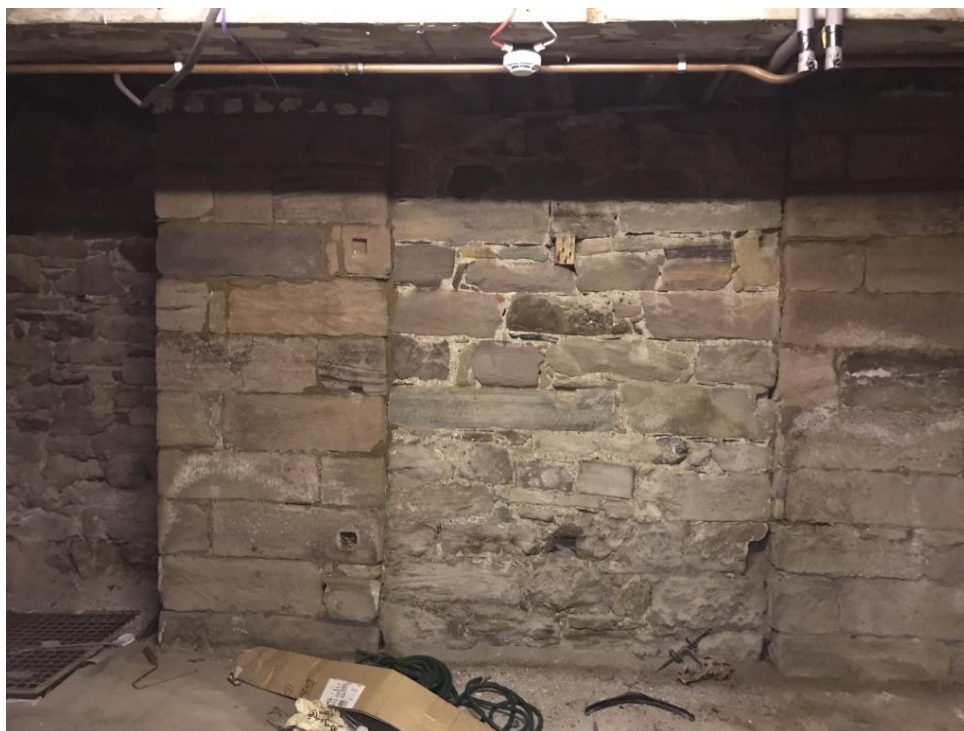
Basement gable wall viewing towards adjacent property – Basement stonework indicates the alignment of two chimney stacks within the building which rise through three floors. Central infill of stone is referenced on upper two floors.

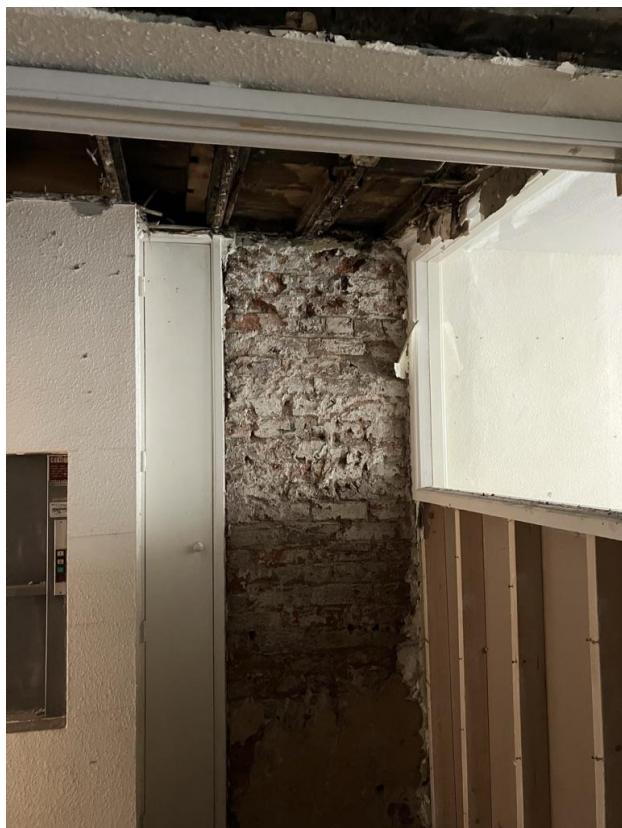
Rear half of front room in Apartment 2 ground floor, exposed brick aligns with chimney stack on first floor and basement.

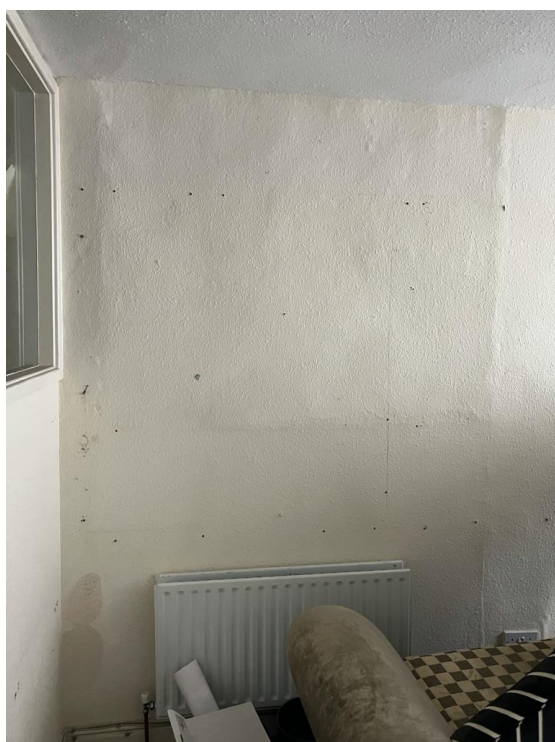
Apartment 2 – assumed former fireplace location sat centrally between two existing chimney stacks and remains unaltered. Profile of two distinct chimney stacks to left and right hand side visible in plaster profile. No works are proposed to this chimney stack with the except of inserting an air brick for ventilation.

It is not proposed due to the location of the former fireplace within the new Apartment to open this up, it is assumed given the 'flat' wall profile that a no historic fireplace exists behind this.

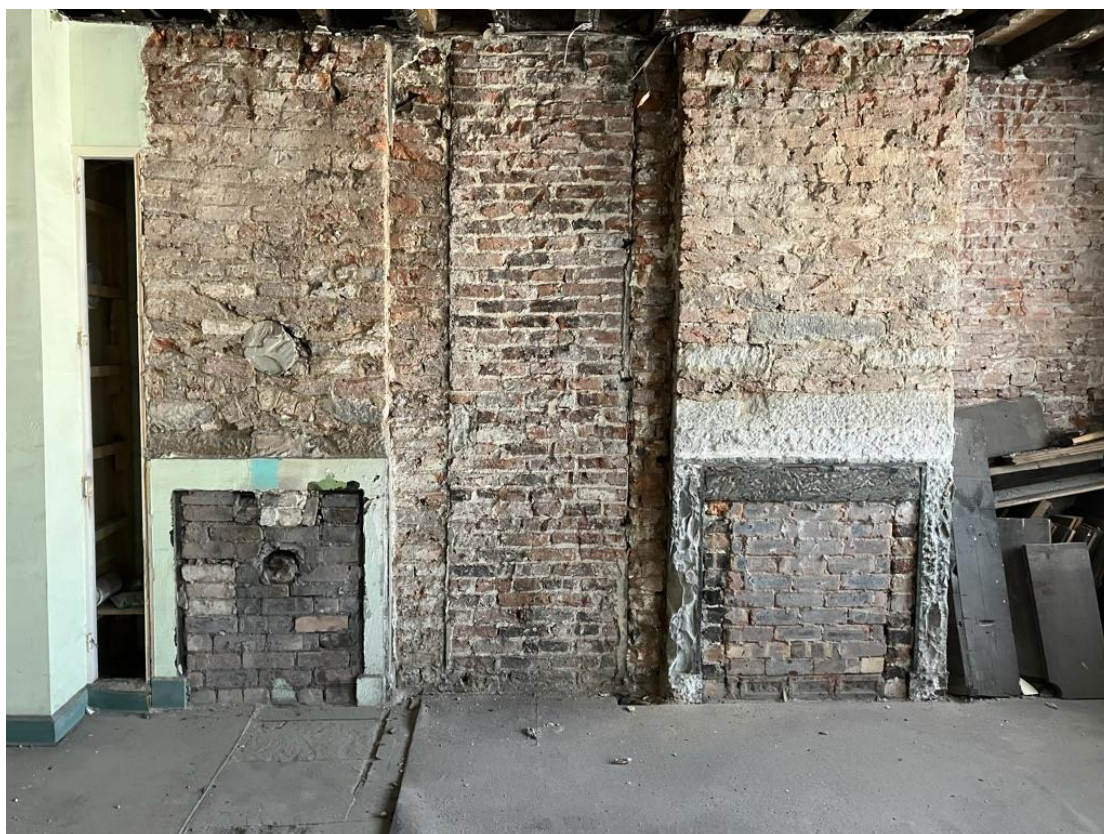
Chimney stack at first floor gable with central stack shown centrally between, and serves fireplace in ground floor of apartment 2.

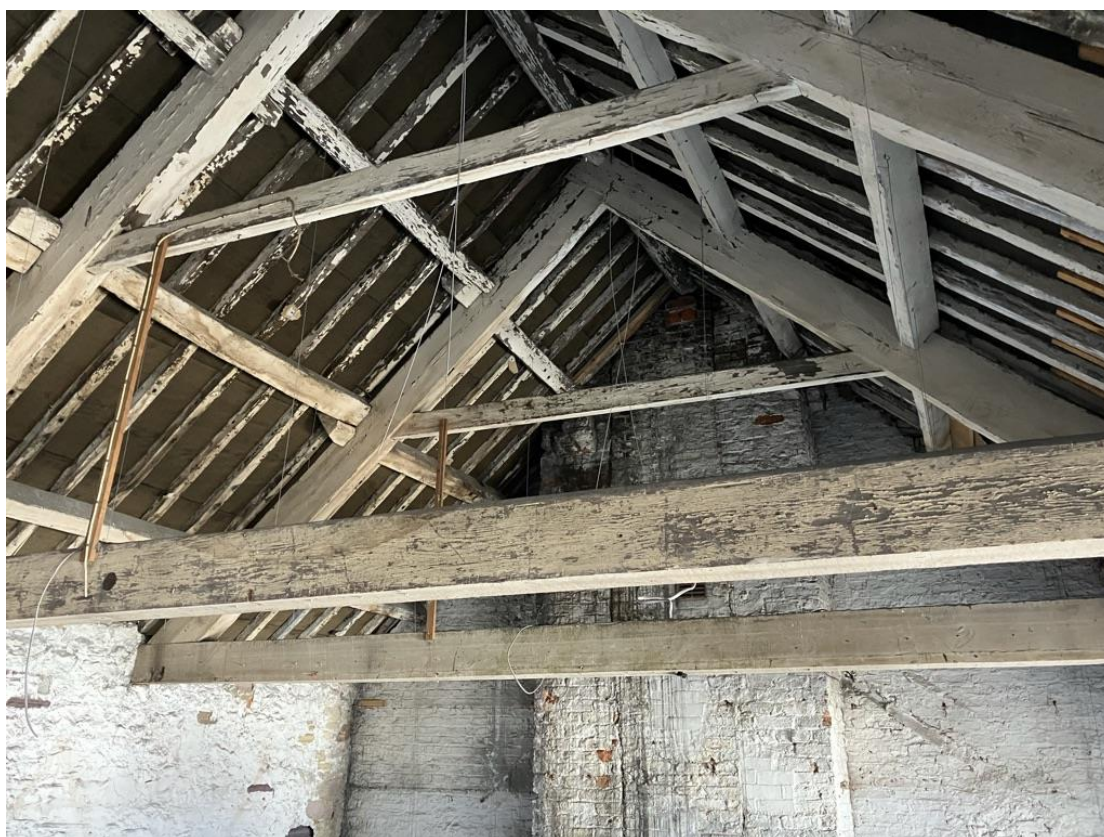
Chimney stack in second floor rising to main stack on roof all built in brickwork

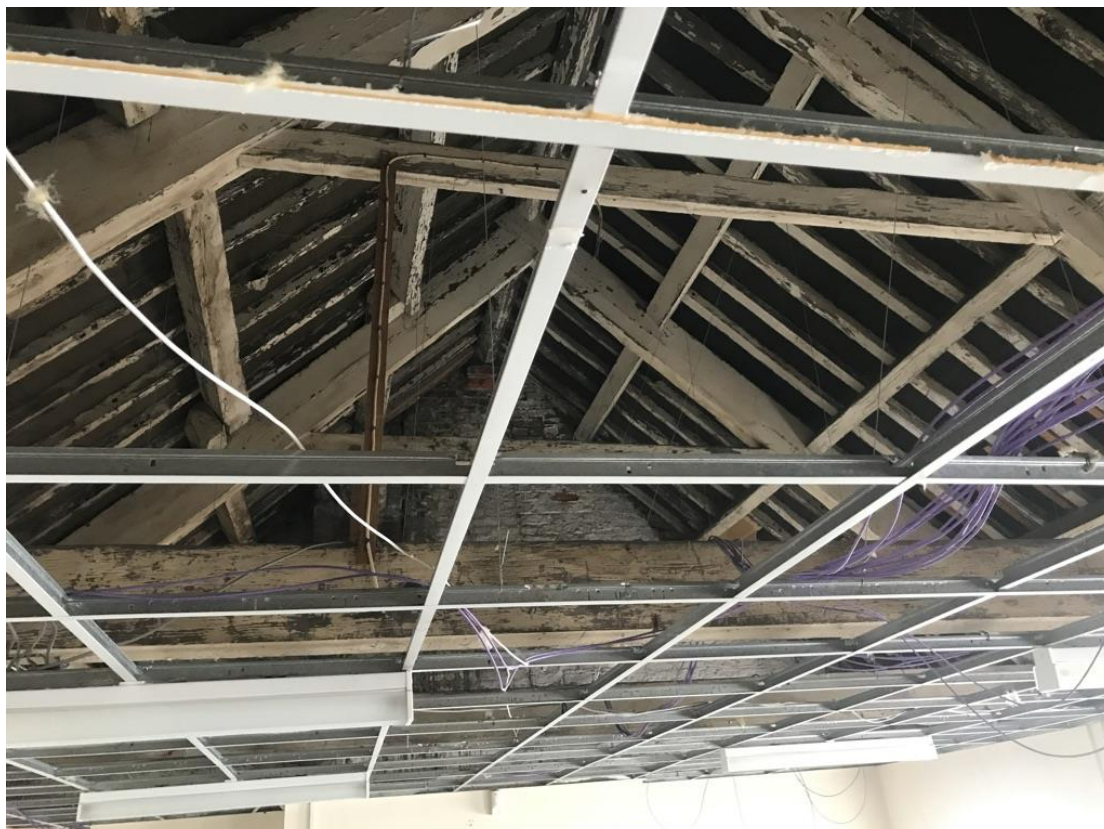
Sample photograph of second floor attic level which reflected the majority of floors where existing plastered or lath and plastered ceilings had all been previously removed and timbers all covered with thermal quilt insulation

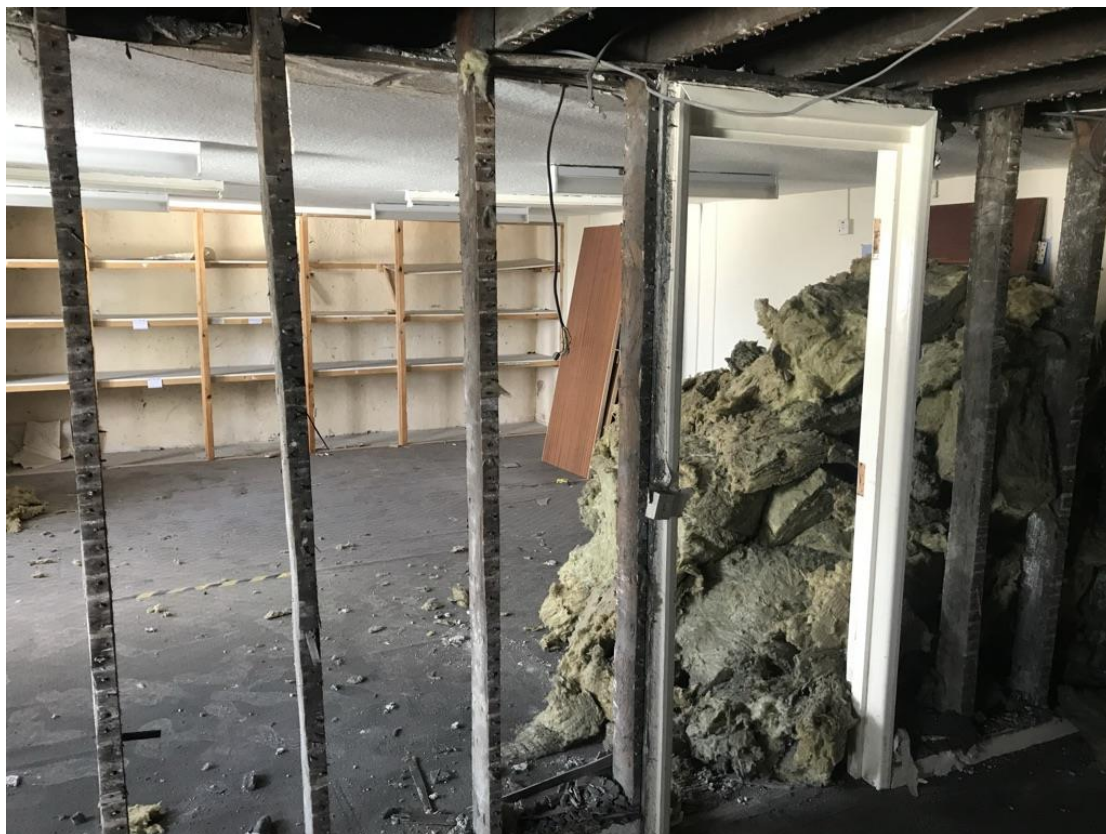
Thermal insulation removed from roof voids to allow inspection of the existing timbers

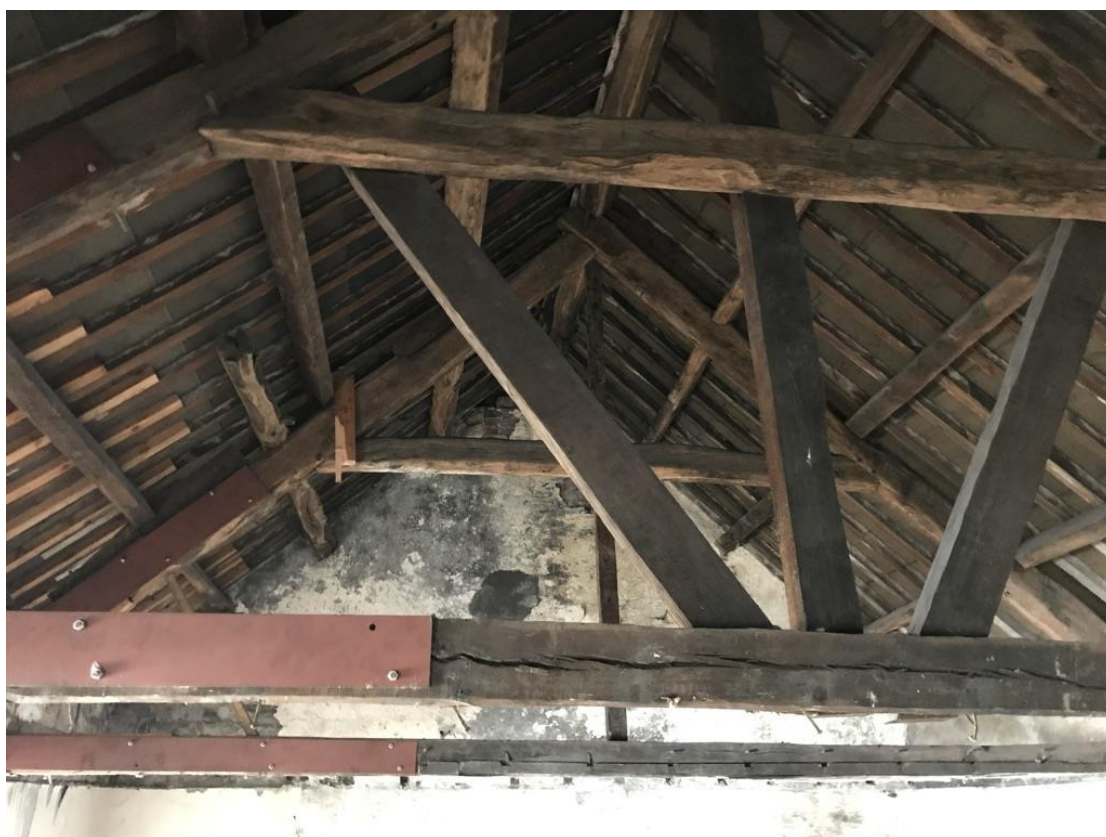
Previous steel strengthening works to roof trusses. Evidence of additional modern timber bracing also added to main trusses.

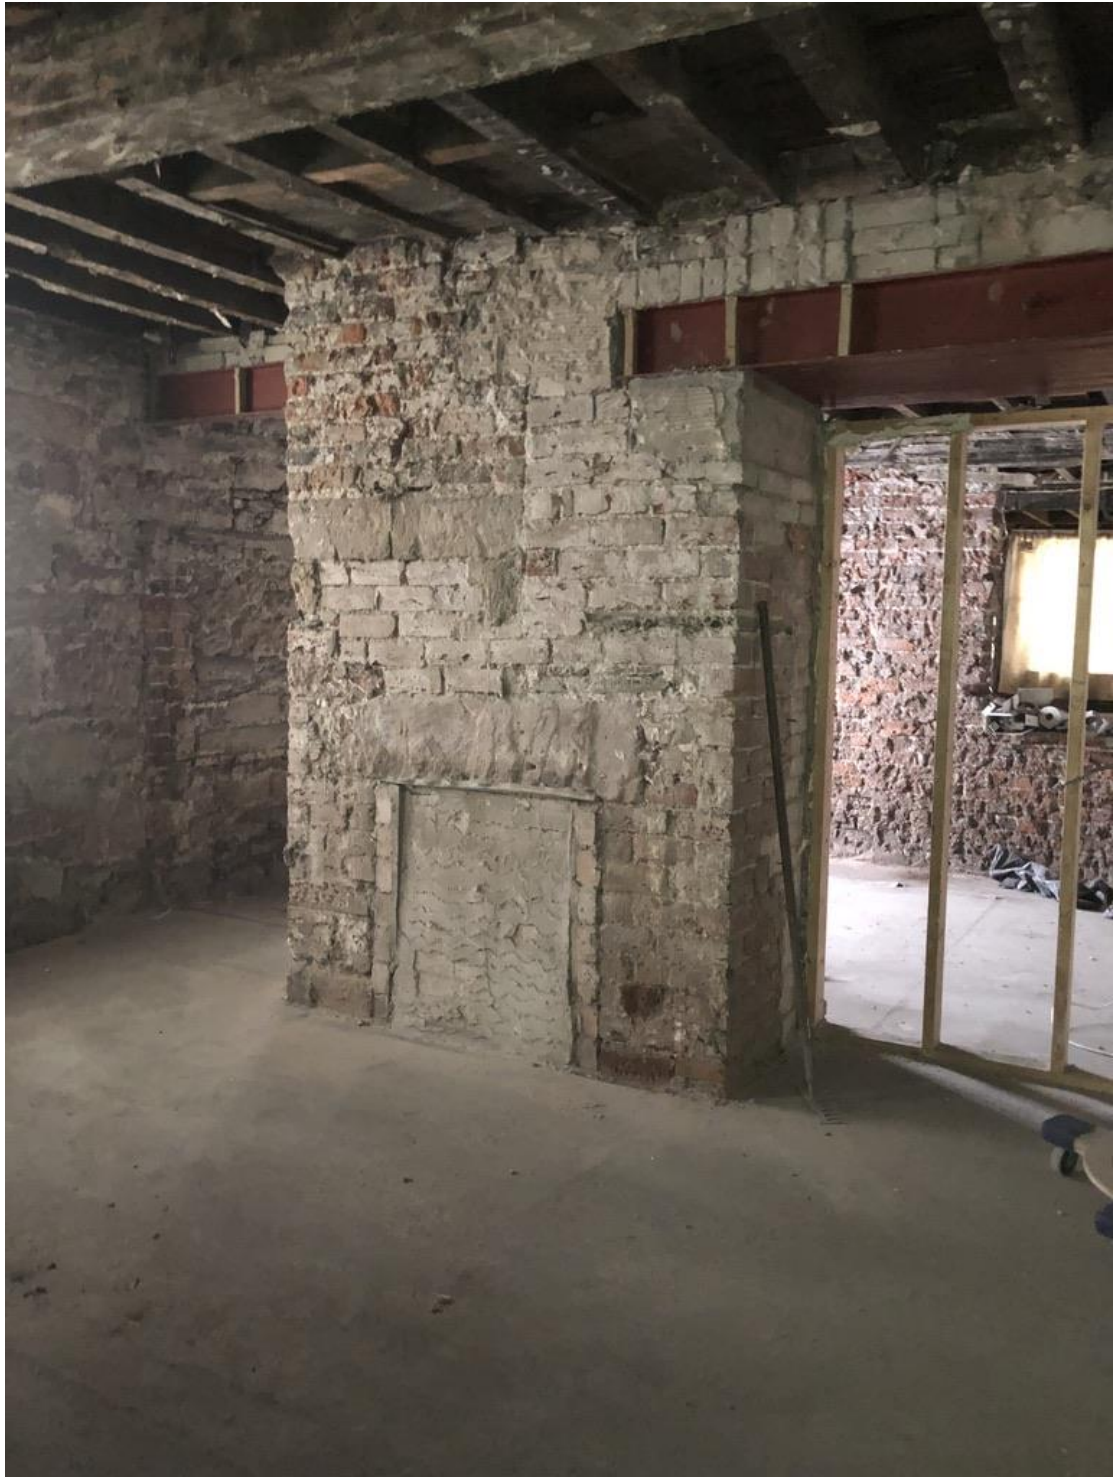
Modern steelwork and strengthening works to existing openings with new brickwork over.

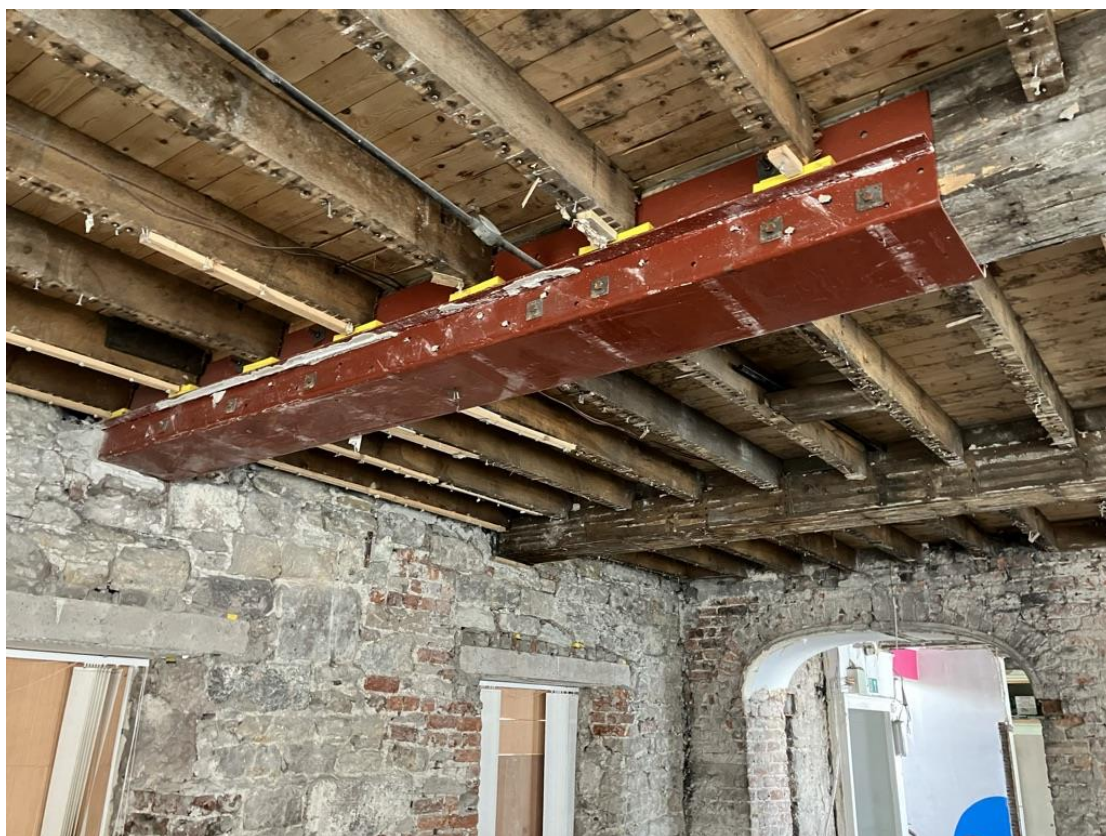
First floor ceilings with previously installed steel strengthening by previous building owner. This also indicates modern floor joists and floor boards installed within the last 50 years.

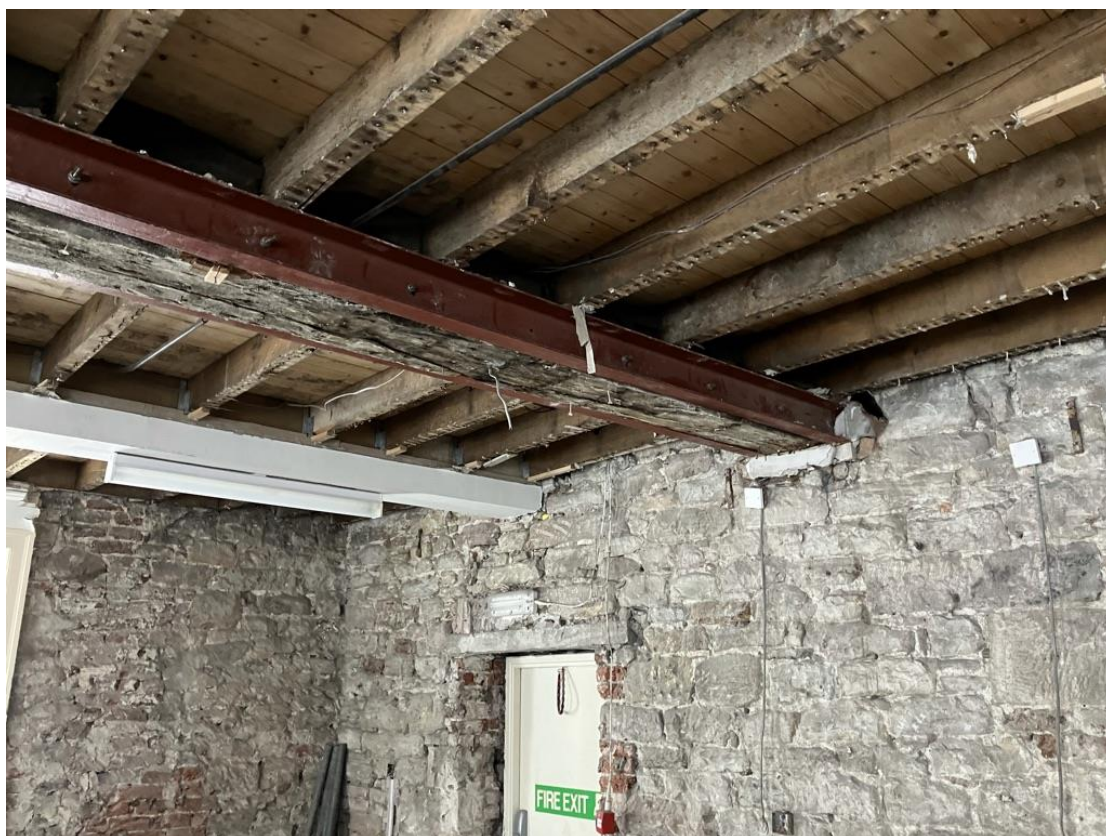
Strengthening works to existing timber beams

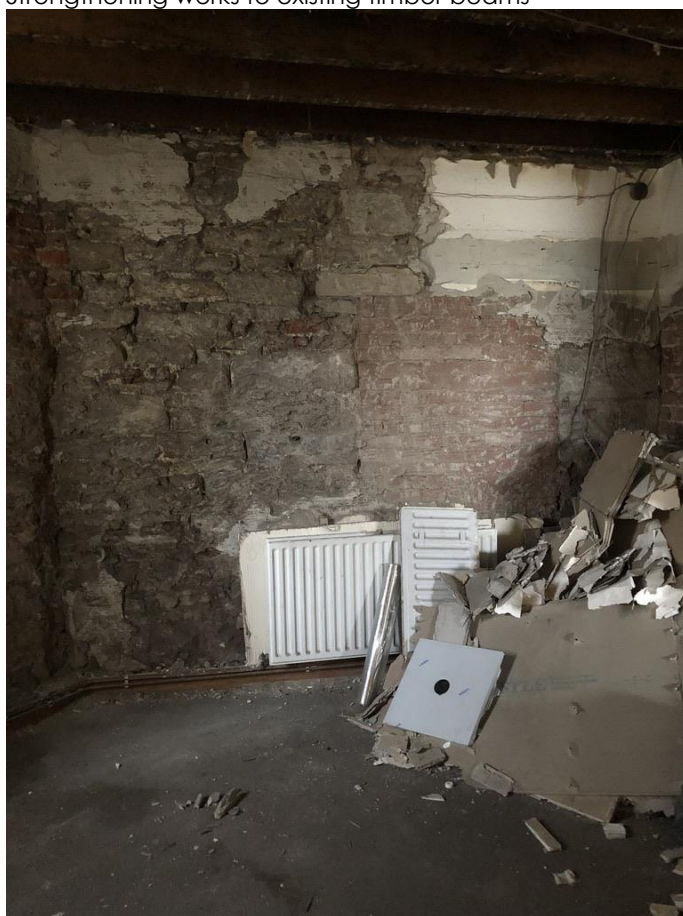
Gypsum based modern plaster and plasterboard removed from external walls.
