Design & Heritage Statement
9 Oakbank, Whitehaven
June 2020

Grade II Listed Building. Listing ref. 1336011. NGR NX 97959 18930

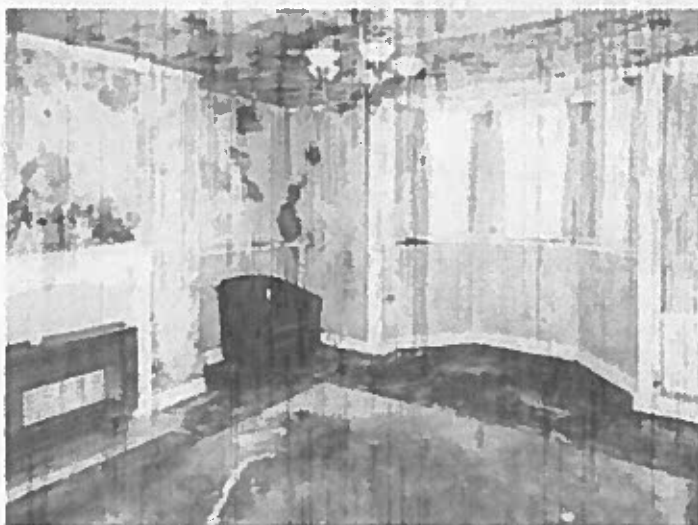
- a. Photograph of the basement at the front of the property. Marked as Bedroom in appendix 2.

The following photographs were taken prior to the recent refurbishment work. They provide evidence of the wet rot, dry rot and damp that need addressing immediately, and that no original features have been altered or removed as a result of this work.

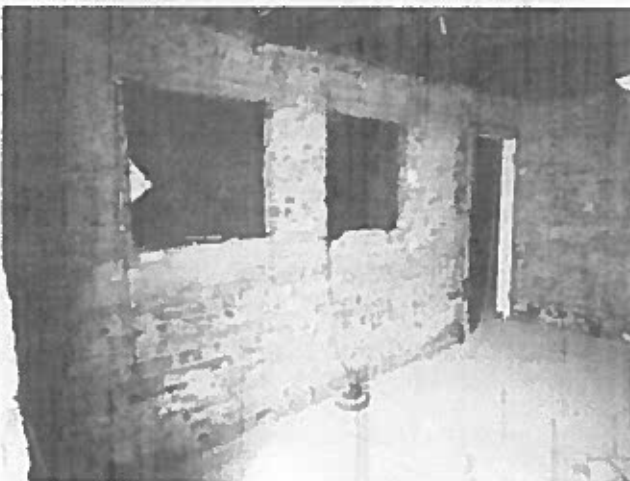
b. Wall to be removed and replaced by B2 in engineers specification

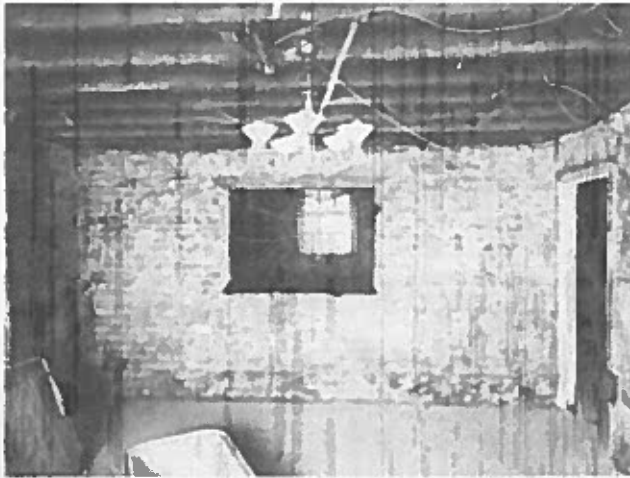
c. Wall to be removed and replaced by B3 in engineers specification

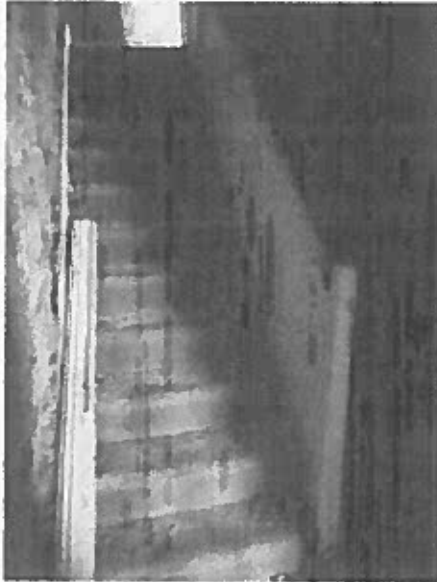
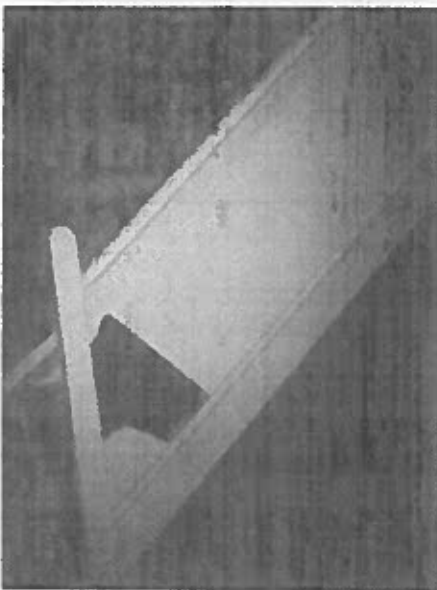
e. Staircase to be removed.

the existing stairs will remain and be converted into a cloakroom. The staircase will be removed and a replacement installed in the same position. See photographs below.
