HERITAGE STATEMENT ADDENDUM

**SEASCALE HALL
SEASCALE
CUMBRIA**

**PREPARED BY LANPRO SERVICES
ON BEHALF OF
NDA PROPERTIES**

September 2022

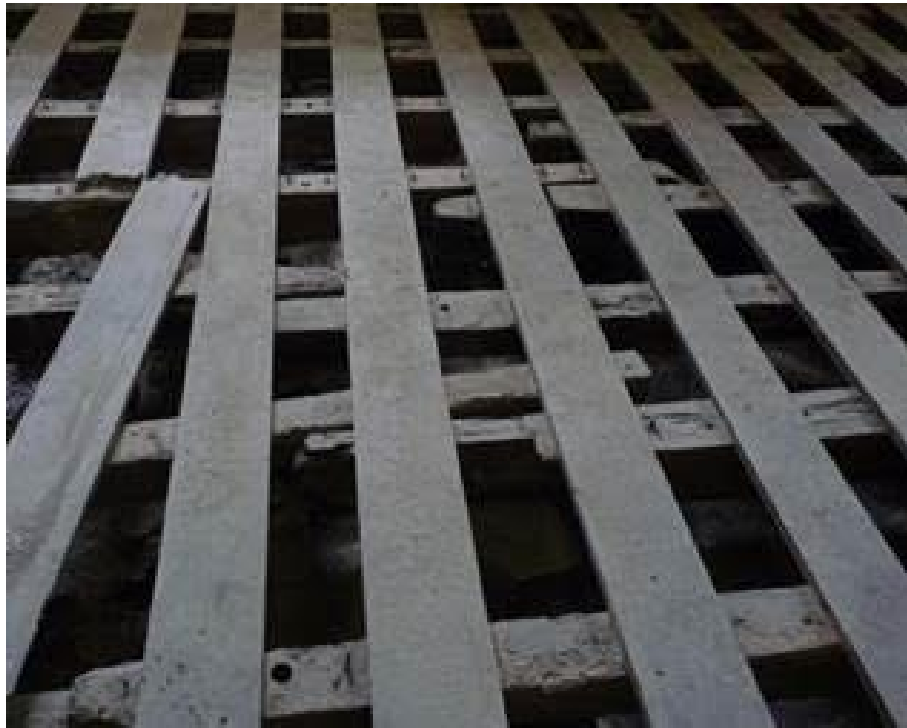
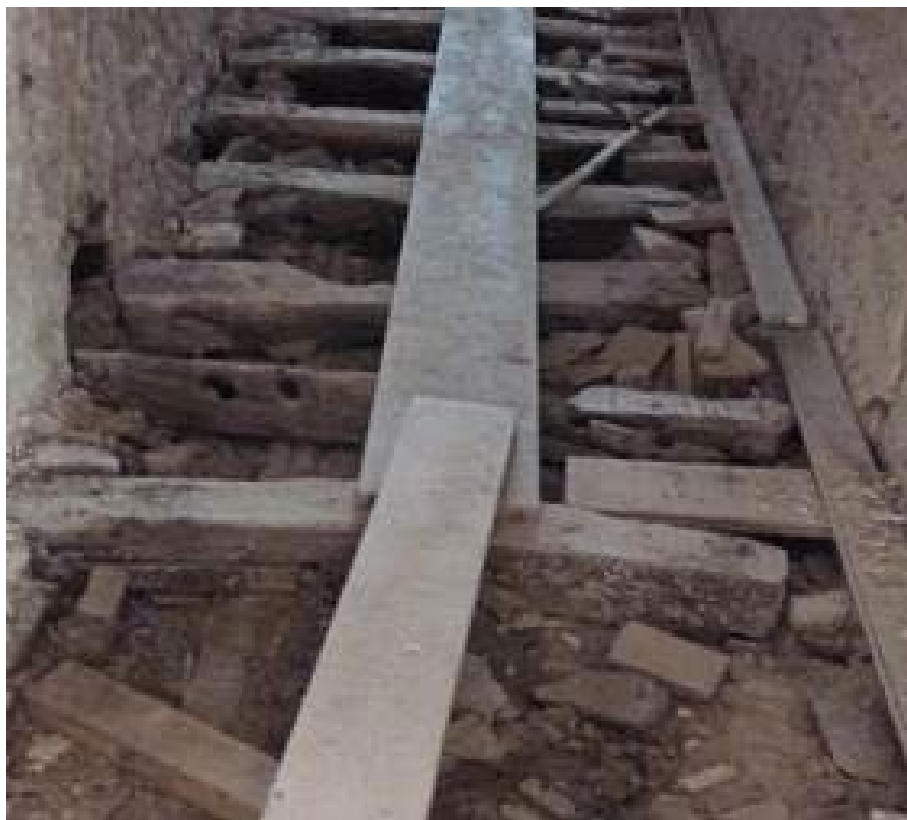
- 3.2 Following stripping-out, the existing floors were found not to be tied into the walls and to be constructed of random lengths and widths of timbers. These timbers were subject to damage from rot and evident infestation. These floors were only supported by random wedges of stone, broken in places, with over floors deflecting and unstable. As a result, the flooring in its current state is structurally incapable of supporting the required use and is undermining the wider structural integrity of associated sections of the building.

Plates 1 and 2. Photographs of the existing flooring

- 3.3 It is proposed to replace all suspended timber flooring on the ground floor with solid limecrete floors. The use of limecrete is considered an appropriate response to the circumstances and is in line with the established use of limecrete within the consented scheme where it is to be used in the former Wash Room and Meat Room.

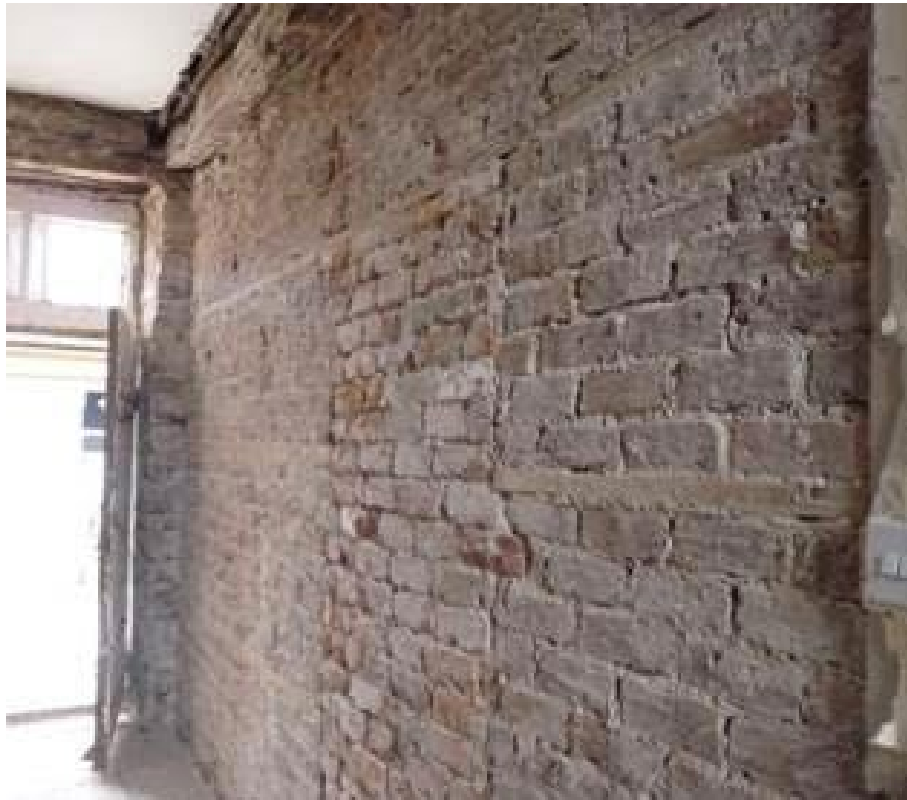
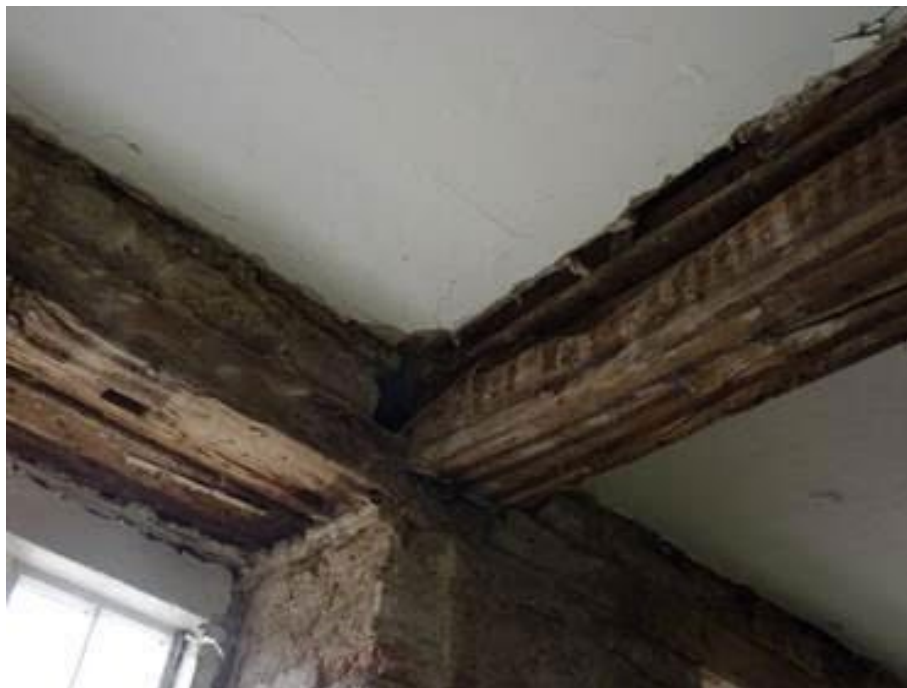
- 3.8 During the course of consented on-site works, the wall between the kitchen and entrance hall was identified as unstable. As a consequence, the LPA's Conservation Officer agreed to its removal prior to receiving Listed Building Consent on safety grounds. This wall has now been removed.

- 3.9 As a result of the wall's removal the structural engineer has confirmed that the two main timber beams (long spans) in the kitchen are subject to deflection. As both kitchen beams span over a large area, steel beams are now required to mitigate for deflection to upper floors. The original timber beams will however be retained in-situ.

Plates 3 and 4. Details of the original wall beam between kitchen and the entrance hall after removal

preserved by record. In addition, rebuilding the wall would result in a less useable space for occupants and is considered un-supporting of modern living standards. The historic beams, which are of more historical and evidential interest, will be retained in situ. In order to ensure they are able to meet the required loading standards, and maintain structural integrity, it is proposed to introduce steel beams. These will be installed below the timber beams and packed to offer the required structural support. This is also intended for the beam spanning centrally within the kitchen.

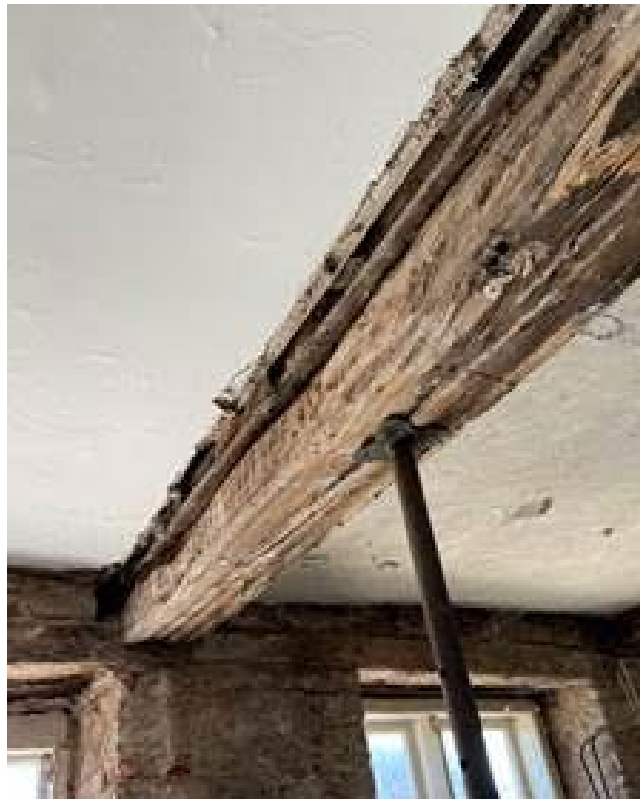
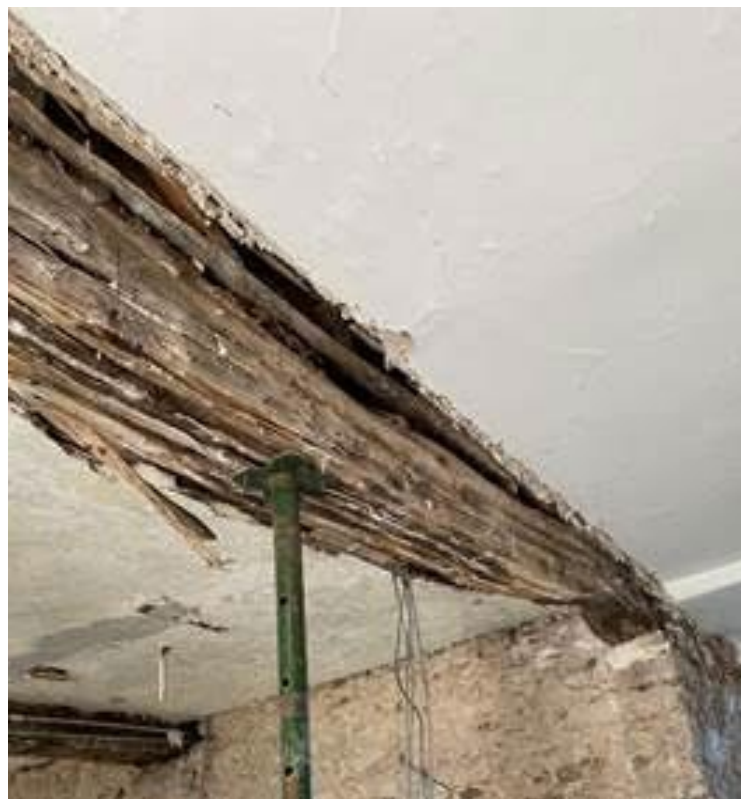
Plates 5 and 6. Details of the original wall beam between kitchen & the entrance hall after removal

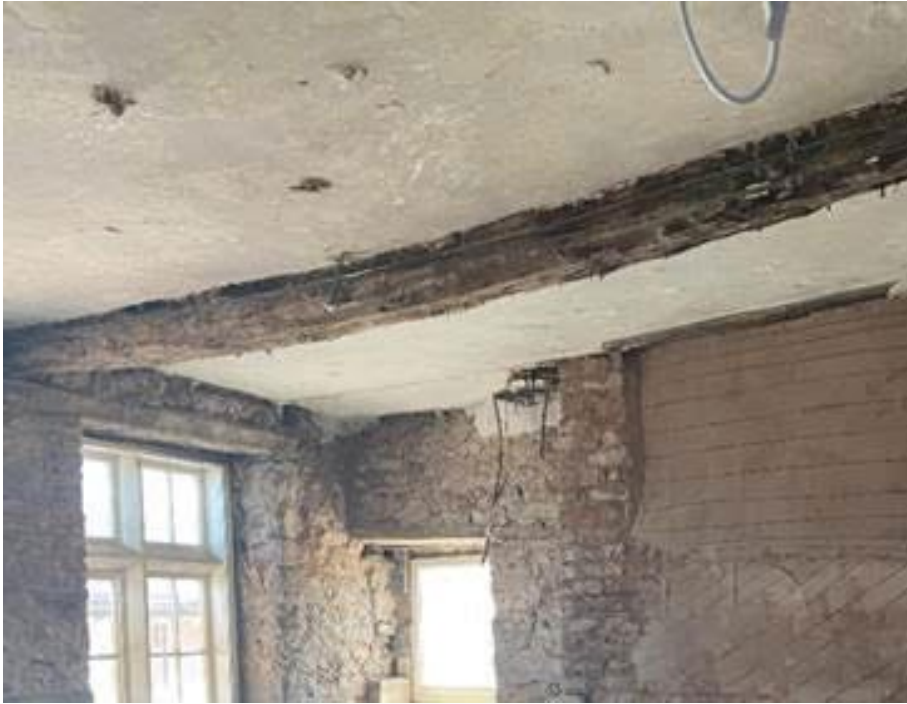
Plate 7. General view of the original wall beam between kitchen & the entrance hall after removal

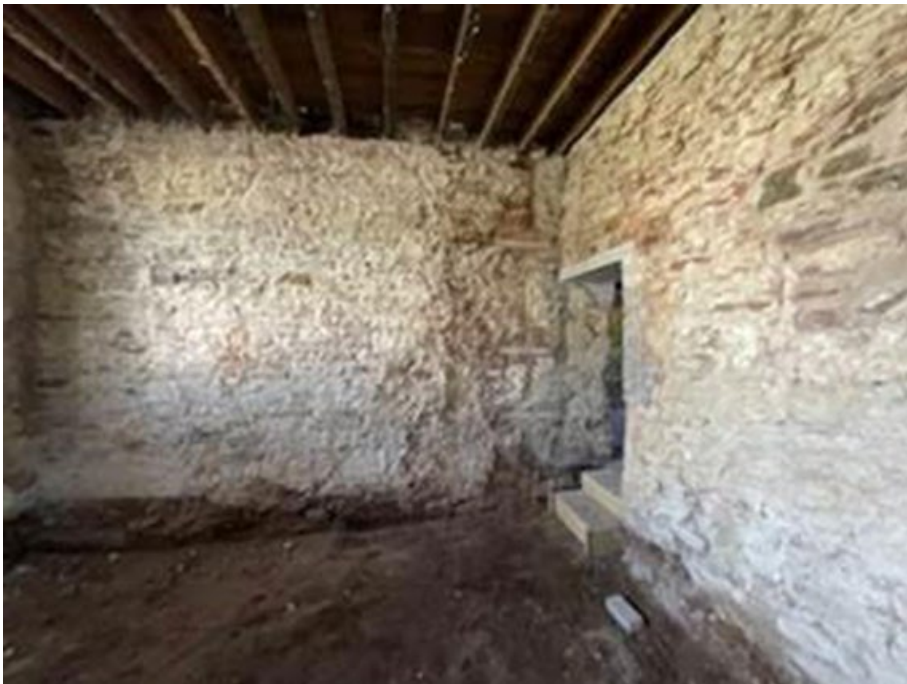
- 3.14 During the course of consented on-site works the plaster on the wall separating the former Meat Room and Lounge 2 was removed. This revealed a timber lintel and evidence of an opening on both sides of the dividing wall. It is proposed to introduce the new doorway within the wall where this earlier historic opening has been identified. This will require the removal of the rubble wall fill and the introduction of a concrete lintel, padstones and doorway.

Plate 8. The location of the proposed door between Meat Room and Lounge 2

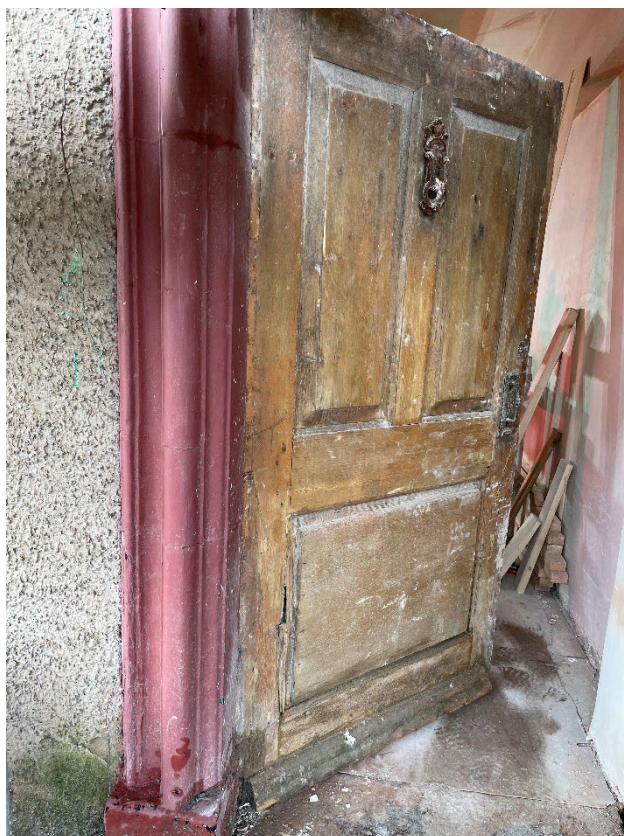
- 3.19 The existing front door is of three panel raised and fielded appearance externally (Plate 9) and plank construction appearance internally (Plate 10). There are two long wrought iron fish tail strap hinges hung on iron pintles fixed into the reveal, which is stone. The other ironmongery consists of two substantial bolts, a decorative latch and an iron mortice lock. There is a knocker externally. The door has suffered from neglect and is in quite poor condition and has been variously repaired with modern timber.

Plate 9. External appearance of the front door

- 3.20 The door in its current form does not fully open, restricting access into the house and it is proposed to replace this door with an identical, but 170mm narrower, replacement with a new frame set in to the existing reveal. The proportions of the three panels and rails will remain the same, only the stiles will be reduced in width. The door will be hung on replacement traditional heavy duty hinges, the existing hinges and pintles will be removed, stored within the loft space, their location being referenced in the health and safety file. Copies of the existing internal hinge bars will be fixed to the new door replicating its traditional internal appearance and all the other existing ironmongery will be fixed back to the new door.

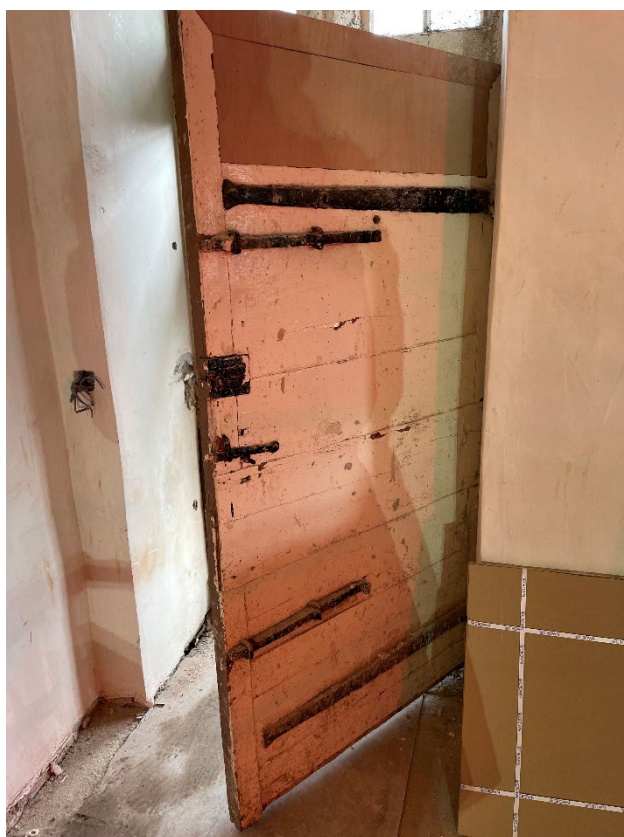
Plate 10. Internal appearance of the front door
