HERITAGE STATEMENT

FULL RENOVATION OF EXISTING No 11 TERRACE HOUSES

St Bees, 1-11 Lonsdale Terrace, Parish Council, Cumbria

M.A.C Architects, Project Number: 2019:303

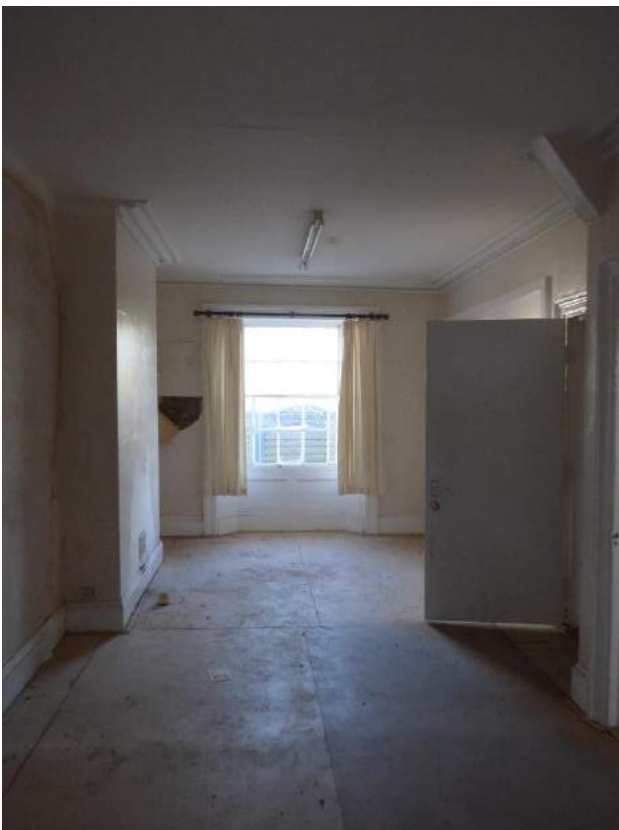
Left: In the existing lounge, the period features below and to the sides of the existing windows both front and back are in good condition, it is proposed to carefully refurbish the existing timber shutters.

Existing cornice to be made good in locations where redundant services are to be removed and where hairline cracks have appeared.

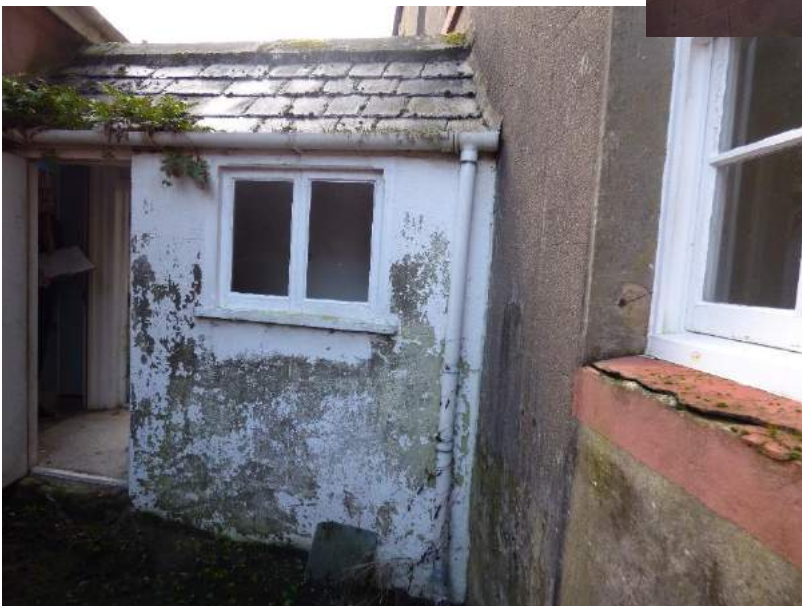
Rear of property – render to be repaired by specialist and decorated with off white render.

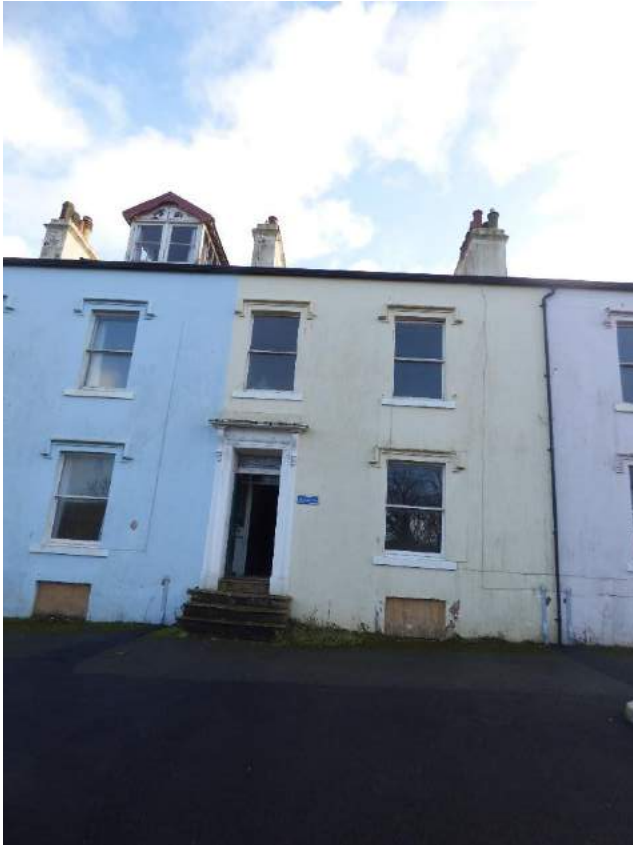
Left: The main entrance is mentioned in the listing text and is to be entirely retained.

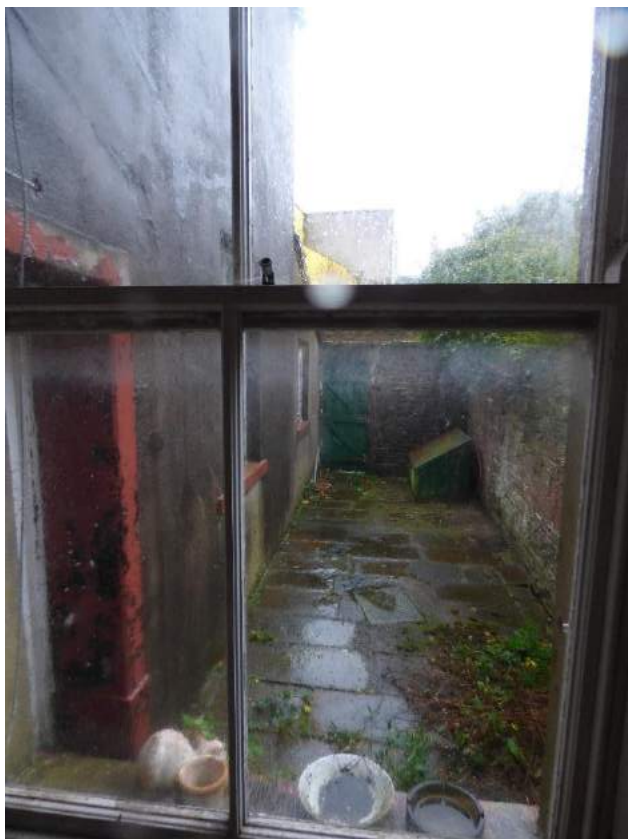
Left: View of rear of property – render to be repaired by specialist and decorated with off white render.

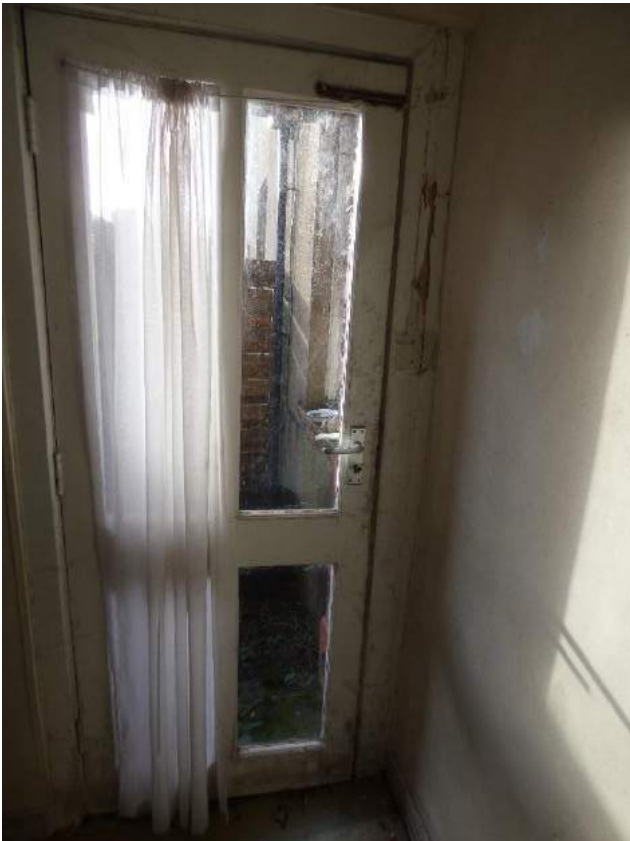
Left: rear door to be replaced with a Georgian style as front door.

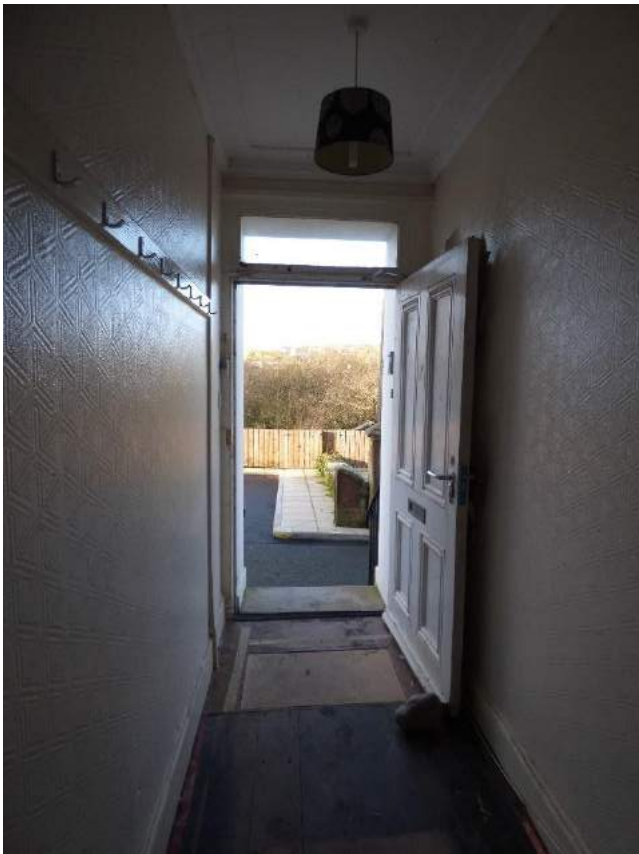
Left: Existing ramp to be removed and original step to be reinstated.

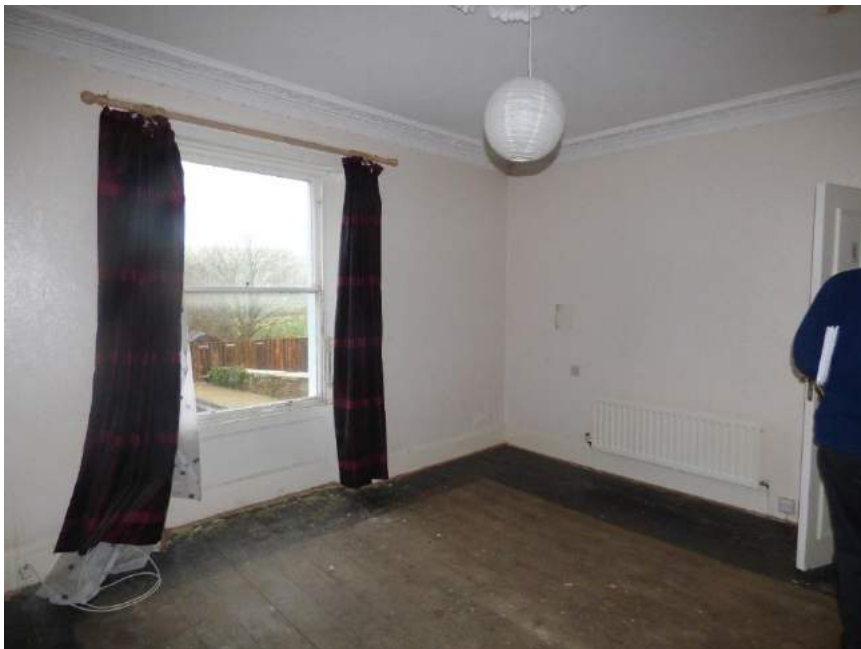
Left: Existing cornice to be made good in locations where redundant services are to be removed and where hairline cracks have appeared.

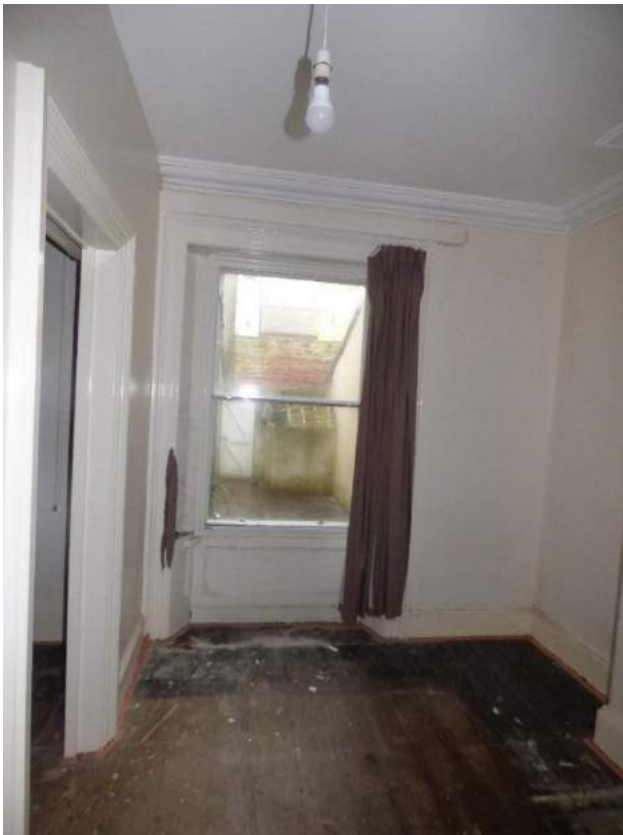
Left: The existing room I partitioned with a stud partition to provide a downstairs bathroom. It is proposed to remove this bathroom and all the associated fixtures and fittings. None are original.

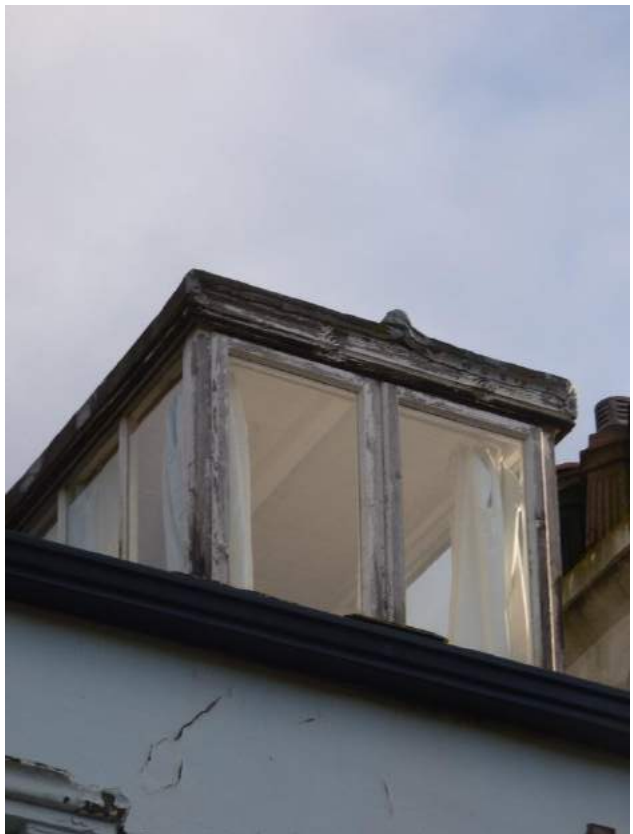
Existing dormer window is in extremely poor condition and it is proposed to completely reconstruct the dormer, in a style to match the other dormer windows on the adjacent buildings.

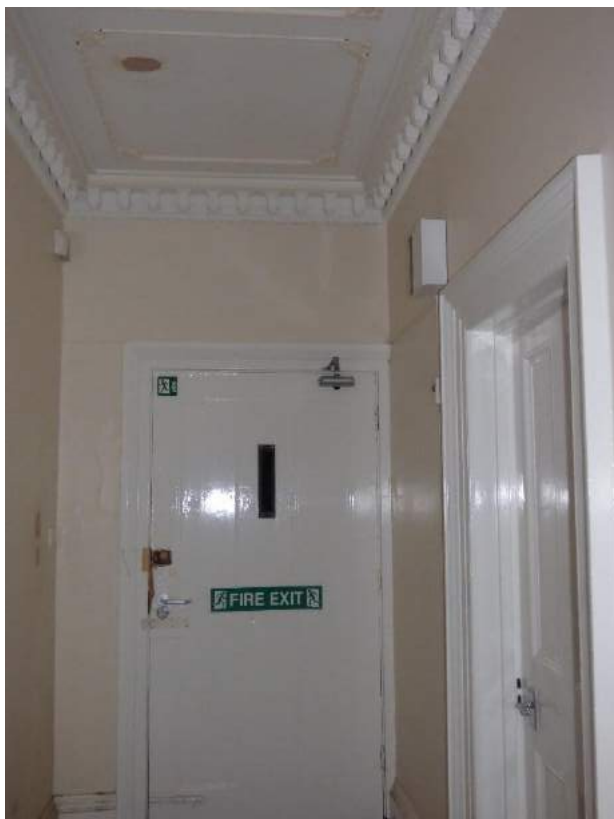
Left: Period features to be retained, including archway and architraves. (Modern lighting to all be stripped out and make good services./ All architraves and plaster features to be retained.
