Bat Survey

Former Natwest Bank, St George's Road, Millom

18th July 2024

Report No. 0724/4

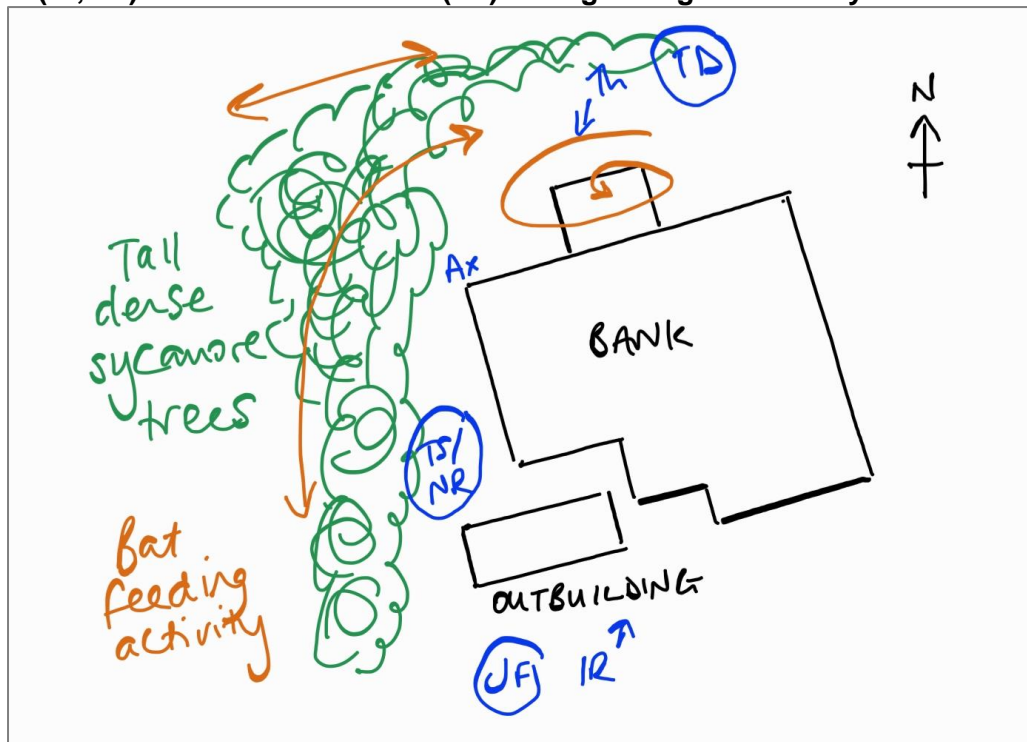
Figure 3. Sketch showing bat activity and position of surveyors (TD, JF and NR/TS), cameras (IR, Th) and Anabat recorder (Ax) during emergence surveys.

N.B The east side of the building was scoped out of the survey as there were no potential roosts identified in this area, and it was very well lit by streetlights. No activity was seen along the front of the building by TD in either survey.

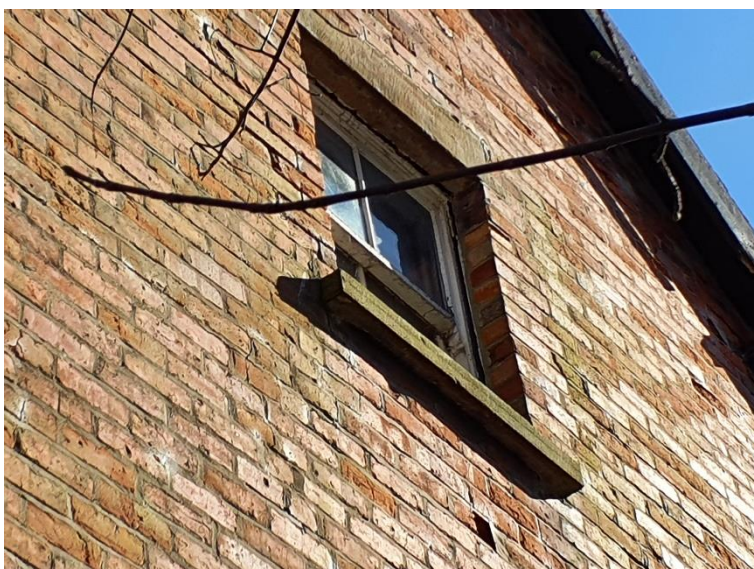
Roosting potential was identified around the wooden window frame of the upper floor window (rear elevation) and under slates on the rear and south elevations where slates have slipped, or where gaps are present along the rakes, and under slates on the outbuildings.

Image 6.
Window on rear
elevation where
brickwork has
bowed out creating
gaps around the
wooden frame
suitable for
roosting bats.

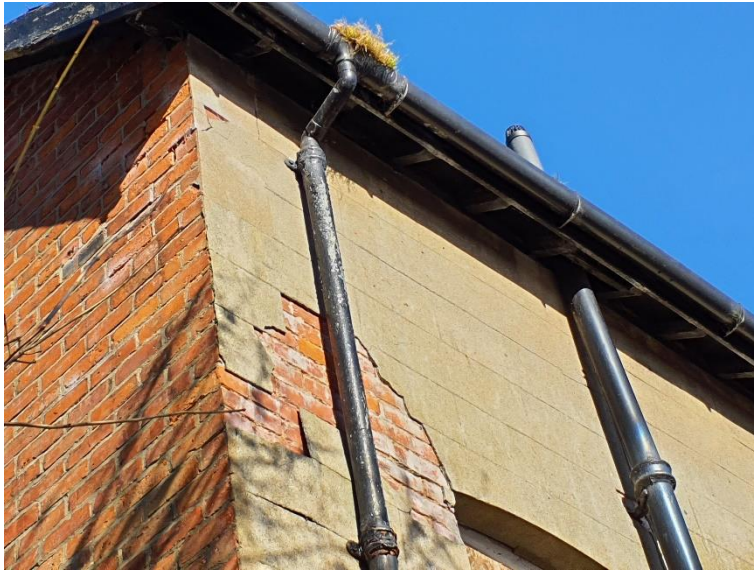
Image 7.
South-west corner of the building where the render has crumbled to reveal brickwork. No gaps at wall tops seen.

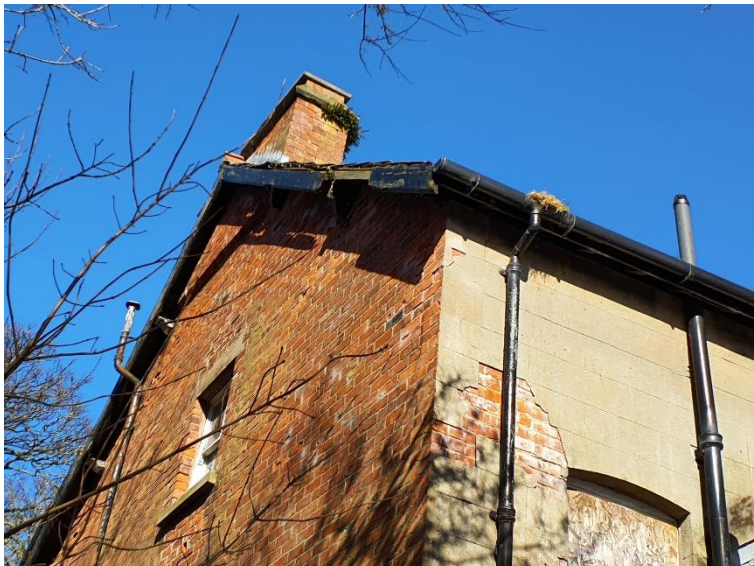
The roof slates are generally all in place and tightly fitted together (especially on the steeper pitches of the front elevations). Some missing slates were noted on the side (north) elevation in the structural report – but these could not be seen due to the covering of snow on the inspection date. There were gaps noted along the rakes on the rear and south elevations where the barge boards had rotted away.

Image 8.
West elevation showing gaps along the rakes where the boards have rotted – potential for use by bats.

As there is a good level of pipistrelle activity in the vicinity of the building, several potential roost sites in the roof of the building, and bats can often change roost site or exploit new ones (even on a temporary basis) – a precautionary approach is recommended for the re-roofing work.

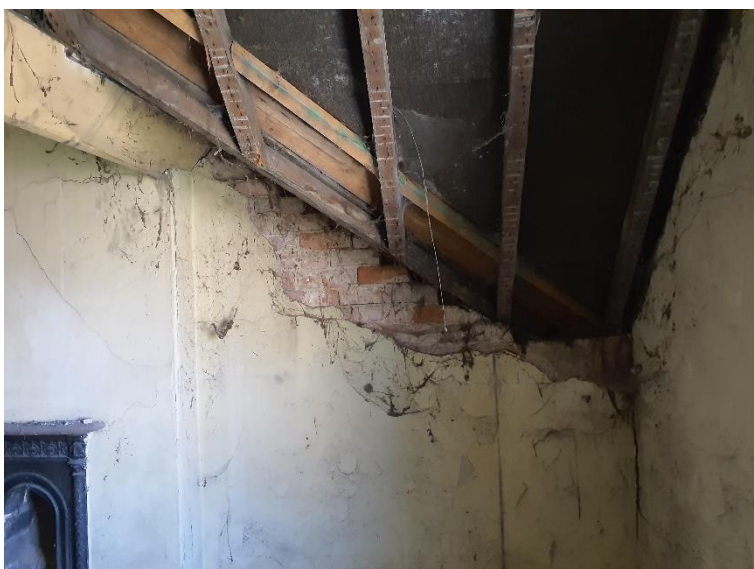
Image 9.
Second floor of property, showing poor condition of rooms on this floor, and clearly visible roof timbers.

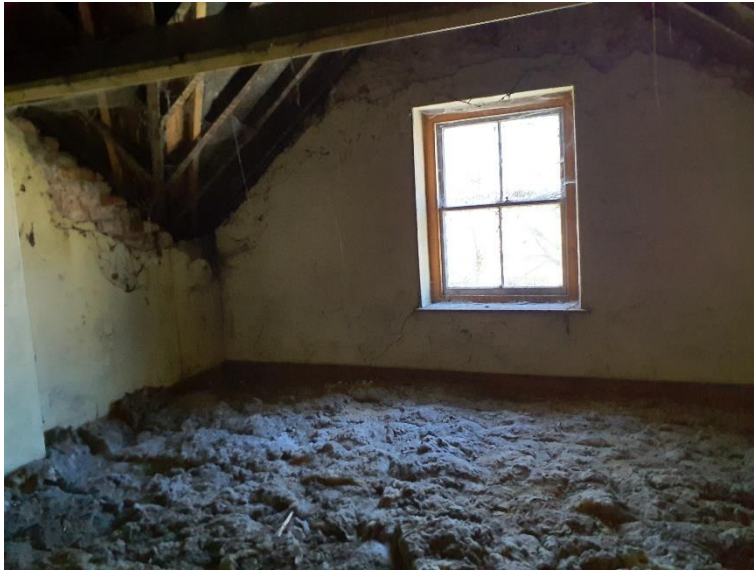
Image 10.
Second floor room, showing crumbled mortar around eaves, and the roof insulation covering all the floorboards.

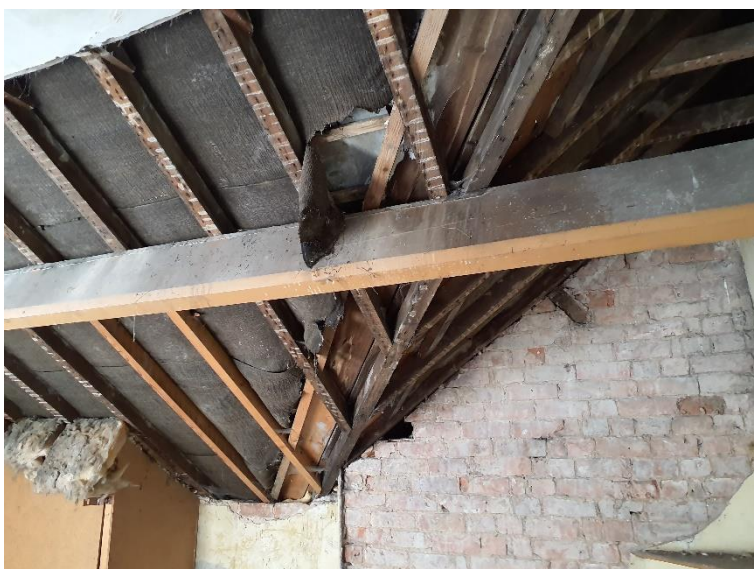
Under the roof slates the roofing felt was in good condition in most parts of the void, with few tears or sags. Daylight could be seen in places where slates were missing, and at the eaves – but the majority of the voids were fairly dark. The roof voids were of varying height, depending how far into them the second floor rooms extended. All had extensive cobwebs around roof timbers without any insulation around the timbers or floors, and the air was very dusty.

Image 12.
Second floor room at the front of the property with tear in roofing felt. Felt in quite good condition throughout the rest of the roof area.

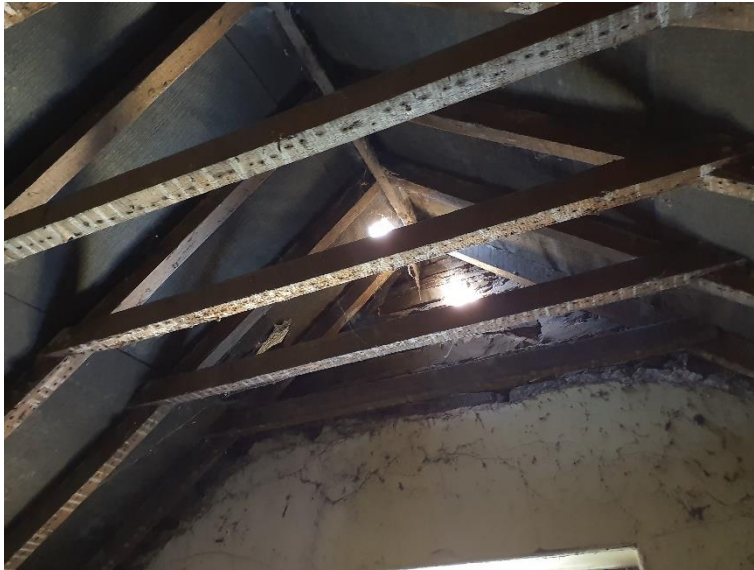
Image 13.
Roof void seen through fallen ceiling, showing missing slate (clear daylight).

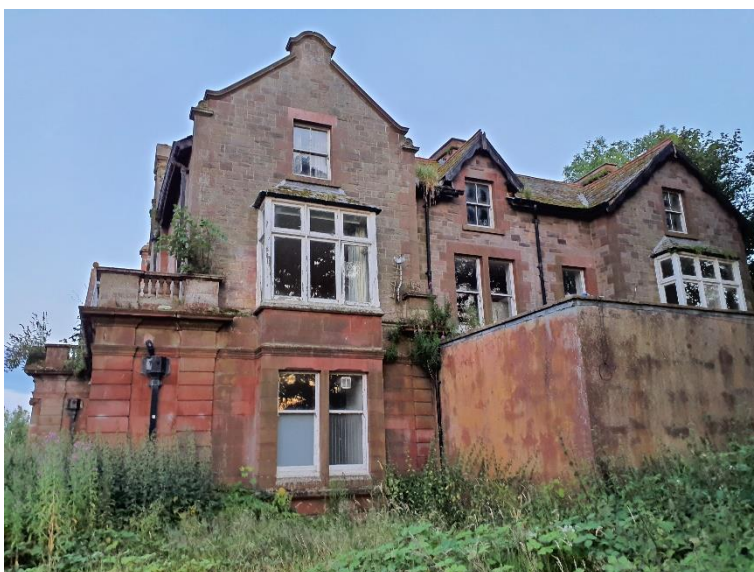
Image 15.
Image taken 16/7/24.
Showing the northern elevation of the building- much of the roof is still in reasonable condition with just a few notable gaps.

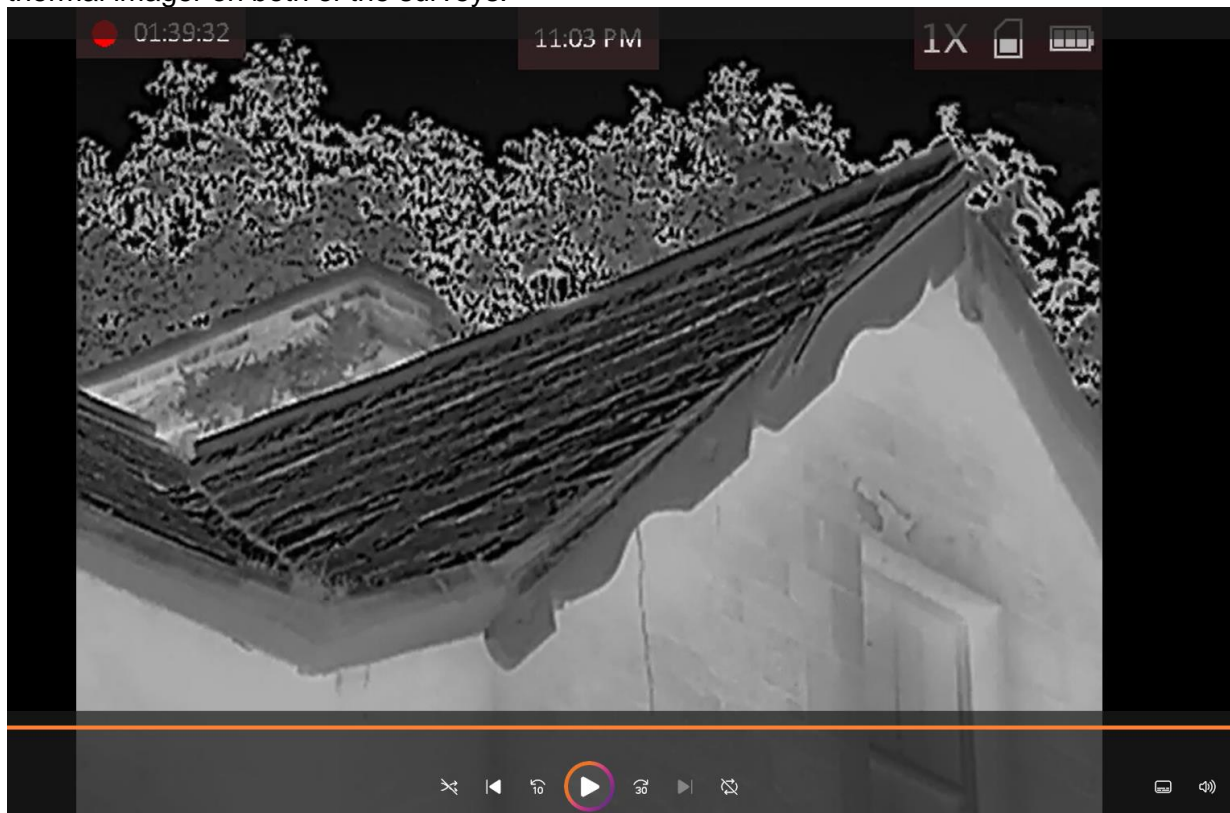
Image 17. View of the northern dormer with significant gaps around as seen through the thermal imager on both of the surveys.
