# MINOR PLANNING AMENDMENTS TO APPROVED CONSENT

APPLICATION REF: 4/21/2242/0L1

# **FULL RENOVATION OF EXISTING No 11 TERRACE HOUSES**

St Bees, 1-11 Lonsdale Terrace, Parish Council, Cumbria

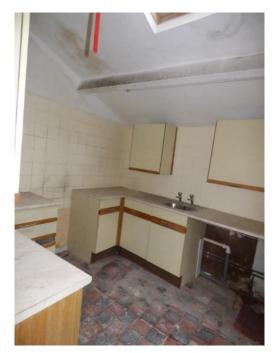
### House No 6

Left: It was proposed and approved that the existing utility spaces to be fully renovated.

All damp and damaged/blown plasterwork and repair with lime plaster (Solo lime plaster from Lime Centre) and skim and decorate throughout.

Apply an insulated plasterboard 62mm thick to underside of ceiling. The Laminated plasterboard and PIR have a vapour barrier incorporated so interstitial moisture would be prevented. New heritage style rooflights to replace existing modern style rooflights and to be installed with flashing kit that mounts unit flush with the roof surface.

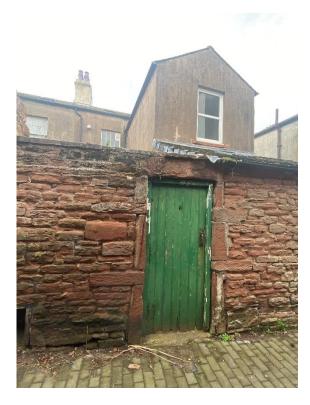
From the rear of house, no 6, a modern dry verge has been applied to the verge of the roof which is completely out of character. See below.

The roof is covered with a modern cement tile with a dry verge detail.

The current roof pitch is 15 degrees.

The proposal is to replace the rotten joists with new joists as recommended by the structural engineer as 45 x 95 C16 GR multi rafters.

The proposal is then to replace the roof itself as the detail attached, with a roof tile that is warrantied at 15 degrees. The proposal is then to apply a traditional wet verge.

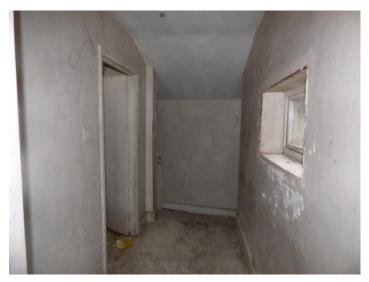
### House No 7

Left: It was proposed the existing utility and WC to be reconfigured.

Blown plasterwork to be removed and reinstated with lime plaster and skim finish.

Apply an insulated plasterboard 62mm thick to underside of ceiling. The Laminated plasterboard and PIR have a vapour barrier incorporated so interstitial moisture would be prevented. New rooflights to be installed with flashing kit that mounts unit flush with the roof surface.

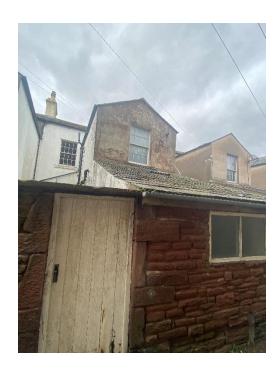
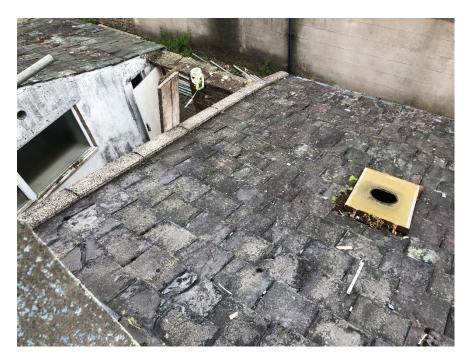
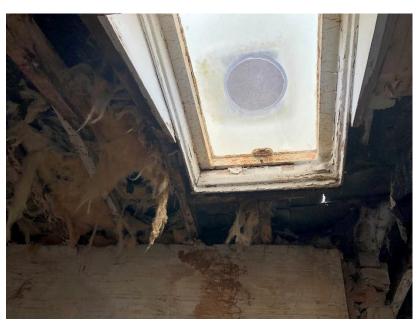
Below: It was accepted the roof above utility and w.c. requires significant repairs to slate roof and to lead flashings (which require replacement). Blown plasterwork to be removed and reinstated with lime plaster and skim finish. (Solo lime plaster from Lime Centre).

From the rear of house, no 7, a natural slate roof is the finish, however at 20 degrees – the absolute MINIMUM roof pitch, a slate roof is feasible, however the construction of this slate roof is not inaccordance with the Building Regulations as the British Standards Ref: BS 5534:2014 which require slates to be a min size of 500 x 225 with a 135mm head lap, hence why the roof is leaking and again the joists suffering considerable damage.

For the reasons outlined above the proposal is then to replace the roof itself as the detail attached with a roof tile that is warrantied at 20 degrees. The proposal is then to apply a traditional wet verge.

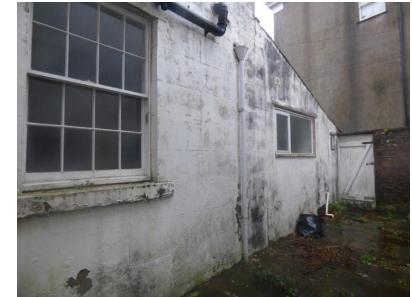
From the rear of house, no 8, a natural slate roof is the approved finish, at 20 degrees. This is the absolute MINIMUM roof pitch where a slate roof is feasible, as acknowledged by Building Regulations - British Standards Ref: BS 5534:2014. However, the roof itseld does not accord with the Building Regulations, as the same British Standard require slates to then be a min size of  $500 \times 225$  with a 135mm head lap. The low pitch along with the slate sizes, and the location of the buildings, is why the roof is leaking, leading to the considerable damage to the joists (as

demonstrated by the photographs

For these reasons, the proposed amendment to the approved plans is to replace the roof itself as shown by the detail attached above, with a roof tile that is warrantied at 20 degrees. The proposal is then to apply a traditional wet verge.

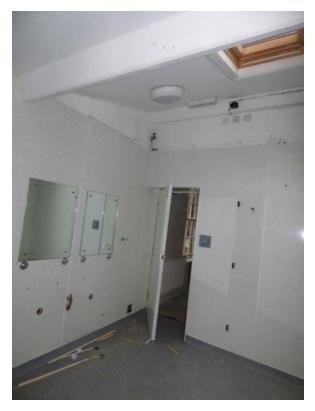
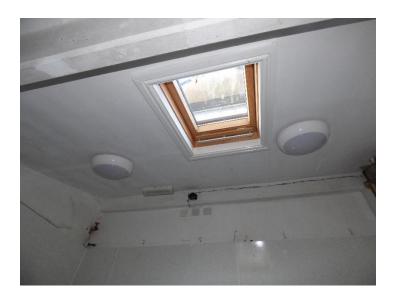
## House No 9

Left and below: The existing shower block ceilings and walls were concealed with moisture resistant boards. So while it was acknowledged that some minor repairs would be required, the extent of repairs required are far greater than envisaged, now that the existing finishes have been stripped out – please see the before and after photographs above and below.

Now that they have been exposed, it is clear that the original joists have been replaced in most of the roof, unfortunately with new joists that are completely inadequate for the loads involved, and will require replacement with suitable sized joists.

It is also noted that this roof comprises a modern cement tile that is to be replaced with slate, so as to be consistent with the other rear extensions.

The pitch to this roof is also only 17 degrees, the low pitch not only been unsuitable for purpose but also a direct contributor to the damage identified. As this is a later extension, it is proposed to raise the pitch to the minimum required level, to prevent further issues. The change would not, however, be readily apparent, if at all.

For the reasons outlined above the proposal is then to replace the roof itself as the detail attached, with a roof tile that is warrantied at 20 degrees. The proposal is then to apply a traditional wet verge.

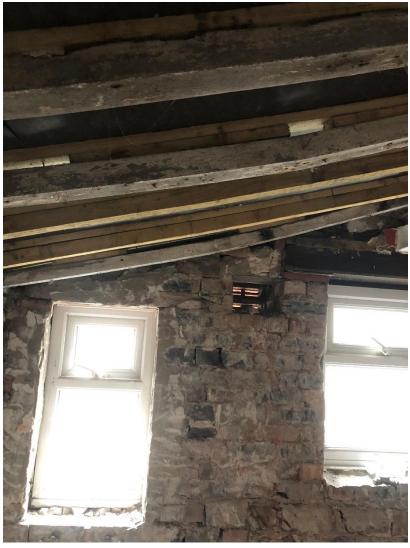
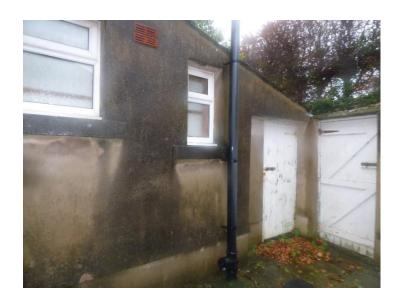
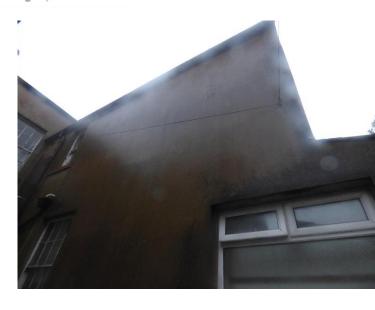
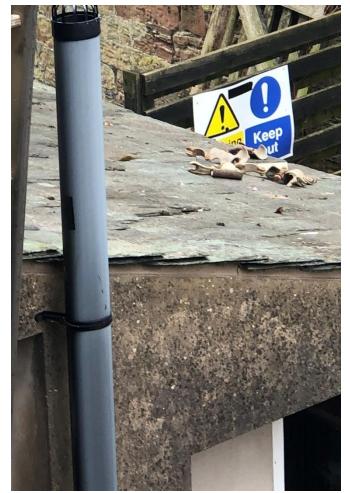
As for the other properties, once stripped out, the structure is exposed to reveal substandard rotten joists which have undergone inappropriate repairs. The joists are insufficient for the roof load and will require replacement.

The existing roof is covered in natural slate.

From the rear of house, no 10, a natural slate roof is the finish, however at 20 degrees – the absolute MINIMUM roof pitch, a slate roof is feasible, however the construction of this slate roof is not inaccordance with the Building Regulations as the British Standards Ref: BS 5534:2014 which require slates to be a min size of 500 x 225 with a 135mm head lap, hence why the roof is leaking and again the joists suffering considerable damage.

As identified previously, not only does the roof not conform with Building Regulations, but this has led to the issues identified, and the works required. In order to prevent them from reoccurring in the future, the proposal is to replace the roof itself as per our detail attached, with a roof tile that is warrantied at 20 degrees. The proposal is then to apply a traditional wet verge.

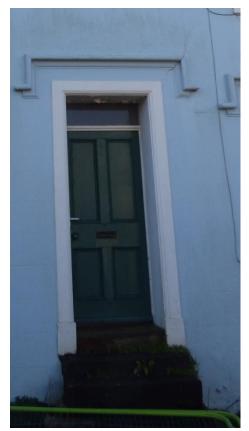
Letterbox aperture to be retained in existing position – but no letterbox to door.

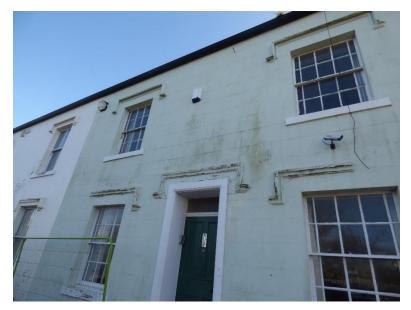
Letterbox to house no 2 is completely impractical as the aperture is too small for post. Given that this is a later addition, it is proposed to retain the position but replace the letterbox with a more appropriate version (as detailed).

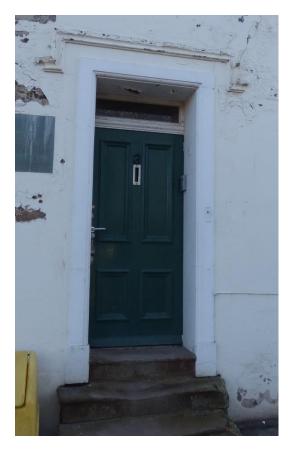
Like House no 2 - The letterbox to house no 3 is a completely impractical later addition. The proposal is to retain the position but lengthen and replace with heritage metal work.

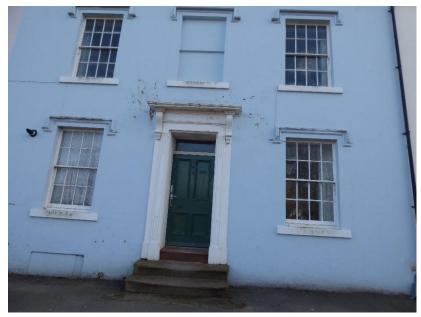
The letterbox to house no 4 appears to be another later addition, but this time is completely impractical as not only is the aperture far too small for post but very

impracticably located. The proposal is to restore the door to its previous condition and locate a new letterbox in the mid rail as house no 1.

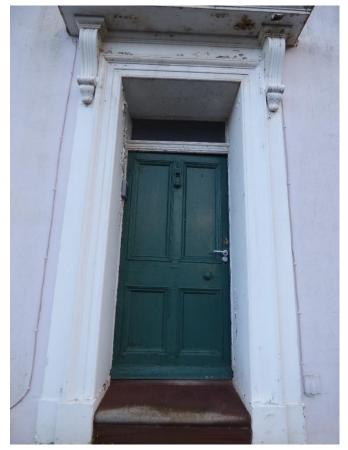
There is no letterbox to house no 5 – so a letterbox is required to be installed. The proposal is to restore the door to its previous condition and locate a new letterbox

in the mid rail as house no 1

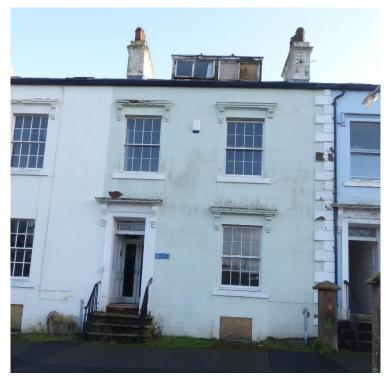
There is no letterbox to house no 8-so a letterbox is required to be installed. The proposal is to restore the door to its previous condition and locate a new letterbox in the mid rail as house no 1

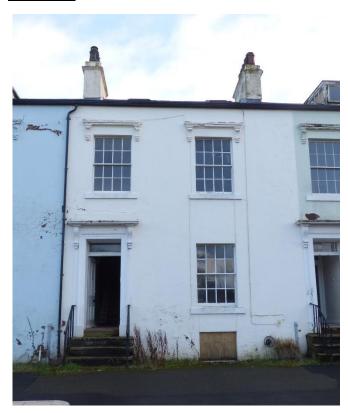
Like Houses no 2 and 3 - The letterbox to house no 9 is completely impractical as the aperture is too small for post. The proposal is to retain the position but replace the letterbox.

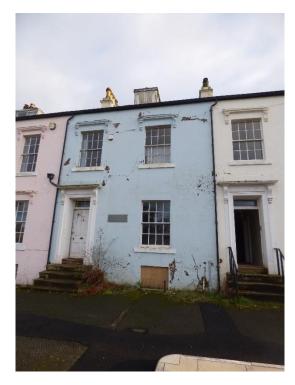
The existing letterbox is incredibly small – so while it is proposed to retain the Letterbox in its existing position – it is proposed to increase the aperture and a new letterbox to be provided to match the other houses in the street.

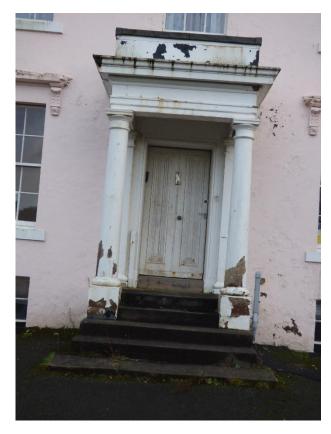
Like Houses no 2, 3 and 9 - The letterbox to house no 11 is completely impractical as the aperture is too small for post. The proposal is to retain the position but replace the letterbox.

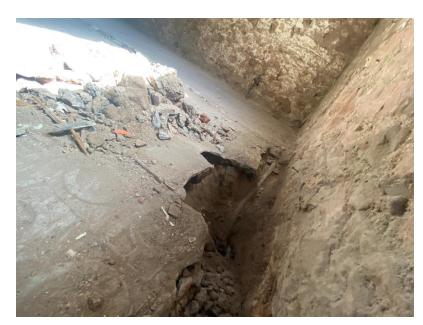
### House no 6

Obviously, this is not a suitable substrate for the loads which will be applied to a domestic floor, and the floor is likely to subside and break up. Our proposal is to sensitively remove the existing slabs and provide and install new floors to these areas as specified in the sketch (right).

Left: Exposed floor to proposed kitchen and utility.

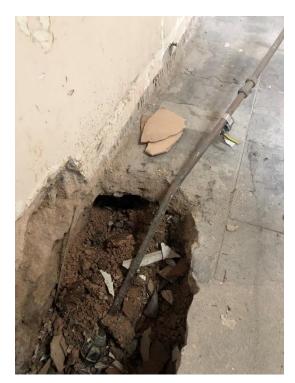
Left: Exposed floor to proposed kitchen and utility.

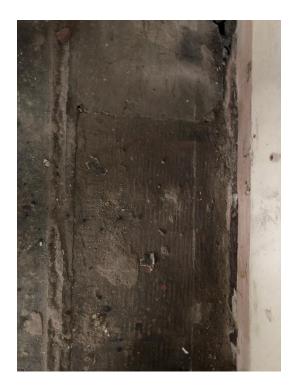
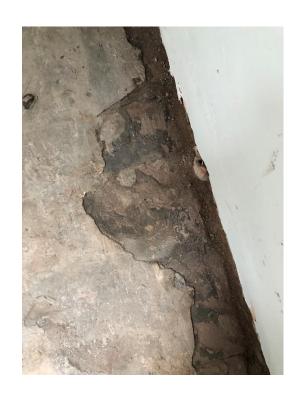
# House no 8

Above: Kitchen

and utility floors

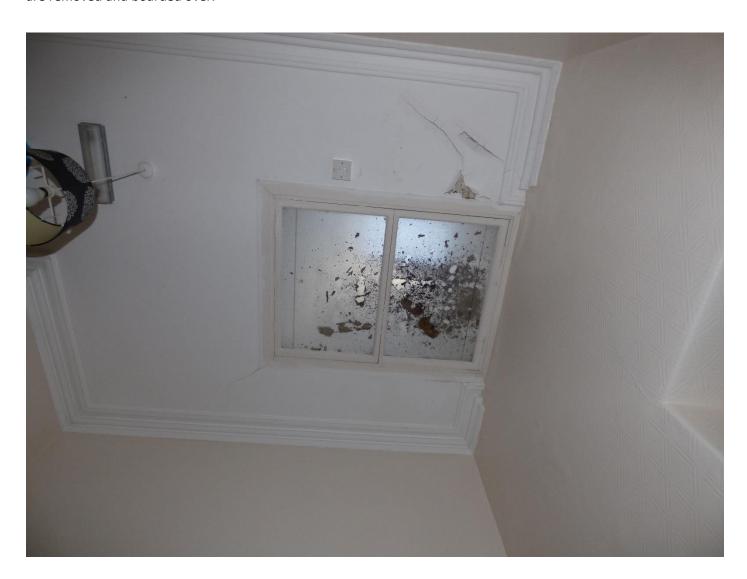
Above the staircases in properties 7, 8, 9 and 10 on the landing is a glazed light in the ceiling to bring natural daylight into the property. The glass to all properties requires carefully taking out and cleaning, however this will always be a problem. Given the location at the top of the stairs – this is acknowledged as being a hazardous process to undertake. Health and safety have suggested for the safety of the properties and their end users that these features are removed and boarded over.

Above: House 7 ceiling light.
