# St. Bega's Chapel, Cleator Moor

BS5837:2012 Tree Survey and Arboricultural Impact Assessment

October 2021

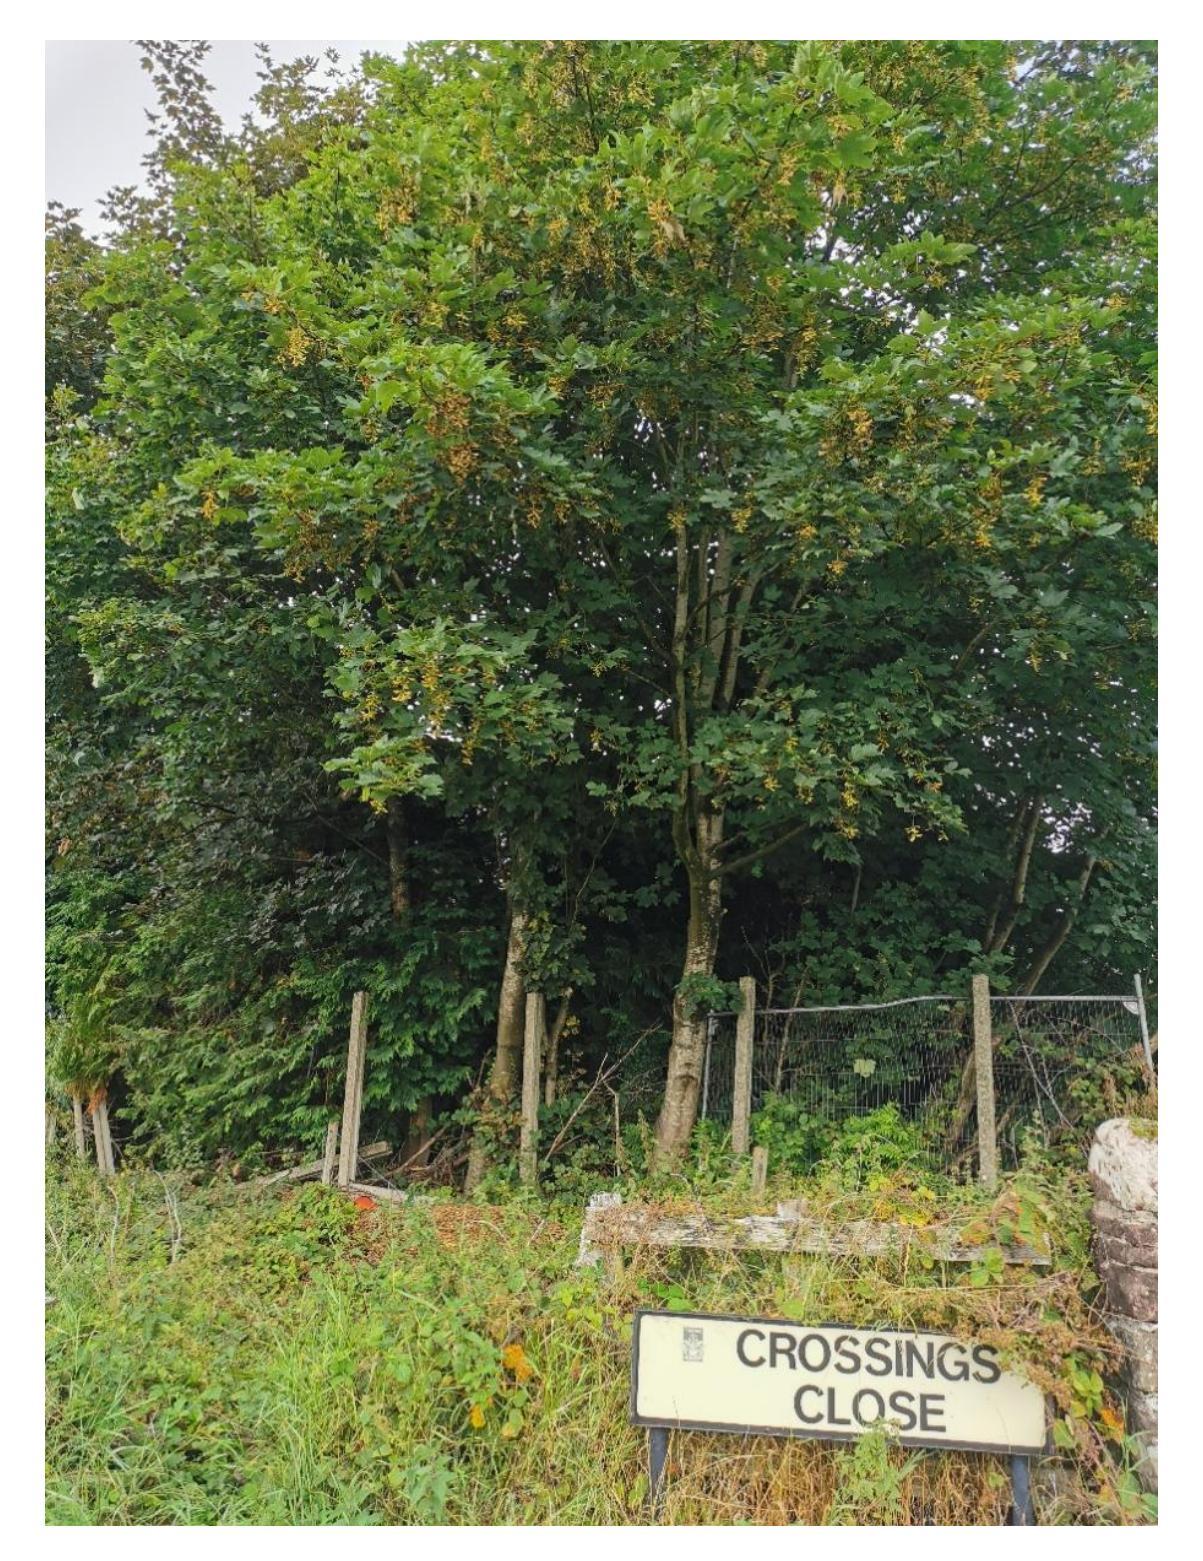
Plate 1: T1, T2 and T3.

T1, T2, T3 exist as an extension of G1 and at the northern most tip of the group. These are not significant landscape or amenity features and are of no significant stature in the immediate surrounding landscape. They are exhibiting a generally good overall condition but with no special merits.

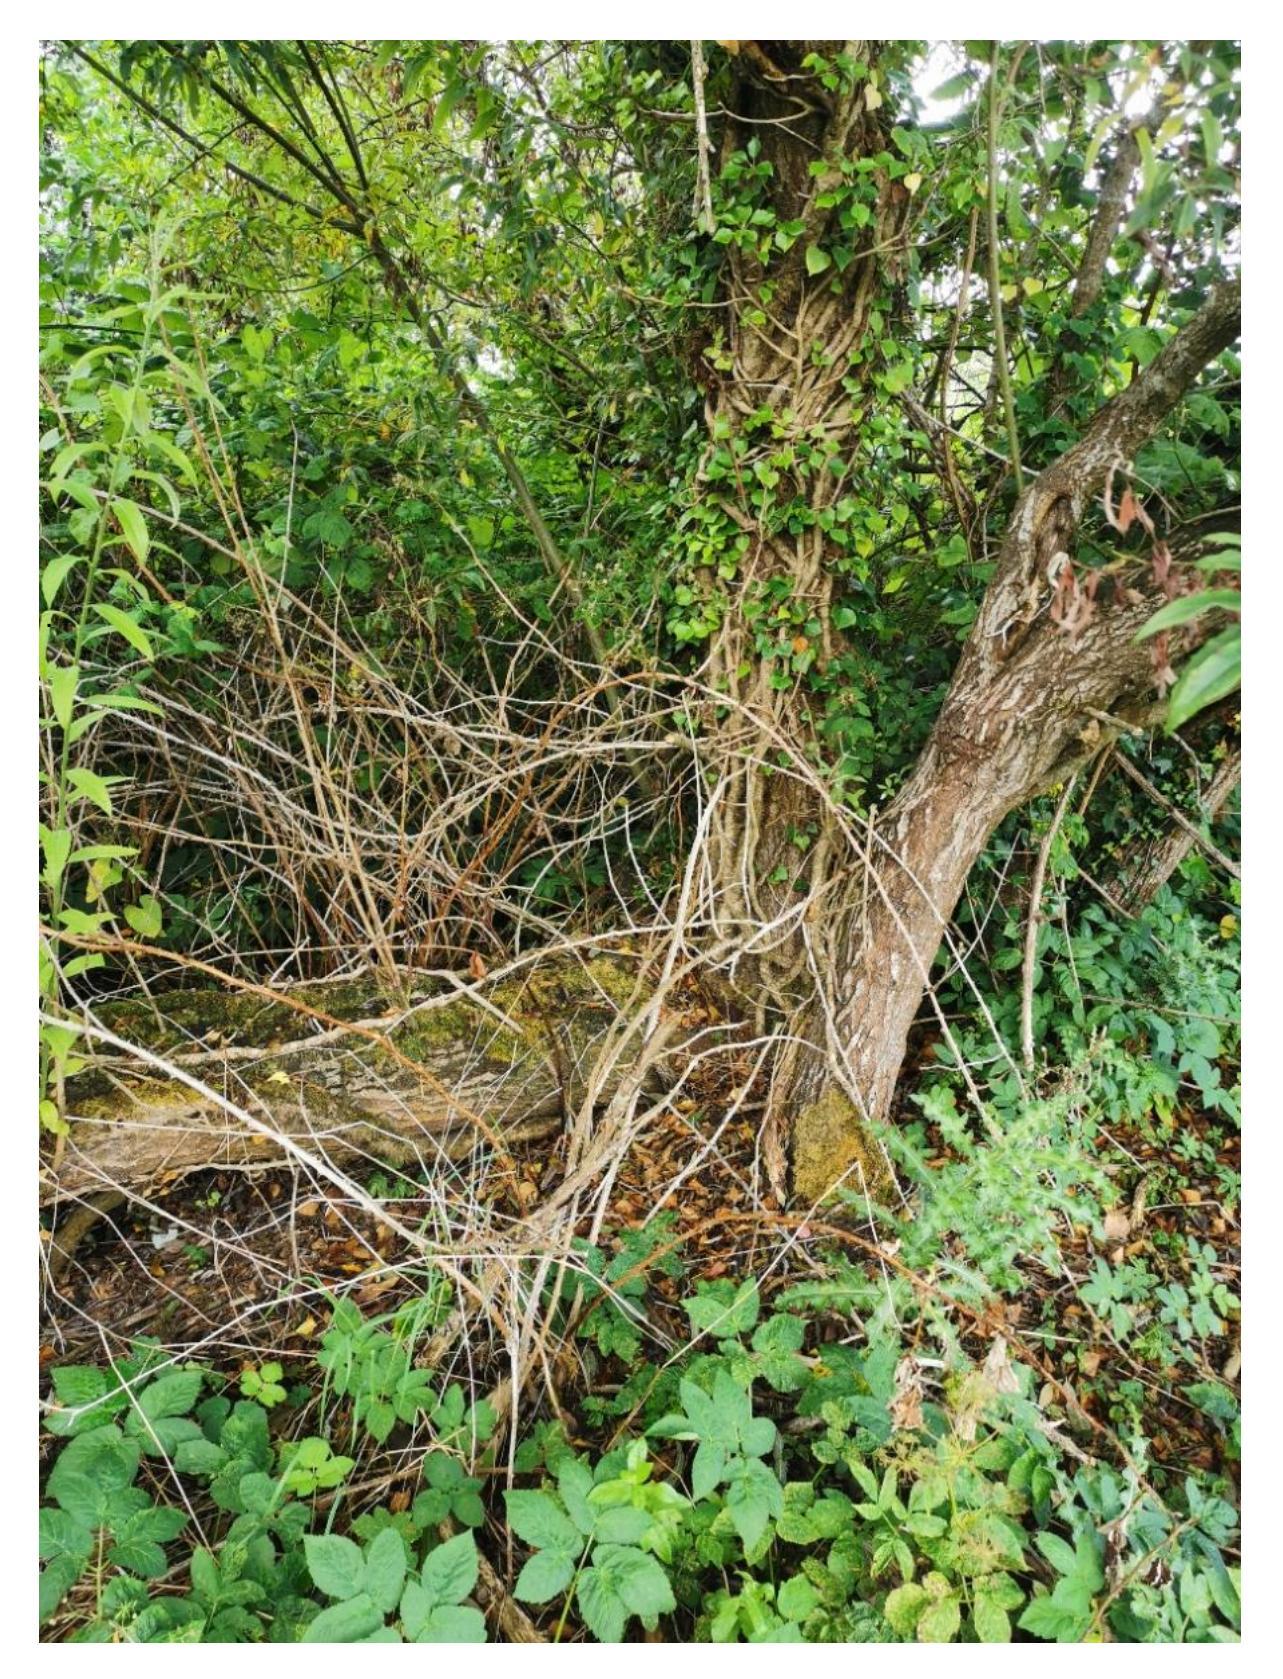
**Plate 2:** ⊤4.

T4 is a partially collapsed crack willow tree close to the south-eastern border, again with no special merit or stature within the landscape.

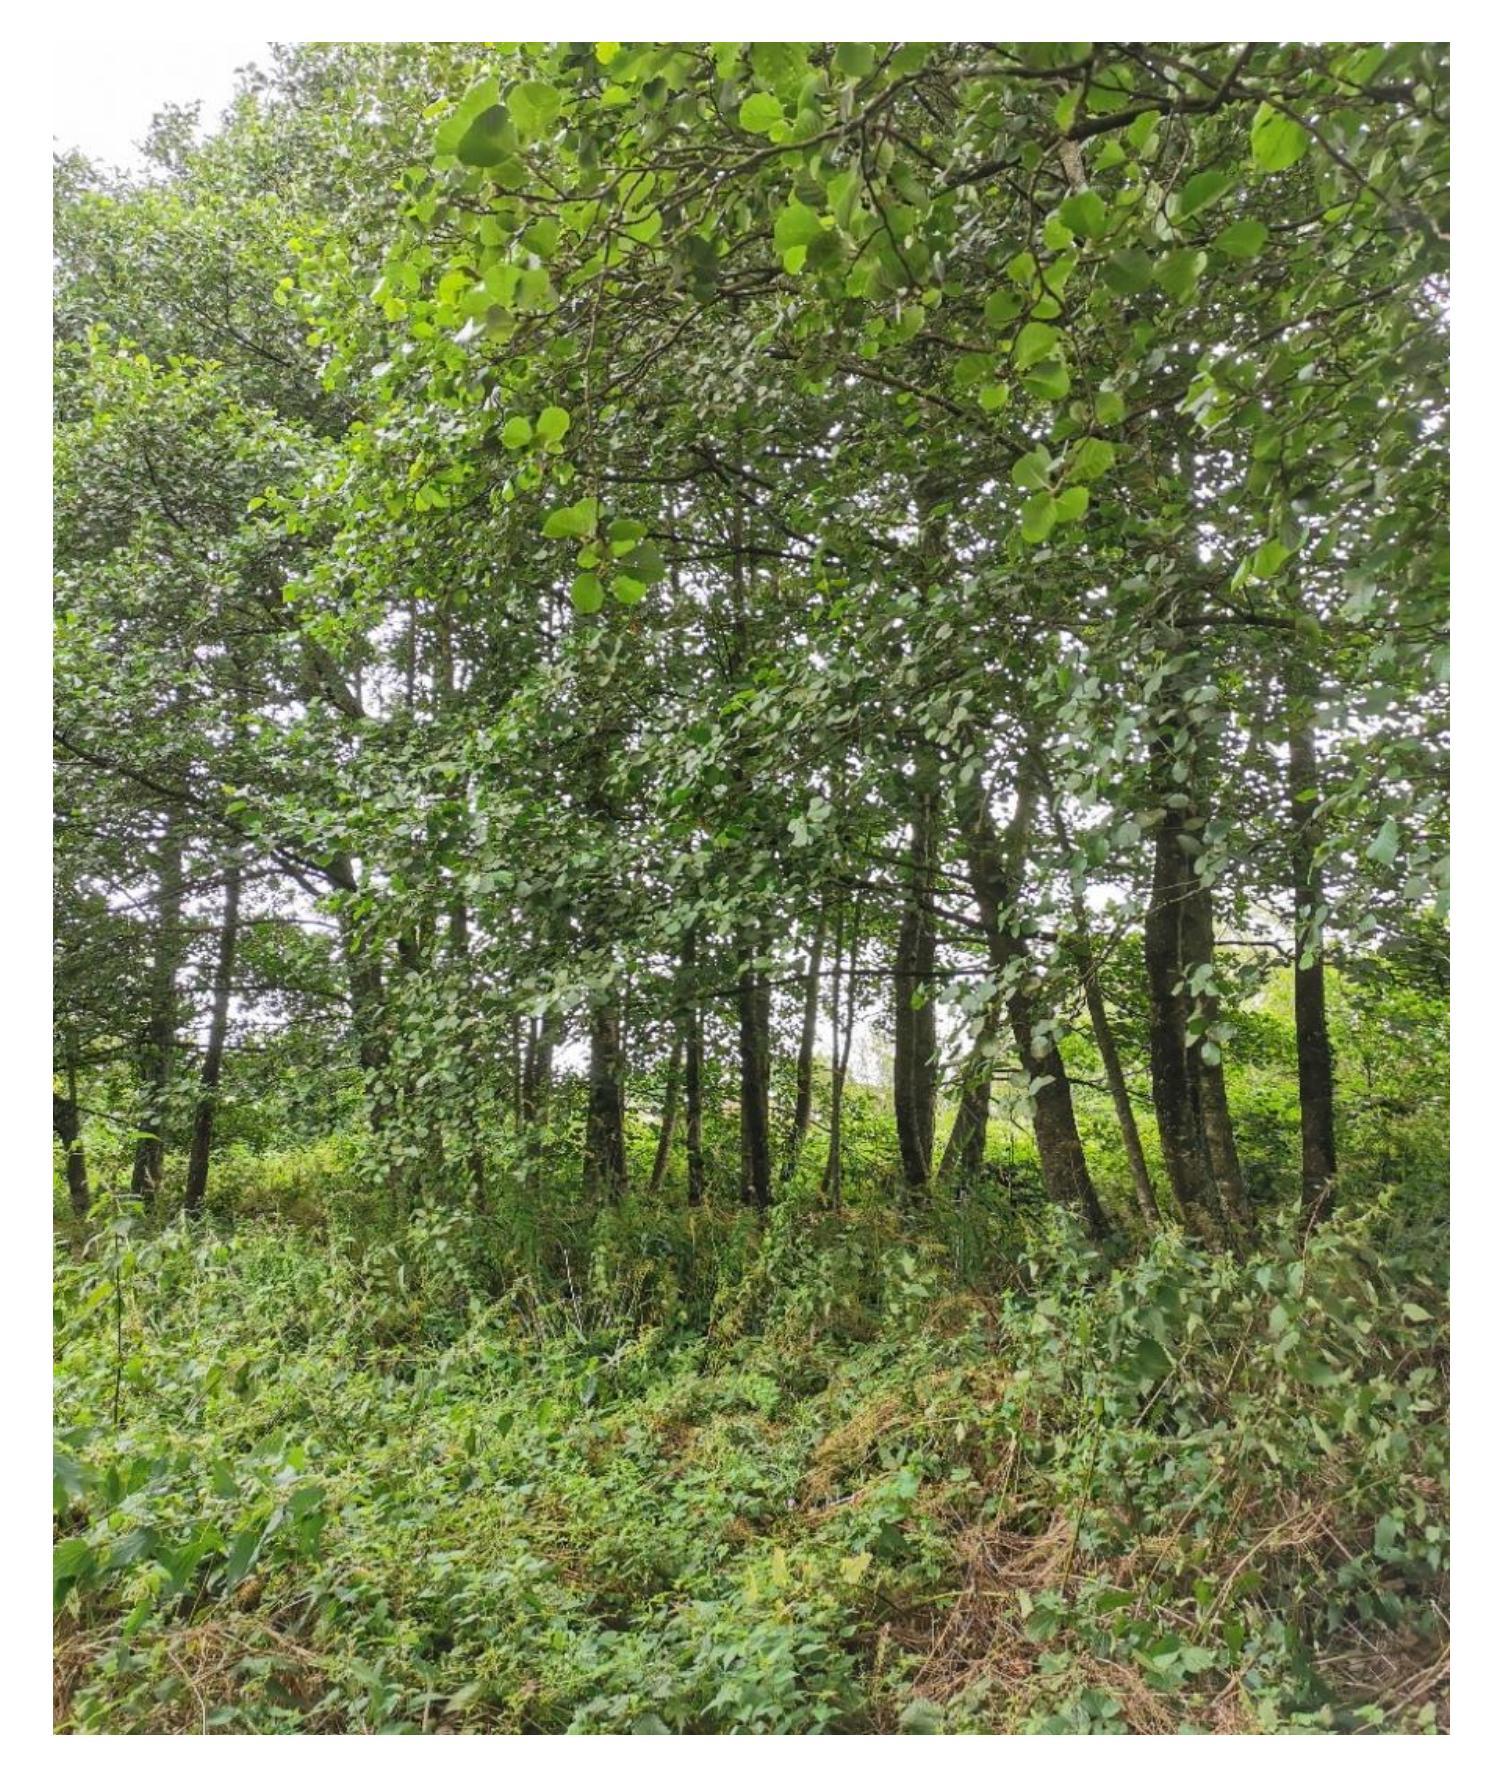
Plate 4: G2.

G2, a small copse of common alder trees, existing at the far south of the site, exhibiting a generally good condition but with no special merits.
