LAKELAND
TREE CONSULTANCY
ARBORICULTURAL PLANNING SPECIALIST

BS5837 Tree Survey

Underwood

October 2023

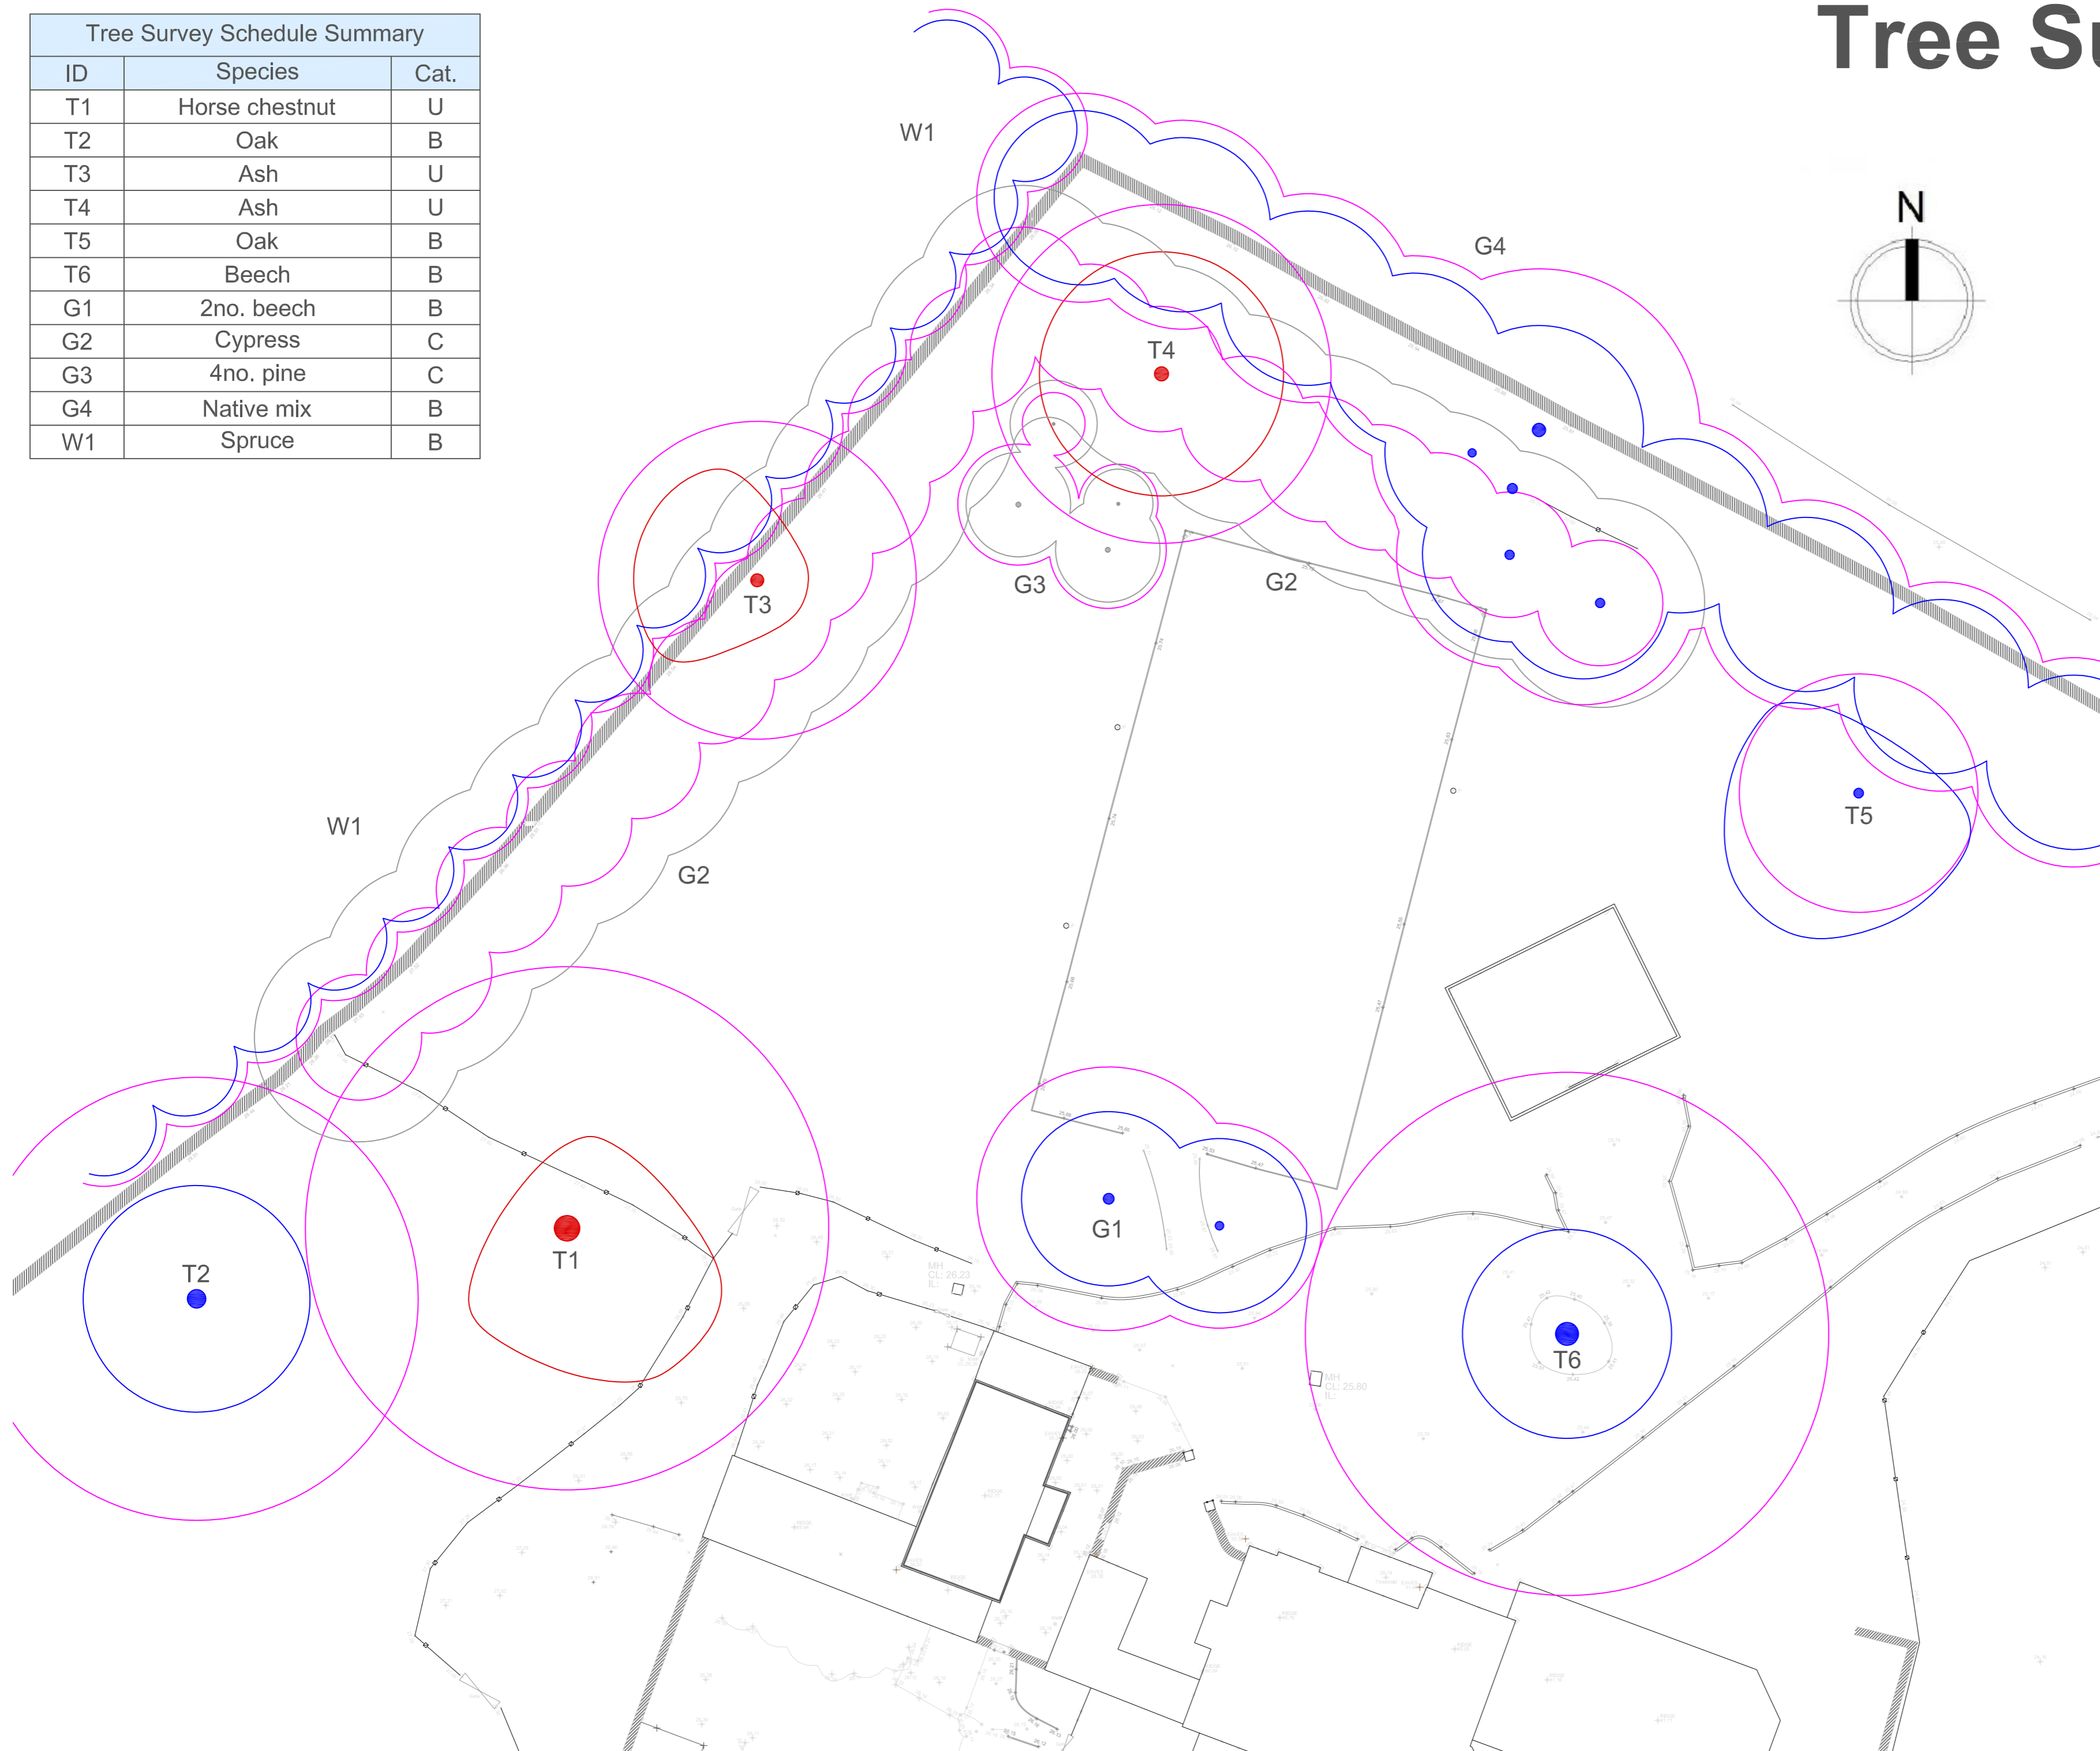
Drawing: LTC237-TSP

Tree Survey Schedule Summary		
ID	Species	Cat.
T1	Horse chestnut	U
T2	Oak	B
T3	Ash	U
T4	Ash	U
T5	Oak	B
T6	Beech	B
G1	2no. beech	B
G2	Cypress	C
G3	4no. pine	C
G4	Native mix	B
W1	Spruce	B
