TREE SURVEY REPORT

PROPOSED RESIDENTIAL DEVELOPMENT

Rheda Cross, Frizington, CA26 3TA

Revision C 24.03.25

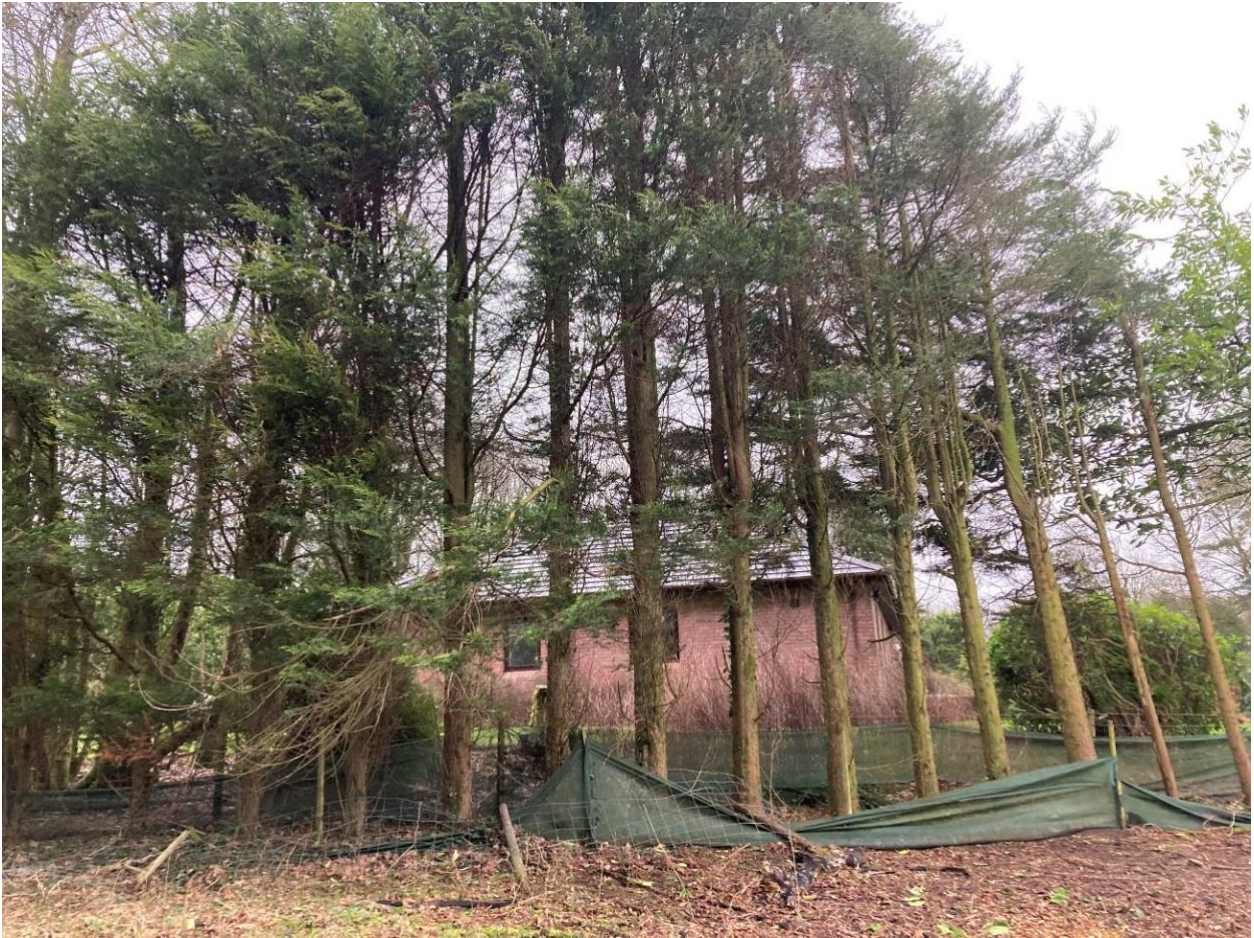
15. Tree T560 Sycamore
